FIELD SURVEY ON DAMAGES IN THE EPICENTRAL AREA OF THE EARTHQUAKE (M = 6.2)

by S. OKAMOTO

C. TAMURA

On 16th October, 1970, the south-eastern area of the Akita prefecture in the north-eastern district of Japan has suffered the earthquake of M = 6.2. Authors have carried out the field survey on damages due to the earthquake mainly in the epicentral area.

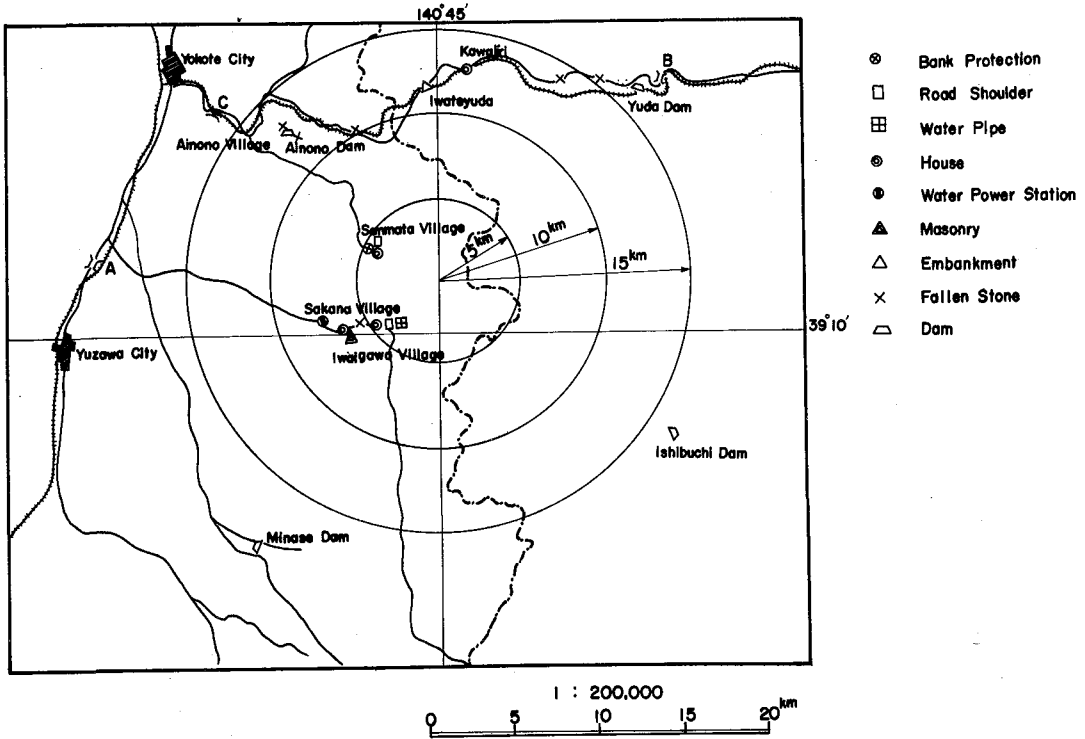
Fig. 1 Distribution of the Damages

Damages of the structure are as shown in Fig. 1. Number of the damages at any particular site may generally depend upon the number of the structure existing indicating there by that the intensity of the earthquake do not always relate directly with the distributions of the damages in some cases. But author's survey shows that damages of the structures have mainly been found out in the narrow long area lying from the Iwaigawa village to the Kawajiri village via the Sanmata village.

Fallen stones were found in places as shown in Fig. 1.

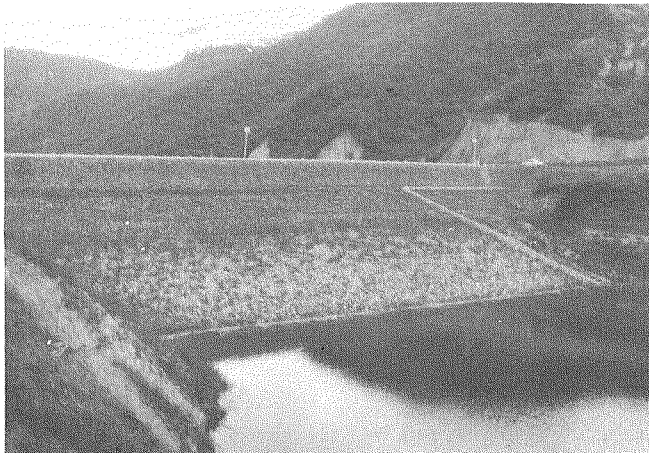
Photo. 1 View of the upstream side of the Ainono Dam

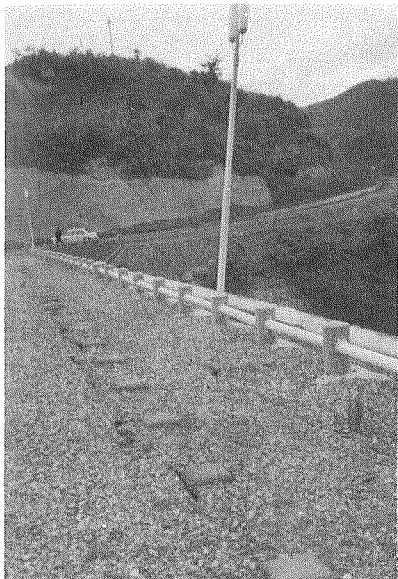
As regards the damages of the dam body, there were only 2 fissures with ca. 30 m length along the dam axis at the top. These fissures may have been caused by the shape of the upstream-face near the top, that is, the masonry parapet wall with 4 m height was built vertically at the upstream side of the top. No other damage was found out in the dam, except the intake tower suffered some damages. This is a hexagonal reinforced concrete structure. In control room at the top of the tower, walls were found cracked, and the glass of the windows were broken down etc.

Photo. 2 Fissures on the top of the Ainono Dam

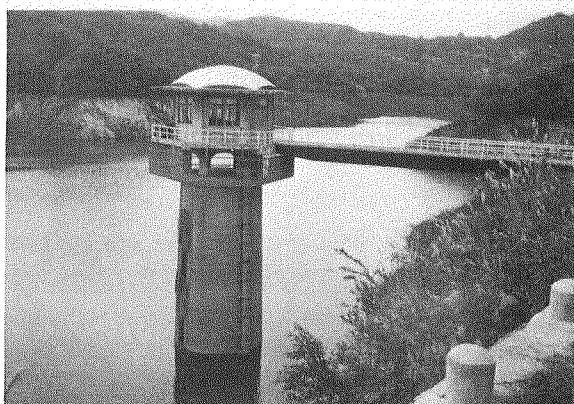
Photo. 3 Intake tower of the Ainono Dam

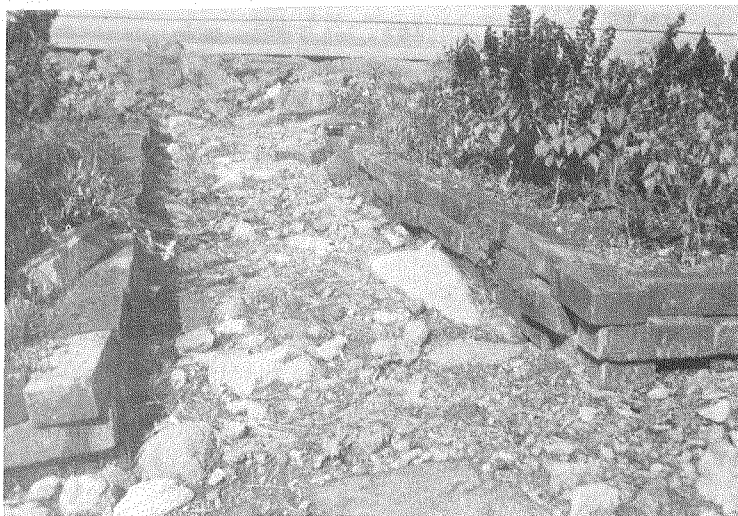
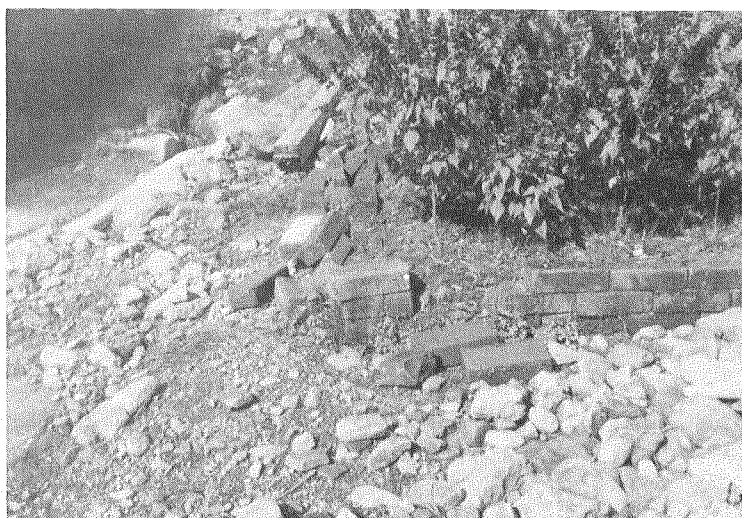
This village is located at the epicentral area. 10 or more domestic houses were found shattered at the foundations that are generally masonry works and several houses slid about 10 cm on the foundation.

Photo. 4 and 5 show brick works slid by the earthquake. Frictional coefficient of the brick obtained by the simple test at the site was about 0.55. Even if the vertical ground motion taken into account the horizontal max. acceleration seems to exceed 300 gals.

Photo. 4 Slip of the brick laying, the Sanmata village

Photo. 5 As Photo. 4

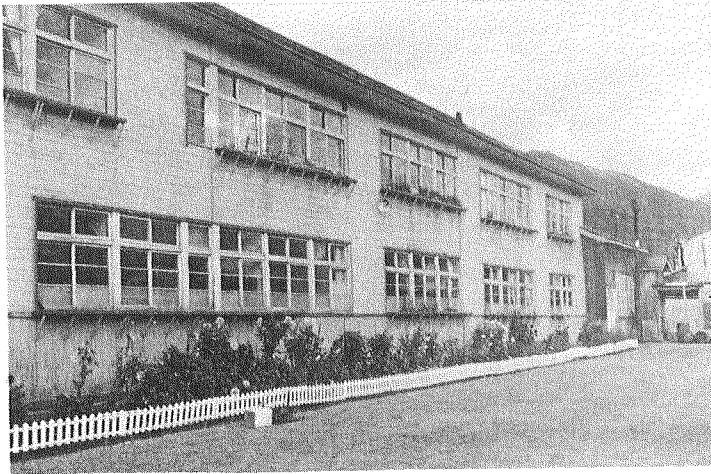
Photo. 6 The school structure suffered no damage,
the Iwaigawa village

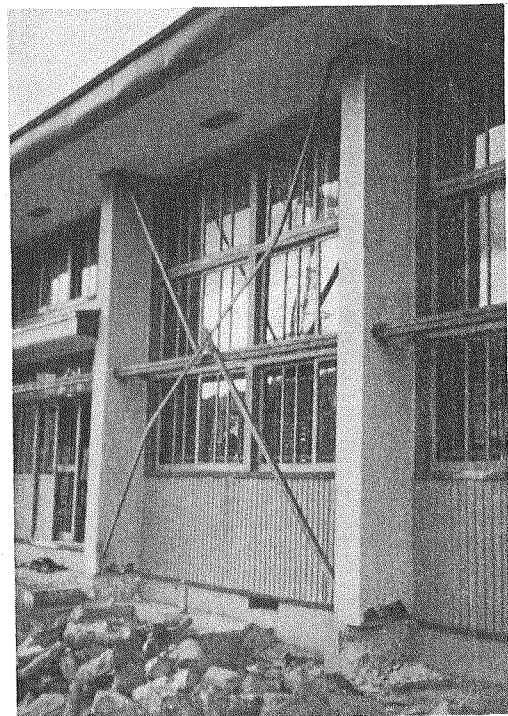
Photo. 7

The wooden school structure suffered no damage but the attached gymnasium made of light gage steel frame was damaged as shown in Photo. 6 and 7. Diagonal members for reinforcing were broken due to shearing off of the rivets, and interior wall plates waved and fell down.

Diagonal member broken due to
the shock, the the gymnasium of
the same school as Photo. 6

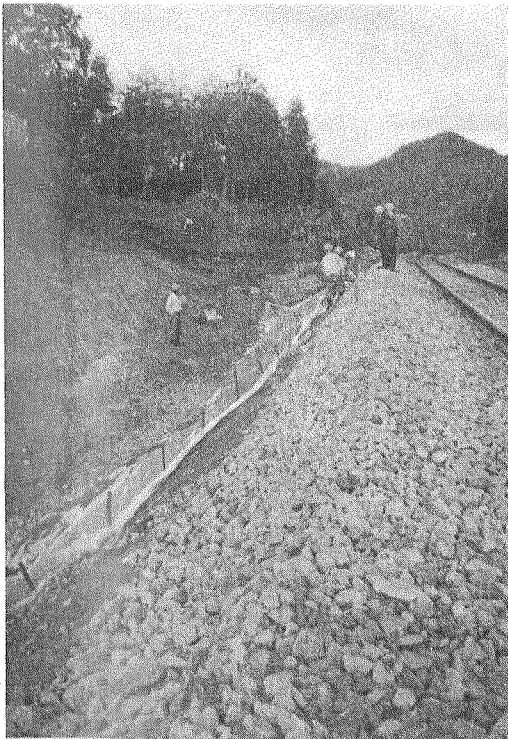
Photo. 8

Several bankings suffered by the earthquake. Heavy damage of the banking was found at some hundreds meters from the Iwateyuda station, J.N.R. This railway banking is 6 - 7 m in height and constructed on the soft ground. Due to the earthquake the slope slipped at the toe and settled down flatly.

The banking that settled down flatly due to the earthquake has been immediately reconstructed, near the Iwateyuda station.

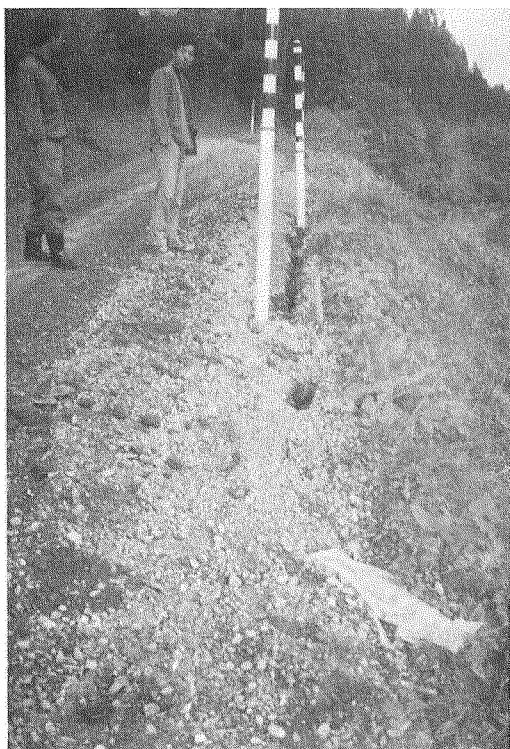
Photo. 9

Near the end of the Sanmata village, we found out the road with cracked road shoulder.

The cracked road at the shoulder
