SOIL LIQUEFACTION AND DAMAGE TO SOIL STRUCTURE
DURING THE EARTHQUAKE OFF MIYAGI PREFECTURE ON
JUNE 12TH, 1978

SYNOPSIS

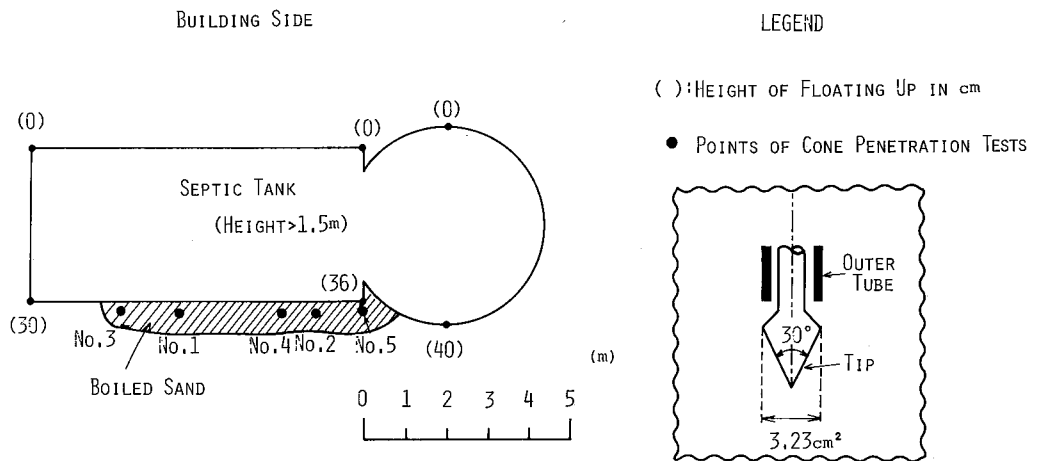
Fig.2. Floated up Septic Tank at Arahama, on the Right Bank at the Rivermouth of Abukuma River

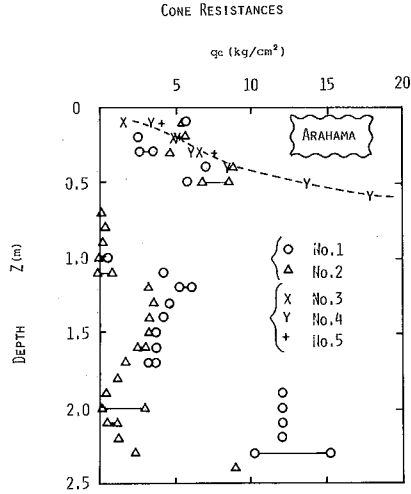
increased rapidly with depth as in ordinary sandy deposits. But at two points, resistances did not increase with depth (to 2.5 m). This low resistance may be due to the formation of very loose layers in the ground as a result of dissipation of excess pore pressure.

Fig. 3. Results by Cone Penetration Tests along the Floated up Septic Tank

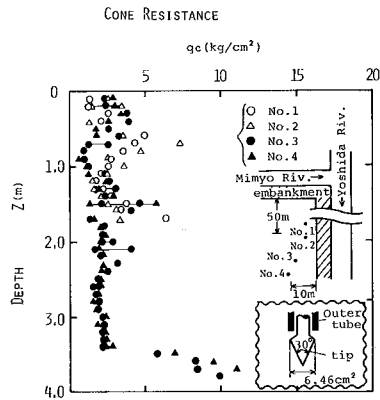
EMBANKMENT AT YAMAZAKI: The embankment on the right bank of Yoshida River settled over 5 km, the maximum settlement being 2 m. This embankment appeared to have slid due to the failure in the soft ground (Photo. 7). Cone resistances measured along the embankment were shown in Fig. 7. It can be seen from this figure that the ground underlying the embankment is very soft to the depth of 3.5 m at least.

Fig.7. Cone Resistances along Yamazaki Embankment of Yoshida River

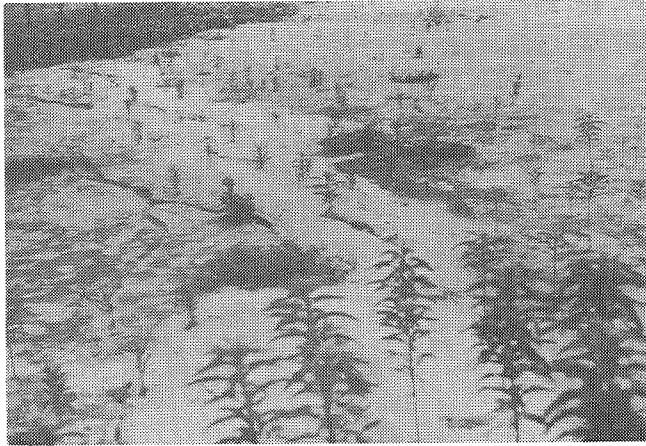
ARAHAMA: At a National Recreational Area which is located behind a sand dune on the right bank at the mouth of Abukuma River, several cracks opened during the earthquake from which water spouted (see Photo. 1). The bottom face of a swimming pool was cracked by upward flow of excessive porepressure generated during the earthquake (see Photo. 2). Also, one side of a septic tank floated up 40 cm above the ground surface as shown in Photo. 3 and Fig. 2. Sand boils were observed only on the displaced side. Cone penetration tests were conducted at five points using a double tube cone penetrometer as illustrated in Fig. 2. At three locations, resistances

Photo. 1 Boiled Sand at Arahama

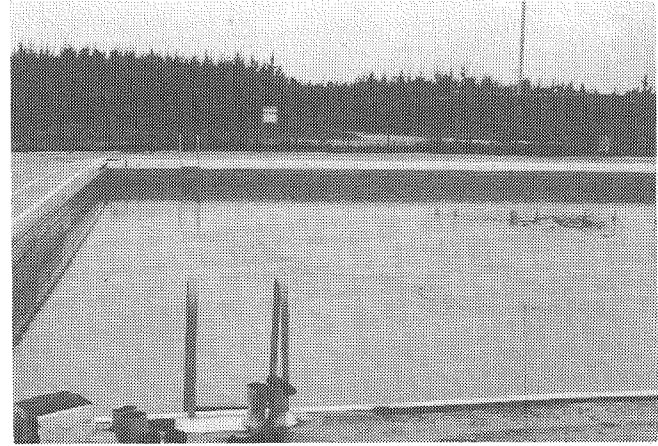
Photo. 2 A Swimming Pool Damaged by Soil Liquefaction at Arahama

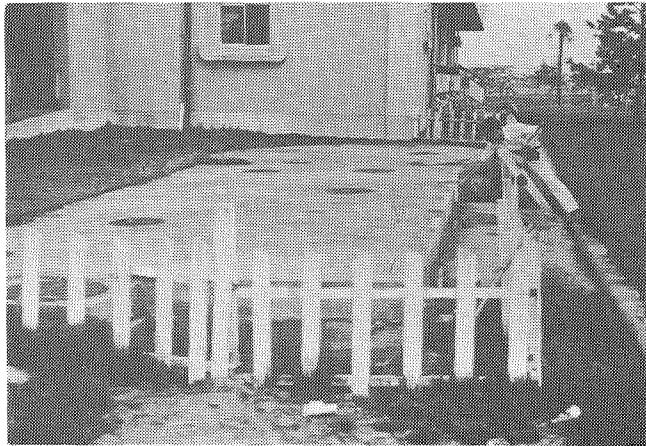
Photo. 3 A Floated Up Septic Tank at Arahama

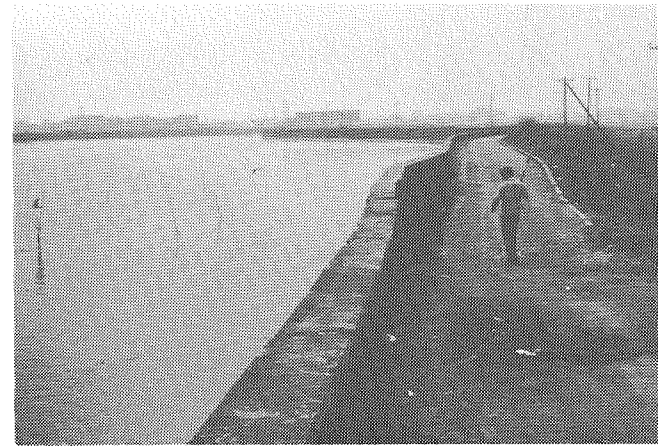
At several points along the lagoon named Torino-umi which is placed closely to the National Recreation Area, retaining walls facing to the lagoon tilted toward the lagoon and the pavements of road which is placed just behind the retaining walls settled, the maximum settlement being 2 m (see Photo. 4). At the place where the maximum settlement of road surface was observed, some boiled sands were observed just behind the tilted retaining wall, at the cracks on the ground surface along the opposite side of the pavement to the lagoon and on the ground surface nearby the cracks. Therefore, it can be considered that soil liquefaction triggered the sliding and the tilting of the retaining wall.

Photo. 4 Tilted Retaining Walls and Settle Road Faces Along Torino Umi

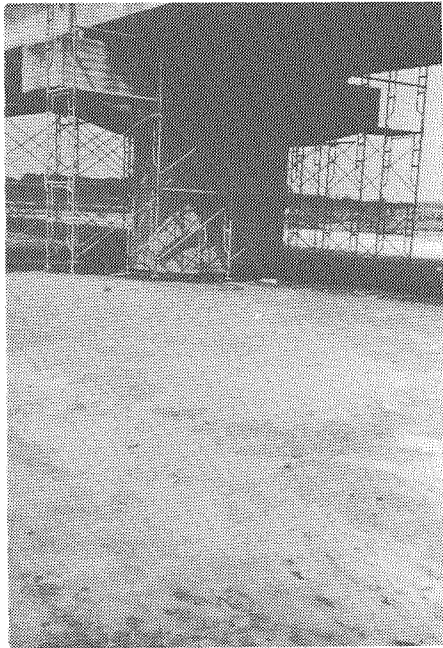
YURIAGE BRIDGE: On the narrow flood plain between the right embankment and Natori River, many cracks opened from which much water sprouted around the pier foundations of Yuriage Bridge. This bridge is placed 1.5 km upper-reach from the rivermouth. Along these cracks, boiled coarse sands were observed (see Photo. 5). It seems that at this site soil liquefaction can not be simply related with the damage to structures. Firstly, no damage to nearby embankments was observed. Secondly, while horizontal small cracks on the RC piers appeared above the ground surface which were placed between the right embankment and the river channel, much severer cracks were observed on the RC piers which were placed between the left embankment and the river channel around which no cracks on the ground and no sand boils were observed.

Photo. 5 Boiled Sand Around Yuriage Bridge

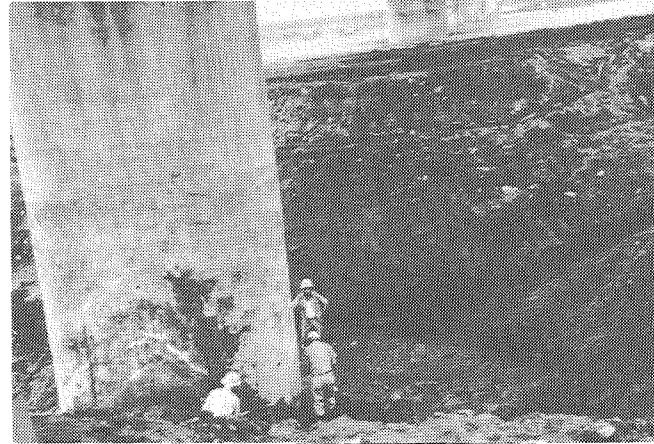
A deep trench was subsequently dug using the well-point method around the pier which is placed nearest to the embankment on the right bank (see Fig. 5 and Photo. 6). This trench was dug to check whether the underground part of the pier was damaged or not. Any crack was not observed. In the trench, loose coarse sand layer of about 2 m thick was found. By the same method as done at Arahama, in situ density of the sand layer was measured in the trench as shown in Fig. 5. As shown in Fig. 5, measured relative densities was 36% and 38% which show a loosely packed state of the sand layer. By the results of the geotechnical survey which was conducted beforehand for the design of the bridge, this loose coarse

Photo. 6 A Trench Dug Around A Pier of Yuriage Bridge

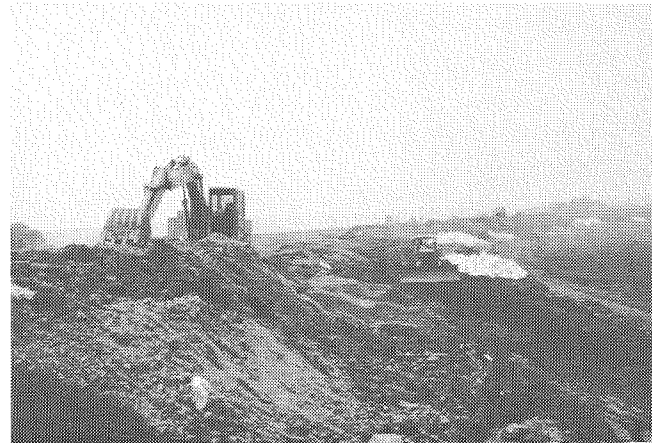
Photo. 7 Damaged Embankments Under Repairing at Yamazaki
