SEISMIC PERFORMANCE OF MEDIUM- AND HIGH-RISE REINFORCED
CONCRETE BUILDINGS TO TANGSHAN EARTHQUAKE 1976

Kaishun WANG I) and Tsuneo OKADA II)

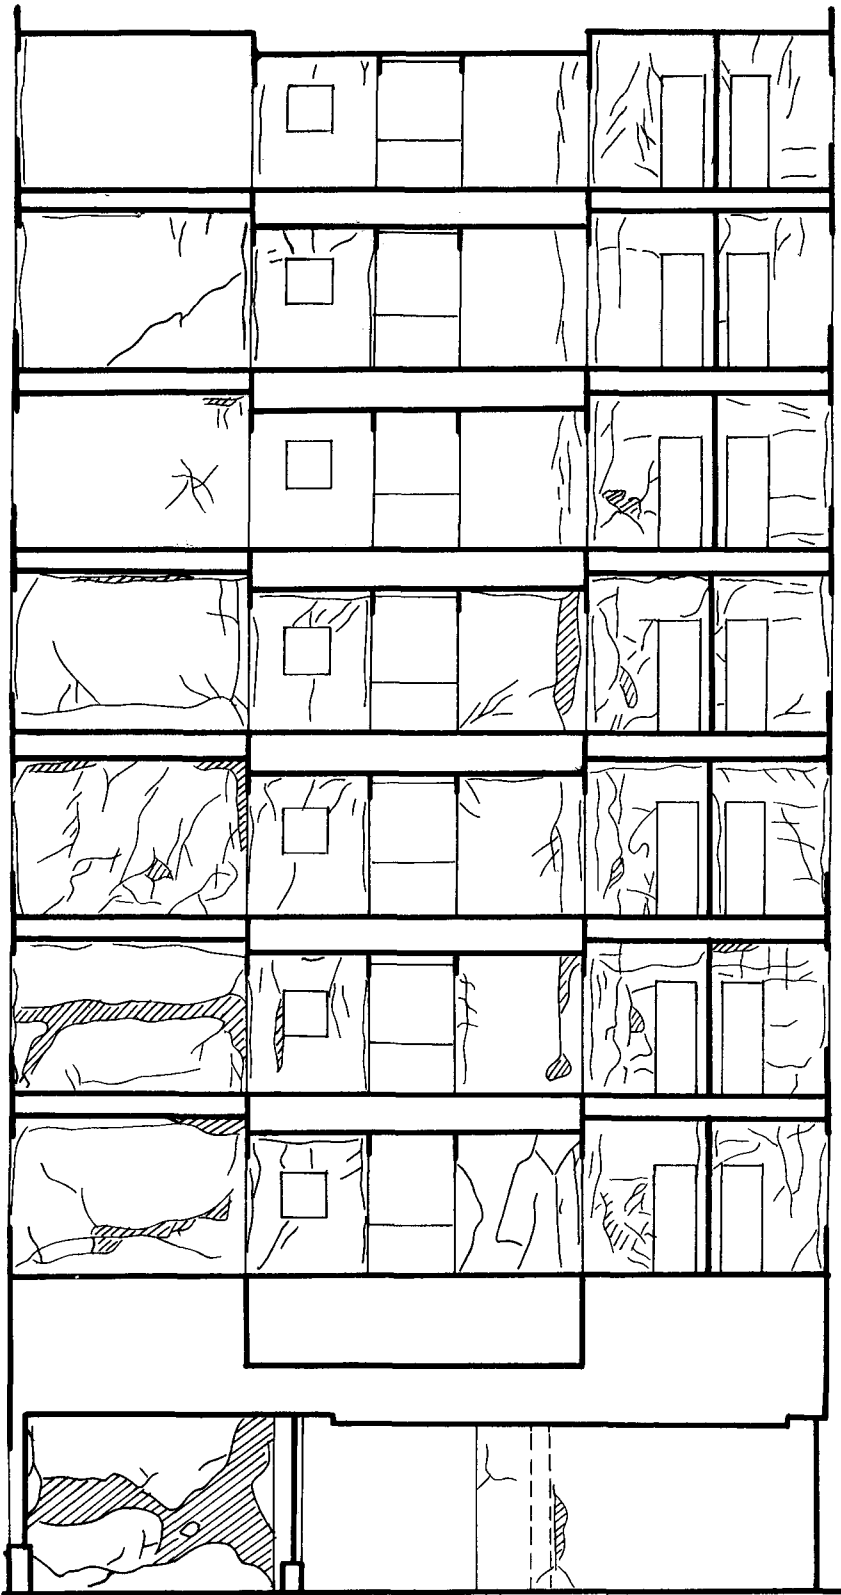
Besides the structural safety, attention must be given to structural stiffness to prevent earthquake damage to non-structural elements such as in-filled walls or architectural ornaments. For example, among ten medium- or high-rise buildings with in-filled walls investigated in Tianjin, all in-filled walls were damaged obviously during Tangshan earthquake. The damage to in-filled walls was widespread phenomena in Beijing although it was not so severe as in Tianjin because the intensity in Beijing was lower than in Tianjin. The expenses for repairing in-filled walls and architectural ornaments are a considerable figure especially for high-rise buildings with modern equipments. By increasing the stiffness of structure, this kind of damage may considerably be mitigated. Tianjin Friendship Hotel [Photo 2] is divided into two parts by an aseismic joint of 15 cm. Tangshan main shock gave damage to all of the in-filled walls of east part of frame structure [Fig.3a)], while the in-filled walls of rigid west part consisting of frames and shear walls were slightly damaged [Fig.3b)]. The in-filled walls of east part were quickly repaired after that shock, but all the repaired walls were damaged again during Tangshan aftershock on Nov. 15th, 1976, because both strength and stiffness were not improved.

Fig.3a Cracks of In-filled Wall of
Tianjin Friendship Hotel [East part]

Thus it can be seen that to increase appropriately structural stiffness is also one of the effective way to prevent damage of non-structural elements for tall buildings.

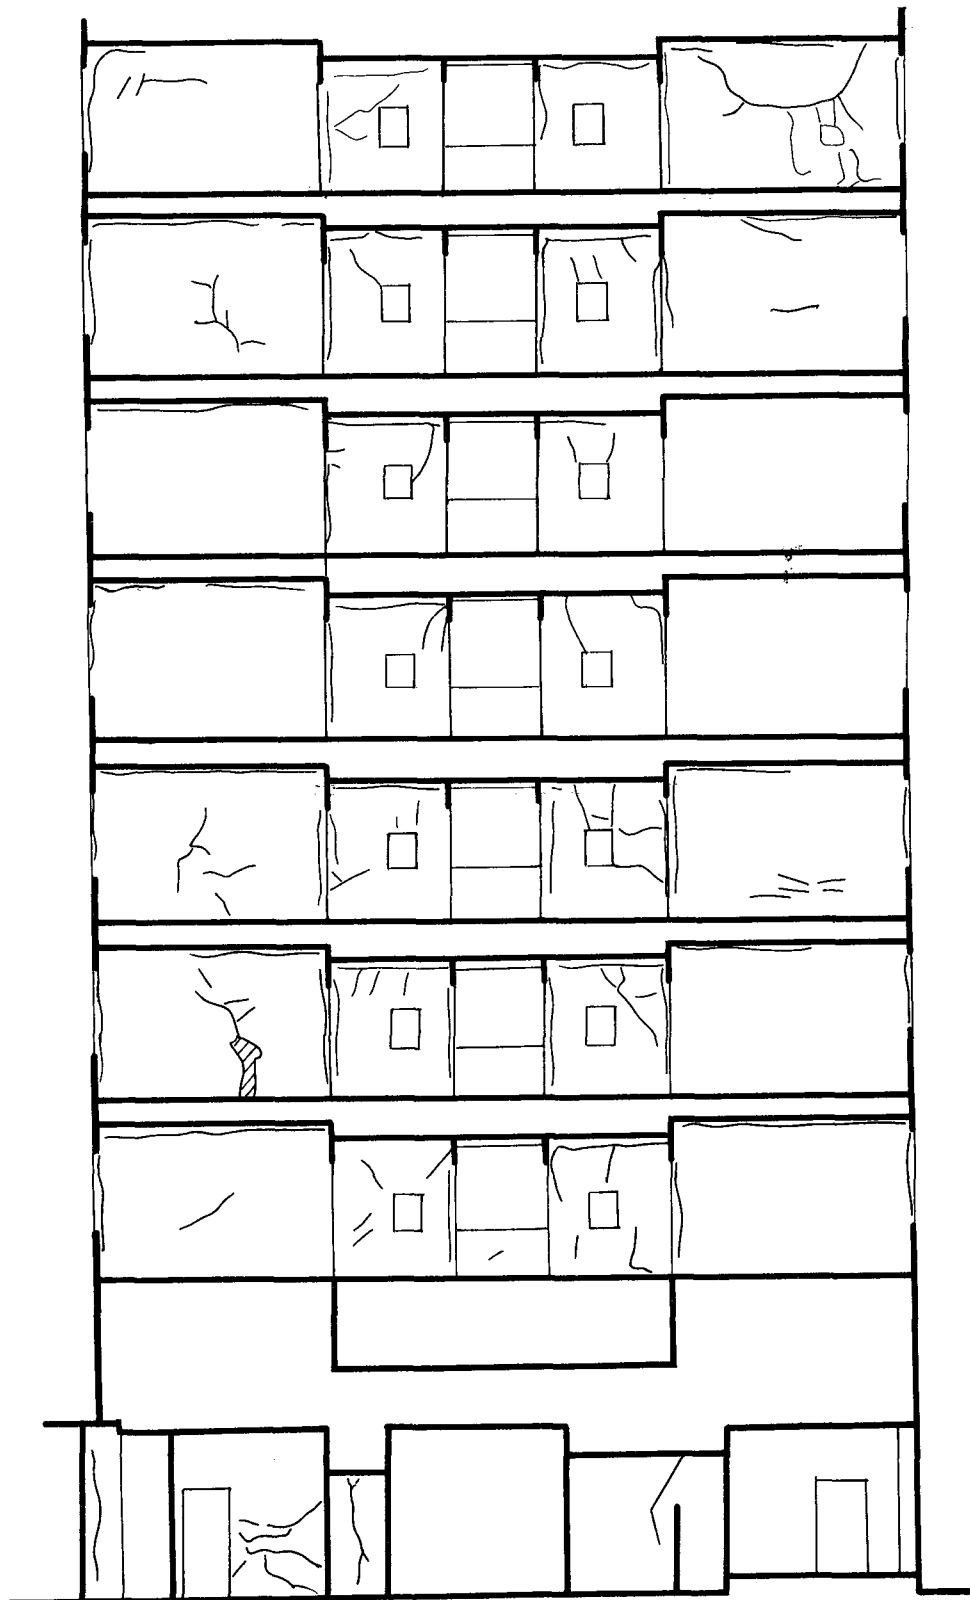
Fig.3b Cracks of In-filled Wall of
Tianjin Friendship Hotel [West part]
FIG. 4B

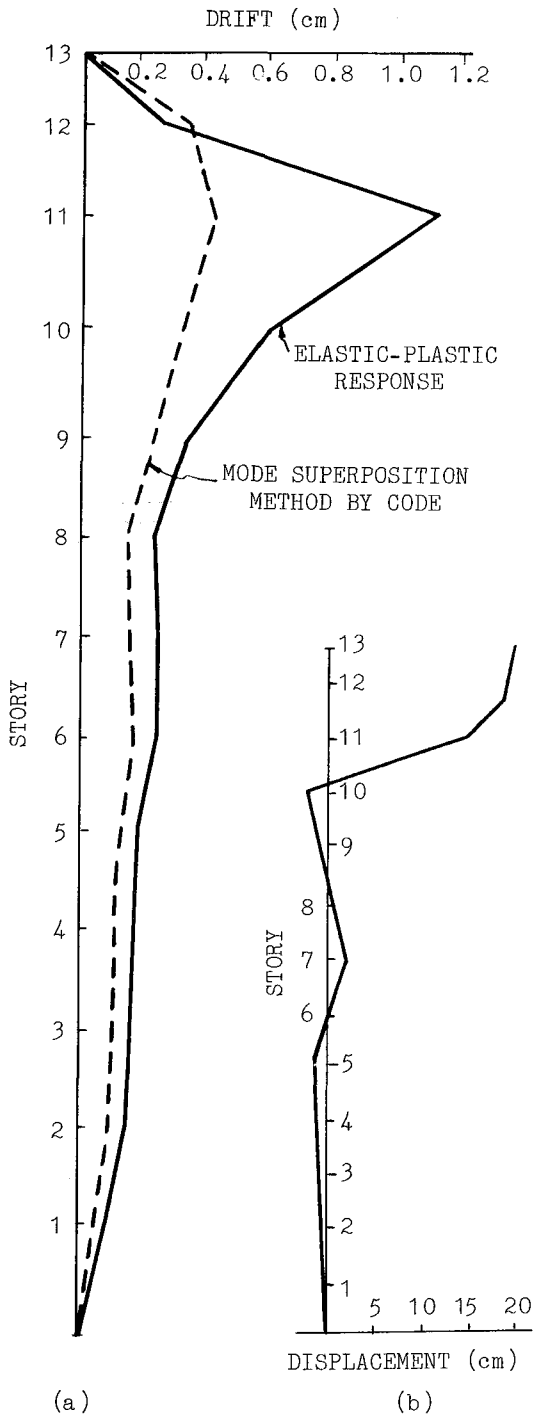
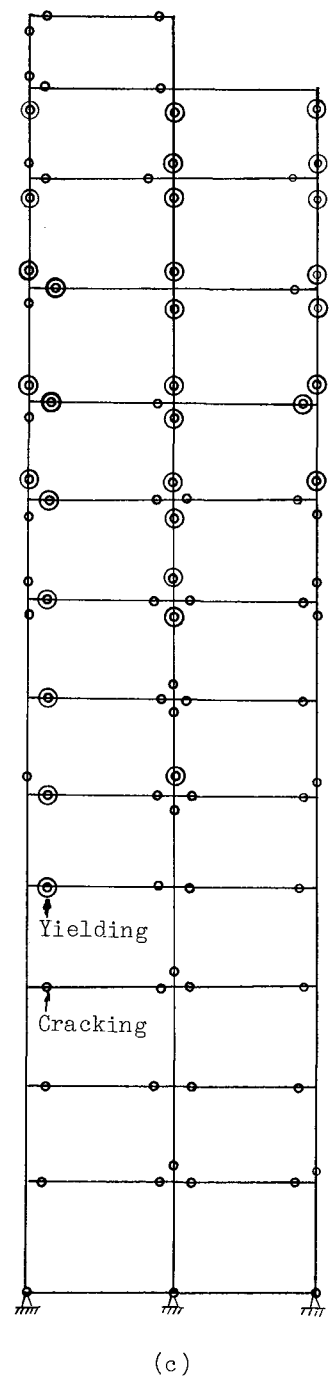
Fig.4 Response Displacement and Failure Mechanism of Tianjin Alkali Factory

Shown in Fig.4 is the result of non-linear member-to-member level analysis of above mentioned frame structure by input of Tianjin earthquake wave of Nov. 15th of 1976, of which the acceleration amplitude was adjusted from 133 gals to 200 gals. From the envelopes of storey drift shown in Fig.4(a), we know that the very great storey drift at 11th floor, $1/40-1/25$, might cause remarkable damage concentration. Fig.4(b) shows the mode shape when the 11th storey drift becomes maximum. The Fig.4(b) and the damage distribution shown in Fig.4(c) tells us, the damage of 6th-13th floors is much severer than that of 1st-5th floors and the damage of middle columns is more serious than that of side columns, which corresponds to the real damage of the structure.

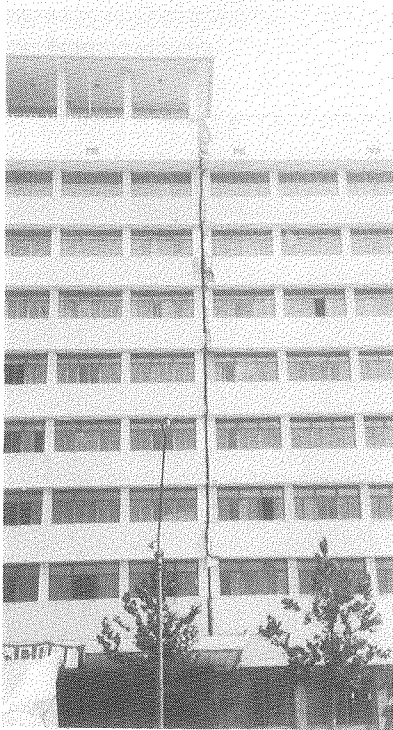
collided with each other during Tangshan main shock. Photo 3 shows the aseismic joint after being knocked. The railing on the roof was broken. The distance between two ends of broken railing was 30 cm [Photo 4]. It showed that the required width of the aseismic joint of that building for Tangshan earthquake was about 30 cm.
