Behaviors of Dams in Mexico Earthquake September 19, 1985

Choshiro Tamura

At the time of the earthquake of M = 8.1 that occurred in September last year (1985) at the Pacific Ocean coast of Mexico, there were two rockfill dams, La Villita and El Infiernillo in the epicentral area or its surroundings. The author made a field reconnaissance in October, the following month, and the information obtained is hastily reported below.

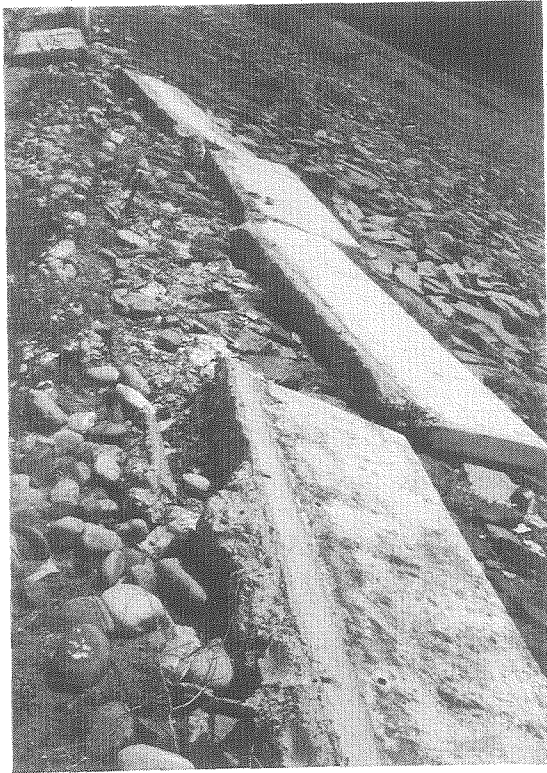
Parapet walls (height 70 cm, thickness 15 cm) are provided at the tops of the upstream and downstream slopes, and 9 panels of the downstream wall had toppled over to the downstream side, but these walls were of simple structure with only steel bars about 20 cm in length inserted as anchors.

Photo 2; Overturning of concrete panels at the top of the downstream slope, La Villita Dam.

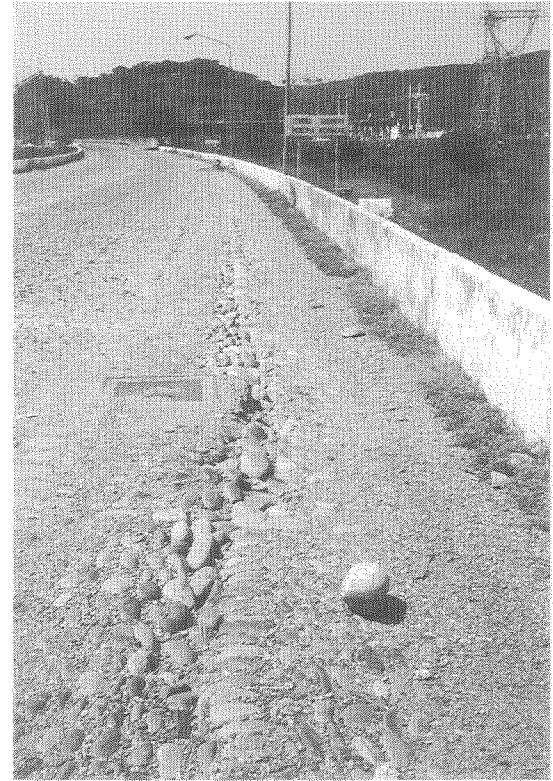
Disturbances brought about by the recent earthquake, as shown in Photo. 1, were small longitudinal cracks formed over lengths of approximately 150 m along the dam axis at the crest of the dam about 1.5 m on the inside

from the tops of the upstream and downstream slopes. The width of the crest, which is being used as a roadway, is 14 m, and 1.5 m of extra banking is provided at the middle portion of the dam. Surveying was being done at the time of the reconnaissance so the amounts of settlement and displacement will be known. In light visual inspection, no remarkable change other than the abovementioned longitudinal cracks was found.

The two longitudinal cracks were formed at locations which were both on extensions of the upstream and downstream slope lines of the core. From the fact that the depths were about 50 cm they can be considered as being disturbances of the kind frequently seen in areas of severe earthquakes.

Photo 1; Longitudinal crack along the shoulder of upstream slope, La Villita Dam.

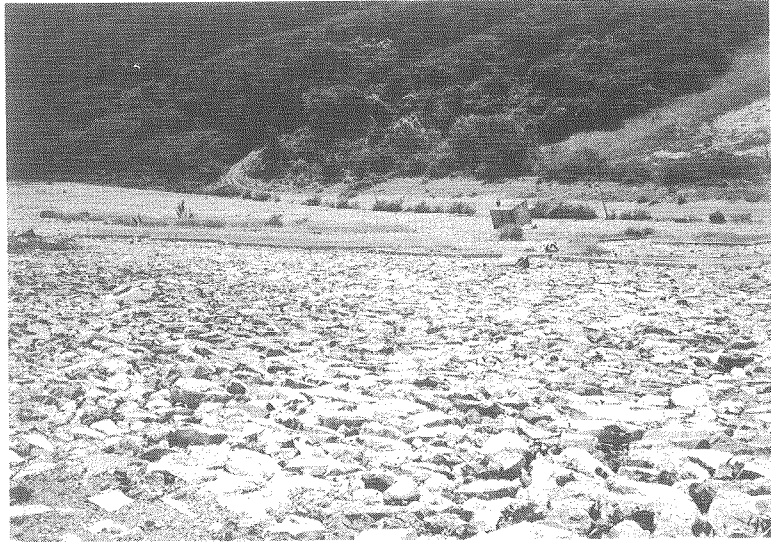
Photo 3; A cover lifted up by the tube of Piezometer owing to settlement of the down stream slope, La Villita Dam.

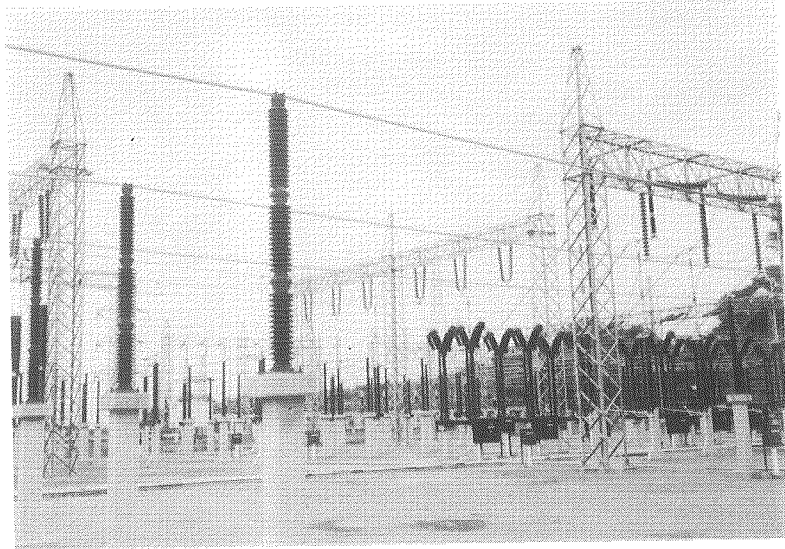
The dam has a spillway (tainter gates) provided at its right-bank side, and no disturbance was seen. Power transmitting and transforming facilities (power transmission at 230,000 V) were located on the right-bank bedrock (andesite), but there was no damage at all. There was partial cracking produced at walls and ceilings of the one-story administration building, but the damage was extremely light.

Photo 4; Substation of La Villita Dam.
(No Damage)

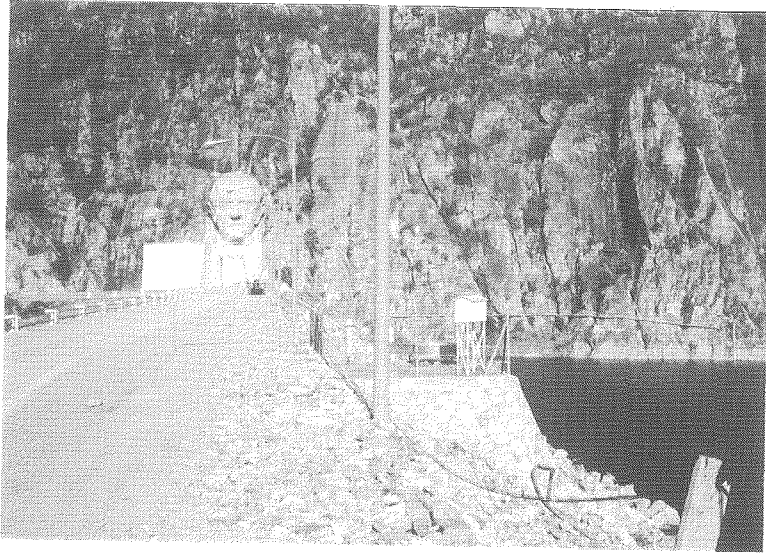
The standard cross section is as shown in Fig. 7 with the construction on bedrock (andesite), and with the upstream and downstream slopes fairly steep at 1:1.75. In the recent earthquake longitudinal cracks of depth about 60 cm were formed respectively on the insides of the tops of upstream and downstream slopes. Settlement of approximately 10 cm occurred at the middle, while conversely there were rises of about 10 cm at the two ends.

Raising of the core was being done when the author visited the site and it was not possible to observe the longitudinal cracks formed as a result of the earthquake. Nothing that appeared like a disturbance could be seen at the downstream slope surface. There was no damage to the power transmitting and transforming facilities on the bedrock at the downstream side of the dam, while it was said that rockfalls did not occur either.

Photo 5; Top of the El Infiernillo Dam.

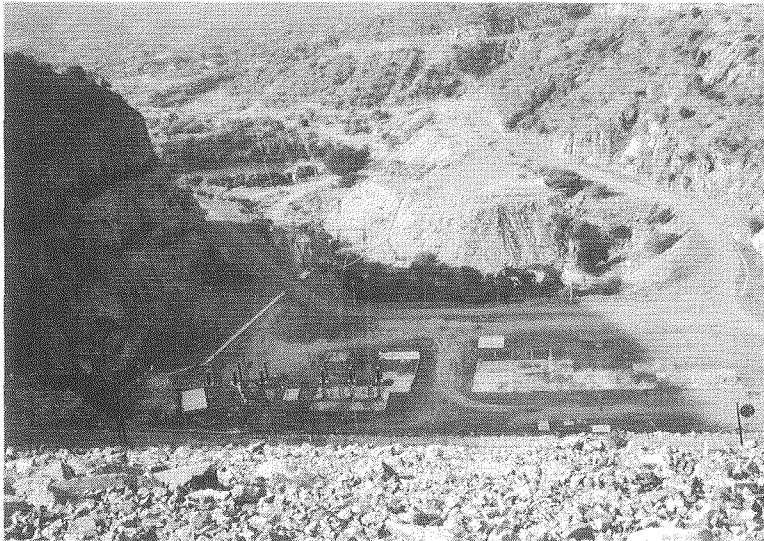
Photo 6; Downstream side, El Infiernillo Dam.
