**SEISMIC CAPACITY OF REINFORCED CONCRETE BUILDINGS
WHICH SUFFERED 1985.9.19-20 MEXICO EARTHQUAKE**

ABSTRACT

Seismic capacity of twelve reinforced concrete buildings suffered 1985.9.19-20 Mexico Earthquake were estimated by the Japanese Standard for Evaluation of Seismic Capacity of Existing Reinforced Concrete Buildings, and correlation between the estimated capacity and the degree of damage were examined. An applicability of the Japanese Evaluation Standard to Mexican buildings was confirmed.

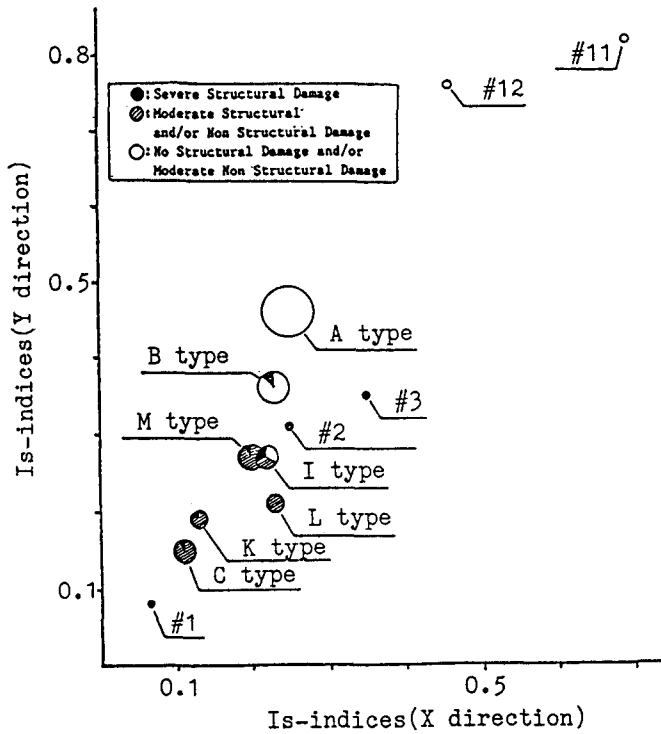
Fig.2 Is-indices by Second Level Screening Procedures vs. Earthquake damage in Mexico [Ref.(2)]

Relationship between the estimated seismic capacity and the degree of damage is illustrated in Fig. 2. The I_s -index of the east-to-west direction is plotted in the abscissa and that of the north-to-south direction is in the ordinate for each building. The mark of \circ indicates severe damage and the mark of \circ small or slight or no-damage. The size of the mark shows of the number of buildings and shaded and hatched portions show the ratio of severe damage, and medium damage, respectively. According to decrease of the I_s -indices, the number of damaged buildings increase and the I_s -index of around 0.4 is a border between damage and no-damage.

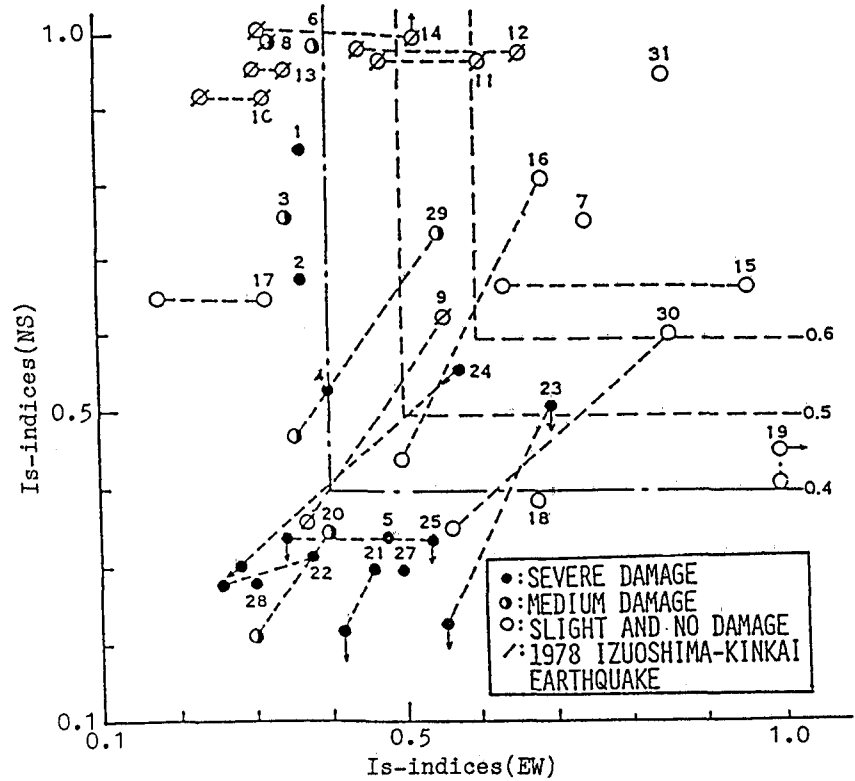
Fig.3 Is-indices by Second Level Screening Procedures vs. Earthquake damage in Japan [Ref.(5)]

Fig. 3 demonstrates the similar characteristics of Japanese buildings experienced 1968 Tokachi-Oki Earthquake, 1978 Izuoshima Kinkai Earthquake and 1978 Miyagiken Earthquake. The border of the damage and no-damage is about 0.6 in I_s -index.
