## URGENT REPORT ON THE CHIBAKEN-TOHHO-OKI EARTHQUAKE OF 1987\*

Choshiro TAMURA<sup>1)</sup> and Kazuo KONAGAI<sup>2)</sup>

## 1. PREFACE

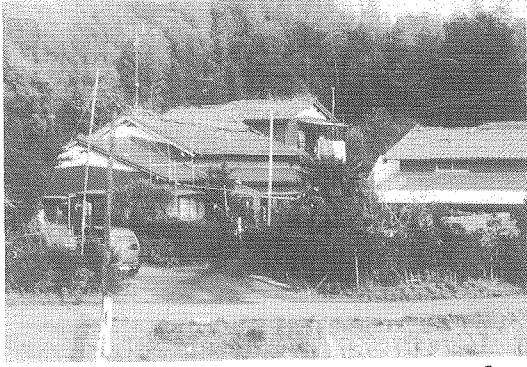
One of the most conspicuous damages on structures are collapse of ridge tiles on roofs of wooden houses. Many of them can be seen in the area with the epicentral distance  $\Delta \leq 50\text{km}$ . We, however, found that quite few houses lost their roof tiles in the vicinity and the south-western area of the Taito-zaki, though the area is the closest to the epicenter in the Boso Peninsular. Many outcrops of mud rock or sand rock in this area show that the ground is firmly solidificated. This ground condition seems to have mitigated remarkably the damage on roof tiles. In the area encompassing the vicinity of the epicenter ( $20\text{km} < \Delta < 50\text{km}$ ), large regional deviation in a damage on roof tiles can be seen. It will be a general feature that there are many damaged houses on an alluvial formation near diluvial hills. In Chonan-Town located on a long and narrow valley, almost half of the whole houses (=3000) were rocked to loose their ridge tiles, and we could see that almost houses in Ozawa district were severely damaged. However, special attention should be paid on the fact that there are some evidences of severe tremor even on diluvial formations. Inunari is one of the villages on those hills. This village faces a prefectural highway connecting Chiba City and Mobara City, and is about 35km away from the epicenter. Almost ridge tiles fell onto the ground north-west side of these houses. In the grave yard near the village, all tombs were collapsed, and some of them

Photo. 1 Damage to ridge tiles of wooden houses(Chonan town)

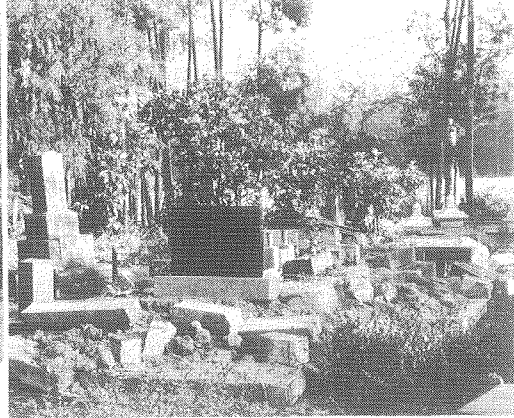
Photo. 2 Collapse of grave stones (Inunari village)

appeared their charneles, and we could see some evidences that the tomb stones had been shifted in north-west direction.

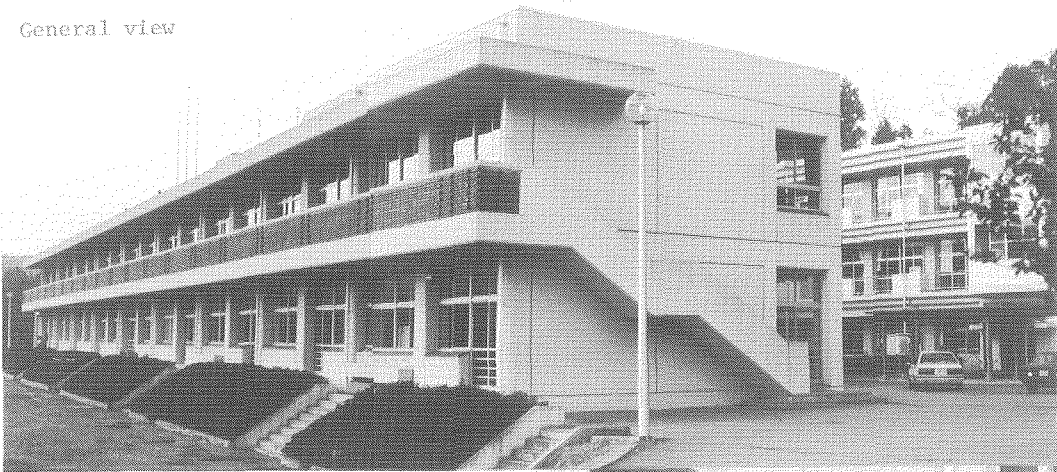
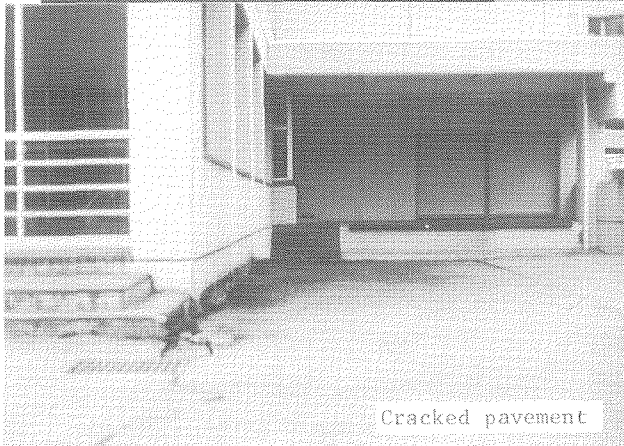
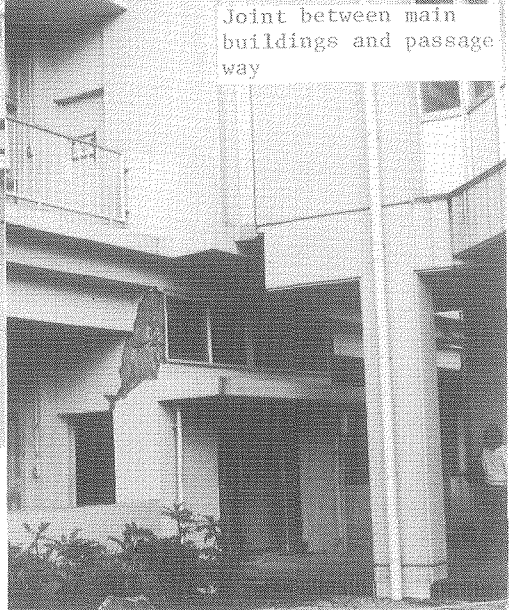
Photo. 3 Chonan junior high school

General view

Cracked pavement

Joint between main buildings and passage way

Quite few R-C buildings are severely damaged by the quake. The buildings of Chonan Junior-High School and the Chonan Town Office were examples of these few. Either of them was constructed over a cut terrace and sandy embankment on soft soil deposits. Chonan Town Office has a long rectangular base with its front entrance on its long side. The backside of this office underlays the cut terrace while front side was on sandy banking. X-shaped cracks on the walls parallel to the short side of this building is suggestive of a strong rocking motion of this building.

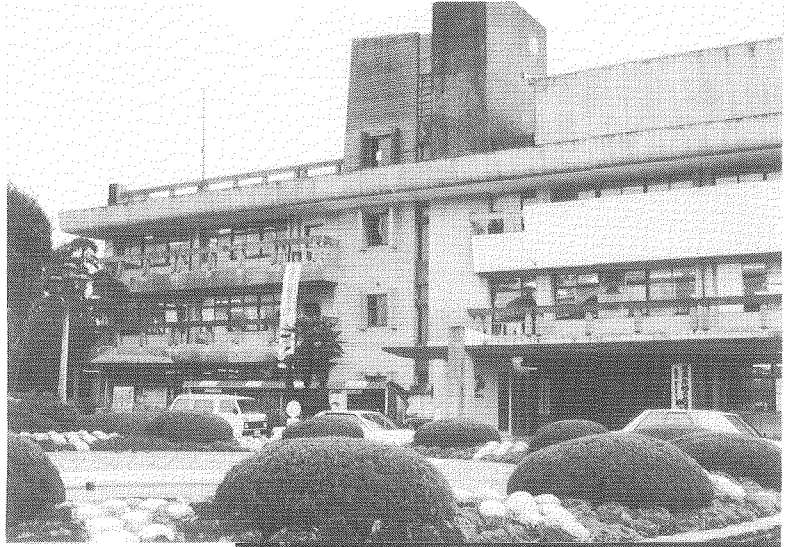
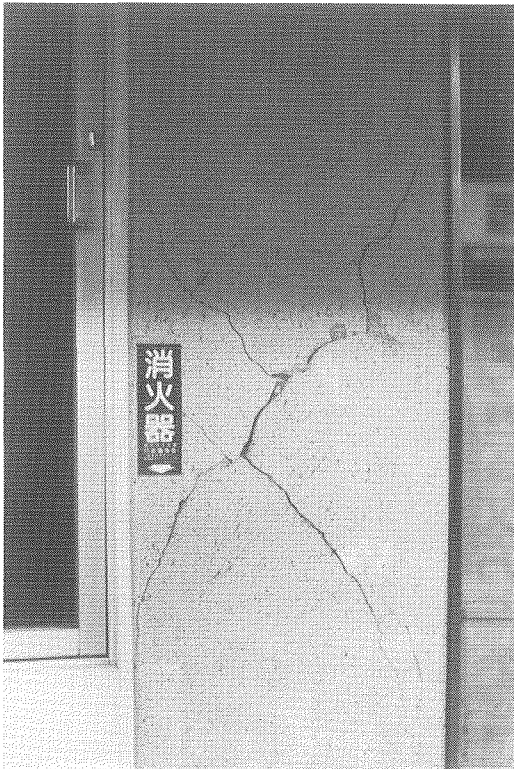
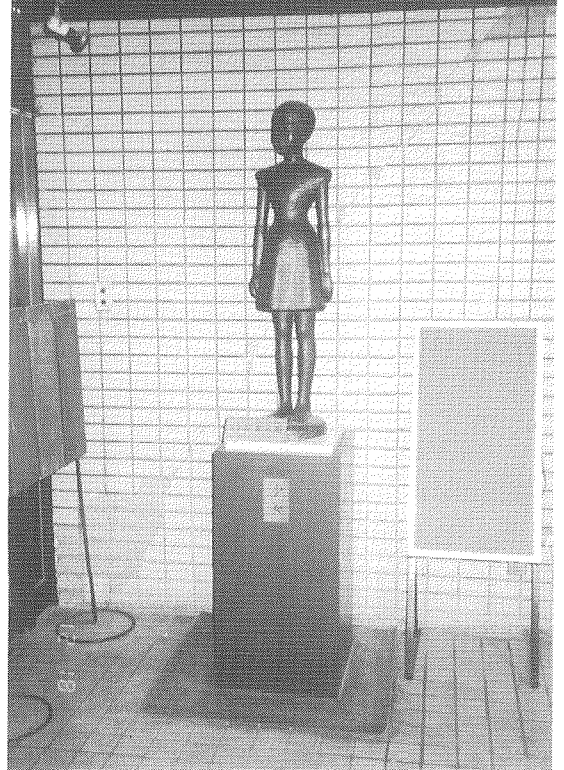
Photo. 5 Mobara city hall

The front of the city hall

Cracked wall

Mobara City Hall was also damaged by this earthquake. About 150 window panes with their frames fixed were broken. There were 17 conspicuous shear cracks on the walls, and an air conditioner was disordered.

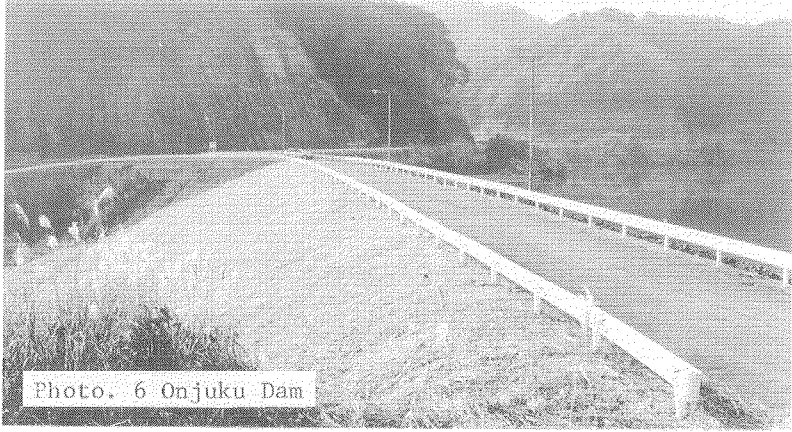
On Dec. 20, we inspected four earth dams in the vicinity. they are the Onjuku Dam ( $\Delta=20$ km, 21m in height), Naguma Dam ( $\Delta=18$ km, 18.5m in height), Azuma-the-First and the-Second Dam ( $\Delta=20$ km, 22m (the first) and 21m (the second) in height) and Arakine Dam ( $\Delta=24$ km, 34m in height). A witness, who happened to be just on the Onjuku Dam, put an emphasis on the strong vertical tremor of the embankment. Every road lamps on this dam was shaken with an amplitude of about 40cm or more. He saw minor ripples on the reservoir surface abated just before the strong quake, and after the severe tremor was over, the whole water surface was waving. We found an evidence of slight slippage at the movable support on the top of an intake tower bearing an access bridge. However this was the one and only evidence of the strong tremor we found through our inspection on the aforementioned 4 dams.

Photo. 6 Onjuku Dam

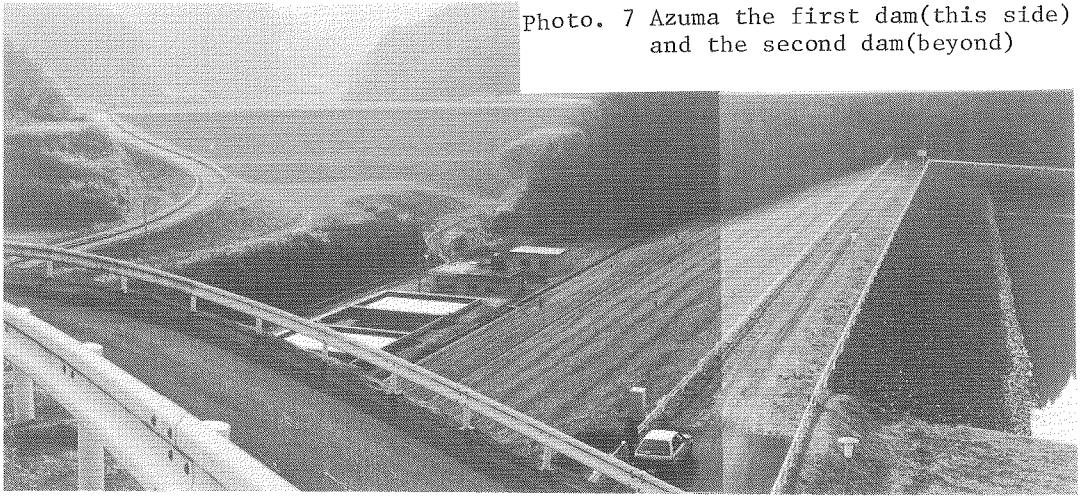
Photo. 7 Azuma the first dam(this side) and the second dam(beyond)

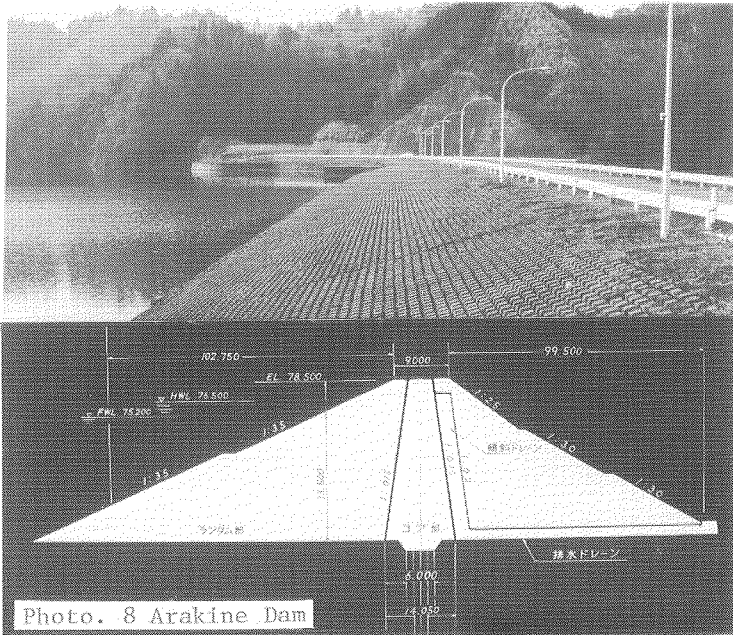
Photo. 8 Arakine Dam

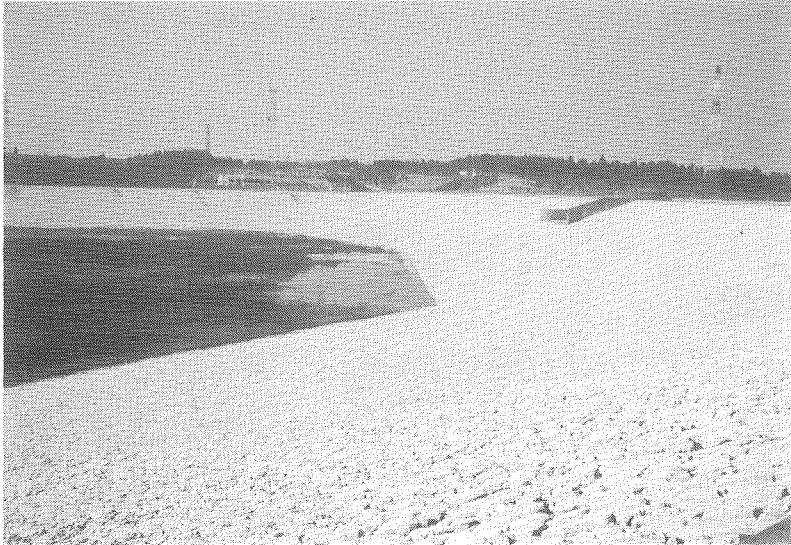
On Dec. 27, we inspected the Nagara Dam ( $\Delta=35$ km, earth dam, 52m in height) near the Inunari Village where some severe damages on houses and graves were seen. The schematic view of this dam was shown in Fig.3. We found some cracks on the pavement on the top of the dam, and a long and narrow soiled portion with width of about 10cm on the concrete wall of the spillway. This shows clearly that the embankment settled more than 10cm. The Moroichi Bridge crossing this spillway are pinned to abutments on both sides, and street drains on the abutments were crushed. However, there was no damage which brought the functional disorder into the dam.

Photo. 9 Nagara Dam

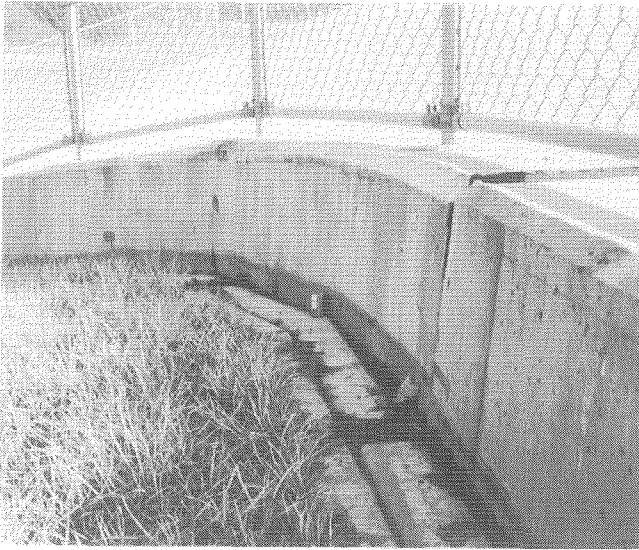
Photo. 10 Backfill of spillway(subsided to an extent of about 10cm)

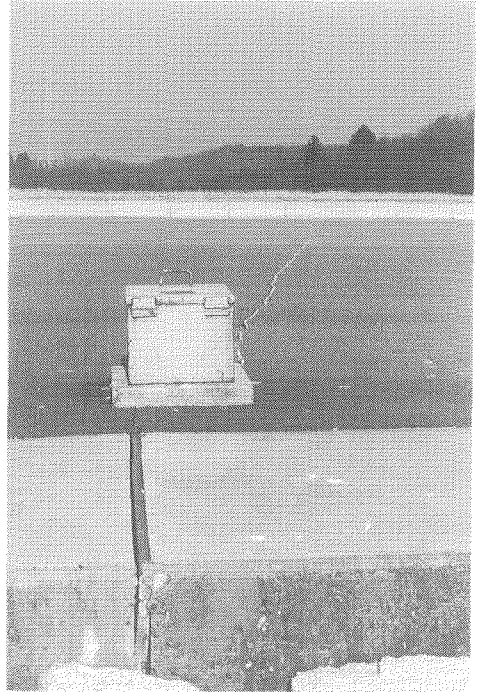
Photo. 11 Crack running across asphalt pavement at the top of dam from a piezometer box

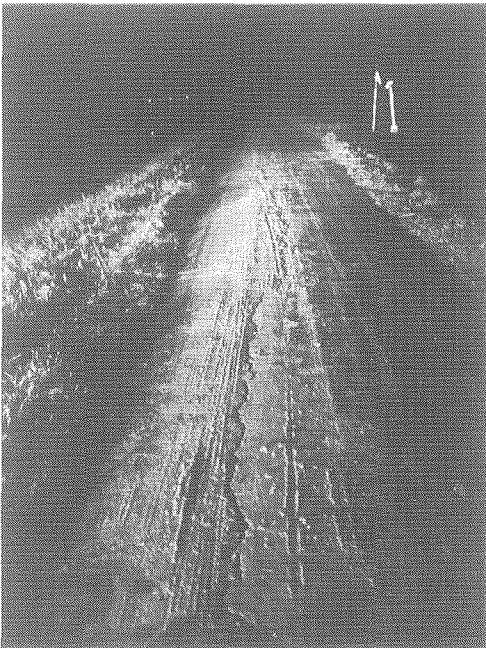
The damaged portion of the bank of the Tone River we inspected lies between the Omigawa Bridge and Tomita district. The maximum horizontal acceleration of 185gal was recorded in this area. Damage to this banking was mainly a longitudinal fissure of pavements on this banking. Total length of these fissures twinning one another along the banking axis may have exceeded 2km, and the averaged width of the opened crack was about 1cm. We checked the toe of this banking slope, and could not find a clear evidence of failure.

Photo. 12 Longitudinal crack on right side bank of the Tone River

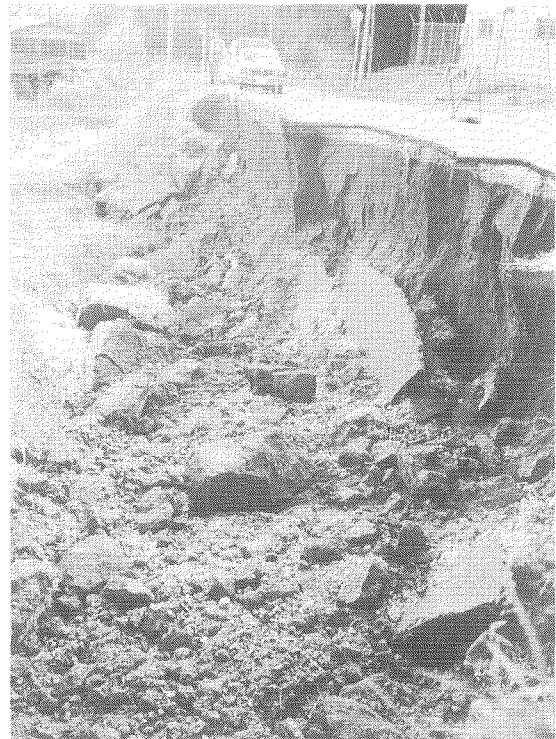
In Manna region in Mobara City, the shoulder of a road was damaged by a slid of the slope with the height of around 5m. This road was banked up on a small valley, and the toe of this slope was bounded by a wet lotus field. The slid mass consists mainly of fine sand, and was oozing with water.

Photo. 13 Collopse of a shoulder of road in Mobarra city

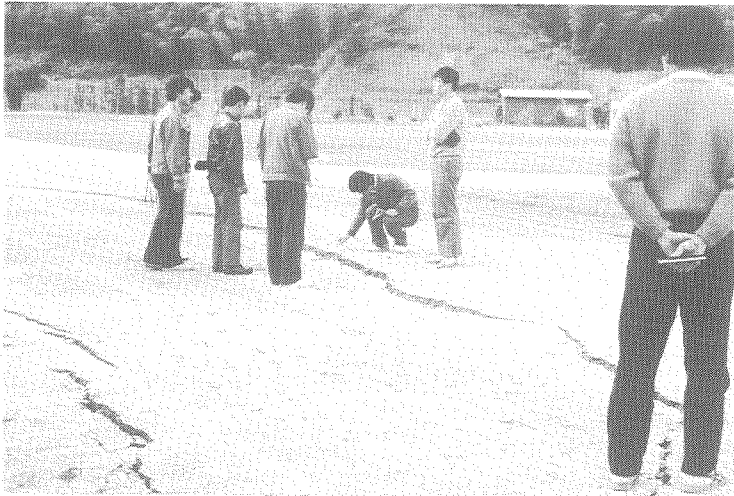
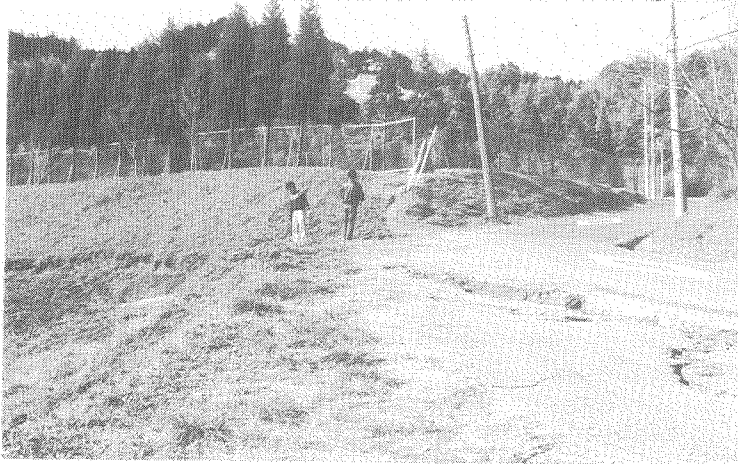
Damages to school grounds of sand banked up on soft soil deposits stood out clearly. The schematic map of the Nagara Junior-High School is shown in Fig.4. In this school, we could see a long cracks running across the school ground and reaching the access road. The half side of the ground which faces a rice field subsided to an extent of 7cm, and the thin steel tape inserted in the opened crack reached at the depth of 1.75m.

Photo. 14 Cracks along the edge line of school ground (reclaimed ground ) and cracks on the slope

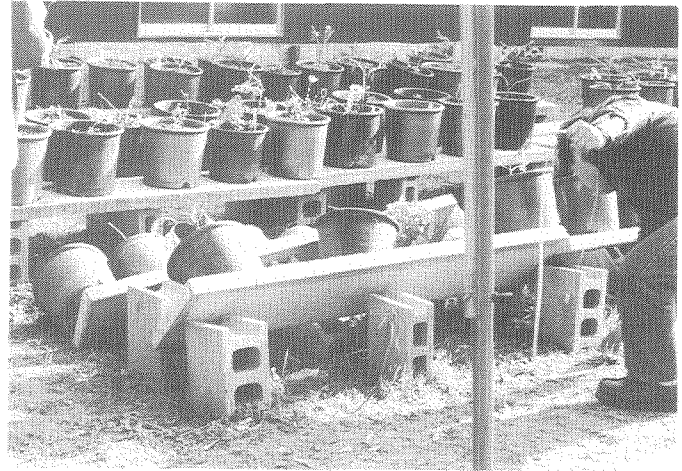
Photo. 15 Flowerpots fallen onto the ground (Nagara junior high school)

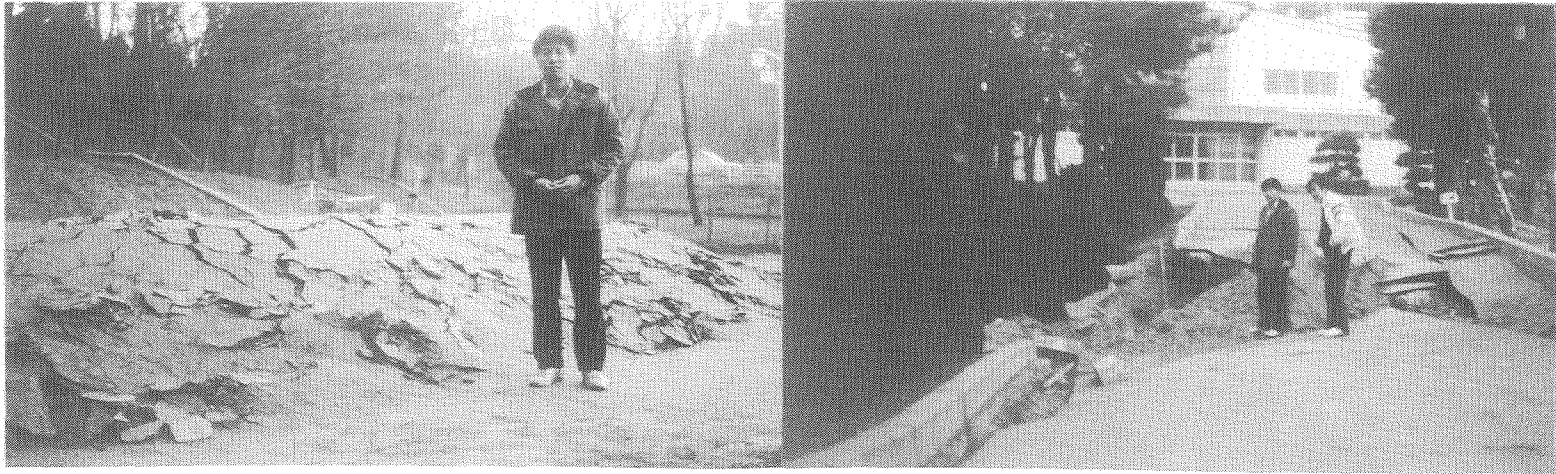
In the Chonan Junior-High School, the school ground constructed on a sandy banking with the height of about 5m was settled over the whole surface, and some evidences of liquefaction were seen in places. North part of this ground and the access road to school buildings were severely damaged by a slide of slopes(Fig.5). The slid area is about 25m in width and 30m in length. This slide resulted in an upheave of the tennis court

Photo. 16 Slide of slope of school ground  
(Chonan junior high school)

adjacent to the slope toe, and there were some sand boils on this upheaval, which must be an evidence that the banking was in remarkably wet condition.

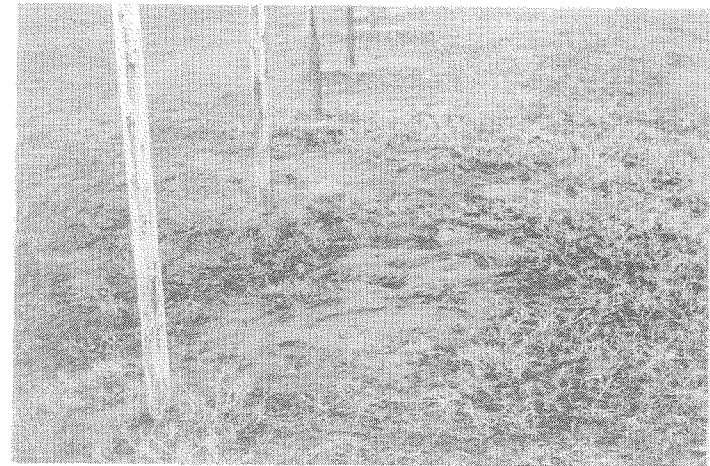
Photo. 17 Sand dunes due to liquefaction  
on school ground

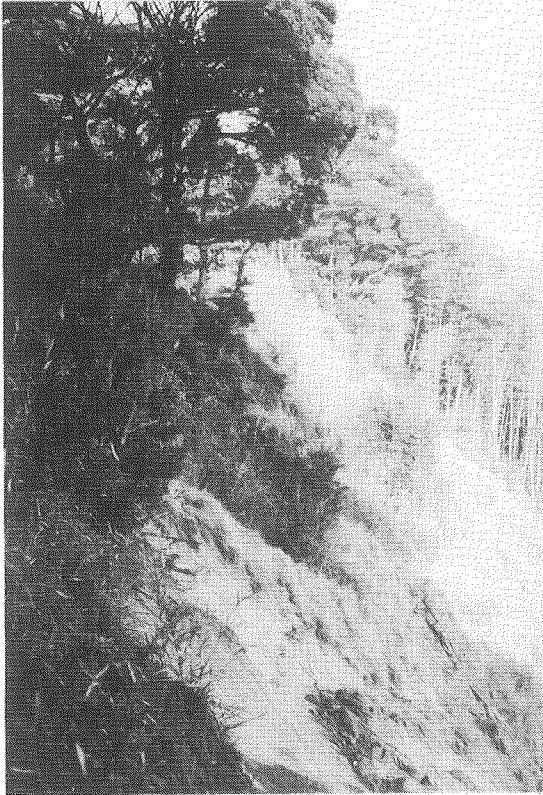
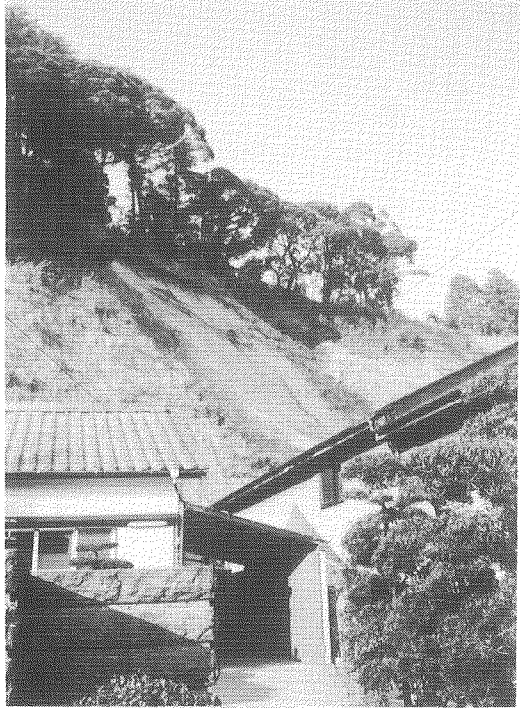
Photo. 18 Slope failure at Matsuo  
in Naruto town

Most of slope failures are concentrated in the valleys of many small tributaries, and boundary areas between diluvial terraces and widely spread alluvial low lands. Togane City and Naruto Town are representative towns in one of the later areas. We surveyed some slope failures which took place in Matsuo Town near the Naruto Town. The sites are fairly steep hill slopes with a gradient of around 60. The height of the terrace is about 30m. The collapsed material deposited on the lower concave slopes includes a lot of fine and wet sand particles. The deposited mass seemed to have slipped on a sand rock firmly solidificated or on hard clay. Some open cracks were observed along the slope shoulder on the surface of the terrace where soft humus is deposited. There are many other towns along the toe of this diluvial terrace. Oami Town is one of these towns and is closer to the epicenter than the aforementioned towns. However, we could hear little in reply to our inquire about occurrence of failures of slope.

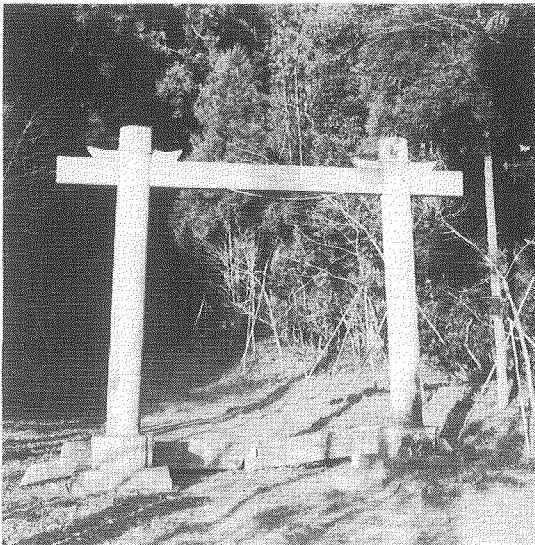
Photo. 19 Stone gate of Washizu  
Shrine (The upper part fell down  
on the ground)

The Washizu Shinto Shrine stands on a small terrace at the middle height of a diluvial hill in Mobara City. There were evidences of strong tremor in this shrine. The upper part of the stone gate fell down onto the ground. The stone steps on the hillside from this gate to the shrine building were settled, and several stones with radius of around 70~80cm were lying around by this building. It is obvious that they rolled down on

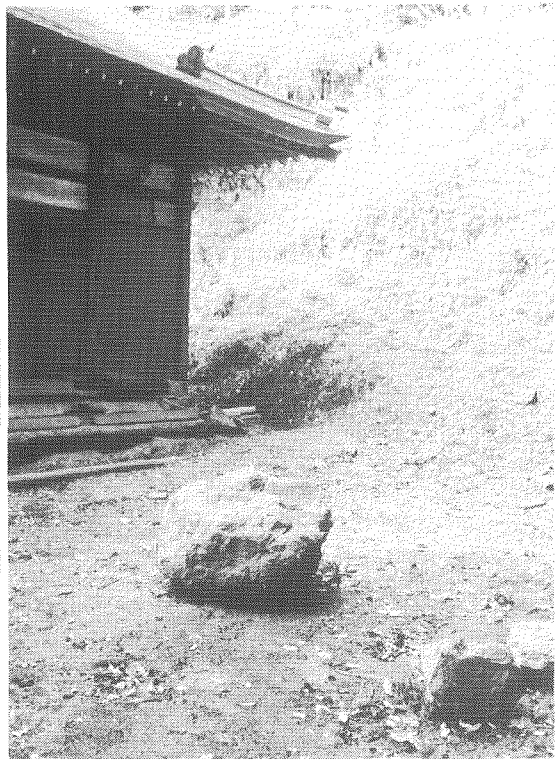
Photo. 20 Fallen stones by the  
shrine building

the rear hill slope to the terrace.

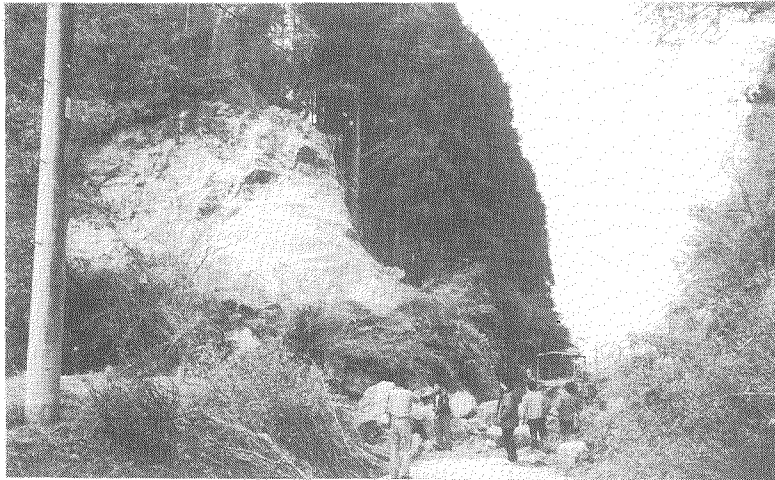
In Hase region in Mobara City, a landslide took place. The collapsed zone are both sides of cutting in a tongue-shaped hill with the height of about 10m. Several stones with the radius exceeding 1m scattered on the road. The cut surface of the hill shows that the mass of rock of this hill belongs to mud silt sediment called "Kasamori Layer" which is not so hard. The fallen mass involving large stones must be a erosive surface of this rock. The road passing through the cutting leads to a small pond along the left hillside. The right-hand surface of the slope of this road was oozing with water, and the water ponded in the silty farm. This finding shows that the erosive surface of the hill was in moist condition.

Photo. 21 Slope failure at Hase in Mobara city

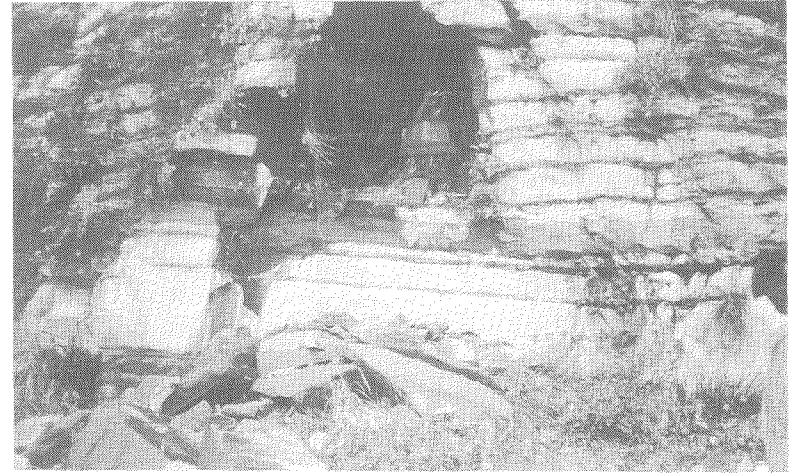
In the vicinity of the epicenter, few evidences of slope failure were observed. One of the few is the collapse of horizontally laminated rock cliff hanging over the sandy beach near the Taito Fishing Port ( $\Delta=7\text{km}$ ). Mud plates and sand plates solidificated lie one upon another, and belong to the so-called "Otashiro Layer". Since the rock is rather firmly solidificated in comparison with the aforementioned rock belonging to "Kasamori Layer", this collapse is suggestive of the strong tremor near the epicenter.

Photo. 22 Collapse of laminated rock near Taito fishing port

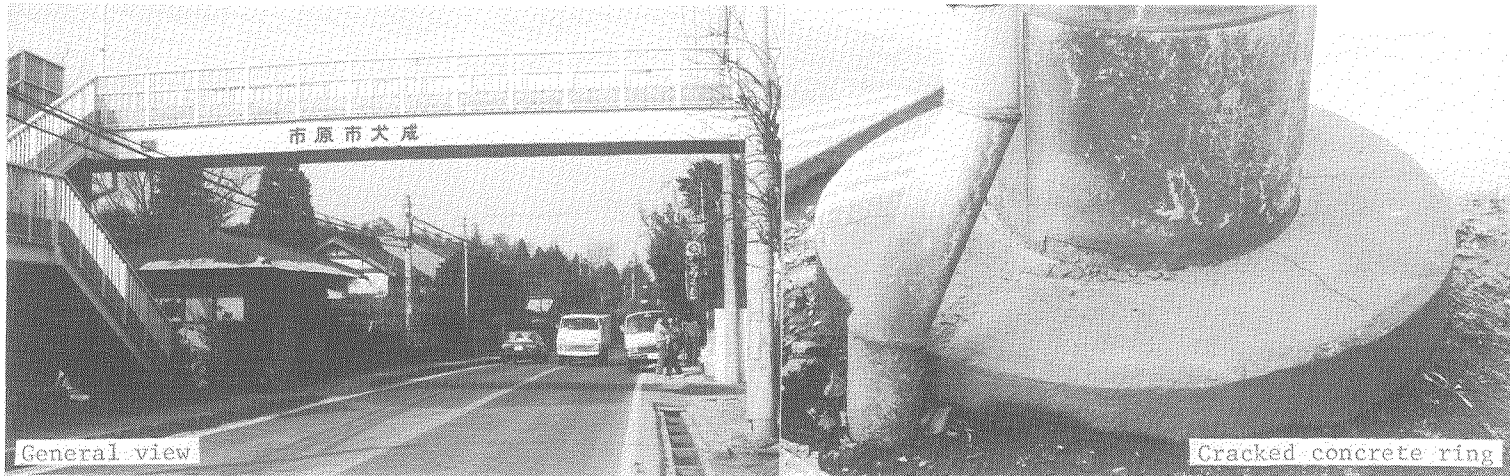
In Inunari village in Ichihara City, small evidences of strong tremor were seen on the pedestrian bridge crossing the prefectural highway connecting Chiba City and Mobara City. This is a simple-spanned steel beam supported on piers of steel pipe. The both piers were tilted a bit toward the highway. The concrete ring holding the pier at its base were cracked. And the floor slab was bent so that the center portion along the axis of the bridge was heaved a bit. We also could see a buckled portion on the lower franges of the bridge, though it is not confirmed it was resulted from the earthquake.

Photo. 23 Pedestrian bridge at Inunari village

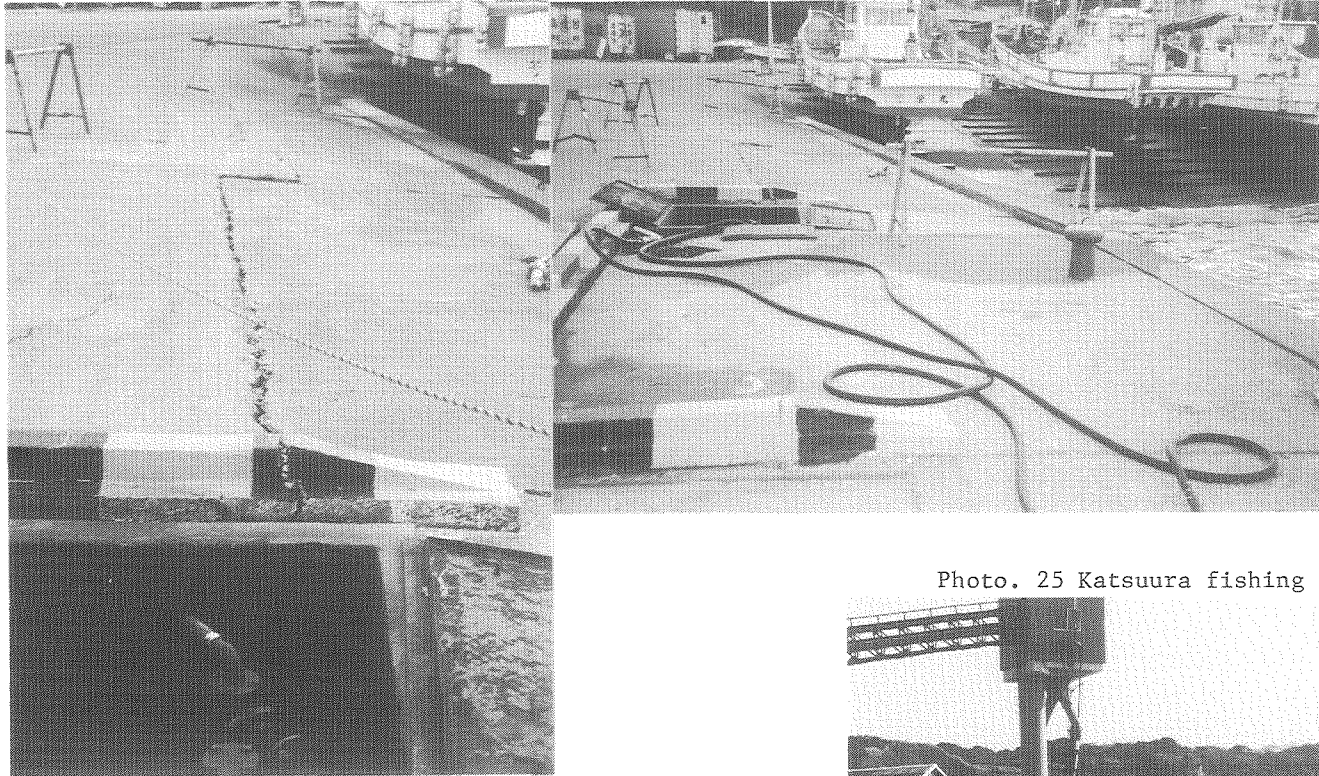
We surveyed two fishing ports in the vicinity of the epicenter. One is Taito ( $\Delta=7\text{km}$ ) and the other is Katsuura ( $\Delta=24\text{km}$ ). One of the quaywalls of the Taito Fishing Port was tilted forward slightly to an extent of 2 to 3cm which was followed by subsidence of the backfill. And this is one and only evidence of the quake we found.

Photo. 24 Tilt of a quaywall and subsidence of backfill at Taito fishing port

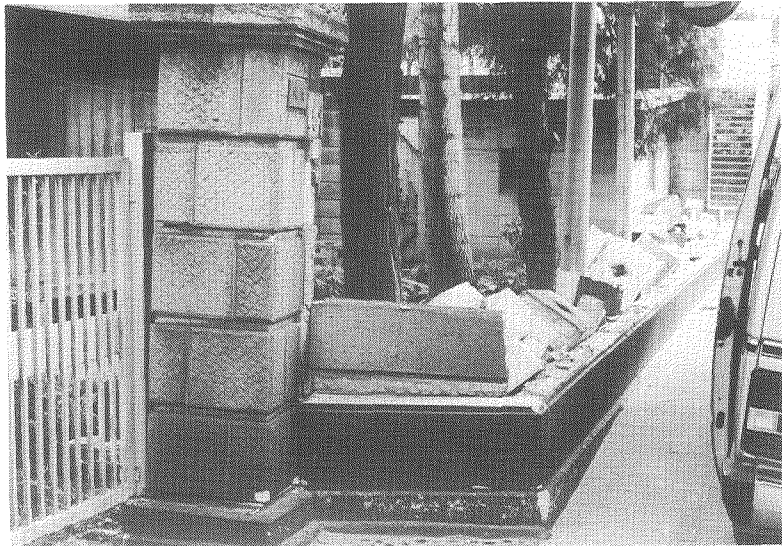
Photo. 26 Collapse of stone wall  
at Inunari villege

Collapses of stone or concrete walls are also conspicuous. Distribution of the damages to these walls seems to have strong interrelation with those to ridge tile or wooden houses. In Ichihara City, it was reported that a collapse of a stone wall killed one person. In Inunari Village, a massive wall made of Ohya stone blocks cluttered the street, though there were deep scratches on each block to be cemented tightly. An interesting phenomenon was observed on a concrete block wall in Tagoshi region. This village lies along the boundary between a diluvial hill and widely spread alluvial low land. This wall was cracked and expanded in its longitudinal direction, which is normal to the terrace slope.

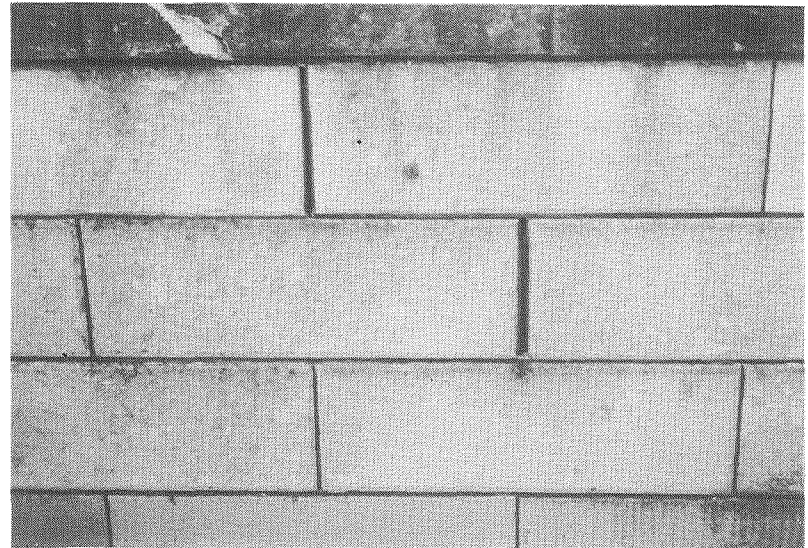
Photo.27 Expanded stone block  
wall at Togoshi in Naruto  
town

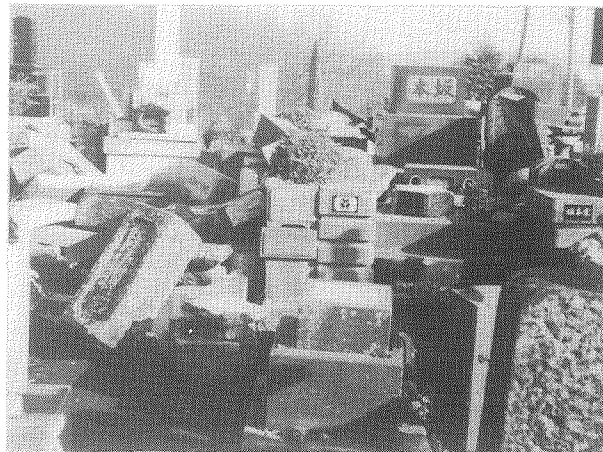
Photo. 28 Collapse of grave stones  
in Ichihara city
