**DAMAGE REPORT OF THE BIHAR NEPAL EARTHQUAKE
OF AUGUST 21, 1988**

Rajiv DUGGAL (I)
and
Nobuhiko SATO (II)

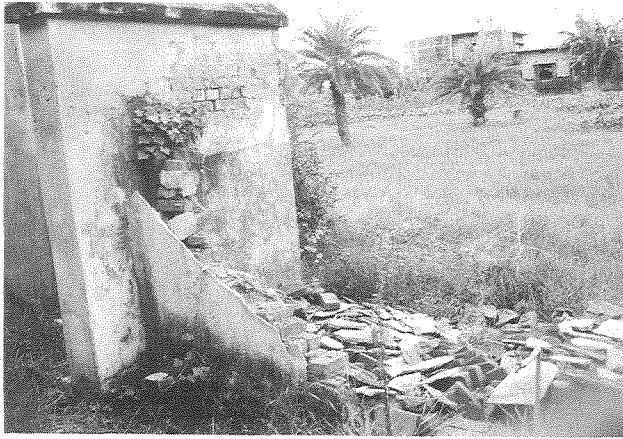
Photo 1. Collapsed boundary wall of Girls School, undamaged RC house in back view (Dharbhanga)

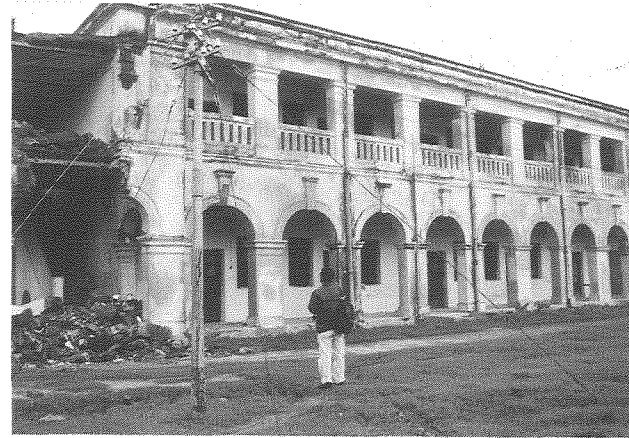
Photo 2. Old Medical Boy's Hostel (Dharbhanga)

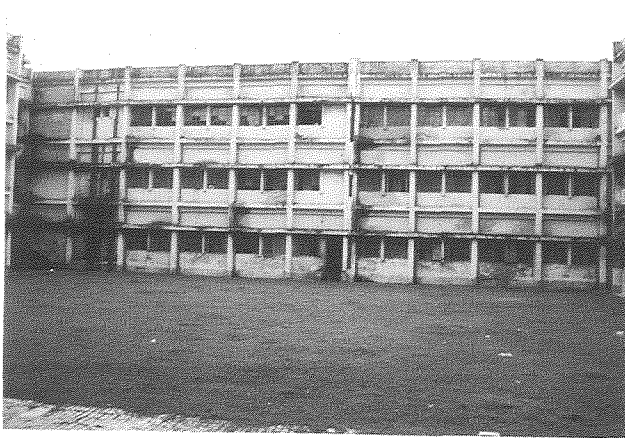
Photo 3. Rear view of Surgical Hospital (Dharbhanga)

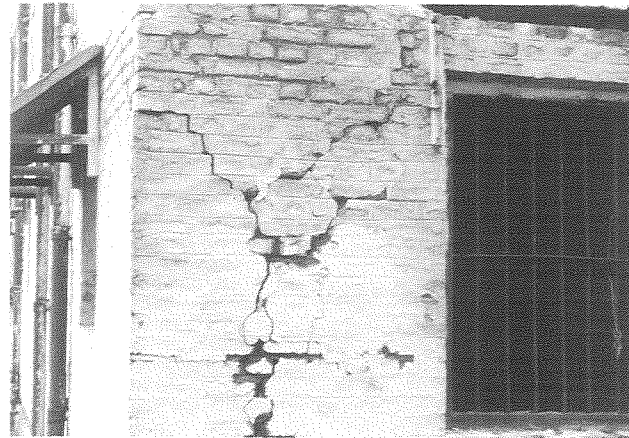
Photo 4. Damaged Jila School (Dharbhanga)

horizontal/diagonal cracks beginning from the openings (Photo 4).

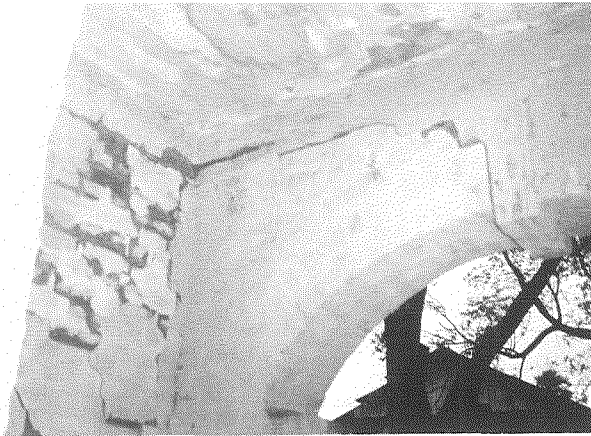
Photo 5. Cracked arch of same building

4) Single/multiple cracks in the masonry arch: The crack starts at or near the crown of the arch and propagates upwards in the masonry wall (Photo 5).

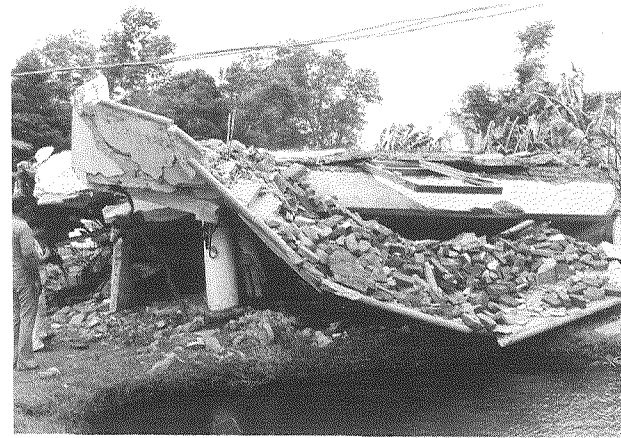
Photo 6. Collapsed I. T. I. Building (Dharbhanga)

Of the reinforced concrete framed structures, those which were designed without regard to lateral forces suffered damage. The most dramatic of these was the Indian Training Institute building, which collapsed (Photos 6 to 8). It was reported that with one exception, the rest remained standing.

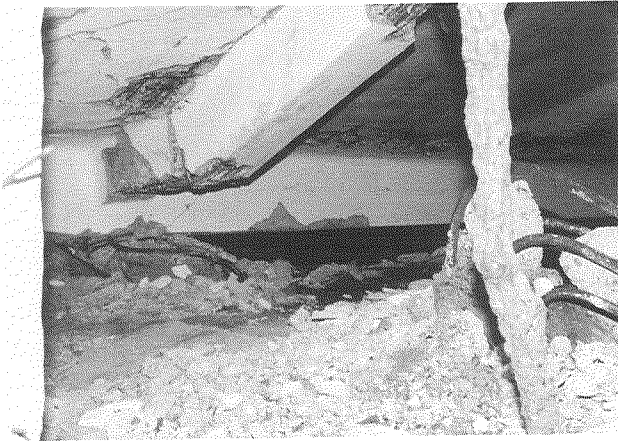
Photo 7. Crushed column of same building

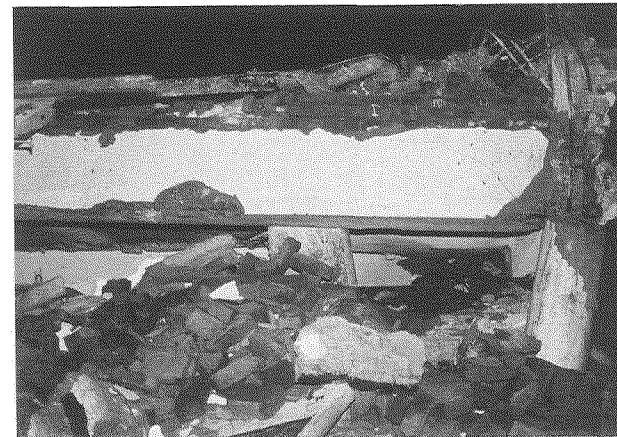
Photo 8. Undamaged beams of the same building

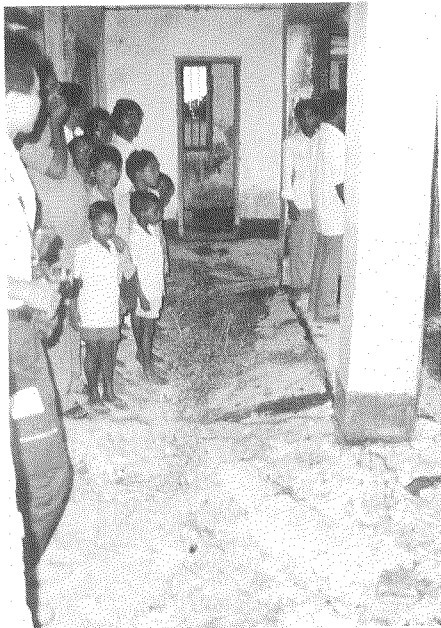
Photo 9. Damaged floor due to soil liquefaction

Ground Liquefaction: In many areas near the epicentral region sand erupted along with water, like a volcano, up to a height of 6 feet. Nearby houses were badly damaged, with the bursting of the floors under pressure from rising sand (Photo 9 and 23). It is said that here many wells became filled with sand and the water turned reddish. Also some hand pumps which earlier were dry, had water flowing in them after the earthquake.

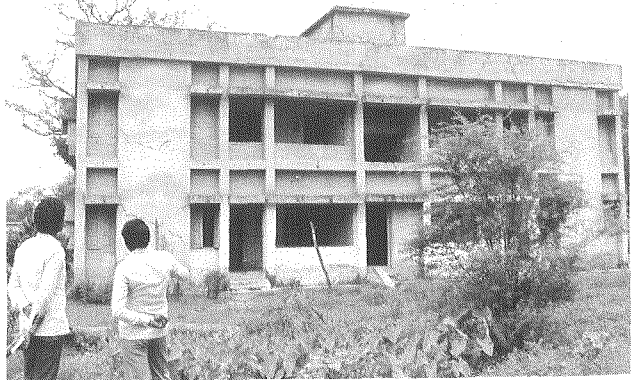
Photo 11. Apartment Building (Samastipur)

The principle of relative rigidities assures that the resisting elements of a structure, subjected to lateral load, share the load in proportion to their rigidities. The most rigid element assumes the greatest burden and if it is incapable of assuming it, failure results. Examples of this are seen in the Samastipur apartment buildings (Photos 11 and 12).

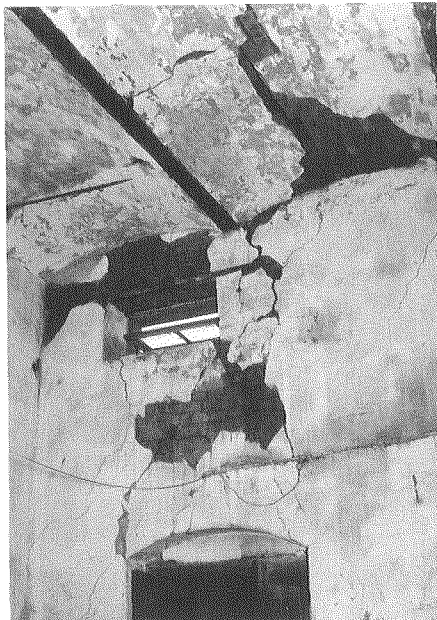
Photo 10. Damaged Roof of Clinic Building (Sakira)

6) Distress in Jack arch roof: These are brick masonry arch roofings supported on I beams. They have spans of about 1.0-1.5 m and a rise of about 15 cm. Loosening of brick units, rendering them susceptible to collapse, occurred in many places (Photo 10).

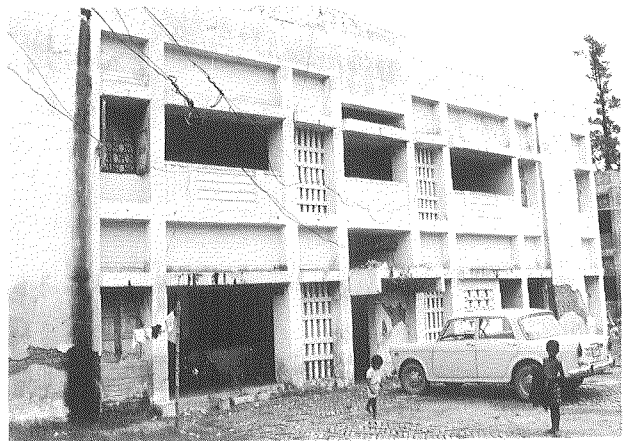
Photo 12. Apartment Building (Samastipur)

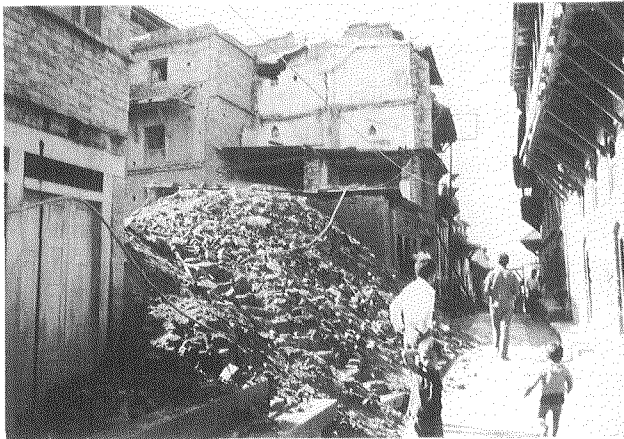
Photo 13. A damaged house (Bhakatpur)

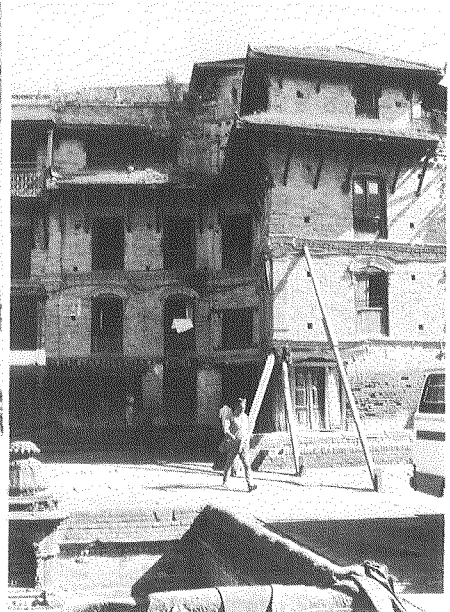
Photo 14. View of 4 storeyed brick houses (Bhakatpur)

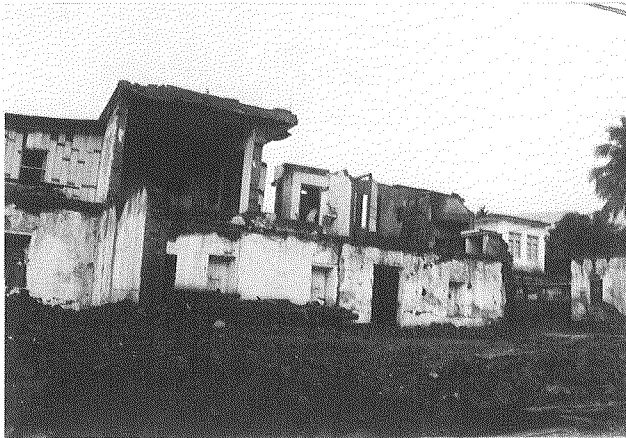
Photo 15. A damaged house (Dharan)

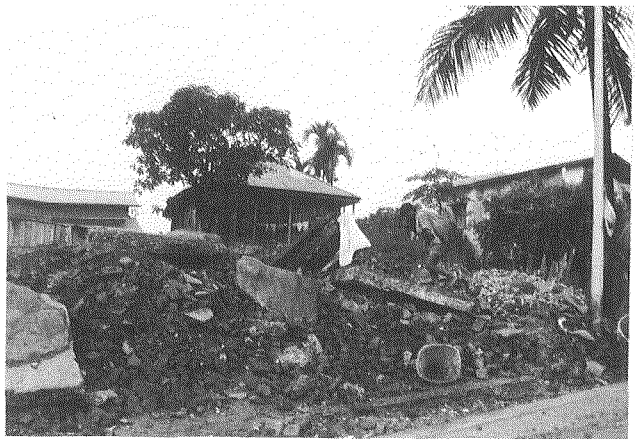
Photo 16. Collapsed masonry dwelling, intact tin roof house in backview (Dharan)

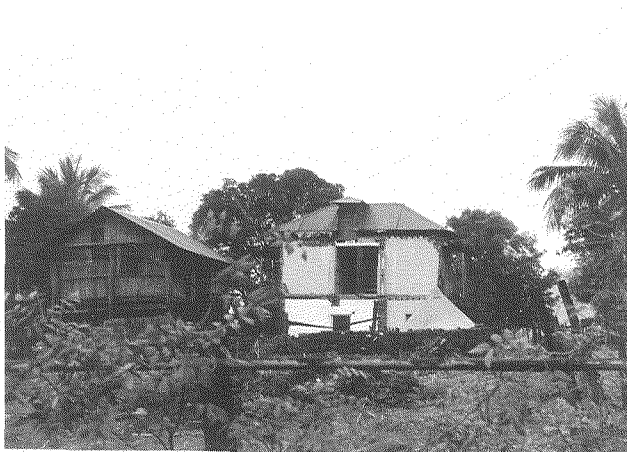
Photo 17. Undamaged wooden frame house (Dharan)

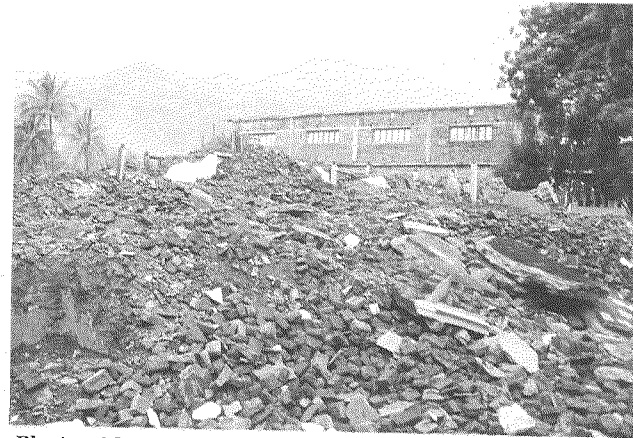
Photo 18. Collapsed masonry of school building, intact RC frame in back view (Dharan)

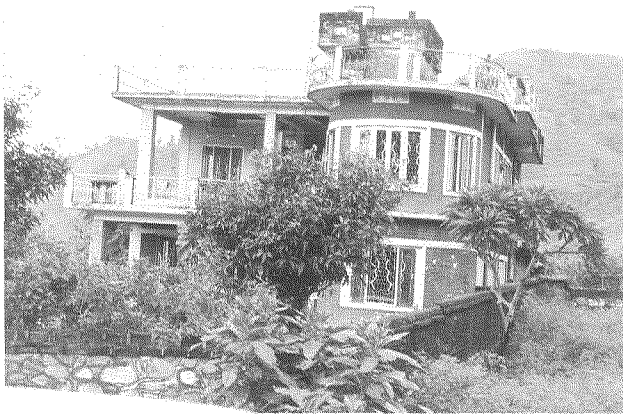
Photo 19. A house tilted after the quake (Dharan)

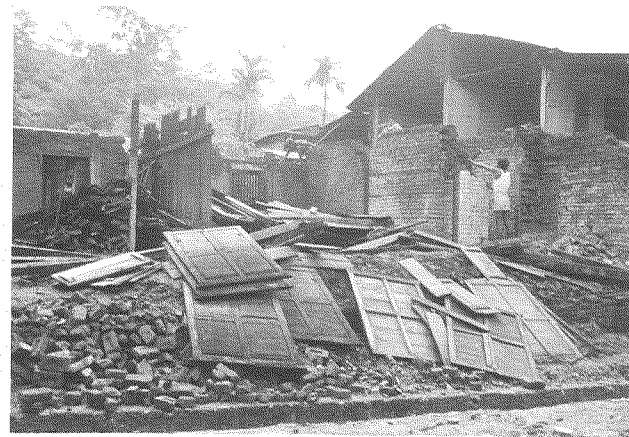
Photo 20. Another damaged dwelling (Dharan)

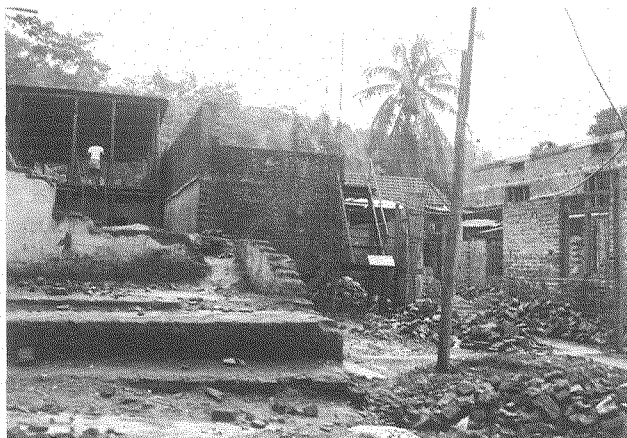
Photo 21. A damaged house under reconstruction
(Dharan)

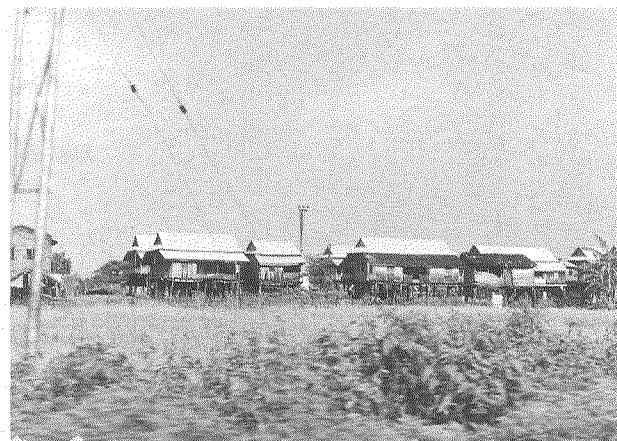
Photo 22. Undamaged traditional houses supported
on wooden planks (Dharan)

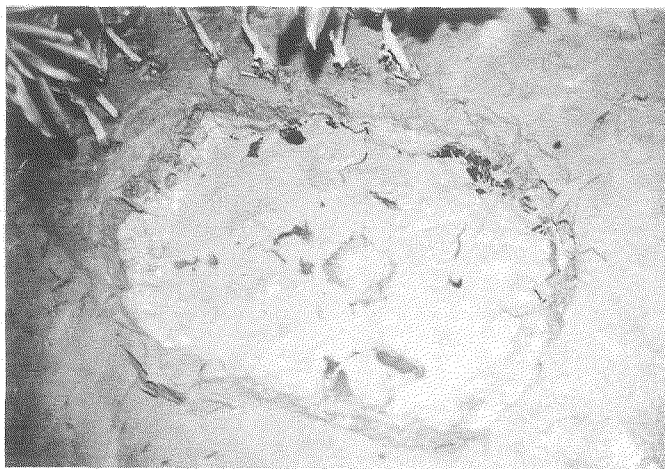
Photo 23. Soil liquefaction Site (Nepal)
