DAMAGE REPORT OF THE LOMA PRIETA EARTHQUAKE ON OCTOBER 17, 1989

A strong earthquake of Ms=7.1 occurred in Santa Cruz Mountains of northern California at 5:04 p.m., October 17, 1989. About 40km of the San Andreas fault slipped with about 1.8m horizontal and 1.2m vertical displacements. Extensive damages were reported in the San Francisco Bay Area as well as the epicentral region.

Two weeks after the earthquake, five faculty members of Institute of Industrial Science flew to San Francisco to investigate various damages due to the earthquake. This news letter shows typical damages of buildings, transportation facilities and lifeline structures.

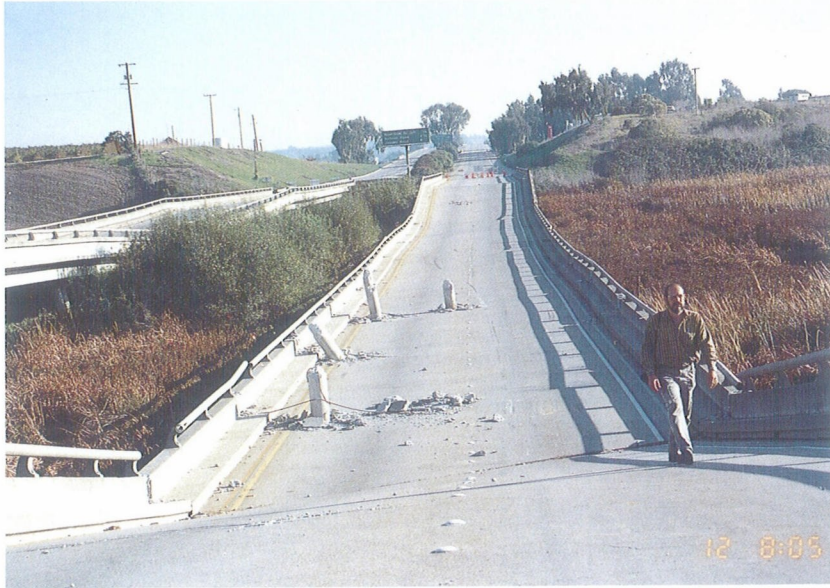
Photo 1. The slab of the Narrow Bridge of California State Highway 1 fell onto a wet low ground in Watsonville where many wooden and masonry buildings in the downtown area were severely damaged. The slab was punched by RC piles with diameter of about 37cm.

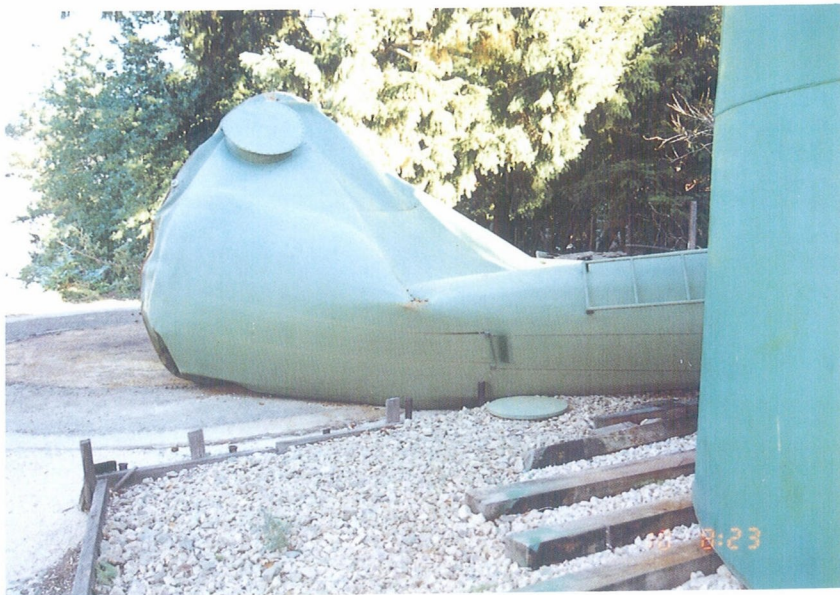
Photo 2. Water tanks by the Summit road running along the San Andreas Fault were severely ruptured. The 20,000 gallon water tank was shifted in the direction of $N75^{\circ} E$ about 120cm on the timbers. The bottom plate of the 18,000 gallon water tank in the background was peeled off from the concrete foundation.

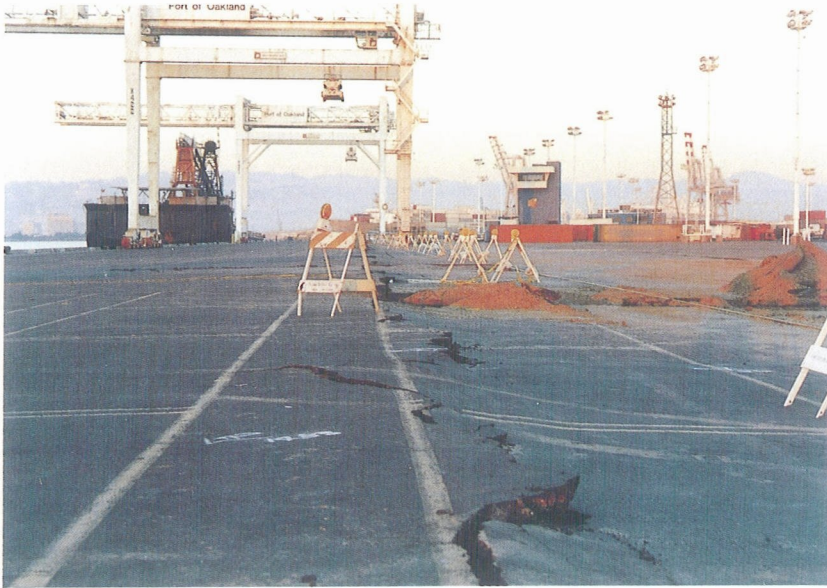
Photo 3. The backfill of the container pier in the Port of Oakland was settled about 1 to 1.5 feet resulting in cracks of piles supporting this pier and a tilt of cranes with their sea-side wheels on the pier and inshore-side wheels on the backfill.

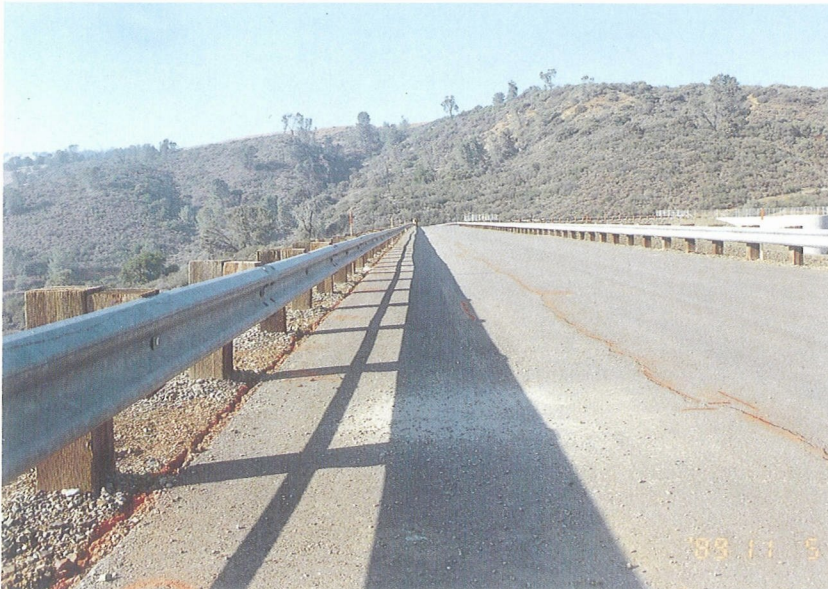
Photo 4. There are about 7 dams in the area within the epicentral distance of 20km. All of them are of fill-type and minor damages on these dams are reported. Longitudinal cracks are running on the Anderson Dam ($\Delta=20\text{km}$) where the maximum horizontal acceleration was 0.43g on the crest and 0.23g at the downstream recorder site.

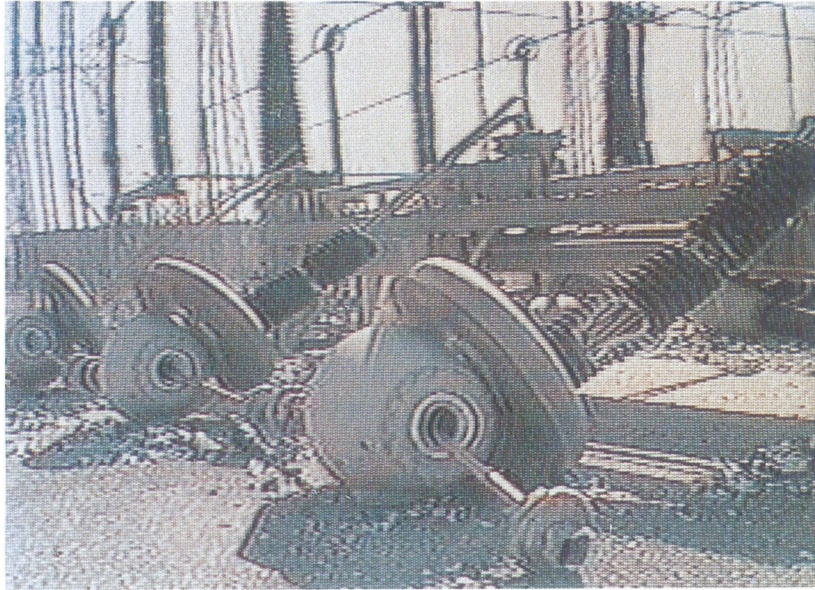
Photo 5. Three major substations, Metcalf, San Mateo and Moss Landing, were severely damaged in their switchyards, then about 1.4 million customers lost electric power. Top heavy circuit breakers turned over and oil leaked from transformers. (From the video tape of PG&E)

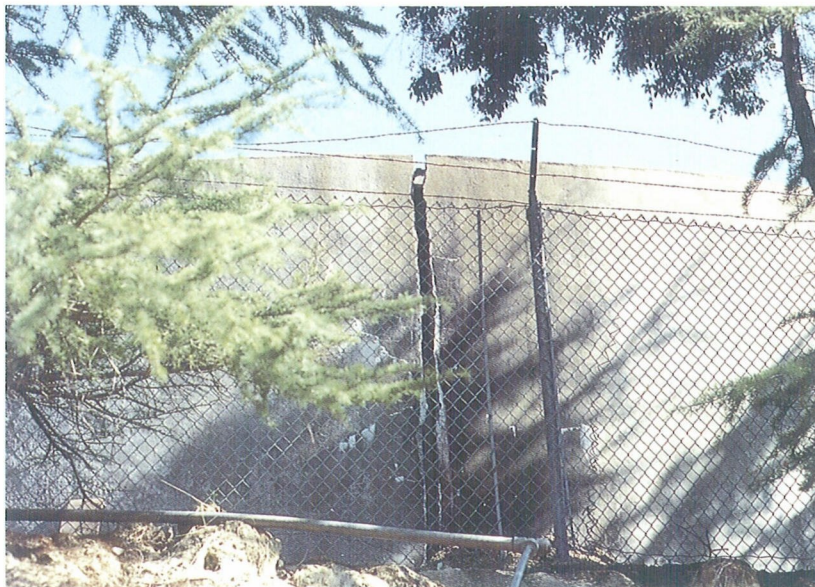
Photo 6. A prestressed concrete water tank broke from top to bottom and the full storage water flew out in Los Altos Hills. This tank of 1 mega-gallon was located unfortunately just above an extended fissure.

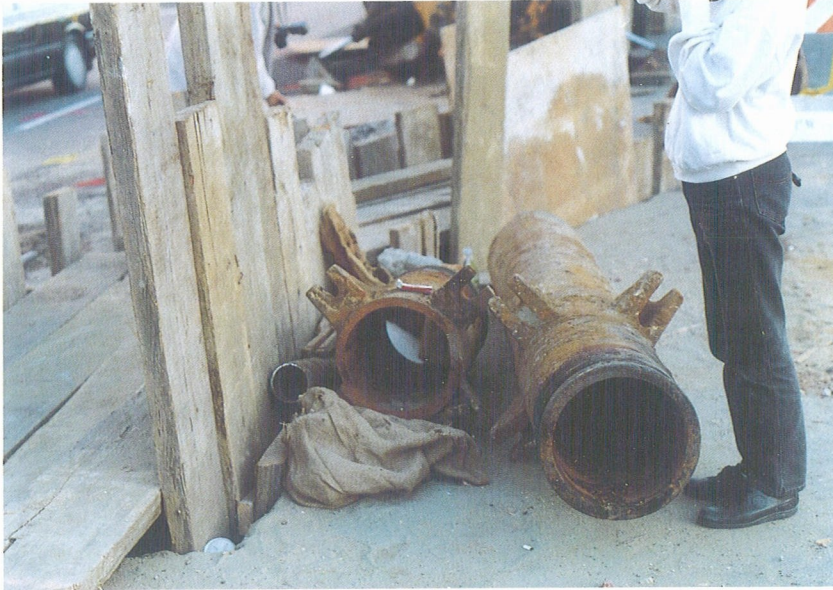
Photo 7. San Francisco's auxiliary water line broke at the south of Market Street. Due to the break of 12 inch high pressure line, water pressure of the fire fighting system dropped. Thus a fire boat was brought in for the fire fighting in Marina District.

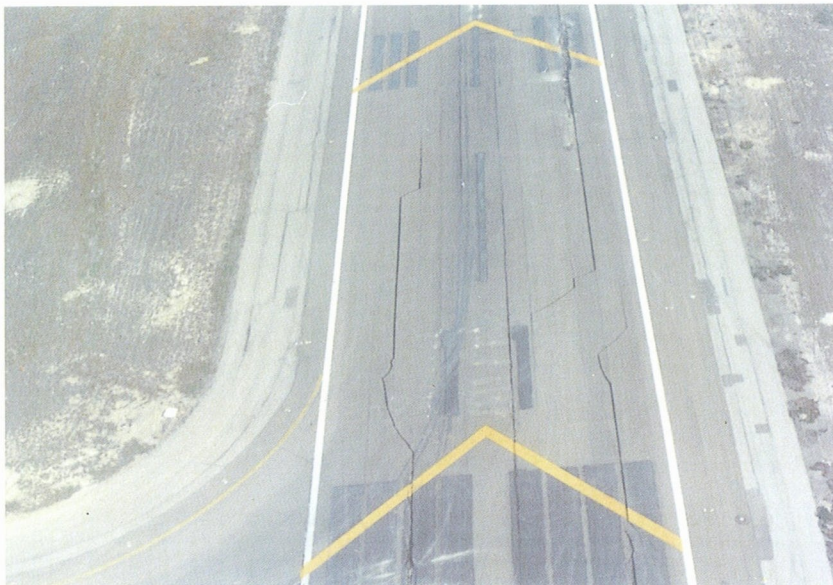
Photo 8. In Oakland International Airport, 3,000 feet of the 10,000 feet main runway were severely damaged. An extensive cracking was developed and many sand boils were observed. However, the airport was kept open except for very large aircraft.

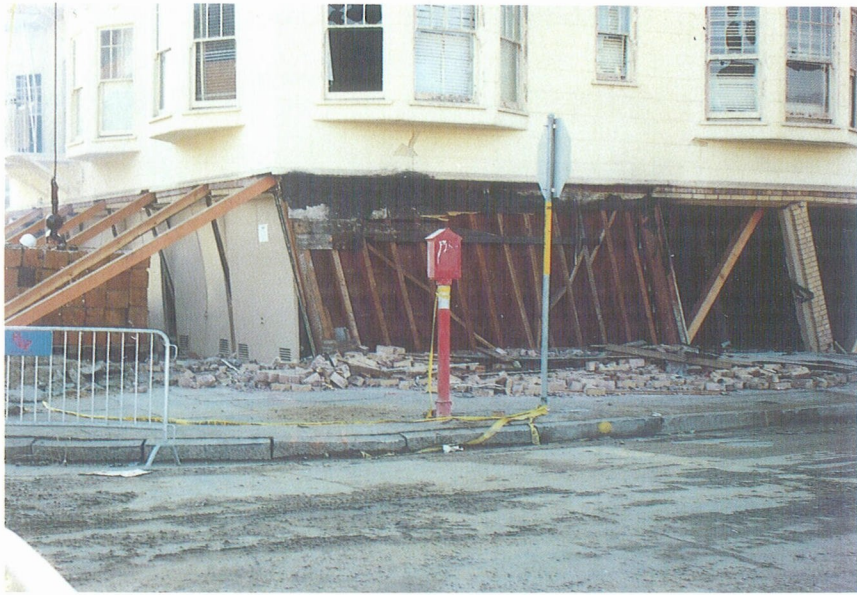
Photo 9. In Marina District, corner buildings were severely damaged. Most of them were 3 or 4 story apartment buildings in which the first story was taken up almost entirely by garages. The ground story had less lateral resistance than the upper stories and thus resulted in the "soft first story" behavior.

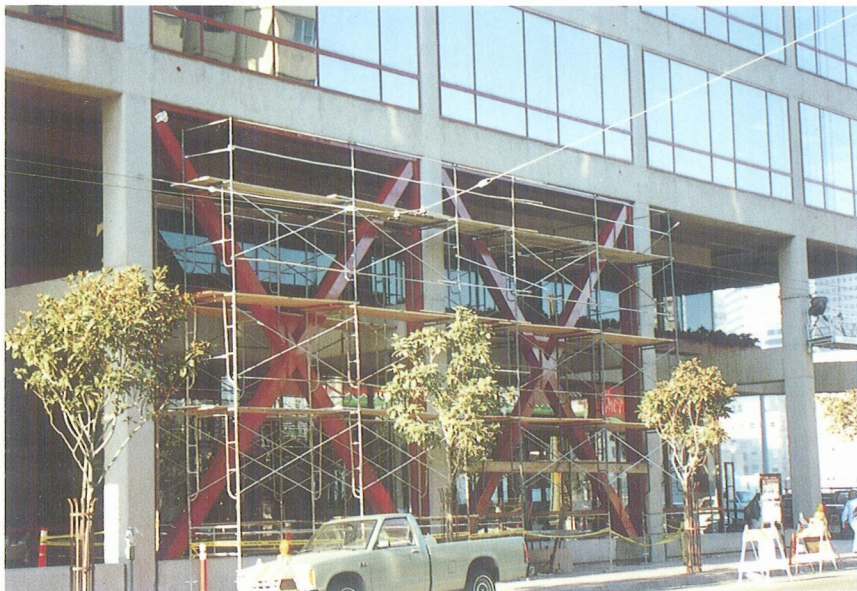
Photo 10. This relatively new reinforced concrete building at 4th and Harrison Streets in San Francisco had been strengthened and stiffened using steel brace systems before the earthquake. A large local buckle, however, developed in one of the brace systems and it was replaced immediately after the earthquake.

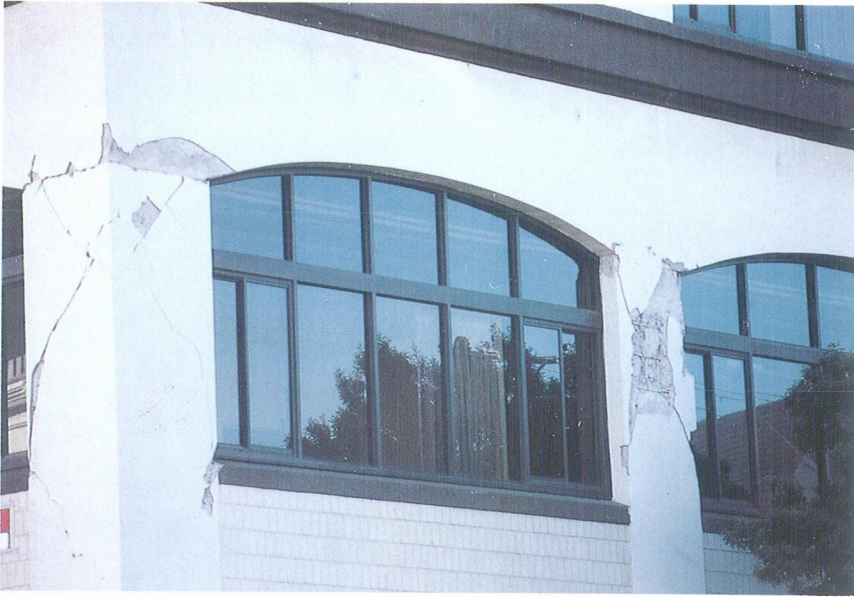
Photo 11. Shear cracks developed in the second story of a relatively new reinforced concrete building at Oak Street and Gough Street in San Francisco, mainly due to the presence of shear walls in the first story.

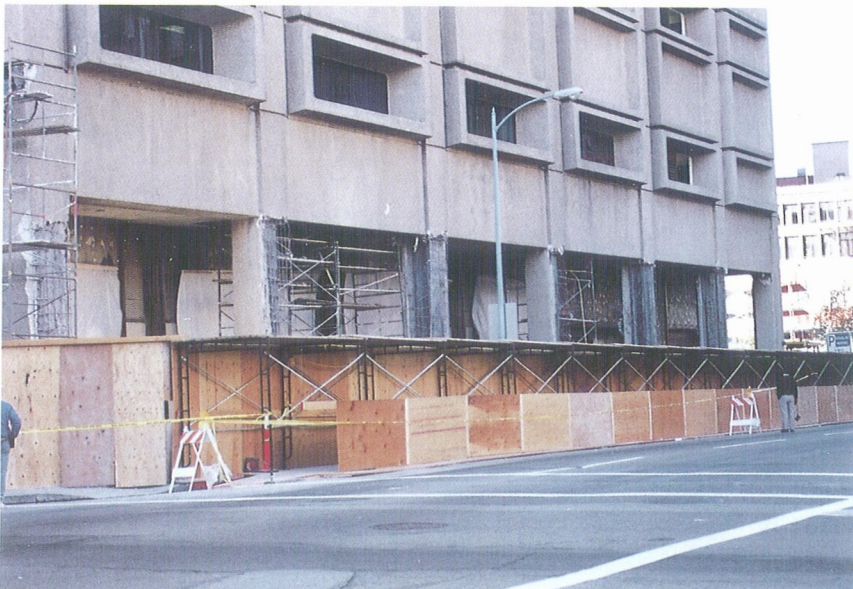
Photo 12. A steel frame building at Franklin Street and 17th Street in Oakland constructed in the early 1960s suffered major shear cracks in the lightweight concrete walls and columns. The damaged elements were under repairing when the investigation team arrived at the site.

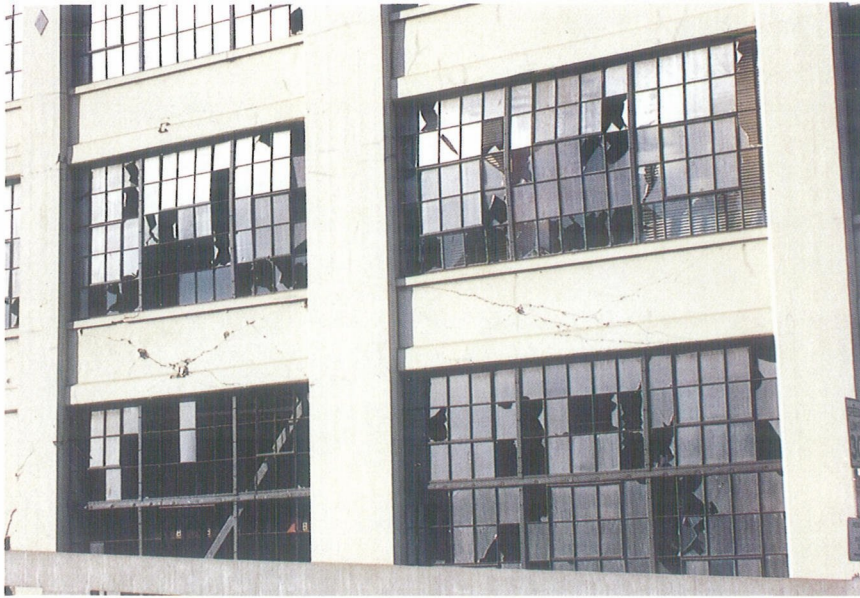
Photo 13. An old reinforced concrete warehouse in Emeryville suffered severe shear cracks in beams, columns, and walls. A highrise building, which is several hundred meters away from this building, experienced a strong ground motion, with a peak acceleration of 0.22g at the ground floor.

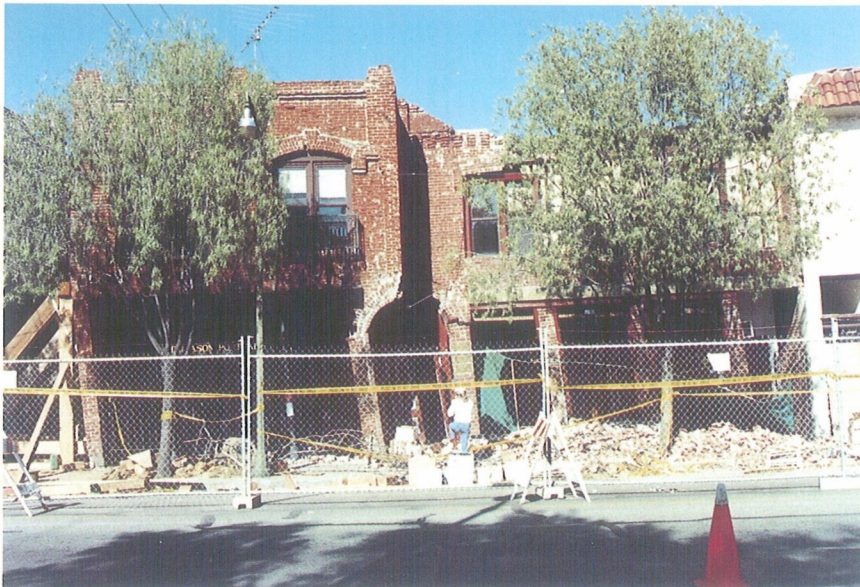
Photo 14. Unreinforced masonry buildings in the epicentral region suffered severe damages and partial collapses such as out-of-plane failure in parapets and the upper portion of the wall. This building on the main street in Los Gatos was extremely deformed in the first story.

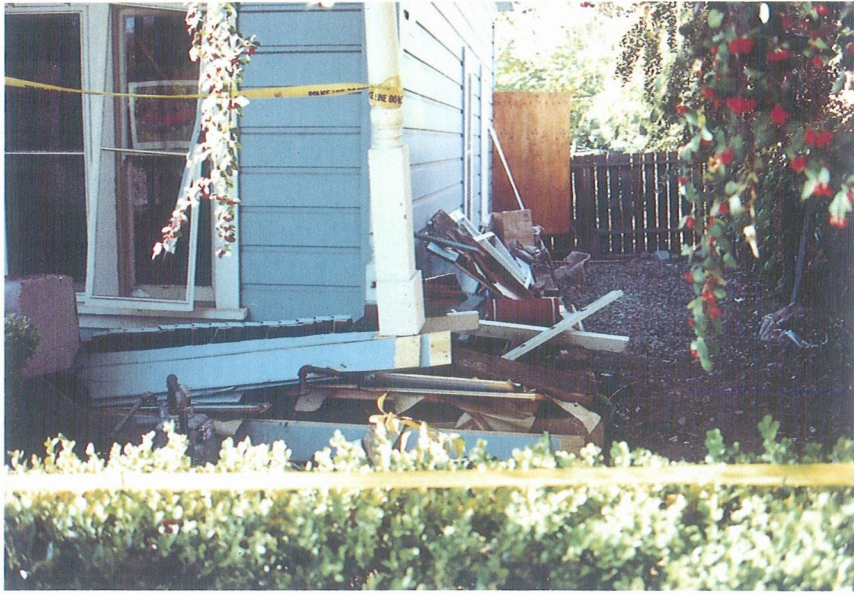
Photo 15. Another typical damage in the epicentral region was found in old wooden frame residential structures built on the cripple (or pony) walls of approximately 50cm high. These walls had poor lateral resistance and collapsed during the strong shaking.

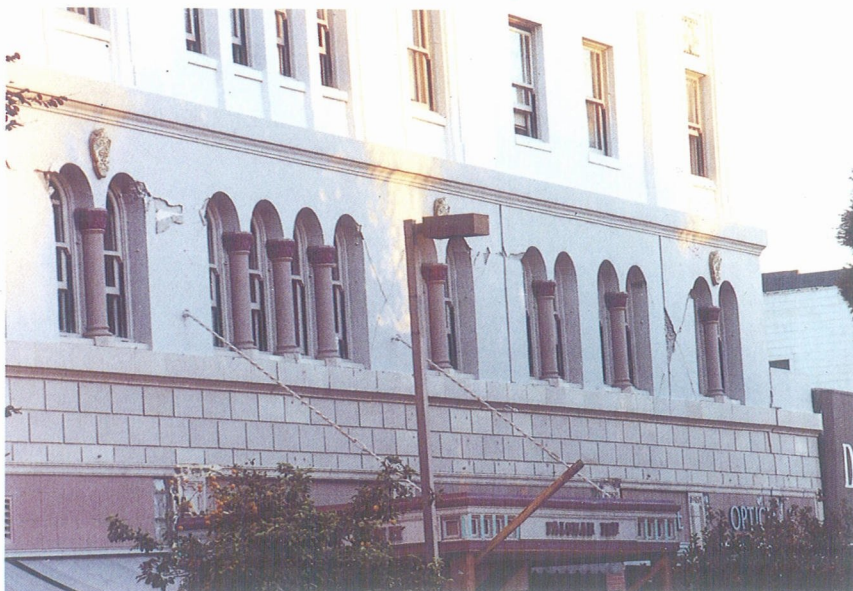
Photo 16. Old buildings on the Pacific Garden Mall in Santa Cruz suffered most severe damages in the epicentral region. This seven story old reinforced concrete hotel (Palomar Inn) suffered crackings in all of the shear walls at the second story. A few people were killed in this area.
