## **RECONNAISSANCE REPORT ON STRUCTURAL DAMAGE IN BAGUIO BY THE JULY 16, 1990 LUZON EARTHQUAKE**

by :  
Gilbert L. MOLAS\* and Fumio YAMAZAKI\*\*

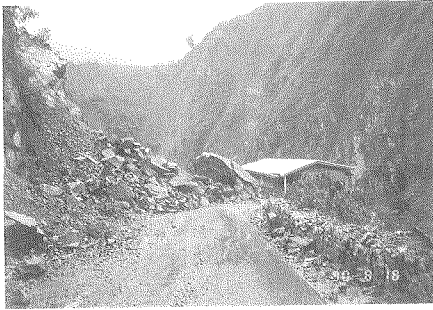
Photo 1 Kennon road blocked by rockslides

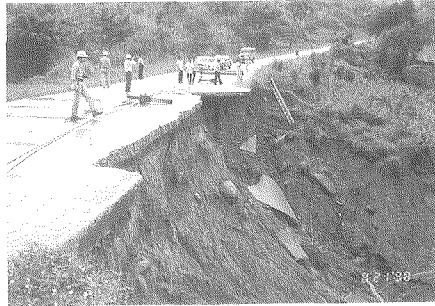
Photo 2 Failure of road foundation on Marcos Highway

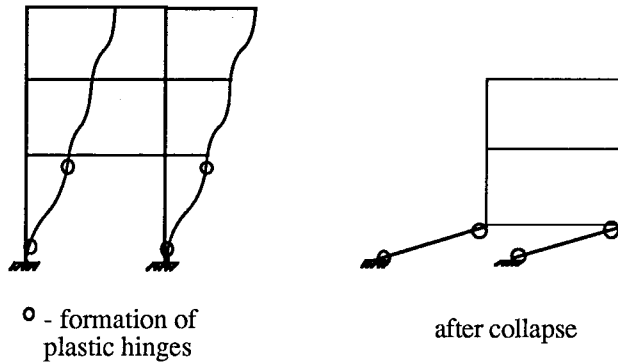
1) Soft-first storey It is common in the Philippines to use the ground floor of a multi-storey building for commercial purposes like a store or restaurant to increase the utility of the property. In such a case, the ground floor will usually have a longer unsupported length for the columns. There will also be a tendency to have more and larger windows, while the upper stories will have mostly reinforced concrete hollow blocks (CHB) for exterior and interior walls. This abrupt change in the storey stiffness will cause the first storey to have a larger drift than the rest. The result would be the formation of plastic hinges at the maximum moment sections of these columns (Figure 5). The damaged buildings which experienced this kind of failure mode are the FRB Hotel, Royal Inn, Nevada Hotel, and Cafe Amapola.

Figure 5 Soft First Storey Failure

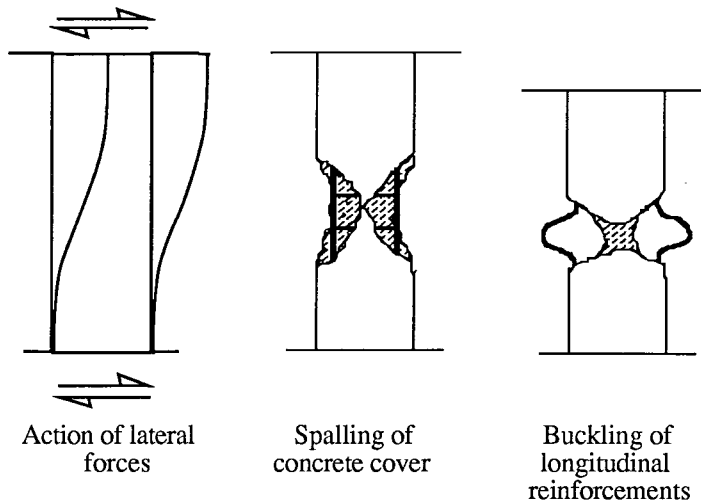
2) Shear failure of columns Due to the large horizontal forces brought about by earthquakes, columns (especially the lowest ones) experience large and cyclic shear stresses. If the shear stress goes beyond the capacity of the column, then diagonal cracking will initiate near the center of the column. Because of the cyclic reversal of the stress, this results in the characteristic X-cracks (Figure 6). Examples of damaged buildings are the S&L Building and Quezon Hall in Teacher's Camp.

Infill walls that are not continuous from bottom to top contribute the shear stress by the so called short-column effect. These low infill walls make the lower part of the column more rigid. Thus when the storey experiences drift, the "short" column will experience more induced shear stresses. Examples of buildings with this type of failure are the Skyworld and Baguio Country Club.

Figure 6 Shear failure of columns

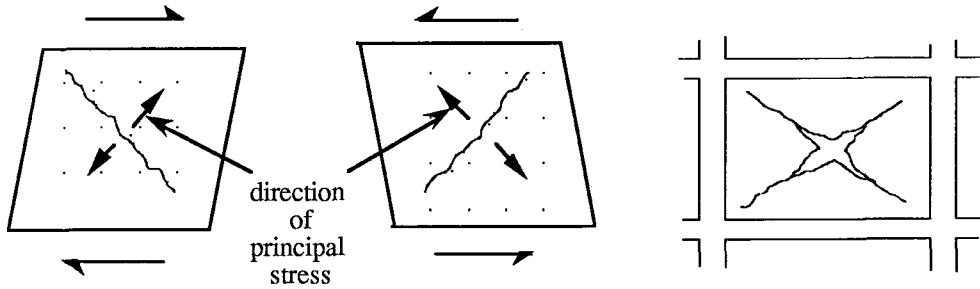
3) Shear failure /cracking of walls In a similar way as with columns, walls that are fixed to the structural elements suffer from large shear stresses. In the Philippines, the most common type of partition is the reinforced CHB. These walls are usually connected to the columns and the upper and lower beams through the use of reinforcement bar studs. Since these walls were not designed to carry significant shear loads, they

are usually the first one to crack and fall off (Figure 7). This type of failure is very common with the damaged buildings in Baguio.

Figure 7 Shear damage of walls

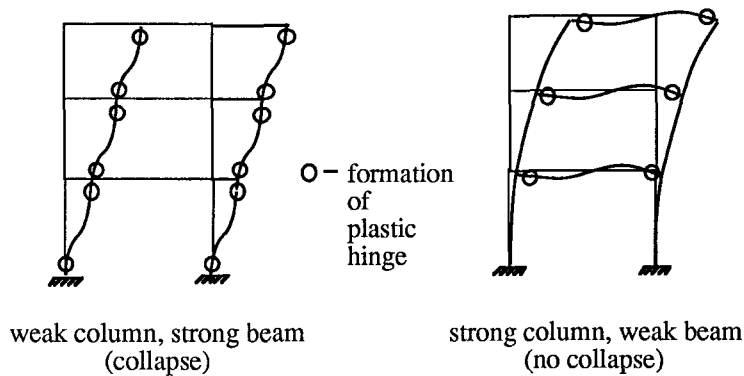
4) "Pancake" collapse This kind of collapse is characterized by the failure of all columns in a storey, or in some cases, all stories (Figure 8). Due to this "total" collapse, a lot of casualties result. This type of collapse can be avoided if the strong-column, weak-beam concept was applied. Buildings which suffered this type of failure are the Baguio Park Hotel and the Hyatt Hotel's Tower Building.

Figure 8 Mechanism of "Pancake" collapse

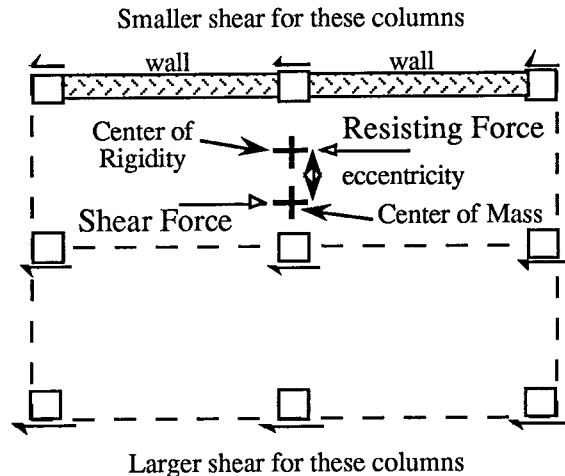
5) Torsional Shear Failure This type of failure is mainly due to the unsymmetrical torsional rigidity of the building. If the center of mass and the center of rigidity has a large eccentricity, then the lateral force will have a torsional moment about the center of rigidity. This will impart a larger shear forces at some of the columns in the storey (Figure 9) . This will also tend to twist the storey from the floors below. An example of this is the University of Baguio College of Commerce and the Golden Bake Shop.

Figure 9 Torsion due to eccentricity of centers of mass and rigidity

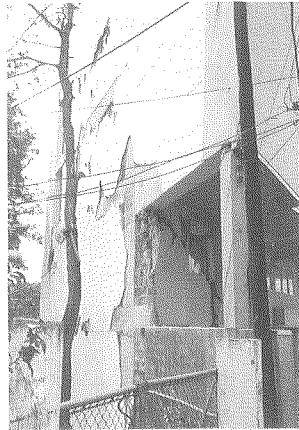
There are large diagonal and X-cracks on architectural columns (walls so designed to look like massive circular columns). The plaster of exterior walls have spalled (Photo 4). And some of the third floor columns

Photo 4 Side view of Golden Bake Shop showing triangular plan

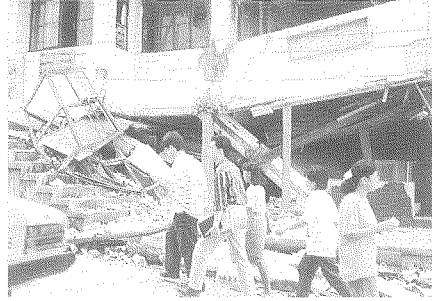
Numerous columns on the first floor failed in bending, developing plastic hinges on both ends of the column. Due to the formation of the plastic hinge, the top four floors swayed and moved backward about 2 to 3 meters (Photo 6). Several columns experienced buckling after the concrete cover has spalled. The beams and girders of this building were observed to be larger than the columns resulting in a strong beam, weak column effect.

Photo 6 Side view of FRB Hotel showing the displacement of a circular column

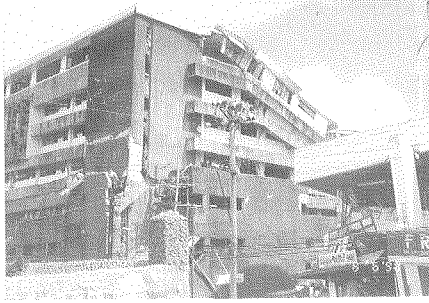
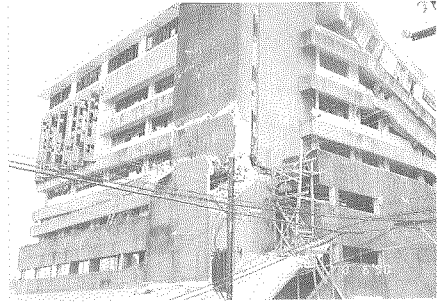
The Commerce building suffered the heavier damage with the complete collapse of the fifth floor. Rotational movement of the upper four stories relative to the lower stories can be observed from Luna Road (Photos 7 and 8). The rotational rigidity of the building is not symmetric. One side of the building is mostly made up of walls. The north side of this building suffered progressive collapse of the columns, starting from the fifth storey to the top (Photo 9). Photo 10 shows shear punching failure of a column on the first floor.

Photo 7 View from Luna road of University of Baguio Commerce building

Photo 8 Rotation of the upper four stories of U.B. Commerce building

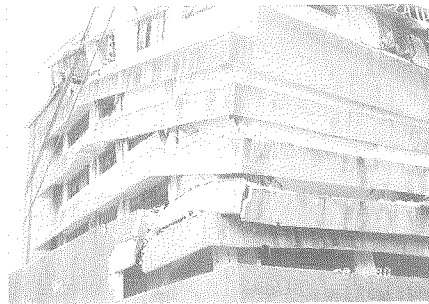
Photo 9 Progressive collapse from the fifth floor and higher of the U.B. Commerce building

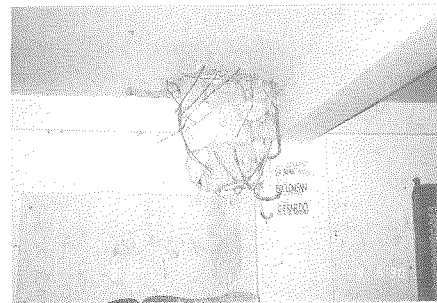
Photo 10 Punching shear failure at the basement of the Commerce building

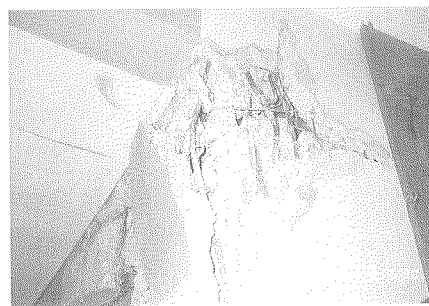
The Engineering building did not experience any collapse but there are severe damage to structural members (Photo 11). One interior wall completely fell down in one piece. Cracks on non-structural walls can be observed near the junction of the wall with the upper beam (Photo 12). Large horizontal cracks can also be observed on the wall lintel beams.

Photo 11 Failure of beam column joint at University of Baguio Engineering building

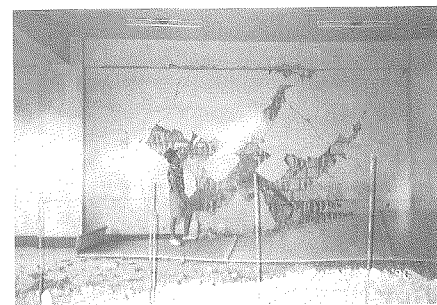
Photo 12 Shear cracks on CHB wall of U.B. Engineering building

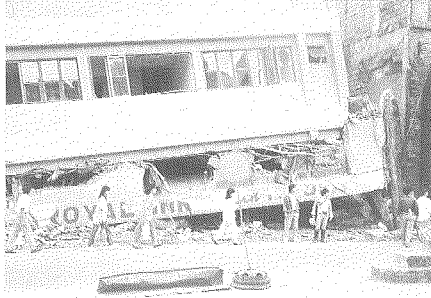
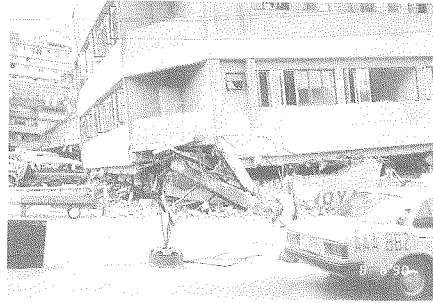
The first two stories of the building collapsed due to the failure of the columns. The rest of the structure does not seem to have any structural damage. The top floors moved about 1 meter to the North-northeast.

It is probable that the first storey was a soft storey and that the second storey collapsed due to the impact of the building when the first storey collapsed (Photos 13 and 14).

Photo 13 View from public market of Royal Inn

Photo 14 The Royal Inn building moved about 2 meters to the left

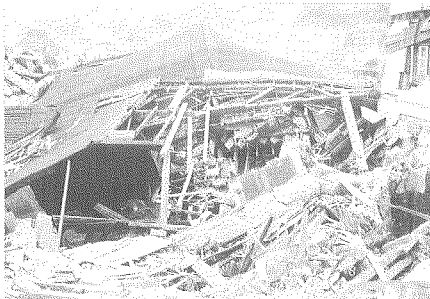
Photo 15 The completely collapsed structure of Aurora Theater

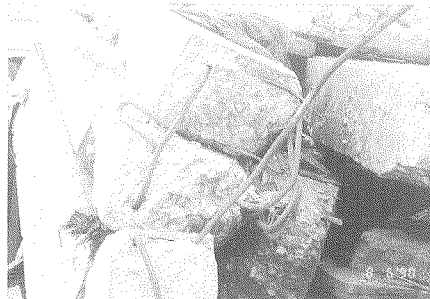
Upon inspection of the rubble, however, the following were observed. The longitudinal bars and tie bars for the rectangular columns used were plain round bars. The concrete has a light brown color. Also, the aggregates used were of different sizes. The aggregates were not ordinary gravel taken from rivers, but more likely taken from the mountainside (Photo 16).

Photo 16 RC columns from Aurora Theater showing reinforcements and concrete with light brown color

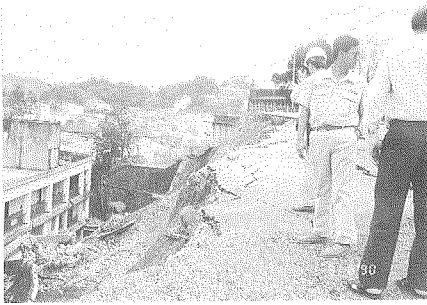
Damage to the exterior is slight with small cracks on the walls. One of two tower roofs was leaning to the southwest direction. The retaining wall supporting the ground failed (Photo 17) and cracks parallel to the failure can be seen on the ground.

Photo 17 Failure of retaining wall of Baguio Cathedral

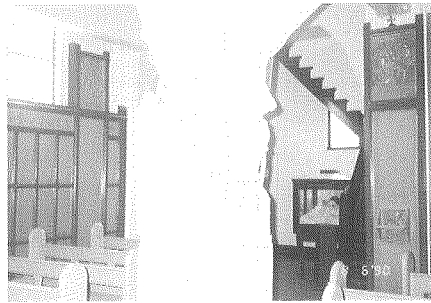
The columns supporting the reinforced concrete framed balcony at the back of the church suffered shear failure, exposing the reinforcement (Photo 18). The RC columns of the balcony on the side suffered only cracks on the plaster at the construction joint. One of the gravity columns supporting the arches twisted with respect to its base (Photo 19). And cracks appeared on the arches.

Photo 18 Shear failure of column supporting balcony at Baguio Cathedral

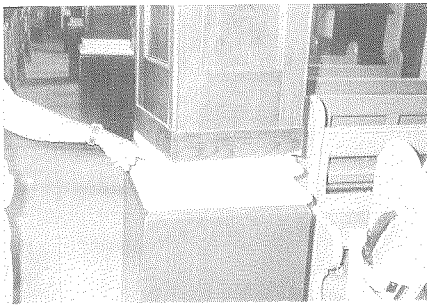
Photo 19 Twisting of gravity type column in Baguio cathedral

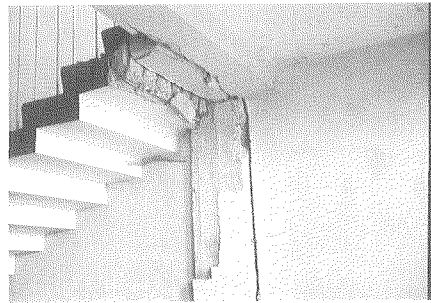
Photo 20 Crushing of concrete at stairs support of Little Angel's Nursery School

The building suffered cracking on the exterior wall and infill walls. The reinforced concrete stairs suffered crushing at the supports (Photo 20) and in one case, completely collapsed.

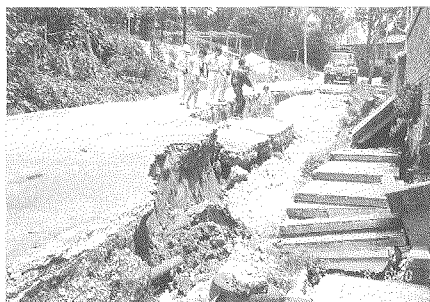
This is a reinforced concrete building with four stories above and four stories below the front ground level. The natural ground line is sloping steeply from the front of the building to the back. The ground around the building subsided about 1 to 3 meters (Photo 21). There are some slight cracking on the exterior walls.

Photo 21 Ground subsidence of 1 to 3 meters can be observed around the S & L building front entrance

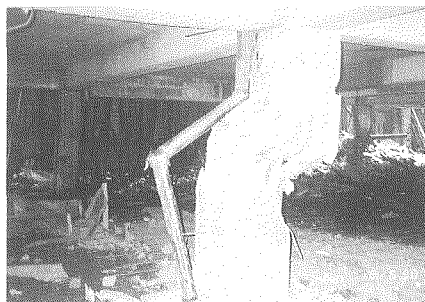
The most serious damage, however, can be found on the lowest basement. Here, almost all the columns suffered severe shear failure. The reinforcements buckled and the top portion of the column shifted (Photo 22 ). Note that small diameter ties with wide spacing were used.

Photo 22 Severe shear failure of columns at the basement of S & L building

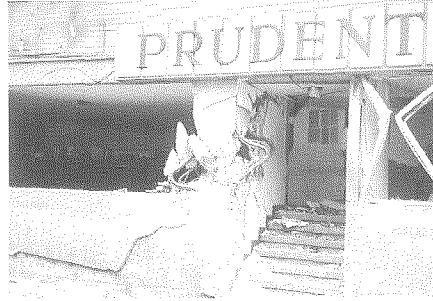
The first floor columns along Session road suffered severe shear failure. Bundled, large diameter longitudinal reinforcements were used together with small diameter ties with wide spacing. The existence of low infill walls also aggravated the situation, producing a short column effect (Photo 24). Numerous diagonal cracks starting from the corner of windows can also be observed.

Photo 24 Column with severe shear damage at Skyworld building

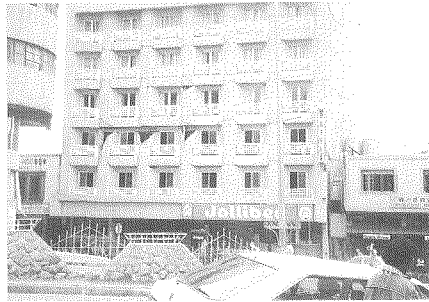
The six storey Jollibee building across the Skyworld building performed well with no structural damage. Damage was limited to shear cracking of non-structural walls (Photo 25).

Photo 25 The Jollibee building across the Skyworld building suffered only damage to non-structural walls

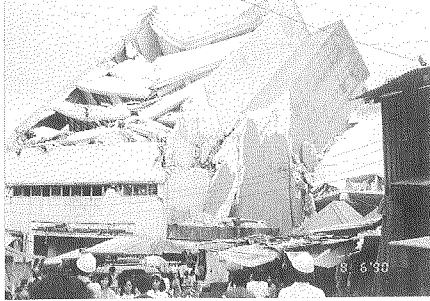
Photo 26 Collapse of Hilltop Hotel

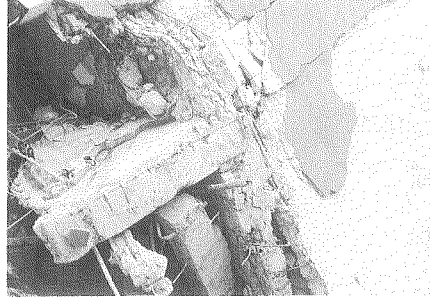
Residents say that this building was damaged during the 1985 earthquake in Baguio and was already condemned before the July 16 earthquake. Photo 27 shows the extension of the reinforcement bars of a beam to the column. Notice that the extension was not placed within the confinement of the column reinforcements.

Photo 27 Damaged beam column joint showing beam reinforcement extensions not confined in column cage

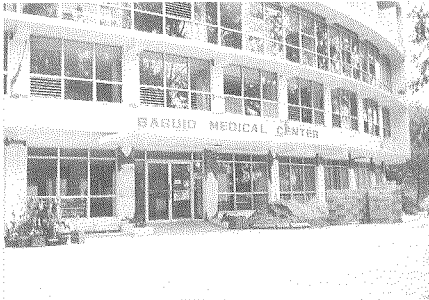
This is a four storey reinforced concrete building with a curved facade. At the time of the survey, damaged columns were already repaired. Damage was limited to the spalling of mortar plaster of the columns (Photo 28).

Photo 28 Almost completed repair of Baguio Medical Center

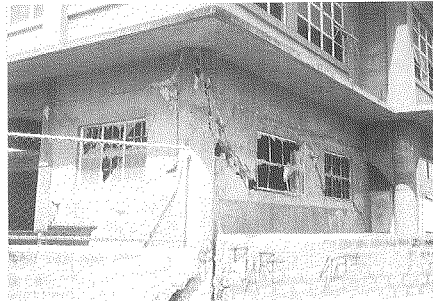
The girl's campus is composed of two buildings. In the first building, there was a severe shear cracking on the walls of one corner on the ground floor level. The crack continued to the corner column (Photo 29). There were also limited spalling of mortar plaster which occurred at the construction joints. Limited diagonal cracks on non-structural walls were also observed.

Photo 29 Severe shear cracking of first storey wall in St. Louis University (Girls' Campus)

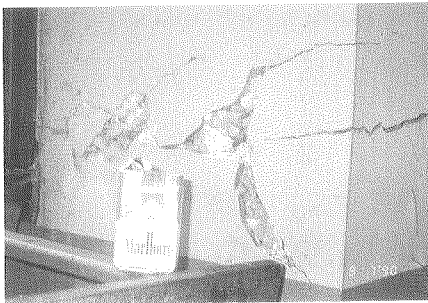
For the second building, limited spalling of concrete occurred. A horizontal crack occurred on top of one column. Photo 30 reveals the use of non-uniform aggregates and the use of mineral rock for coarse aggregates. Horizontal cracking along the boundary of the beam and non-structural wall also occurred.

Photo 30 Mineral rock used as aggregates in St. Louis University (Girls' Campus)

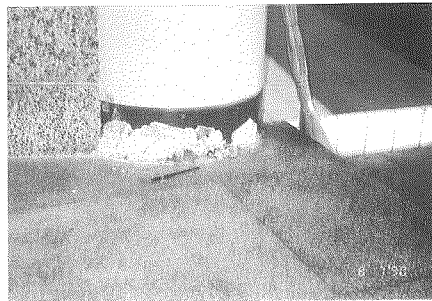
The laboratory building of the boy's campus suffered very little structural damage. Cracking of infill walls near the vicinity of the lintel beam were observed. Another damage was the spalling of concrete on one spiral column revealing a void at the bottom of the column (Photo 31). The void was due to a construction defect in pouring the concrete on the forms. Another circular column holding a spiral staircase was vibrating as the first author was climbing up the stairs. The reinforcements of this

column is not continuous with the roof beam making it act as a long cantilever beam.

Photo 31 Void at bottom of column in St. Louis University (Boys' Campus)

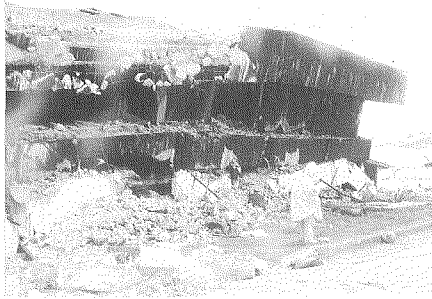
The export processing zone is comprised of two identical buildings. Both are reinforced concrete and have three stories. The south building completely collapsed and burned soon after killing a lot of people trapped inside (Photo 32). The cause of the fire was not known. The north building was severely damaged but did not collapse (Photo 33). Some columns lost their concrete cover exposing the reinforcements (Photo 34).

The difference in performance of two identical buildings only several meters apart may be attributed to the local ground condition. The north building was reported to have been constructed on a cut while the south building was built on a fill.

Photo 32 The burnt out Baguio Export Processing Zone (EPZA) South building

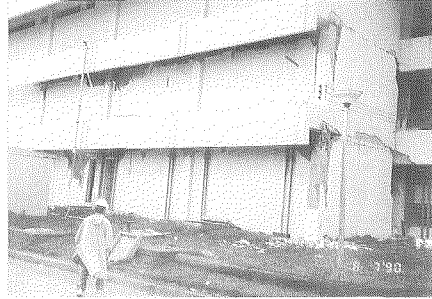
Photo 33 Damage to EPZA North building

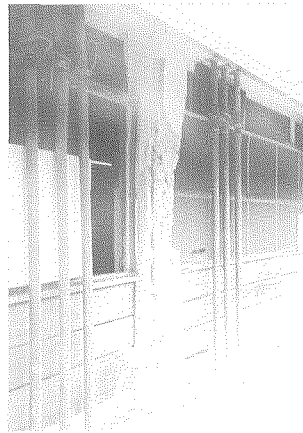
Photo 34 Exposed reinforcements of column in EPZA North building

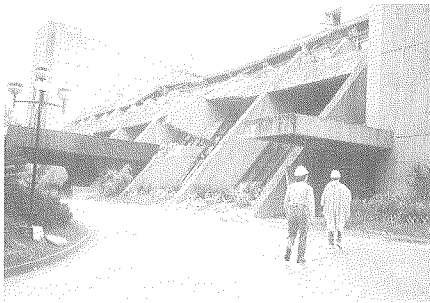
The facade of the Terrace building (7 stories) was sloped and fell into the atrium in a south direction. The inclined wall-type columns failed, reinforcements lost their bond and pulled out (Photo 35). The Tower building (11 stories and 1 basement) completely collapsed in the North direction (Photo 36). The East building (8 stories) suffered severe cracking on exterior walls but did not collapse (Photo 37). The South building (7 stories) suffered little damage on the outside. The West building suffered severe shear cracking on the exterior walls. Damage to columns were limited to the spalling of the mortar plaster (Photo 38).

Photo 35 Inclined wall-type columns collapsed into atrium in Hyatt Terraces Hotel's Terrace building

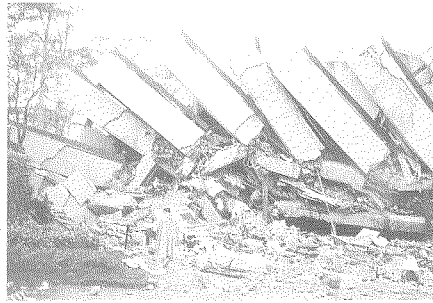
Photo 36 "Pancake" collapse of 11 storey Hyatt Tower building

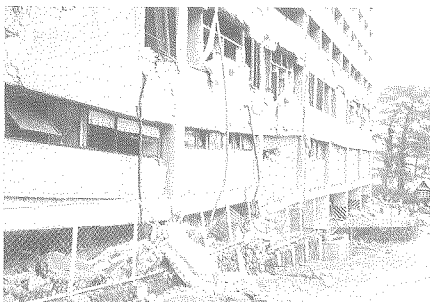
Photo 37 Severe damage on exterior walls of Hyatt's East building

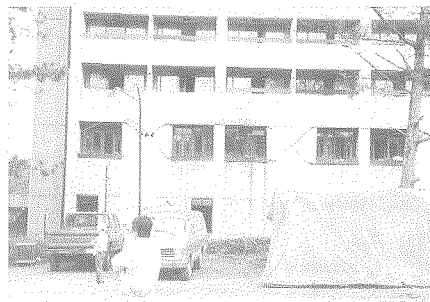
Photo 38 Typical shear cracks on exterior walls of Hyatt's West building

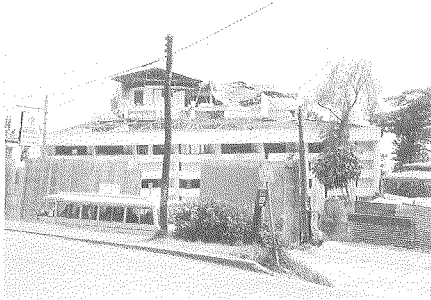
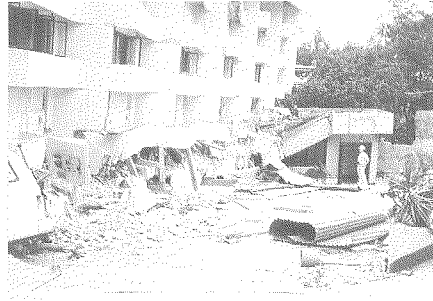
This is a four storey reinforced concrete building with one basement. The first two stories of this building completely collapsed killing several people. The collapse is probably of the soft storey type (Photos 39 and 40).

Photo 39 This Nevada Hotel building tilted and the penthouse damaged

Photo 40 Collapse for first two stories of Nevada Hotel building

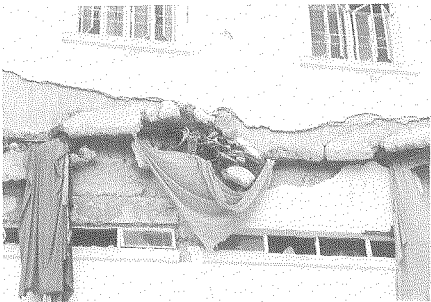
The Rice and Ozaeta Annex's first storey completely collapsed, probably due to a soft storey. The first storey was mainly used as a dining hall (Photo 41). For the Swiss Chalet, the columns suffered shear failure due to the short column effect of the infill walls (Photo 42).

Photo 41 Collapse of first storey (relative to front entrance) of Baguio Country Club's Rice and Ozaeta Annex

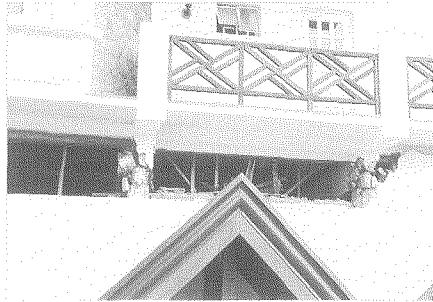
Photo 42 "Short" column shear failure at Baguio Country Club's Swiss Chalet

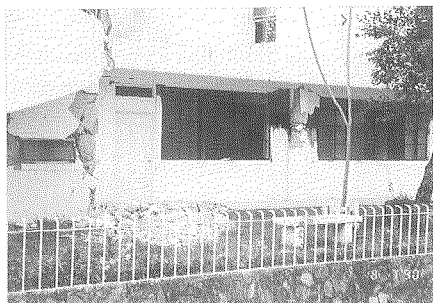
This is a two storey, reinforced concrete building. There were severe cracking of the first storey walls and spalling of concrete cover of the first storey columns (Photos 43 and 44). One non-structural wall fell down completely (Photo 45). This building was relatively small compared to the other damaged buildings. The main failure mode was in shear for the columns and walls.

Photo 43 Shear damage to walls and columns in Quezon Hall at Teacher's Camp

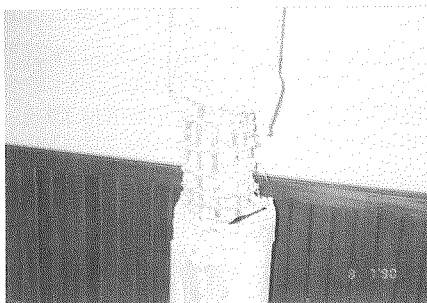
Photo 44 Spalling of concrete cover of round column in Quezon Hall at Teacher's Camp

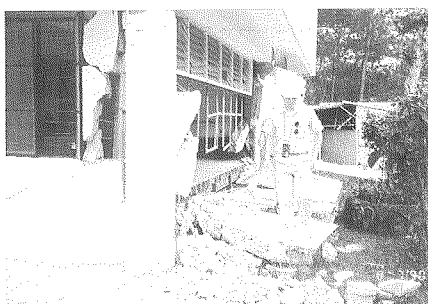
Photo 45 This non-structural wall of Quezon Hall at Teacher's Camp completely fell down .

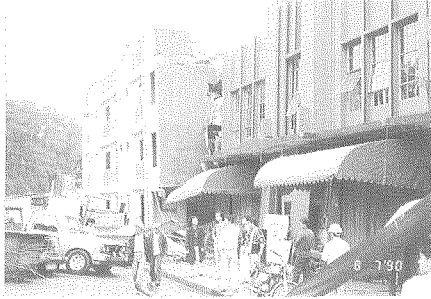
This is a reinforced concrete building with four stories above ground and two basement stories. The first storey of this building collapsed, probably as a soft storey (Photo 46).

Photo 46 Siesta Inn (left) is leaning forward and is currently being demolished at time this photo was taken (building on the right is Cafe Amapola).

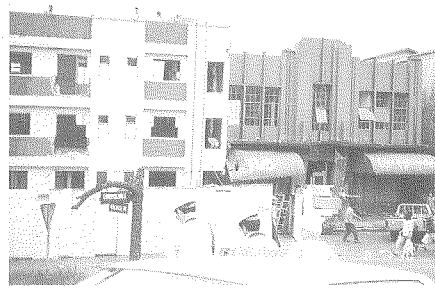
Photo 47 Plastic hinge formation of first floor column of Cafe Amapola (building on left is Siesta Inn)

This reinforced concrete building has two stories above ground and used as a pub/restaurant. The first storey columns suffered bending moment failure causing the second storey to have a permanent drift (Photo 47). It is also possible that the building next to it, the Siesta Inn, pounded against this structure.

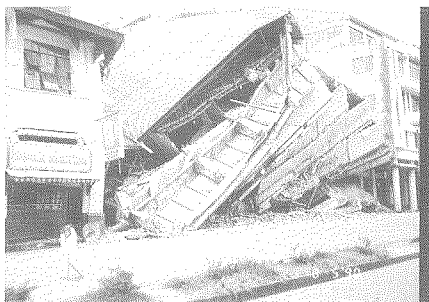
Baguio Park Hotel is a reinforced concrete frame structure with nine stories. This building completely collapsed in a pancake type while buildings next to it did not suffer serious structural damage. Photo 48 shows view from Harrison road. The damage to the building on the left was probably caused by the debris from the hotel. Due to the collapse of the building, the configuration cannot be determined during the field investigation. Photo 49 shows the view from the back.

Photo 48 The collapsed Baguio Park Hotel (building on the left was damaged by debris from the collapsed hotel)

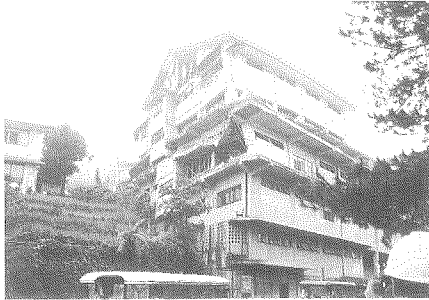
This is a reinforced concrete building with 6 stories and 2 basements. Photo 50 shows the third storey (reckoned from the front entrance) completely collapsed. It was reported that the upper four stories were added by extension works. Photo 51 shows another building of the Baguio Colleges Foundation. This building which is next to the collapsed building is only slightly damaged.

Photo 50 Collapse of third storey of Baguio Colleges Foundation (note hilly terrain of site)

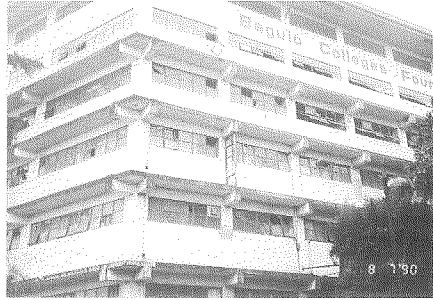
Photo 51 Slightly damaged building of Baguio Colleges Foundation next to collapsed building

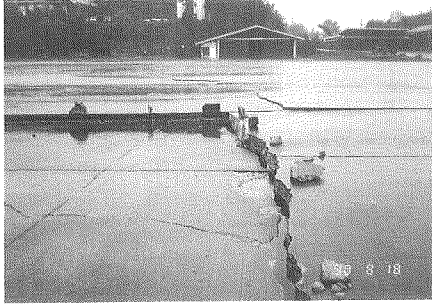
The Baguio (Loakan) airport is located in the southeast suburb of the city near the EPZA. The airport was closed after the earthquake due to an extensive crack that developed in the runway (Photo 52) and to severe structural damage to the control tower.

Photo 52 Extensive crack in runway of Baguio (Loakan) Airport

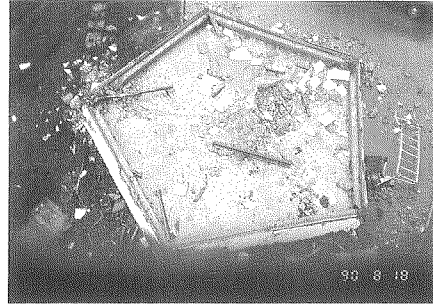
The control tower is a five-storey reinforced concrete building. The roof of the building fell down to the ground and overturned (Photo 53). The steel columns supporting the reinforced concrete roof look too thin to resist horizontal forces. Many shear cracks developed in the first to fourth stories of the control tower building (Photo 54).

Photo 53 RC roof of Control Tower

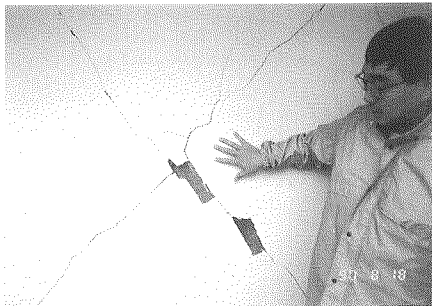
Photo 54 Shear cracks of walls of Control Tower

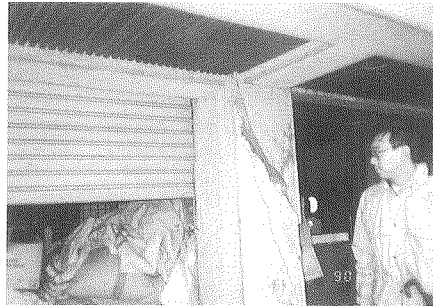
The terminal building, a one-storey reinforced concrete building, had also non-trivial damage. Large shear cracks (Photo 55) were observed in its columns. Since a large permanent displacement which caused the cracks in the runway was observed at the site, the damage to the terminal building may also be related to the ground deformation.

Photo 55 Large shear cracks on column of Terminal building
