**SITE INVESTIGATION AFTER HINDUKUSH EARTHQUAKE ON
FEBRUARY 1, 1991 AND ITS EVALUTION TO EARTHQUAKE
RESISTANT STRUCTURES**

Maliha Fatima*, Fumio Yamazaki and Kazuo Konagai****

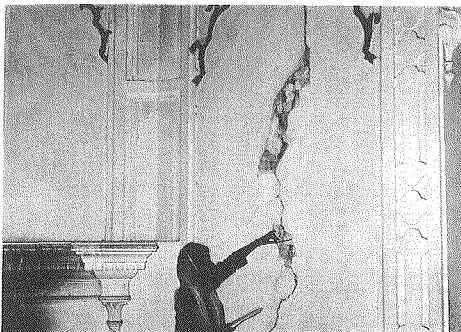
The Pucca buildings resisted the earthquake in a better way. Except for some old ones, no major damage had been reported for these buildings. The damage included wide cracks (Photo 9), spalling of plaster, partial damage of internal walls, collapse of boundary walls, etc.

Photo 9 Damage to engineered structure

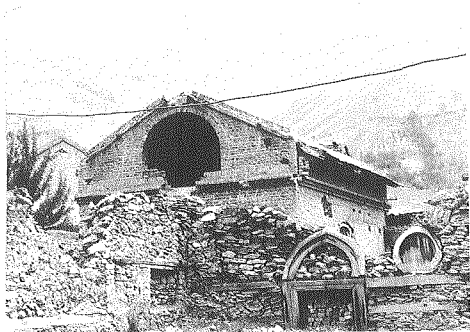
Photo 10 Failure of stone adobe, brick masonry (background) behaved well

moss and dirt and will be round in shape. The mud mortar loses strength with time. When the strength is lost, no bond remains between the stones. During an earthquake, no shearing strength is left except the dry friction between the stones (Photo 10).

- a) To increase the shear strength of the stone walls, a better mortar than mud should be used.
- b) Quarry stones should be preferred over round field or river bed stones.
- c) Bond stones should be provided wherever required.

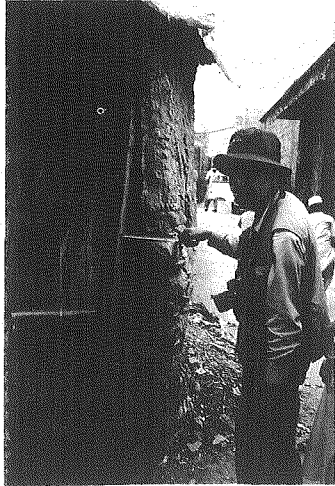
Photo 11 Adobe wall failure

Damage patterns of adobe houses are observed as: pull apart of the longitudinal wall from the transverse wall, propagation of vertical cracks and outward inclination of the wall (Photo 11). Damage is caused by insufficient tension.

- a) Dried grass, rice husk and other similar locally available materials should be added in the clay to improve the strength.
- b) Corners and junctions of the walls should be strengthened by providing wood planks, steel bars, wire mesh, etc.
- c) Continuous timber lintel with enough embedment should be provided around the openings.

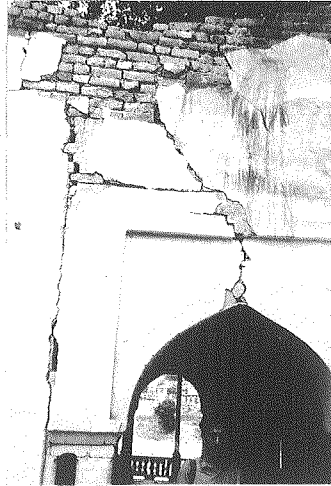
Photo 12 Arch failure, Old Fort, Chitral

In this case, the damage is characterized by the off-plane bending failure. Horizontal cracks on the tension side and partial crushing on the compression side of the wall were observed. Arches across the opening were badly damaged due to the loss of their end thrust under inplane shaking of walls (Photo 12).

- a) Reinforcing bars should be provided at the corners and the junctions of the walls.
- b) Connection between wall and roof should be made carefully.
- c) Better quality mortar should be used.

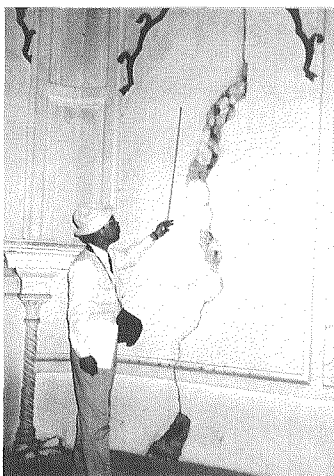
The standard of construction around the city is comparatively good with 30% by Pucca. About 20% of the Pucca buildings received non-structural damage like wide diagonal cracks in the masonry (Photo 13), falling down of parapet wall, spalling of plaster, damage to roof chimneys, collapse of boundary walls, etc. One of the minarets of a city mosque, about 18m high, fell down (Photo 14). Some of the old constructed houses were rather severely damaged.

Photo 13 Cracked masonry wall, Chitral

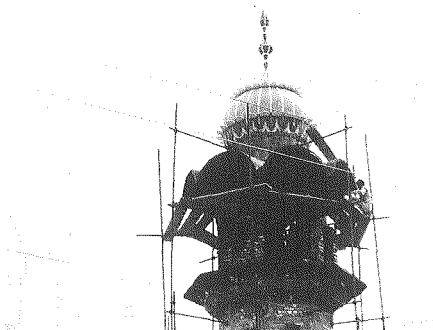
Photo 14 This minaret fell down, City mosque, Chitral

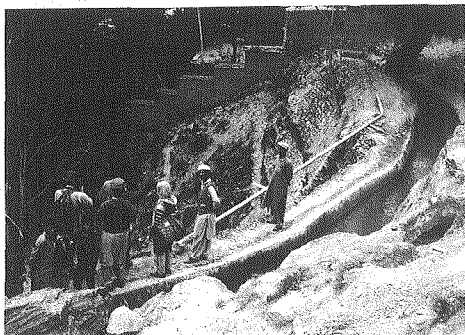
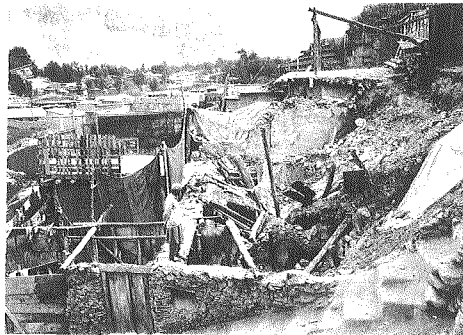
Photo 15 Village built on hillside

Photo 16 26 houses collapsed in this village

The Kucha buildings in this vicinity are made mainly from clay blocks or stones embedded in mud mortar with horizontal timber reinforcement at regular intervals. About 90% of such buildings received damage, 20% of which collapsed totally. In a village near the city area, houses are built on a man-made terrace. Out of 260 dwellings, 26 were completely destroyed and 160 received major damage (Photos 15, 16).

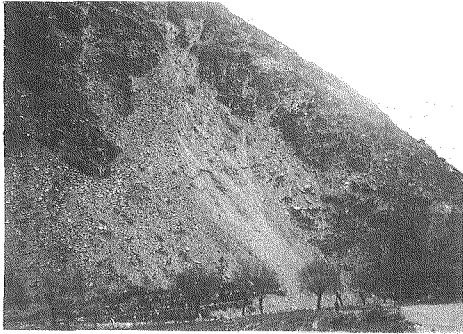
Photo 17 Rockslide near Ayun

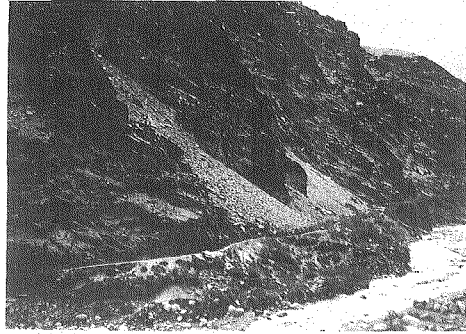
Photo 18 Rockslide in Kalash valley

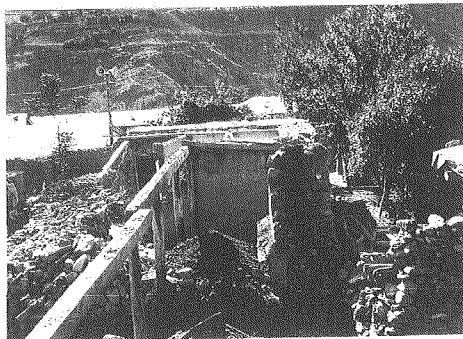
Photo 19 Collapsed houses in Drosh

Drosh is located 30 km south of Chitral City. The intensity was IX in MM scale. 90% of the Kucha buildings and 15% of the Pucca buildings were damaged. Most of the Kucha buildings are made from irregularly shaped stones with or without mortar (Photo 19). Among the Pucca buildings, the Meteorological observatory building was partly damaged with the retaining wall totally destroyed. The Civil hospital also received non-structural damages like spalling of plaster (Photo 20), wide cracks in the masonry and collapse of internal walls.

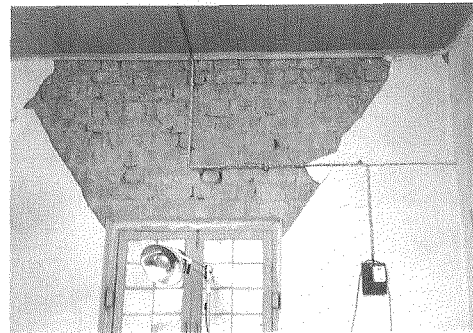
Photo 20 Non-structural damage to Pucca, Civil Hospital, Drosh

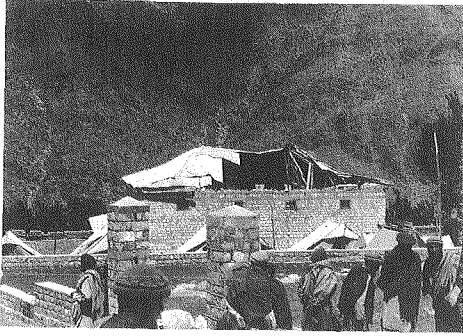
Photo 21 Damage to Pucca, Aradu

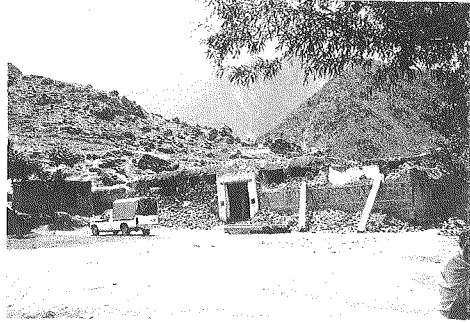
Arandu is located at an altitude of 500m in lower Chitral valley. The distance from epicenter is about 155 to 160 km. It is situated 98 km southwest of main Chitral on the Pakistan-Afghanistan border. The intensity felt estimated as X in MM scale. All Kucha houses and 25% of the Pucca were damaged. For the Pucca, one of the reason of failure may be the poor connections between walls and wall and roof (Photo 21). Most of the Kucha structures either collapsed by ground shaking or demolished afterwards due to major damages. The police station building also collapsed (Photo 22). The boundary wall of a hospital, which was built

Photo 22 Damaged police station, Aradu

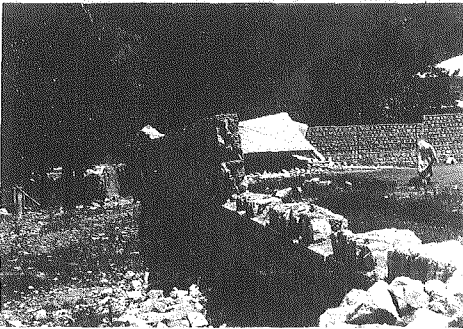
Photo 23 Blocked stone boundary wall, Arandu

from rectangular shaped stone blocks embedded in cement mortar, fell (Photo 23). A village having 300 dwellings was completely razed to the ground (Photo 24). A number of slides were found on the mountain trail leading to the place (Photo 25).

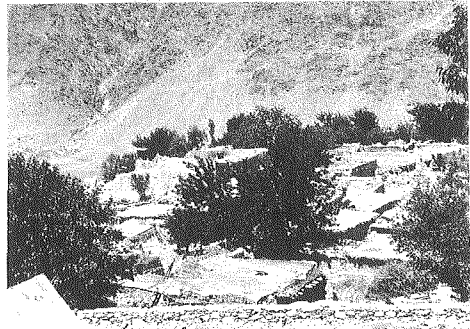
Photo 24 Reconstructed village in Arandu

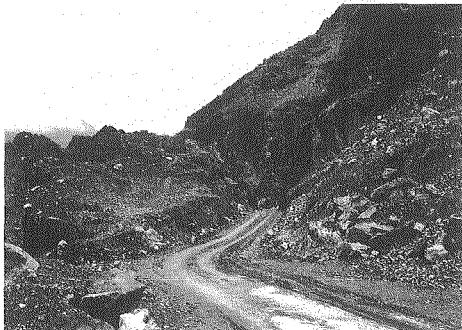
Photo 25 Rockslide on way to Arandu

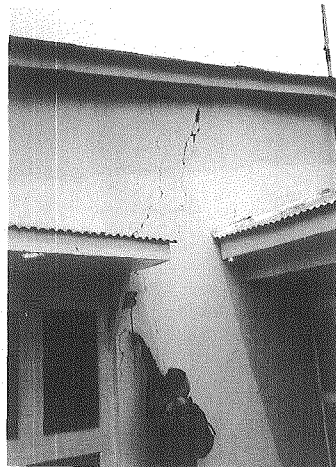
Photo 26 Governor House, Gram Chashma

In the Pucca masonry walls of the Governor's house, cracks developed with spalling of the plaster (Photo 26). Most of the damage in upper Chitral were due to rockfalls from the steep valley. In many instances, large boulders fell on the roofs of the houses which had suffered

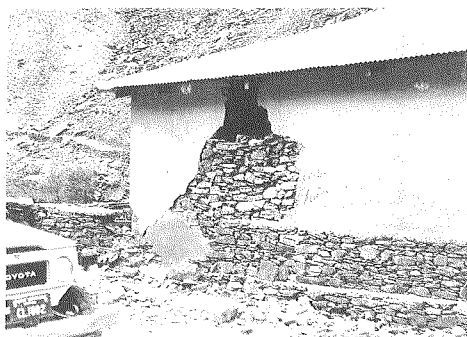
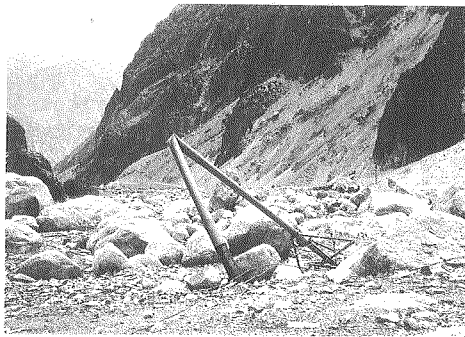
Photo 27 Wall breached by the boulder, which is still inside

Photo 28 Fallen pole, hit by rolling boulders

no structural damage from ground shaking (Photos 27, 28). The structures destroyed by shaking were mostly built of dry masonry with walls more than half meter thick, often made of balanced round stones. Such walls rarely fall sideways as a unit but collapsed due to crumbling (Photo 29).

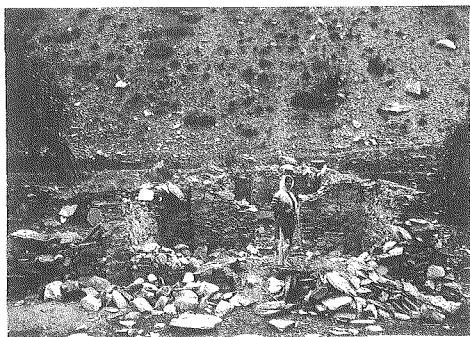
Photo 29 Collapsed dry masonry house, Gram Chashma

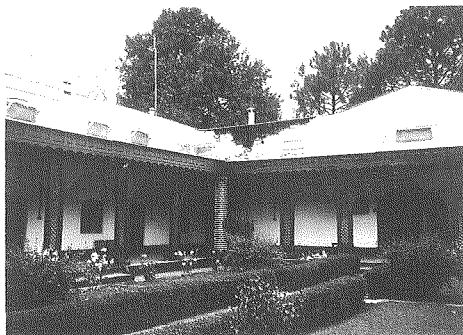
Photo 30 Damaged engineered structure, Swat

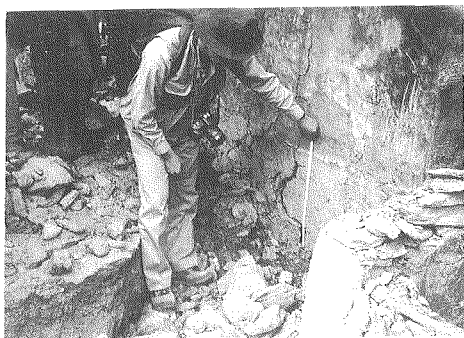
Photo 31 Uneven ground settlement, Barikot

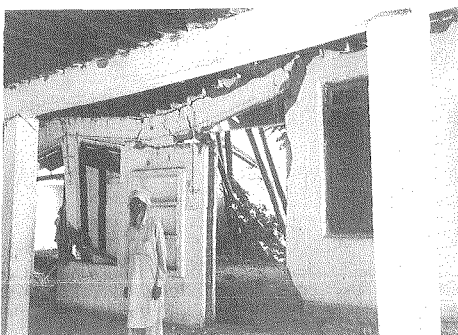
Photo 32 Structural damage due to ground settlement, Barikot

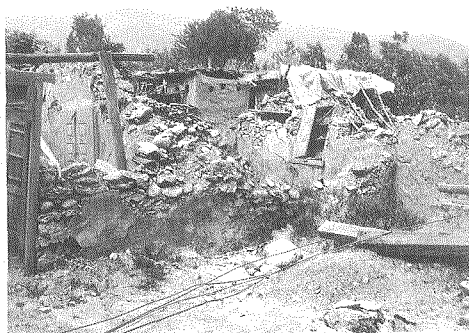
Photo 33 Damaged houses in Bhattai, Buner

Buner District is situated south of Swat. Daggar, the district quarters is located about 280 km from the epicenter. The shaking was severe throughout the district. However, the northern parts were more damaged by the ground shaking (Photo 33). Some of the damaged houses fell down after the earthquake because of the rains which started one month after the earthquake and continued for about two months. In the south of Buner, water came out from the ground which experienced excessive settlements. In places like Rega, Karappa and surrounding areas, collapse of houses and continuous settlement of roads have been reported.
