**Seismic Capacity of Reinforced Concrete Apartment Buildings  
Damaged due to 1992 Erzincan Earthquake, Turkey**

by  
Yoshiaki Nakano\*

This paper describes the seismic capacity of reinforced concrete apartment buildings which were damaged due to 1992 Erzincan Earthquake, Turkey. The seismic capacity was evaluated according to the Japanese Standard and the correlation between the seismic capacity and damage levels observed in the field survey was discussed.

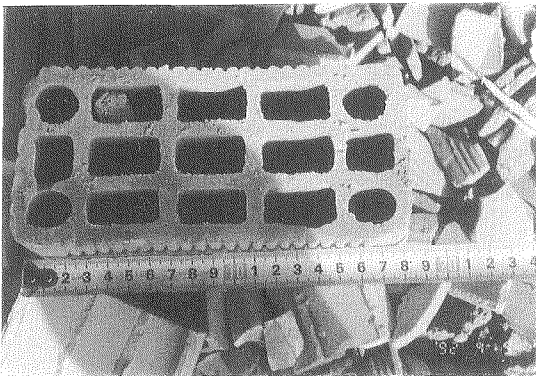
The building was partially infilled with concrete blocks in the basement and hollow bricks (*Photo 2*) in upper stories which were both unreinforced. The story height was approximately 280 cm in each story and the cross section of a typical columns was 40 cm x 25 cm or 60 cm x 25 cm. As commonly observed in the city, each building in this area also had a basement at about 2 m below the ground level. During the earthquake, however, the basements of most buildings were still exposed since the excavation had not been refilled as shown in *Photo 3*.

*Photo 2: Brick wall*

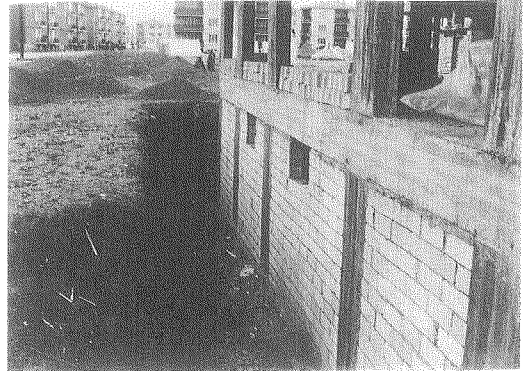
*Photo 3: Basement and surrounding soil*

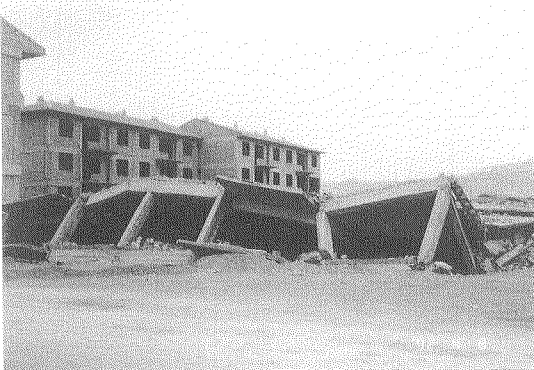
Major damage to the buildings was generally observed in the columns of basement, and some of them totally collapsed as shown in *Photo 4*. *Table 1* shows the damage statistics according to the damage classification used in Japan shown in *Table 2*. Extensive cracks in the columns of basement, poor confinement resulting from inadequate detailing of reinforcement (*Photo 5*), buckling of longitudinal reinforcement due to the absence of lateral reinforcement in the beam-column joints (*Photo 6*), and crushing of concrete in the columns (*Photo 7*) were the commonly observed damage types. In some buildings, the soft story mechanism (flexural failure) was found in the basement columns as shown in *Photo 8*.

*Photo 4: Collapsed building*

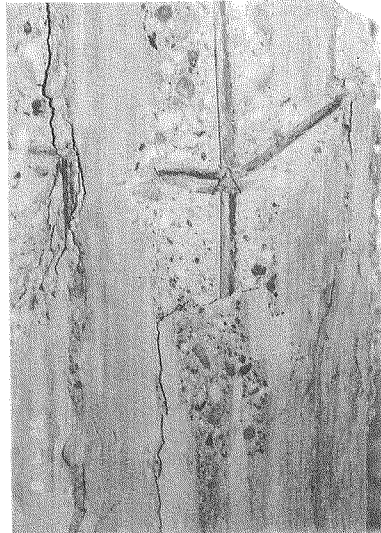
*Photo 5: Sheer reinforcement with 90-degree hooks*

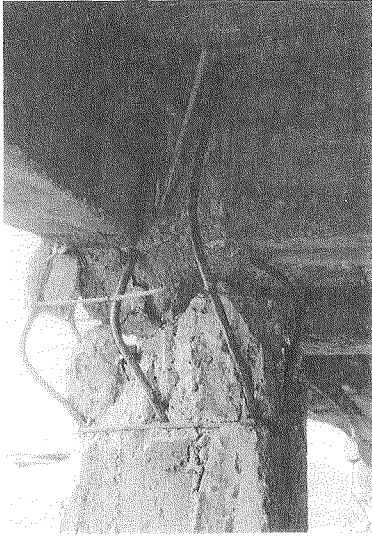
*Photo 6: Failure in beam-column joint  
(no lateral reinforcement)*

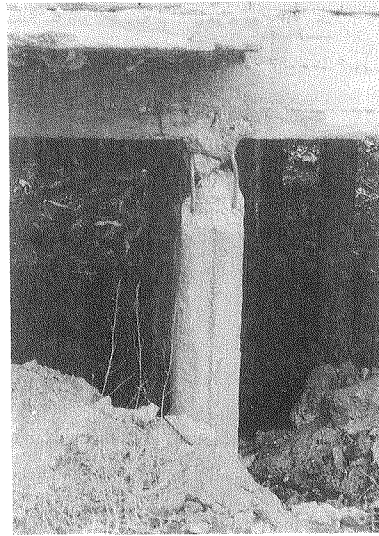
*Photo 7: Shear failure at the top of column*

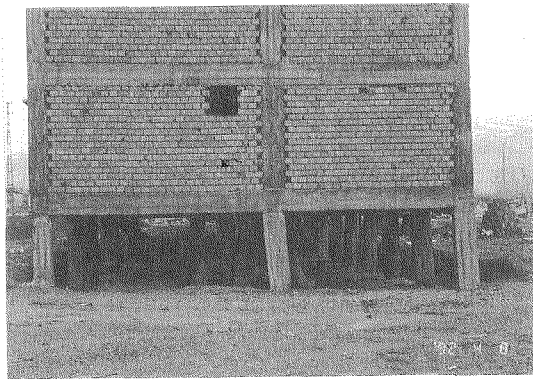
*Photo 8: Side-sway caused by flexural failure of the columns at basement*

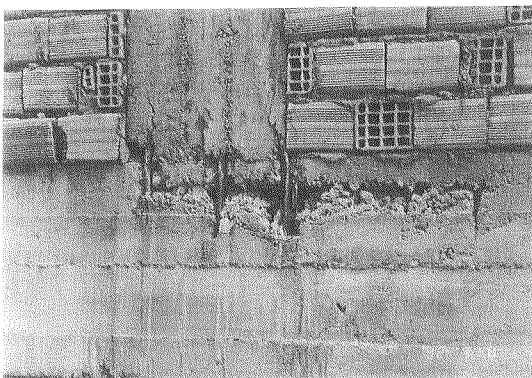
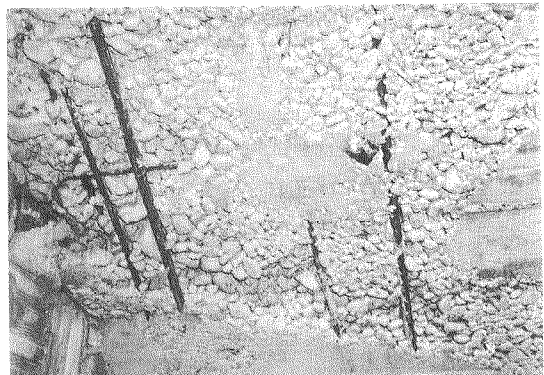
In general, the quality of concrete was poor and honeycombs were observed in many buildings as shown in *Photo 9*. It is interesting to note that the damage levels of the buildings ranged from "slight damage" to "total collapse" although the buildings in the area had identical structural plans. To investigate the correlation between the strength of concrete and the damage level, Schmidt hammer tests (non-destructive) on several buildings in the area were carried out. The test results are summarized in *Table 3*. It is clearly seen from the table that the concrete strength was generally low irrespective of the damage level and no obvious correlation between the damage level and concrete strength was found. However, upon close examination, it was revealed that buildings which suffered slight damage already had concrete block infilled walls in the basement and these walls seemed to have contributed to the strength and stiffness of the building. Furthermore, buildings with basement around which the soil had been already refilled before the quake suffered almost no damage. *Fig. 3* illustrates the arrangement of non-structural walls, basement condition and corresponding damage levels.

*Photo 9: Honeycombs in concrete*

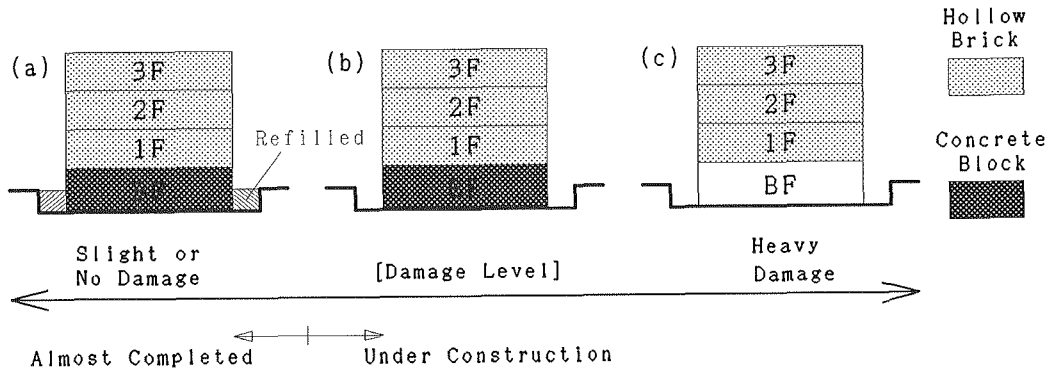
**Fig. 3: Arrangement of non-structural walls, basement condition and corresponding damage levels**

To investigate the effects by non-structural walls and refilling around the basement on the seismic capacity, four cases were investigated as shown in **Table 5**. Note that cases (a) to (c) correspond to sketches shown in **Fig. 3** and that case (d) was studied to investigate the seismic capacity of structure without non-structural walls. In cases with non-structural walls, i.e., cases (a) to (c), their contribution to lateral resistance was allowed for assuming that the ultimate shear capacity was 5 kgf/cm<sup>2</sup> for concrete blocks<sup>[4]</sup> and 1 kgf/cm<sup>2</sup> for hollow bricks.

was severest in buildings which had no non-structural walls in the exposed basement, but  
(ii) almost no damage was found in buildings which had the refilled basement.

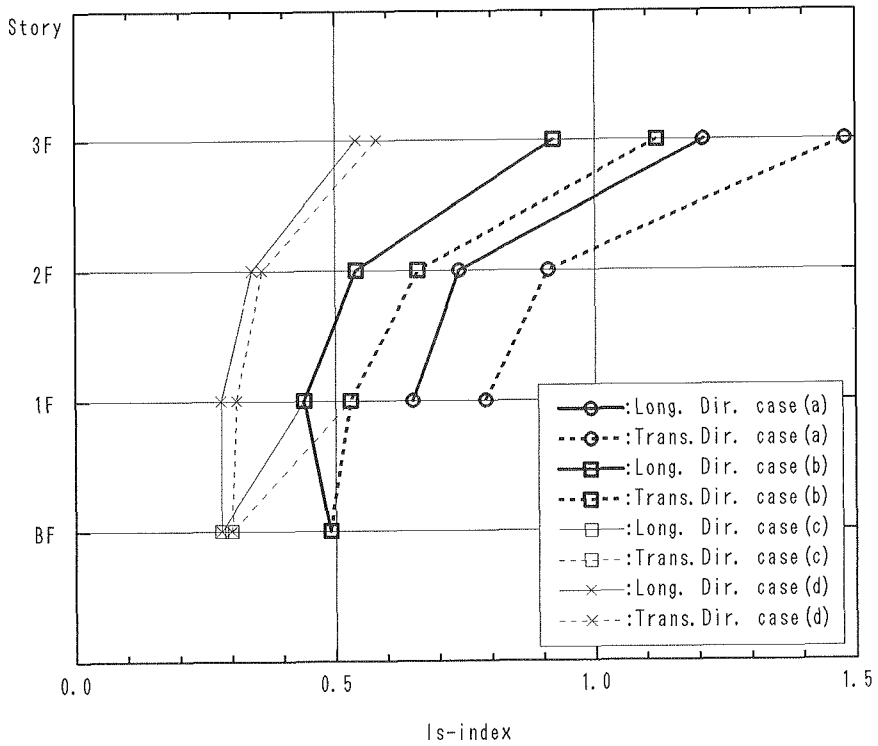
**Fig. 4: Results of Seismic Evaluation**

**Fig. 4** shows the results in each story and each direction, i.e., the longitudinal and transverse direction. From the figure, the following findings can be obtained.

- (1) The seismic capacity of building without non-structural walls is significantly lower than that with non-structural walls and the contribution of walls can not be neglected to understand the discrepancy of damage levels of buildings under construction. [ case (b) vs. case (d) ]

- (2) When non-structural walls are provided in all stories but the basement is not refilled and hence the building is four-story [ case (b) ], Is-index is larger than 0.5 in any stories and directions except for the longitudinal direction of the first story level. When the building has non-structural walls only in the upper stories as was observed in the heavily damaged or collapsed buildings [ case (c) ], Is-index in the basement is significantly lower than that in the upper stories.

- (3) When the basement is refilled and hence the building is three-story [case (a) ], Is-index is larger than 0.6 even in the longitudinal direction of the first story level, where the value was the smallest in the building. This case results in better seismic capacity than any other assumptions in any story levels.
