GENERAL REVIEW OF RECENT FIVE DAMAGING EARTHQUAKES IN JAPAN

Fumio YAMAZAKI*, Kimiro MEGURO* and Huanan TONG**

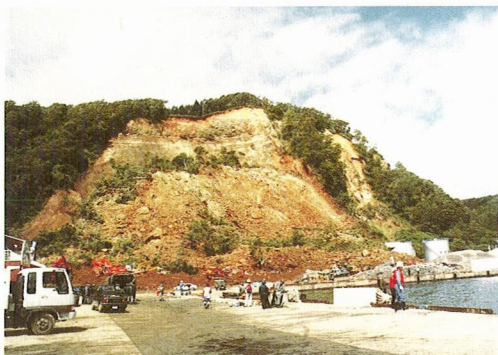
Since most of the land areas in Japan is mountainous, landslides and rockfalls often follow strong ground shaking. In the Hokkaido-Nansei-Oki Earthquake [9], a large landslide occurred in Okushiri Island (Photo 1). A two-story wood-frame hotel and an 800 kl oil tank were crushed and buried by massive amounts of soil. The hotel was located just below a steep cliff with a height of about 100 m. Twenty-four people were killed by this landslide. Many other landslides and rockfalls occurred along the coast of Okushiri Island and the southern Hokkaido Peninsula. Fortunately, however, these areas were not populated. Damage to roads and rock sheds was reported.

Photo 1 A large landslide buried a hotel in Okushiri Island in the Hokkaido-Nansei-Oki EQ.

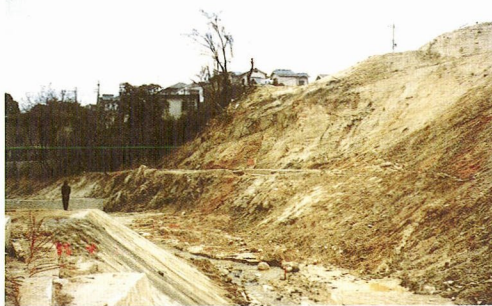
In the Great Hanshin Earthquake, the number of landslides was rather small in spite of the intense shaking probably because of the dry season. One large landslide occurred in Nigawa, Nishinomiya and killed 34 people (Photo 2). The existence of ground water flow is considered as one of the causes of the landslide.

Photo 2 A landslide occurred in Nishinomiya and killed 34 people in the Great Hanshin EQ.

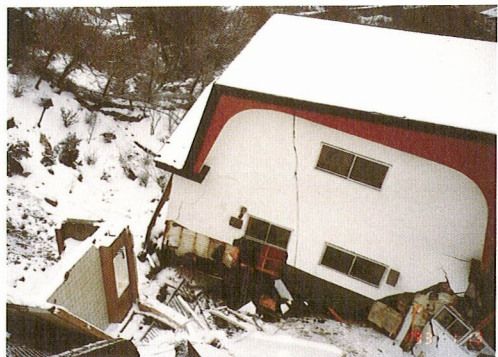
Many embankment failures of roads and railways occurred in the Kushiro-Oki, Hokkaido-Nansei-Oki, Hokkaido-Toho-Oki and Sanriku-Haruka-Oki Earthquakes. Many similar scenes, in which cars and trucks were involved and overturned, were observed in those failures. Most of the failures occurred at fills on soft ground. It was also shocking that a house slid down a slope for about 10 m in the Kushiro-Oki Earthquake (Photo 3). In the earthquake, damage to houses and buried pipes was concentrated at hilly sloping grounds of Kushiro.

Photo 3 A house slid down a slope in the Kushiro-Oki EQ.

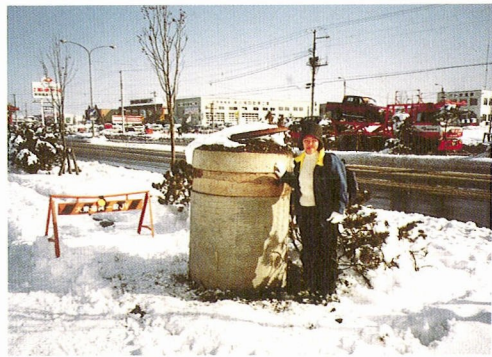
[10]. Settlements and cracks of pavement developed in Kushiro Fishery Port twice within two years. In the Kushiro Industrial Port, liquefaction occurred only in the backyard, outside of the ground improvement zone. Manholes of sewage lines floated up in the same manner in the two earthquakes due to liquefaction (Photo 4).

Photo 4 Manholes of a sewage line floated out of the ground due to liquefaction in the Kushiro-Oki EQ.

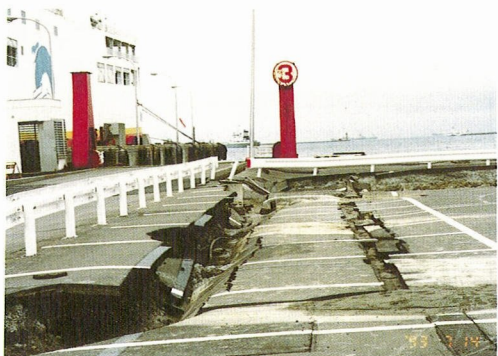
Liquefaction was observed along the coast lines of Hokkaido Peninsula in Hokkaido-Nansei-Oki Earthquake. In Oshamanbe, a town developed on an old riverbed and 100 km from the epicenter, liquefaction occurred throughout the town. Numerous breaks of gas and water pipes and settlements of building foundations were observed. The Port of Hakodate, the largest port in the southern Hokkaido, was severely affected by liquefaction (Photo 5). Large ground fissures and settlement disrupted paved areas and quay walls moved seaward.

Photo 5 Settlement of pavement with cracks were observed in Hakodate Port in the Hokkaido-Nansei-Oki EQ.

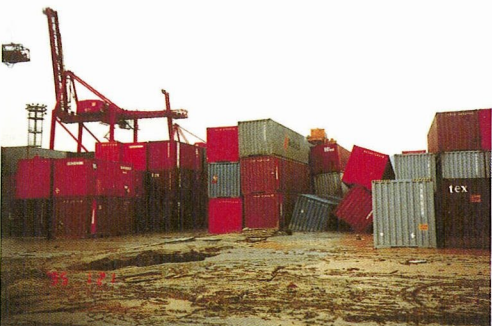
In the Great Hanshin Earthquake, extensive liquefaction occurred in Kobe and its vicinity. The Port of Kobe, the largest container facilities in Japan, had severe damage in its container piers and gantry cranes (Photo 6). Two major man-made islands in Kobe, Port Island and Rokko Island, were covered by sand and mud water. However, buildings with pile foundation to firm layers performed well and no significant damage was reported. Liquefaction affected many industrial facilities located on reclaimed land or natural soft deposits along the Osaka Bay. About 2 kilometers of the banks of Yodo River were also destroyed due to liquefaction.

Photo 6 Extensive liquefaction occurred throughout Port Island in the Great Hanshin EQ.

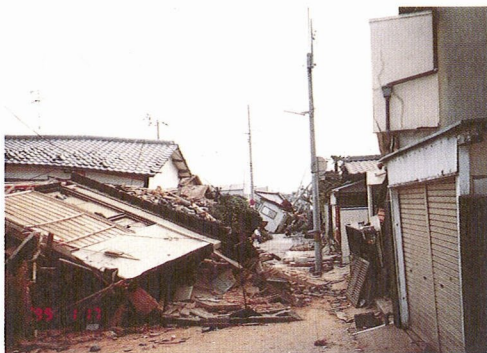
In the Great Hanshin Earthquake[11], traditional wood-framed houses were most severely affected (Photo 7). The collapsed houses were concentrated in a narrow band area of approximately 1 km wide and about 20 km long (Kobe, Ashiya, and Nishinomiya Cities). The area lies between the mountain range and the coast line. The thickness of alluvial deposits are not so large in this area. No surface fault was found in the main land. Hence, the cause of the damage concentration was due to strong shaking related to the soil condition.

Photo 7 Many wood-frame houses with heavy roof totally collapsed in the Great Hanshin EQ.

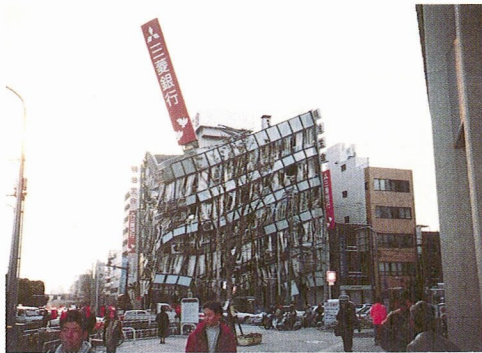
The performance of engineered buildings in the strong shaking area was also bad in the Great Hanshin Earthquake. Both reinforced concrete buildings and steel buildings suffered severely (Photo 8). The damage ratio of buildings was dependent on the construction age, which corresponds to their adopted design code. The seismic provisions of the Japanese building code were revised twice, in 1971 and 1981. The strength of buildings against lateral forces was increased by the revisions. New buildings following the new code performed much better than those designed by the old codes. Mid-story collapse, which was quite rare in Japan, occurred to many medium height (about 10 story) buildings (Photo 9). It was also shocking that many steel buildings had damage in their structural members.

Photo 8 An example of very badly damaged buildings in the Great Hanshin EQ.

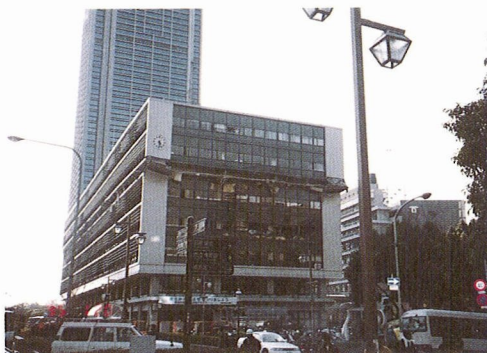
Photo 9 The old building of Kobe City Hall collapsed at a mid-story in the Great Hanshin EQ.

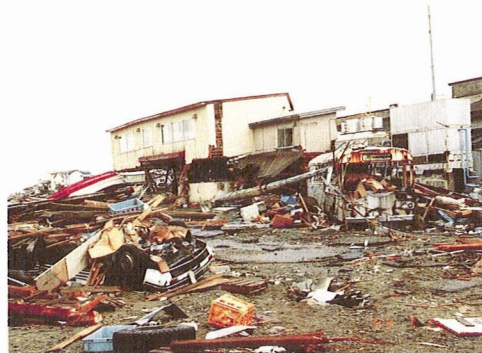
Photo 10 Houses in the Aomae District of Okushiri Island were destroyed by tsunamis in the Hokkaido-Nansei-Oki EQ.

Over one thousand houses and buildings collapsed in the 1993 Hokkaido-Nansei-Oki mostly due to tsunamis (Photo 10). Only a few engineered structures were located in the region of strong shaking of the event.

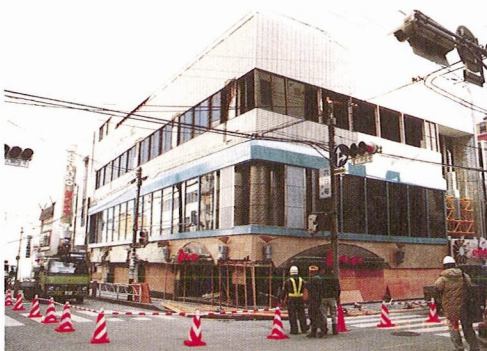
Photo 11 The first story of a pachinco parlor in Hachinohe collapsed in the Sanriku-Haruka-Oki EQ.

In the 1994 Sanriku-Haruka-Oki Earthquake, several reinforced concrete buildings in Hachinohe were severely damaged. A "pachinco parlor" (Japanese game center) collapsed in the downtown of Hachinohe and killed two people (Photo 11). Some other old reinforced concrete buildings were severely damaged. A high school building which had minor damage in the 1968 Tokachi-Oki Earthquake was totally damaged and demolished later (Photo 12). Except for few cases, however, the overall performance of buildings and houses were good in the earthquake.

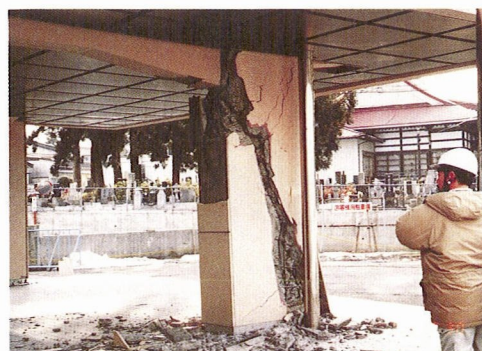
Photo 12 A shear crack developed in a reinforced concrete column of a high school building in the Sanriku-Haruka-Oki EQ.

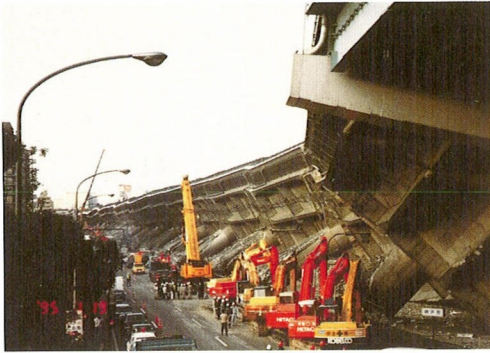
In the Great Hanshin Earthquake, however, a large number of highway bridges (Photo 13, 14) and railway bridges (Photo 15, 16) collapsed, by far larger than all the number of damaged bridges in the history of Japan. For example, the damage ratio of reinforced concrete piers in Hanshin Expressway's Kobe Line was about 50%, 512 piers out of 1012 piers were suffered from severe to minor damage. The damage ratio of shoes was even higher (64%). It is obvious that earthquake

Photo 13 A 500 meter section of the Hanshin Expressway rolled over completely in the Great Hanshin EQ.

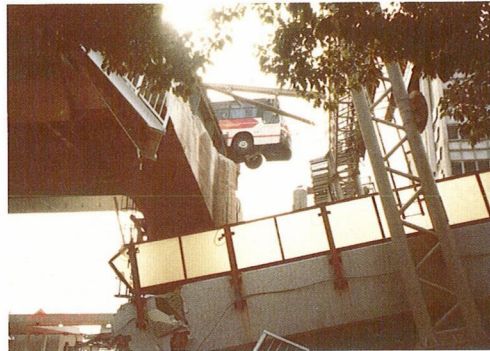
Photo 14 A collapsed section of the Hanshin Expressway in the Great Hanshin EQ. A bus could escape from falling down.

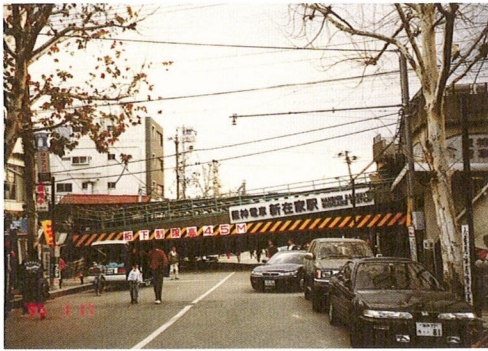
Photo 15 A collapsed bridge of the Hanshin Railway Line in the Great Hanshin EQ.

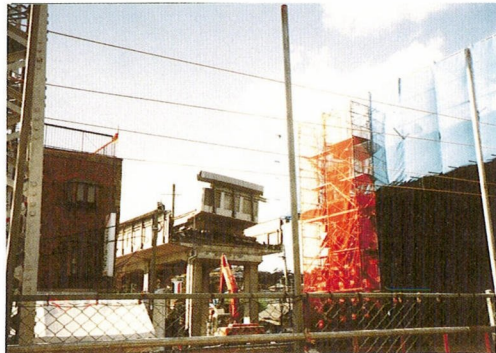
Photo 16 A Sanyo Shinkansen (bullet train) bridge overpassing another railway line collapsed in the Great Hanshin EQ.

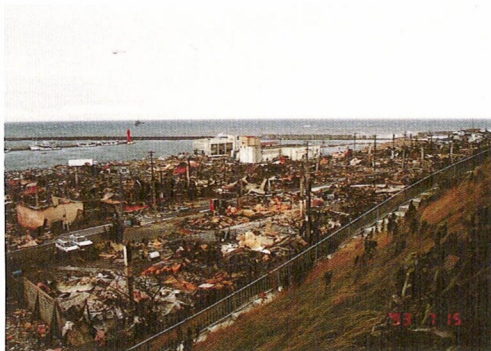
Fires broke out in all the five earthquakes. However, fires spread only in the 1993 Hokkaido-Nansei-Oki and the 1994 Great Hanshin Earthquakes. Due to the fire which broke out in Aonae district of Okushiri Island (Photo 17), 108 houses and 79 other buildings were burned down (5.1 ha). The fire could not be extinguished because of the debris brought by tsunamis and the shortage of water due to pipe breaks.

Photo 17 Houses and buildings were burned down in the Aonae District in the Hokkaido-Nansei-Oki EQ.

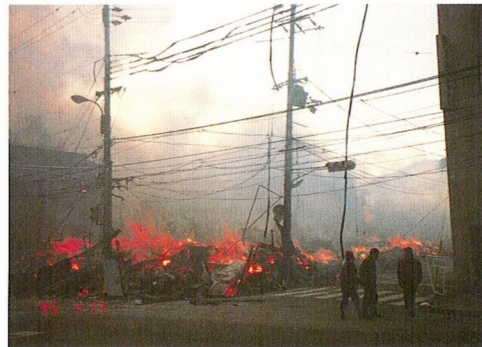
After the Great Hanshin Earthquake, a total of 175 fires occurred within 10 days in Kobe (Photo 18). About half of them started within few hours after the earthquake. Many fires occurred even a few days after. For 44 fires, electricity was estimated as the cause of fire. The total area burned down by the fires was about 70 ha (0.7 km²). Compared with the 1923 Great Kanto Earthquake (34 km² in Tokyo and 9.9 km² in Yokohama), however, the area was much smaller.

Photo 18 Raging fires in Kobe in the Great Hanshin EQ. Fire fighting was almost impossible because of the lack of water.

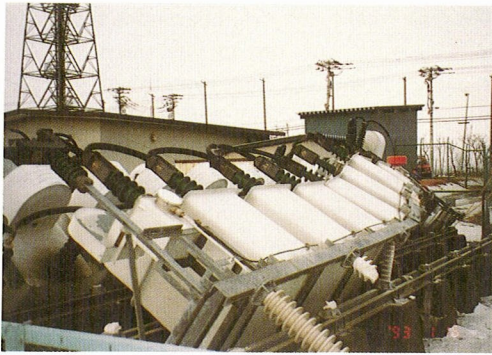
Photo 19 Batteries torn down from the supporting ceramic columns in Kushiyo Substation in the Kushiro-Oki EQ.

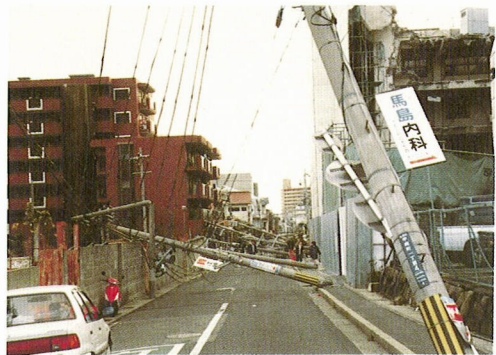
Photo 20 Electric poles were torn down along the street in the Great Hanshin EQ. About 10 thousand poles were damaged.
