## Seismic Capacity of Reinforced Concrete Buildings Damaged by 1995 HYOGOKEN-NANBU Earthquake

Kang-Seok LEE<sup>1)</sup>, Yoshiaki NAKANO<sup>2)</sup>, Fumitoshi KUMAZAWA<sup>3)</sup>, and Tsuneco OKADA<sup>4)</sup>

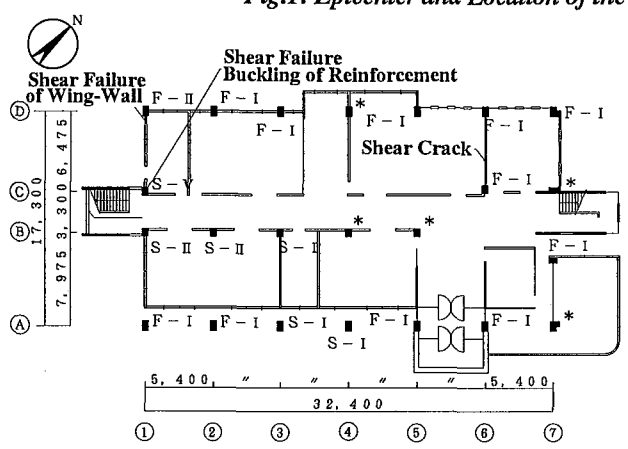
Fig.2-1: Midori-cho Civic Center (First Story)

Damage in the first story is shown in *Fig. 2.1*. This building was a three story reinforced concrete building constructed in 1977. The structure consisted of reinforced concrete frames and a few shear walls in the longitudinal and transverse direction. This building had a reinforced concrete pile foundation.

Remarkable damage was observed in frame 1 in the first story and the staircase connected with frame 1. A column at C-1 sustained severe shear failure with exposed and buckled reinforcement and was categorized in Class V. A wing-wall provided between frames C and D showed shear failure with concrete crush and exposed reinforcement. Slight flexural-shear failures categorized in Class I were observed in many columns of the first story. The damage level of the entire building defined by D-index was "moderate". It should be noted, however, that judging from the field survey the damage level should be identified "light", because the severe damage to the building was localized.

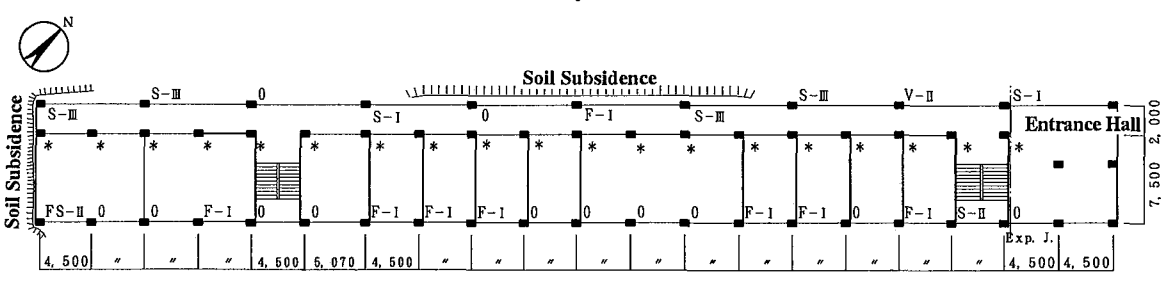
Fig.2-2: Hokudanhigashi Middle School (First Story)

Damage in the first story is shown in *Fig. 2.2*. The building was a four story reinforced concrete building constructed in 1963. Shear walls were provided only in the transverse direction.

Ground failure was observed around the school. Spandrel walls and columns of the north-west frame sustained cracks that might be caused by differential settlement due to the ground failure.

Damage in columns ranged from Class I to III, and the damage level defined by D-index was “moderate”.

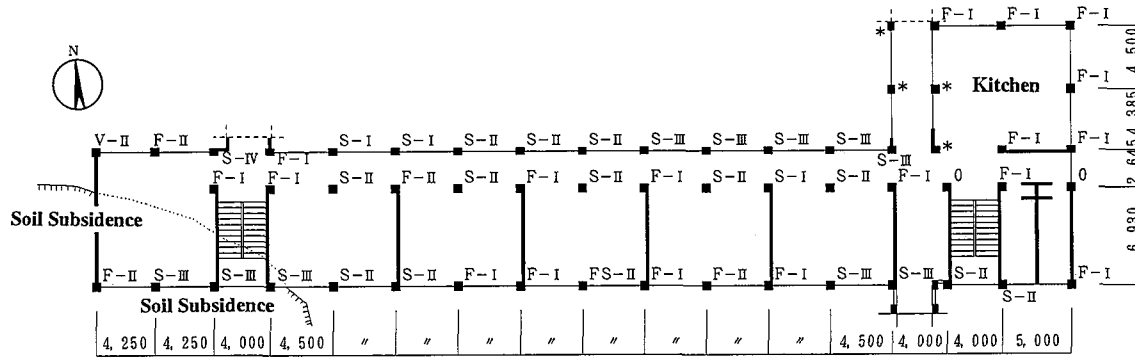
Fig.2-3: Higashiura Middle School (First Story of Building-B)

Damage in the first story is shown in *Figs. 2.3* and *2.4*. The school consisted of three buildings referred to as Building-A, -B and -C. These three buildings were three story reinforced concrete buildings constructed in 1967 and located in parallel on a hill. Each building had shear walls in the transverse direction. Building-B and -C were partially placed on the refilled soil above the slope and more severely damaged while building-A had few damage. The outline of damage to Building-B and -C is as follows.

- 1) **Building-B:** Differential settlement caused by soil damage was observed in four spans of the west zone located on the refilled soil. Columns in the first and second story had many shear cracks due to differential settlement, and the damage level defined by D-index was “moderate”.
- 2) **Building-C:** Soil subsidence was observed in the south-west zone of the building. One span of the west frame tilted about 1 to 2 degrees. Remarkable damage was generally observed in columns of the first story. Many columns in the south and north frame were shaken and failed in shear and resulted in Damage Class V. The damage level defined by D-index was “collapse”.

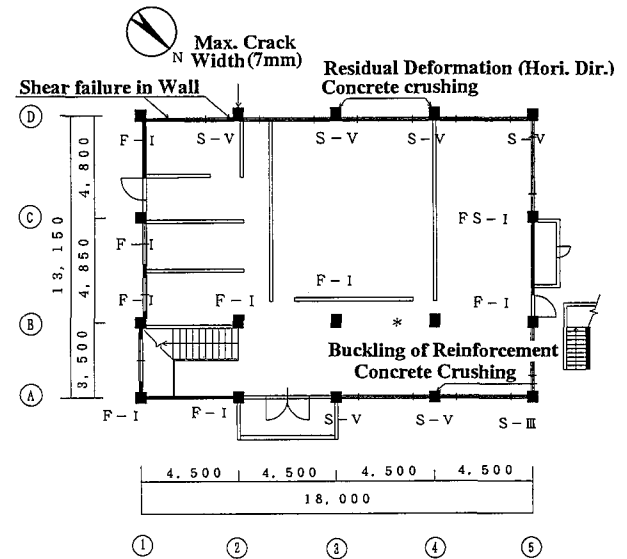
Fig.2-6: Ichinomiya-cho Civic Center (First Story)

Damage in the first story is shown in *Fig. 2.6*. This building was a three story reinforced concrete building constructed in 1969. Shear walls were provided in the transverse and longitudinal direction. This building had a reinforced concrete pile foundation.

Major damage to this building was generally observed in the first story, and many columns in the first story sustained severe shear failures or shear cracks. In particular, six columns in the exterior frames without shear walls failed in shear and were categorized in Class V. Columns at D-3 and D-4 had severe shear failures and the residual horizontal deformation was observed. The column at A-3 suffered from shear failure, concrete crushed and reinforcement was exposed. The damage level defined by D-index was “collapse”.

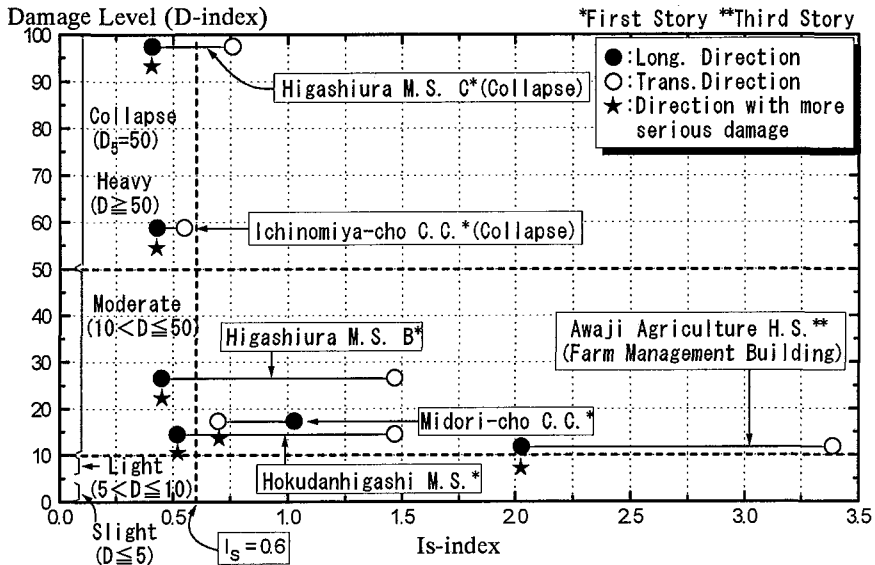
Fig.3: Correlation between Is-index and Damage Level

The correlation between Is-index and the damage level (D-index) is shown in *Fig. 3*. *Fig. 4* shows the correlation between D-index and the construction year of six buildings described in this paper, together with other surveyed buildings in Awaji-Island. From the figures, the following findings can be obtained.

- (1) Excluding Midori-cho Civic Center which had a few shear walls in the longitudinal direction, the seismic capacity in the transverse direction is significantly higher than that in the longitudinal direction, because shear walls in the transverse direction were more provided than in the longitudinal direction [*Fig. 3*].

- (2) Judging from the correlation between the seismic capacity index and the damage level, buildings with higher seismic capacity had less damage. If the damage levels of Midori-cho Civic Center and Awaji Agriculture High School (Farm Management Building) identified by the authors were taken into account, the boundary to avoid serious damage during this event in this district may be around 0.6 in terms of Is-index [*Fig. 3*].

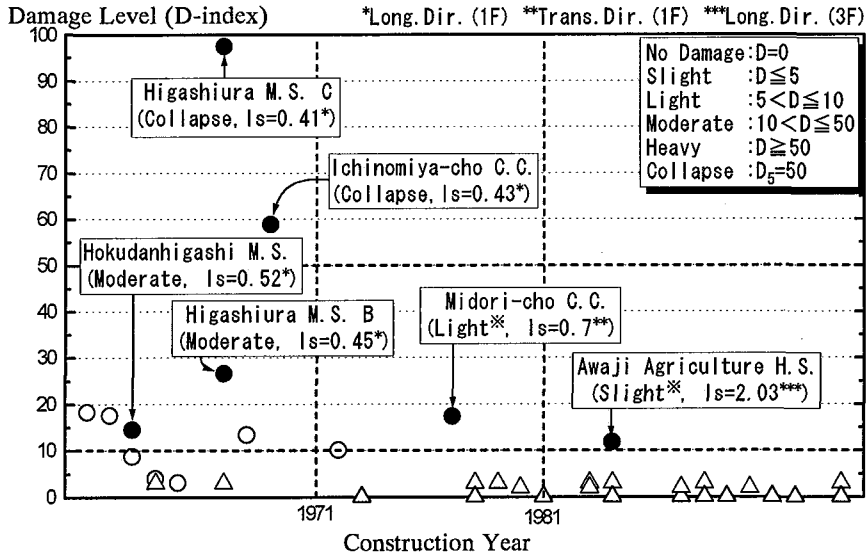
Fig.4: Correlation between Damage Level and Construction Year (Awaji-Island)

- (3) Is-indices of buildings constructed before 1971 were significantly lower and sustained more serious damage than those constructed after 1971. This result can be attributed to the improvement of the shear design due to the code revision in 1971 [*Fig. 4*].

※ : The damage level defined by D-index in Reference[1] was "moderate". Judging from the field survey, however, the damage level should be classified into "light" and "slight", respectively, as shown in the figure.
