Report on Spatial Structures Damaged by the 1995 Great Hanshin Earthquake

K. Kawaguchi ¹ and Y. Hangai ²

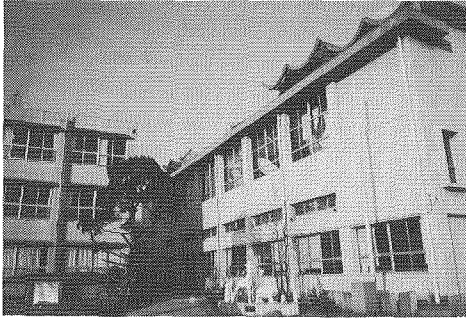
The building had two stories and the gymnasium was at the 1st floor while the ground floor was used for class rooms (Photos 1-4). The dimension of the floor was 18m x 40.5m. Pre-cast cylindrical shell beams, having slight anticlastic curvature along their axial directions, had been used to span the gymnasium. A single span of the pre-cast beam had covered minor direction of the floor. Total number of the pre-cast beams was sixteen and ten of them slid off from the eastern supports. The beams had been anchored at the top of short walls in a simple manner, so that the anchors broke through the walls and the beams slid horizontally by several decimeters.

Photo 1: The elementary school gym.

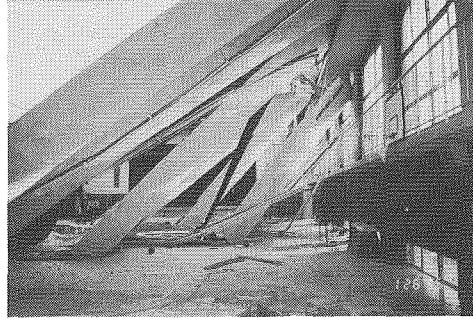
Photo 2: Interior view of the school gym.

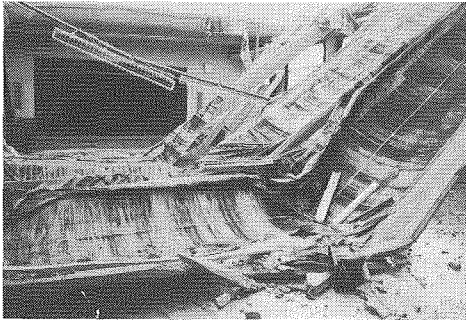
Photo 3: Collapsed beams of the school gym.

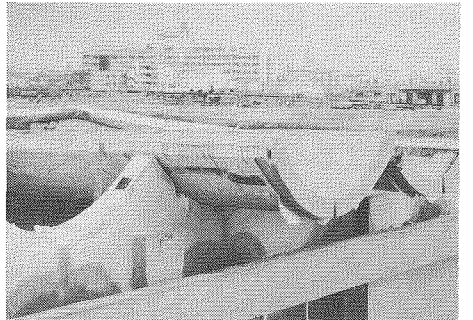
Photo 4: Slid pre-cast beam

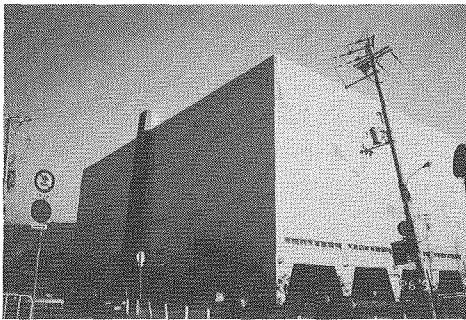
Photo 5: The public gym.

Pairs of the pre-cast shell beams, which are the same type used in the gymnasium in the previous subsection, were leaned on a steel girder spanning the center of the gymnasium floor (Photo 5-8). The dimension of the floor was 29.5m x 38.5m. The girder had a pair of steel pipe ties, anchored at the tops of columns, preventing the girder from horizontal movement. During the earthquake most of the shell beams have fallen on the floor. Only four beams which were attached on the walls on their longitudinal edges remained at the position. All of the anchor bolts of the ties were broken off and ties had become ineffective. Cracks which seemed to have been caused by out of plane bending deformation were observed on the wall.

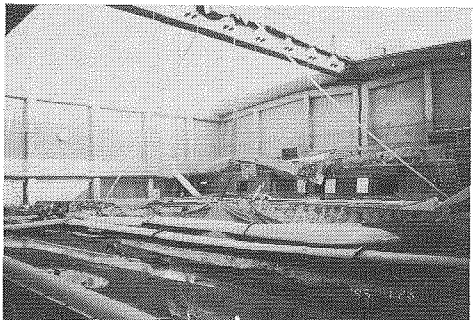
Photo 6: Interior view of the public gym.

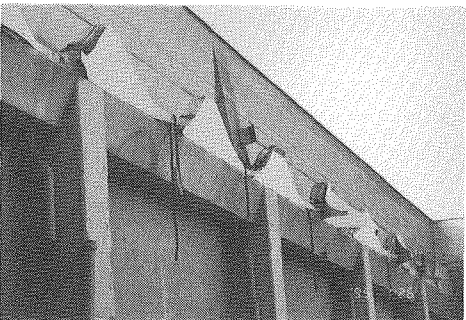
Photo 7: Supports and anchor for the tie

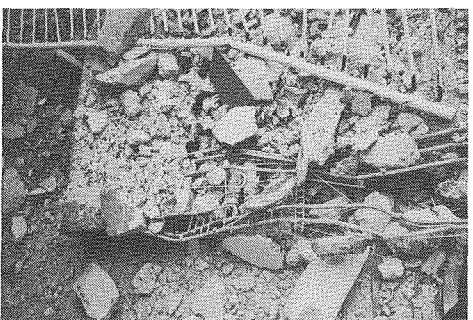
Photo 8: Collapsed beam of the public gym.

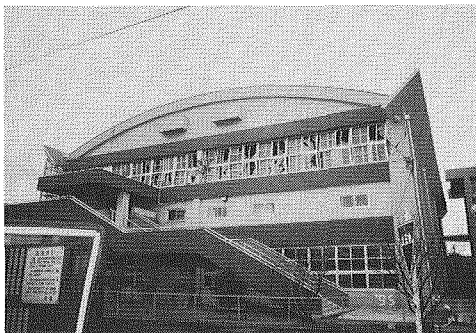
Photo 9 through 12 shows damage to a high school gymnasium. Most of school gymnasiums in this area are extensively built on the roof floor of class room buildings. School buildings are mainly constructed as reinforced concrete structures while the roofs of the gymnasiums are built as steel structures. Structural damage to such buildings is mainly found at the reinforced concrete parts. Damage to steel roof structures is comparatively minor. Some removals of concrete at the supporting parts or break off of braces are often found.

Photo 9: The high school gym.

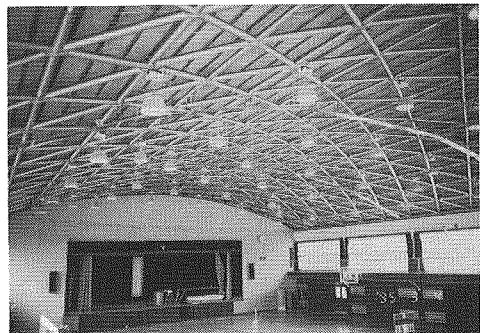
Photo 10: Interior view of the high school gym.

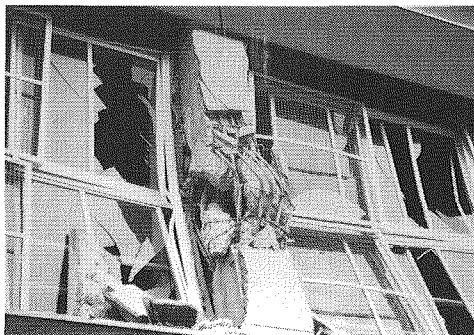
Photo 11: Failure of a column of the gym.

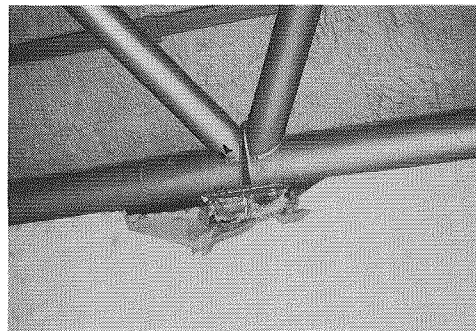
Photo 12: Damage at an anchor to concrete wall

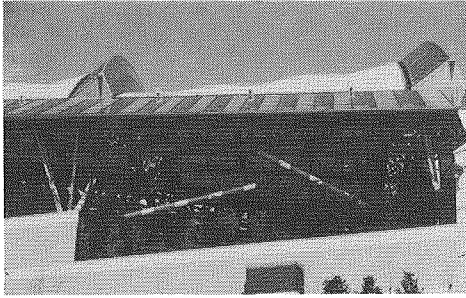
Photo 13 through 15 show damage to space frame roof structures of a hippodrome stand. Many members were buckled and broken off from joint globes. Some of the anchor bolts of a main arch was pulled off from an anchor block.

Photo 13: The hippodrome stand roof

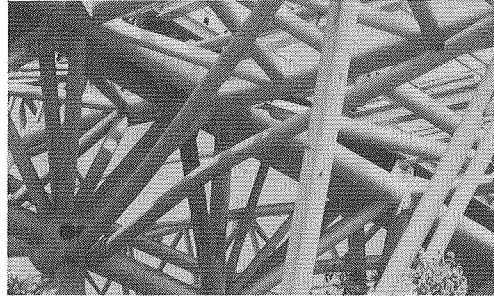
Photo 14: Disconnection at a joint and bent members
(photo by prof. T.Saka)

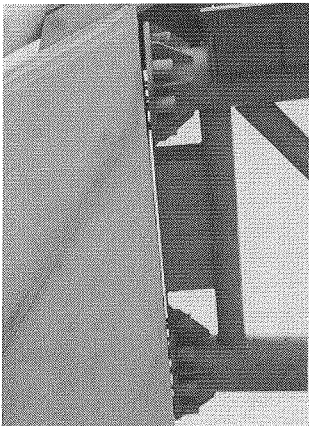
Photo 15: Pull off at main arch anchor of the hippodrome
(photo by prof. T.Saka)

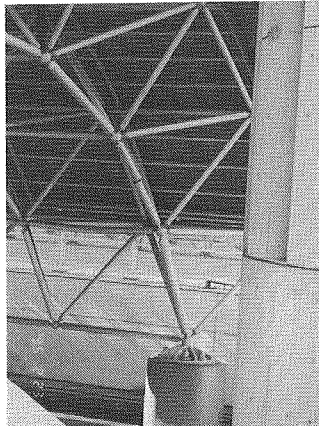
Photo 16 shows interior view of a system truss roof used for a theater atrium. A lot of members were bent or broken off in the middle of the length or at the connections.

Photo 16: Cut off member of the theater atrium

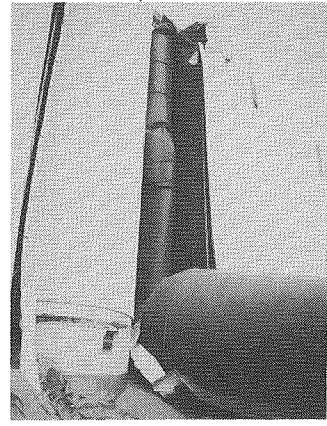
Photo 17: Buckled and collapsed silos

Eighty silos for wheat storage were standing on an artificial island. Sixteen silos of them were made of steel and the others reinforced concrete. Twelve steel silos were heavily damaged by buckling (Photo 17-19). Diameter of each silo was 7.2 m and thickness of steel was 4.5mm at the top and 14mm at the bottom. The silos were filled with wheat by eighty percent of the capacity when the earthquake hit them. The buckling was occurred near the bottom of a silo where wheat inside is gathered to the center by a hopper. No internal pressure of filling restrains the shell from buckling at this part. After the buckling the height of the silos were reduced by about 3m so that hoppers reached the ground. No damage was found to reinforced concrete silos.

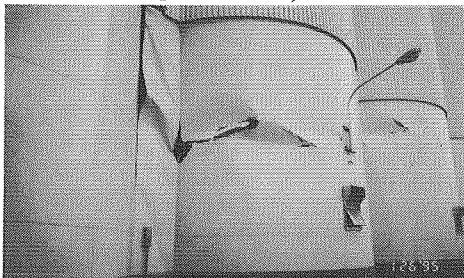
Photo 18: Buckled silos

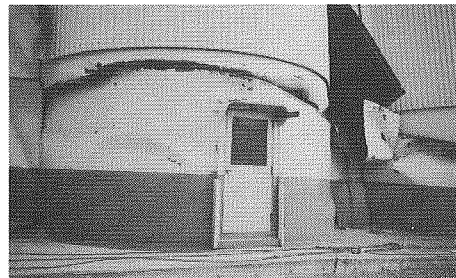
Photo 19: Buckled silos (Compare with Photo 18.)

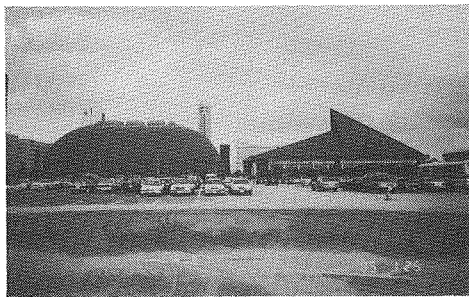
Photo 20 through 22 show two sports arenas which were built on a major artificial island. The arena at left hand side in Photo 18 is a space frame dome structure having 110m x 70m dimension in plan. The other arena is a large space truss structure of which dimension is 100m x 74m in plan. The maximum horizontal ground acceleration recorded on this island was 340.8 gal at the surface while 678.8 gal at -79m down hole. No major structural damage was found in both arena structures.

Photo 20: Two arenas on an artificial island

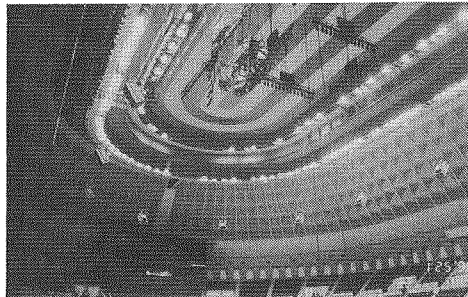
Photo 21: Interior view of the l.h.s. arena

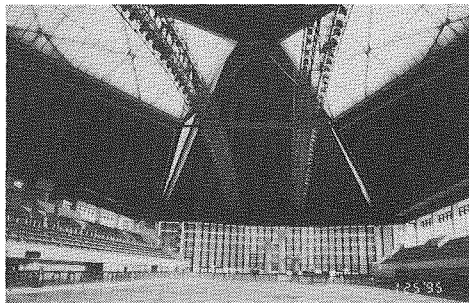
Photo 22: Interior view of the r.h.s. arena

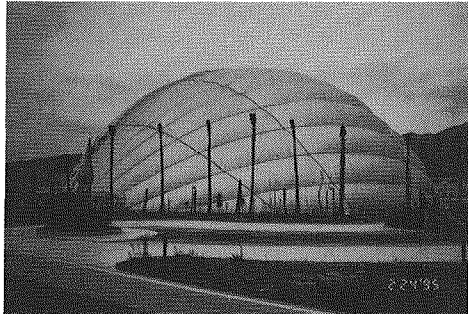
Photo 23: A pneumatic dome

A pneumatic structure on artificial land safely survived (Photo 23). After the earthquake, the public electric power failed and the independent electric generator started to keep the necessary internal air pressure. Since the reserved oil could drive the generator only for five hours a lot of efforts have been paid to maintain the independent electric supply system for a week.

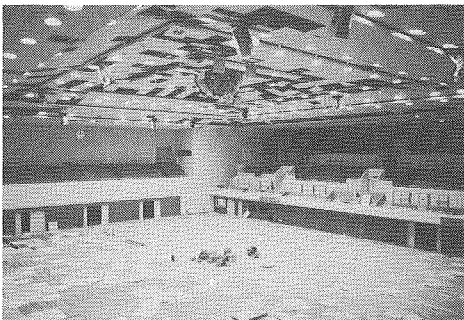
In many halls suspended ceiling panels or other facilities suspended from the roofs fell off while the roof structures themselves remained undamaged (see Photo 24). In Photo 27, one can see a huge speaker frame fell on the floor of the arena. So far, 117 damaged spatial structures, such as public halls or gymnasiums, were reported to us. From the view point of structural engineering, most of the damage to them were minor. Among the damage to spatial structures, the rate of damage to suspended facilities, especially damage to suspended ceiling systems, is very high. Fig.1 shows items in fall of suspended facilities. Fall of suspended facilities is reported in 38 cases among 117 investigated spatial structures. Above all, the major failure is fall of suspended ceiling systems, which is reported in 31 cases. Fig. 2 and 3 show distribution of damaged spatial structures. Fig. 3 shows JMA intensity 7 area and distribution of damage to spatial structures. Most of the spatial structures damaged to structural elements are around the intensity 7 area while spatial structures damaged to suspended facilities are found in broader area.

Photo 24: Fall of suspended ceiling panels

In most of public halls and arenas a lot of heavy facilities are suspended from the roof structure at very high place above the audience and spectators. Aseismaticity of suspended ceiling systems or other facilities suspended from the roof structure should be come to attention since their fall off could injure many people inside and mar the function as public shelters or refuges after the disaster, even if the structure itself survived safely.

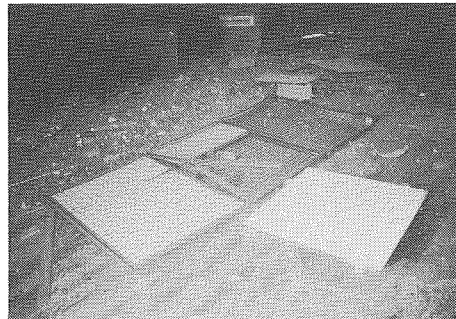
Photo 25: Fall of suspended ceiling systems

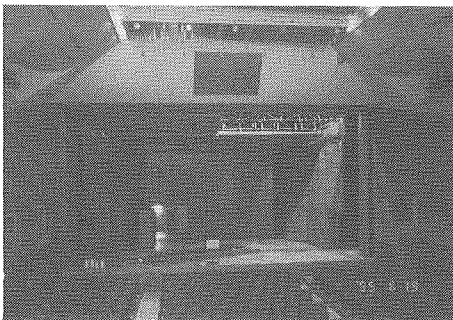
Photo 26: Fall of a mobile acoustic panel

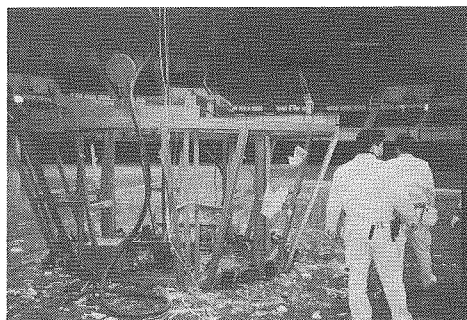
Photo 27: Fall of a huge speaker frame
