DAMAGE REPORT ON THE 1994 HOKKAIDO-TOHO-OKI EARTHQUAKE

Kimiro MEGURO¹, Fumitoshi KUMAZAWA² and Atsushi MIKAMI²

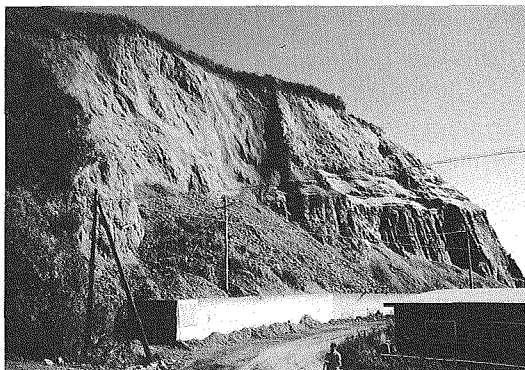
Photo 1 Landslide at Hanasaki Port

age was one of the main causes of damage to houses/buildings and civil infrastructures. **Photo 1** shows the landslide observed at Hanasaki Port. **Photo 2** shows the slope at Midorigaoka, Kushiro City, during this earthquake and during the 1993 Kushiro-Oki earthquake (upper photo) where houses collapsed. In this earthquake, no failure occurred because of reinforced reconstruction of the slope. A tank that emerged above the ground surface due to the liquefaction of the sand fill around the tank is shown in **Photo 3**. Liquefaction caused various damage to port facilities and lifeline systems. **Photos 4** and **5** show the damage due to liquefaction similar to that by the 1993 Kushiro-Oki earthquake. Although Kushiro Port was restored, it sustained similar structural damage after the 1994 Hokkaido-Toho-Oki earthquake (**Photo 4**). People made a manhole that surfaced due to liquefaction during the 1993 Kushiro-Oki earthquake as a monument to the earthquake disaster. Manholes near the monument again emerged above the ground due to liquefaction during the 1994 Hokkaido-Toho-Oki earthquake.

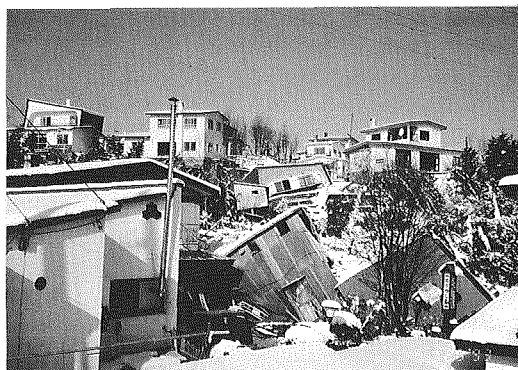
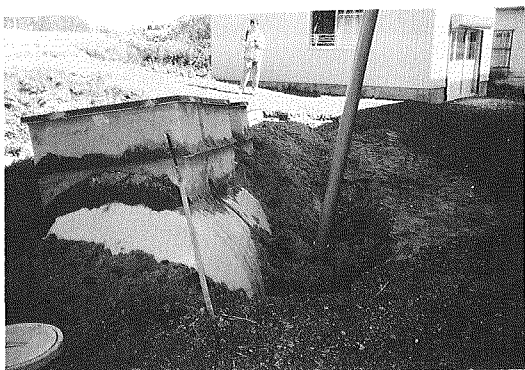
Photo 3 Tank floated up to the surface due to soil liquefaction (Hanasaki)

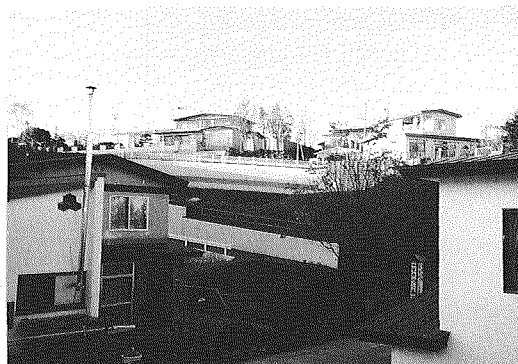
Photo 2 Landslide (Top: due to the 1993 Kushiro-Oki earthquake, Bottom: due to the 1994 Hokkaido-Toho-Oki earthquake)

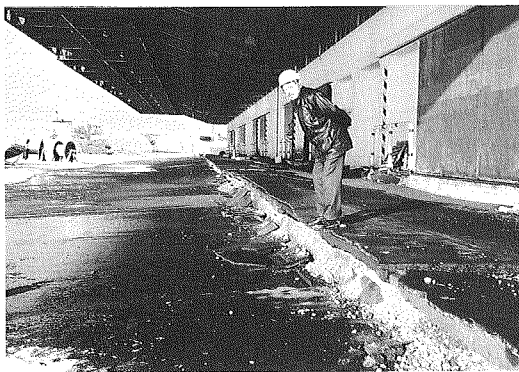
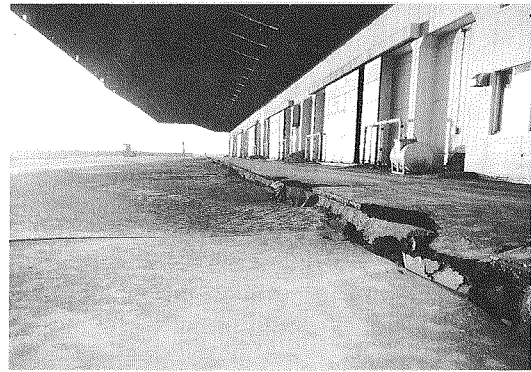
Photo 4 Liquefaction caused similar damage at Kushiro Port
(Left: 1993 Kushiro-Oki earthquake, Right: 1994 Hokkaido-Toho-Oki earthquake)

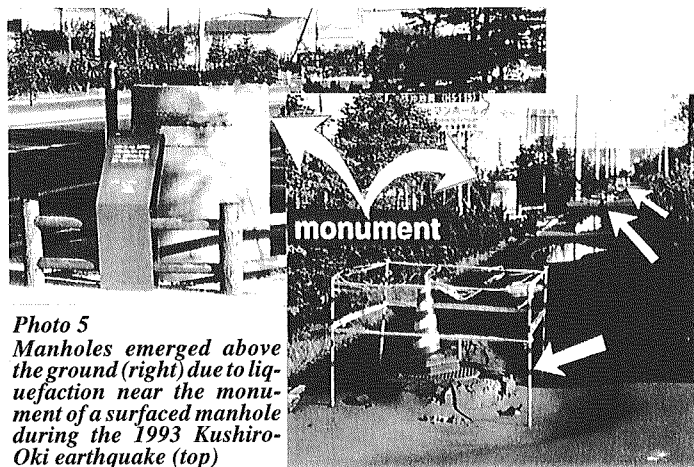
Photo 5
Manholes emerged above the ground (right) due to liquefaction near the monument of a surfaced manhole during the 1993 Kushiro-Oki earthquake (top)

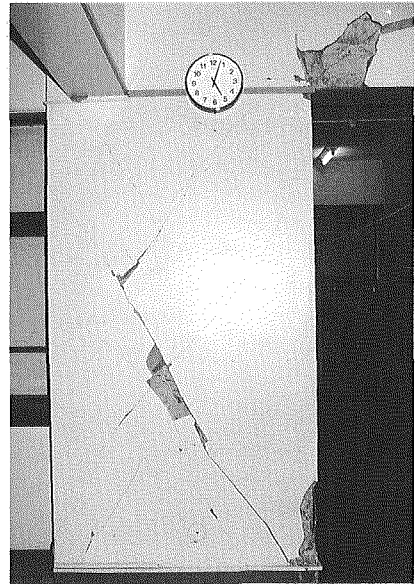
Photo 7 Shear failure of column with wall and shear failure of beam (Nakashibetsu Citizen's Hall)

Nakashibetsu Citizen's Hall and Nemuro Hospital, which were constructed in 1962 and 1958, respectively, were severely damaged by shear failure of the columns on the first story (**Photos 6-10**). Many shear cracks on columns were also observed at Nakashibetsu Hospital that was constructed in 1968 (**Photos 11 and 12**). Many wooden houses on reclaimed land were damaged due to

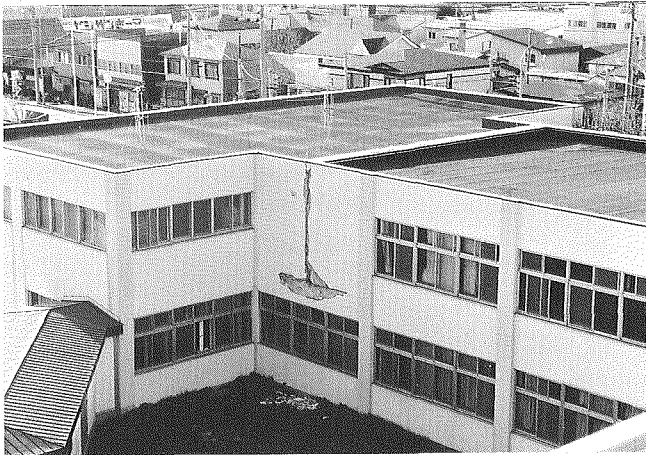
Photo 8 Failure at joint of low-rise parts (Nemuro Hospital)

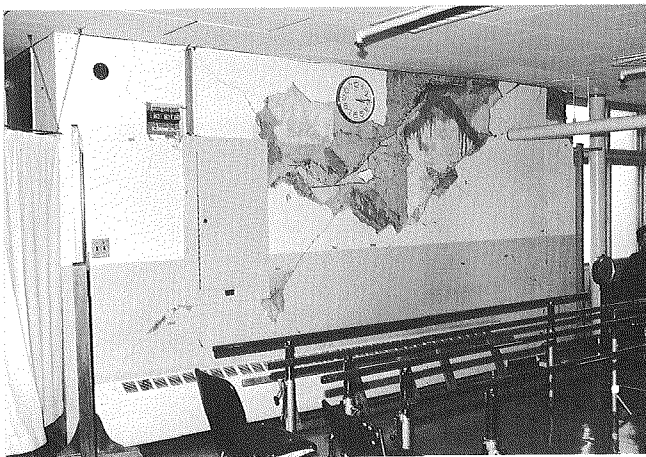
Photo 9 Shear failure of shear wall (Nemuro Hospital)

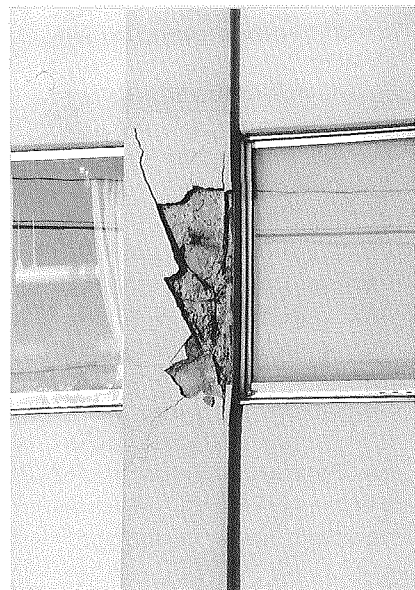
Photo 10 Shear failure of column (Nemuro Hospital)

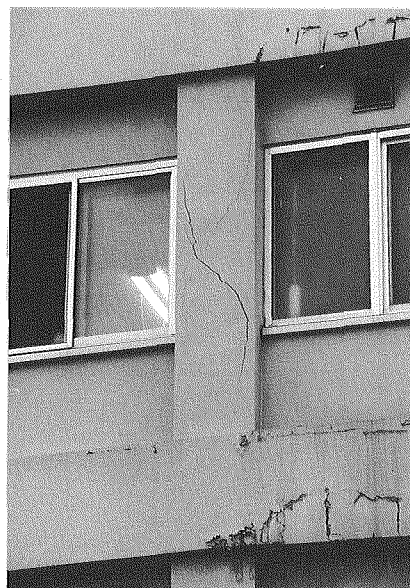
*Photo 12 Shear crack of column
(Nakashibetsu Hospital)*

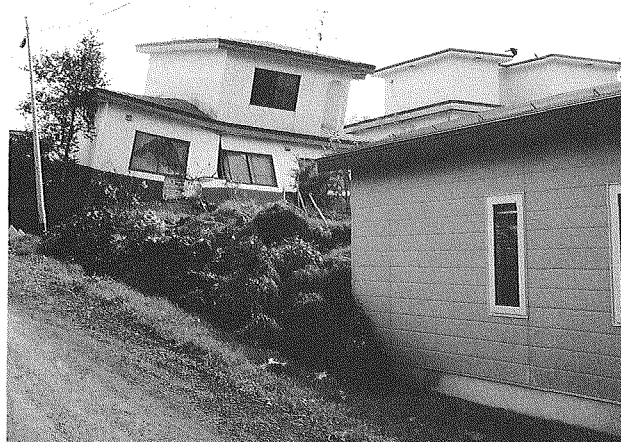
Photo 13 Wooden houses collapsed due to land failure

land failure (*Photo 13*). *Photo 14* shows a house that was slightly damaged but the foundation was destroyed. Threat to people's lives does not come only from destruction of structural elements. Many people could have been injured or killed by damaged nonstructural elements if the earthquake occurred in daytime. In an event hall of the Nemuro Cultural Center constructed in 1992, about 200 seats were buried under fallen ceiling panels as shown in *Photo 15*. Also, a nonstructural wall collapsed in Koyo

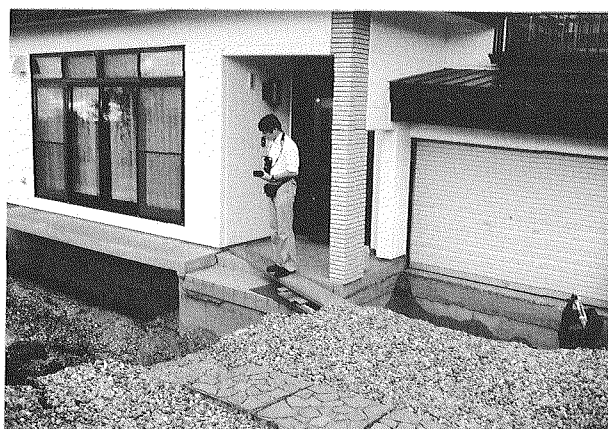
Photo 14 A wooden house with its foundation displaced horizontally by 3.5 m and vertically by 1 m

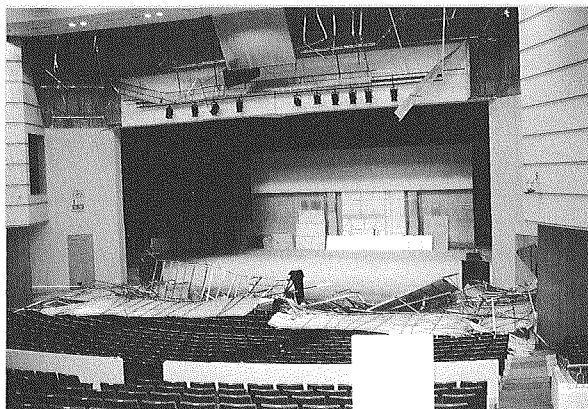
Photo 15 Fallen ceiling on about 200 seats in a large event hall (Nemuro Cultural Center)

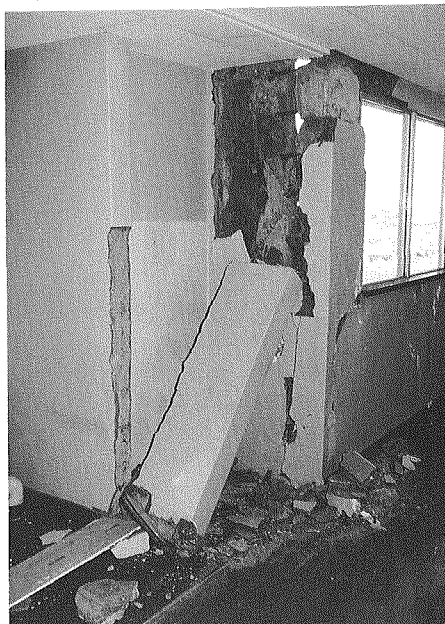
Photo 16 Collapsed nonstructural wall (Koyo Junior High School in Nemuro City)

Junior High School constructed in 1964 in Nemuro City (*Photo 16*). A steel structure office building shown in *Photo 17* has slight structural damage. However, its ceiling panels and air conditioners installed on the ceiling fell down, completely burying the floor inside. *Photo 18* shows the scattered books that fell from the shelves which were bolted to the wall at Higashi-Nakashibetsu Elementary School.

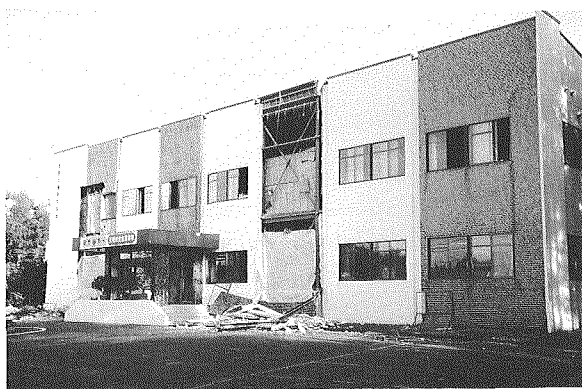
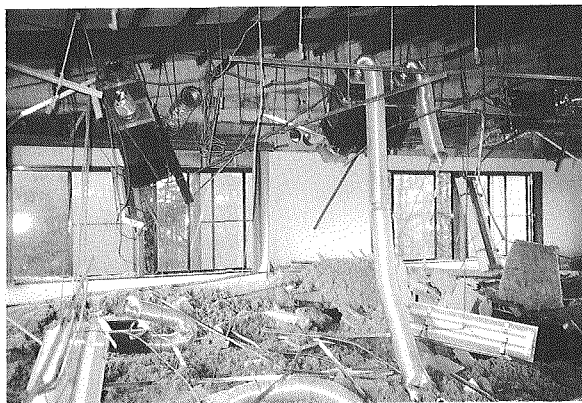
Photo 17 Damage of interior materials of an office building (Top: Outside, Bottom: Inside)

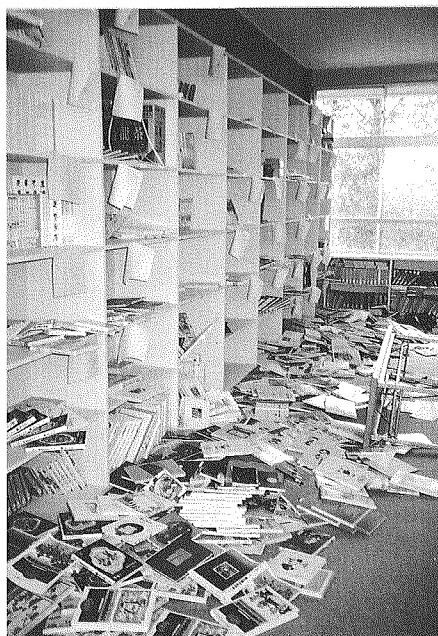
Photo 18 Books fell down from shelves (Higashi-Nakashibetsu Elementary School)

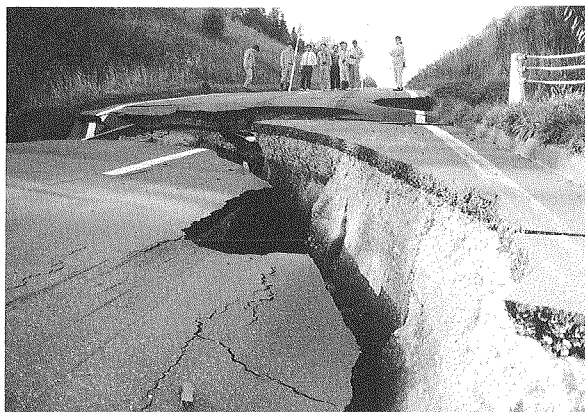
Photo 19 National and local highways are damaged at many locations

ments subsided and slipped at numerous locations, forming large cracks (*Photo 19*). Since roads sustained especially heavy damage, extensive investigations were conducted in eastern Hokkaido.

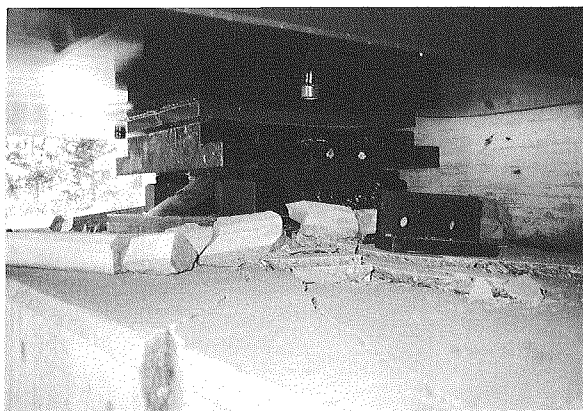
Photo 20 Damaged shoe and anchorage of pier of Rindo-Ohashi bridge

As of early Wednesday morning, October 5, traffic was paralyzed at about 40 locations along more than 30 national and local highways in Hokkaido. This number was reduced by about a half within 3 days. All national highways had been opened by the evening of October 9. Thirty bridges were reported to have been damaged (*Photo 20*).

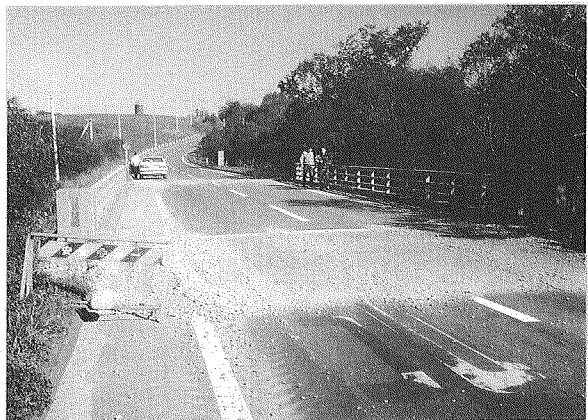
- 1) Vertical separation between bridge deck and approach pavement: The most common disruption at bridge sites was settlement of approach fills due to compaction of embankment materials. These settlements produced vertical separations between the approach pavements and the bridge decks as shown in *Photo 21*.
- 2) Damage at the section between hills: Significant road damage was observed at the valley section between hills or mountains, often with a river flowing through the valley or with high underwater level (*Photo 22*).
- 3) Damage at fill section beside the cut: Fill sections beside the cut were often damaged due to the different motions between these sections (*Photo 23*).

Photo 21 Vertical separation between deck and approach pavement

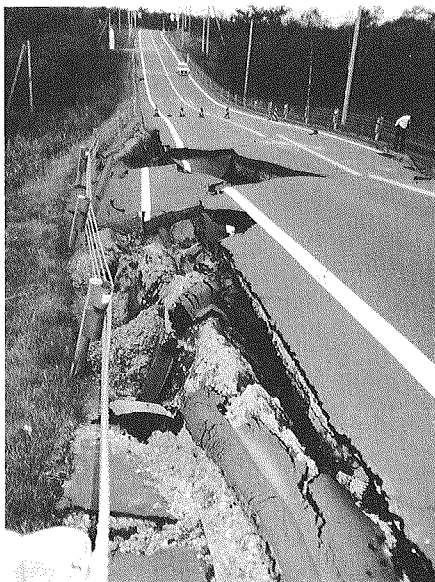
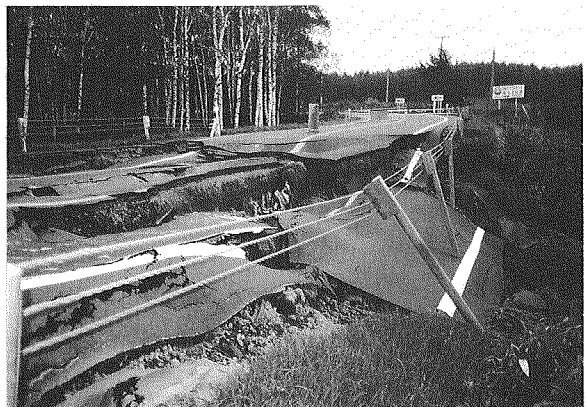
Photo 22 Damage to road at the section between hills

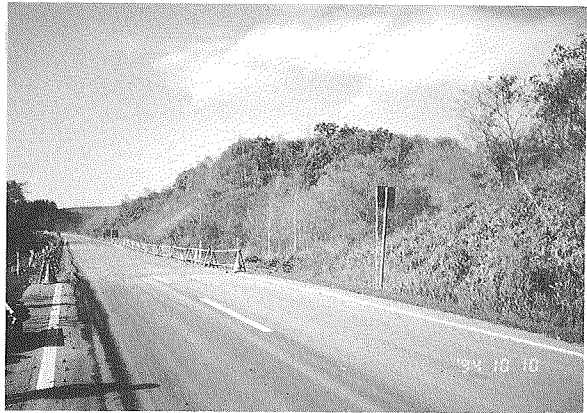
Photo 23 Damage to road at the fill section beside the cut

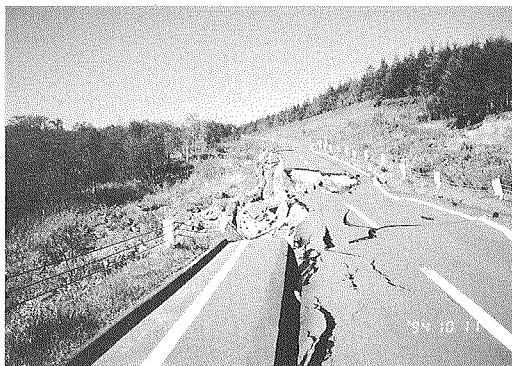
Photo 24 Failure of approach pavement of Shinsei bridge

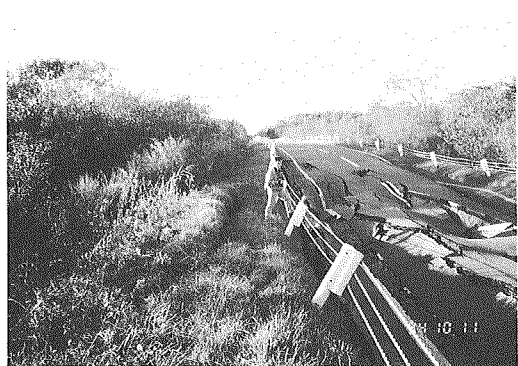
Photo 25 Subsidence of approach fills of Shunkai bridge

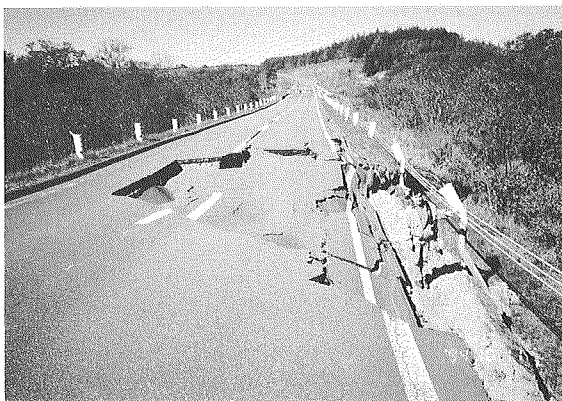
Photo 26 Damage to road diagonally above a corrugated culvert

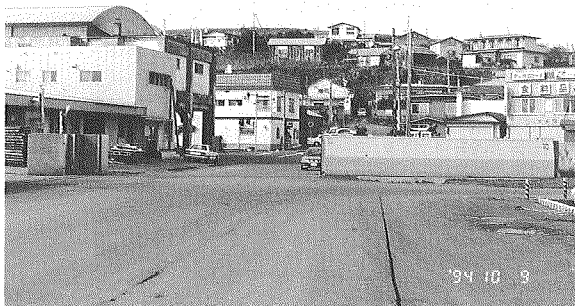
A tsunami about 173 cm-high hit Hanasaki Port but there were no casualties. **Photo 27** shows a tide barrier against tsunamis. It did not perform during this earthquake because ground motions caused the barrier to slip out from the rail. Damage to the quay walls and quay surfaces was also visible in this port as shown in **Photo 28**.

Photo 27 Tide barrier at Hanasaki Port

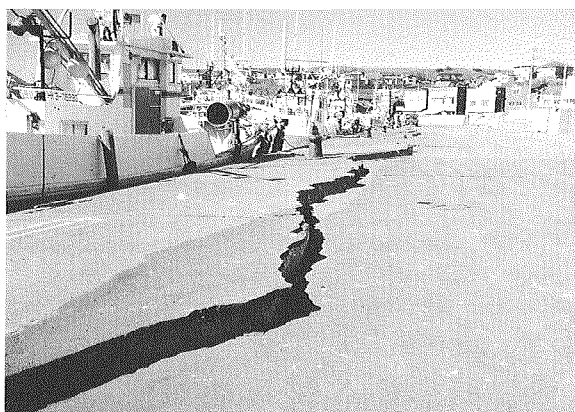
Photo 28 Cracks on quay surface at Hanasaki Port

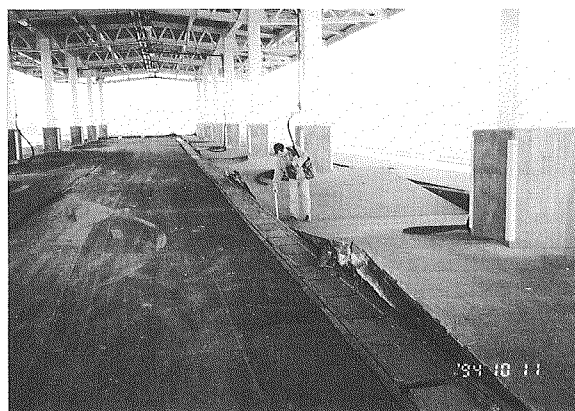
At Odaito fishery harbor, the soil behind the sheet pile-type quay wall liquefied and the concrete plates of the quay surface inclined as shown in **Photo 29**. Damage to this port was estimated at about 1.7 billion yen.

Photo 29 Damage to quay surface by liquefaction at Hanasaki Port

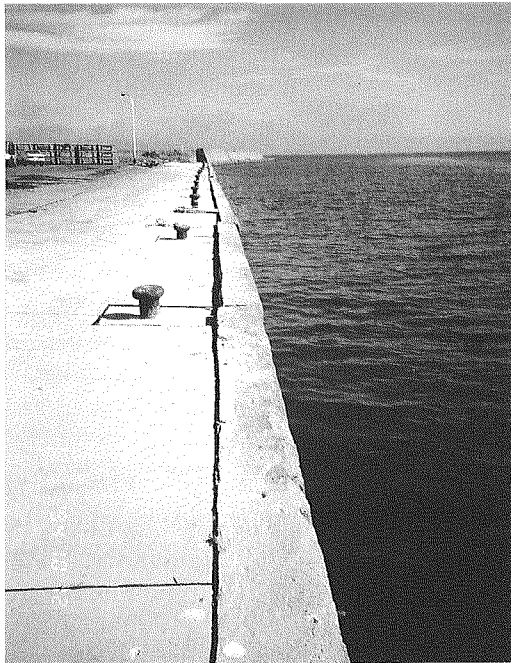
Bekkai fishery harbor is an estuary harbor of the Nishibetsu river. Sheet pile-type quay walls moved toward the sea (**Photo 30**). Cracks were found on the ground surface 6 m behind the quay walls. Damage to this port was estimated at about 0.4 billion yen.

Photo 30 Movement of sheet pile-type quay wall at Bekkai fishery harbor

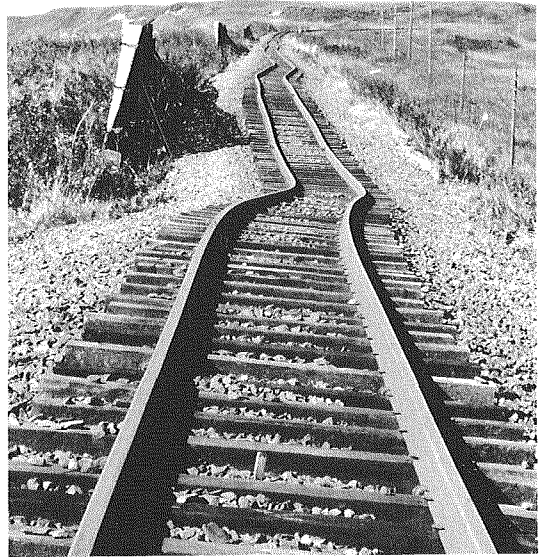
Photo 31 Rails buckled due to subsidence of the embankment at Nemuro Honsen Line

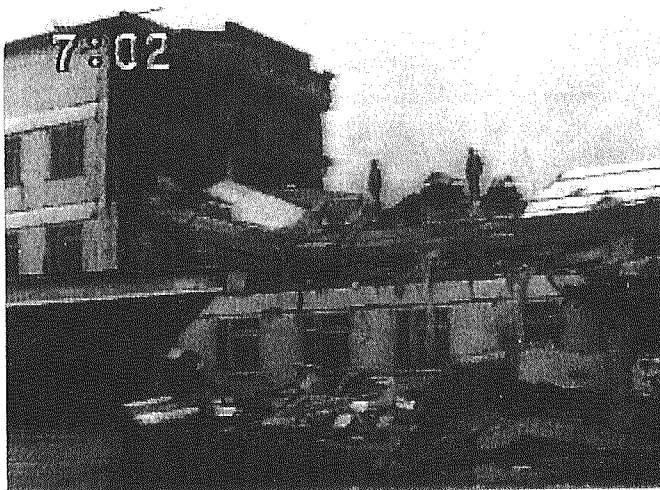
A 3-story military hospital collapses in Etorofu
(From NHK TV news)
