Damage Report on 1994 Sanriku-harukaoki Earthquake

Kenji Kabayama ¹⁾, Atsushi Mikami ²⁾, Yoshiaki Nakano ³⁾ and Choshiro Tamura ⁴⁾

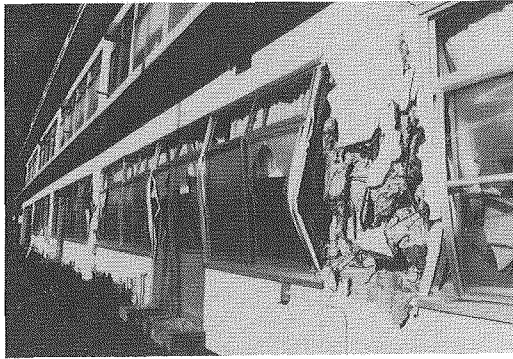
Hachinohe-higashi High School and two pinball houses in Hachinohe City collapsed as shown in Photos 1 through 6. Photos 1 and 2 show damage to Hachinohe-higashi High School which is a three story R/C building constructed in 1963. Two collapsed pinball houses, referred to as “Pinball House A” and “Pinball House B” hereafter, are three story R/C buildings with a basement. Two persons were killed due to collapse of columns in the first story of “Pinball House A” constructed in 1966 (Photos 3 and 4). Photos 5 and 6 show a front view and interior damage to “Pinball House B” constructed in 1959. Photos 7 through 12 show other structural damage to R/C buildings. Most of these damaged buildings were constructed before the revision of Building Standard Law Enforcement Order in 1971, and few damage was observed in buildings constructed after 1982 in accordance with the current seismic code. Fig. 2 shows the relationship between the year of construction and the damage degree of R/C buildings investigated in Hachinohe City. This is strongly showing that retrofitting of older and vulnerable buildings is the most urgent issue.

Photo. 1 Collapsed Hachinohe-higashi High School.
(Photo by Daily Tohoku)

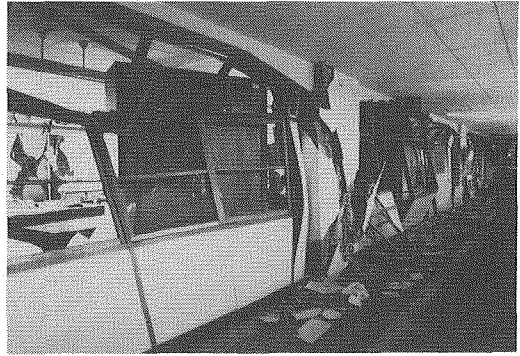
Photo. 2 Interior view of collapsed Hachinohe-higashi High School.
(Photo by Daily Tohoku)

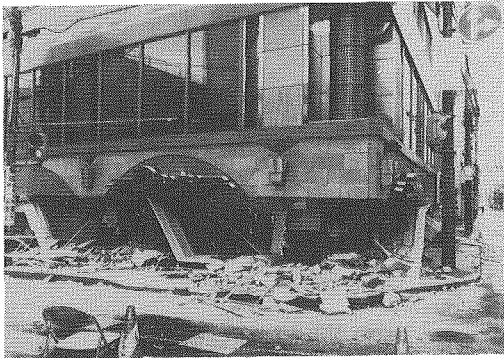
Photo. 3 Collapsed first story of "Pinball House A"
in Hachinohe City.
(Photo by Daily Tohoku)

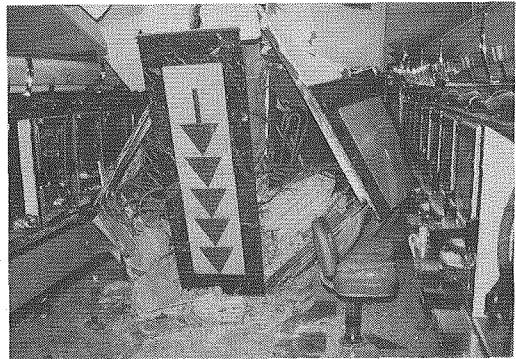
Photo. 4 Collapsed column in the first story of
"Pinball House A".

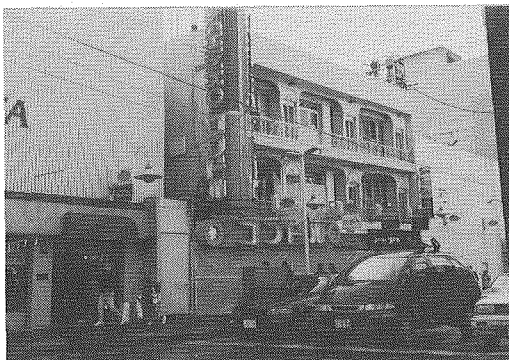
Photo. 5 Front view of "Pinball House B"
in Hachinohe City.

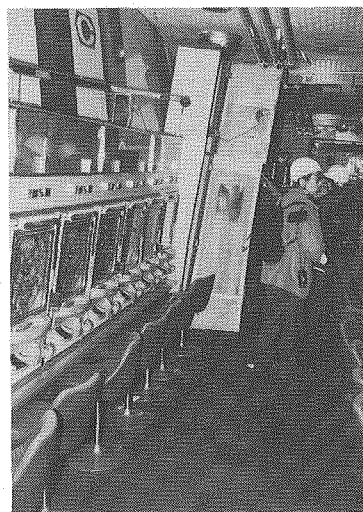
Photo. 6 Interior damage to
"Pinball House B".

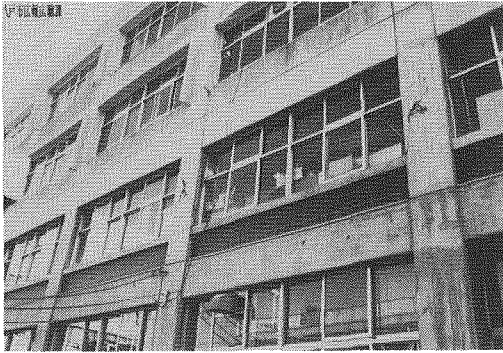
Photo. 7 Shear failure of columns in the second story of Hachinohe City Office Annex.

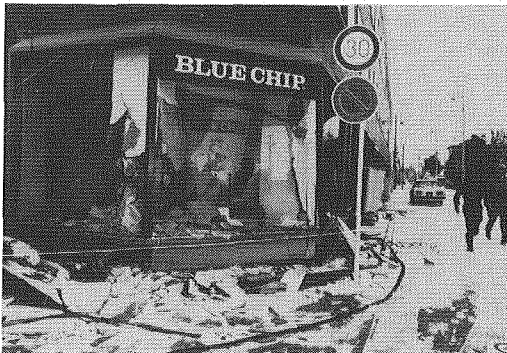
Photo. 9 Damaged show window and collapsed column of Hachinohe Commercial and Industrial Association Office. *(Photo by Daily Tohoku)*

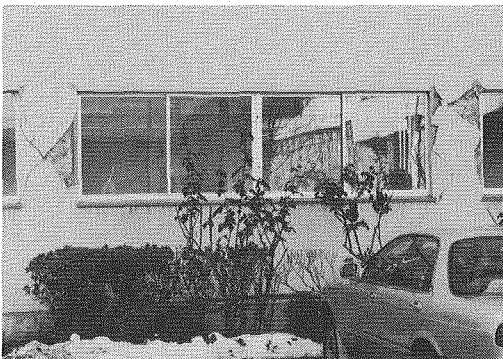
Photo. 11 Severe shear cracks in columns of Chiba-gakuen High School.

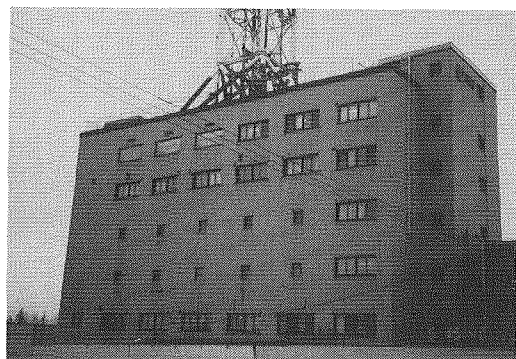
Photo. 12 Shear cracks in columns and walls. Building No. 3 of the NTT Hachinohe Office

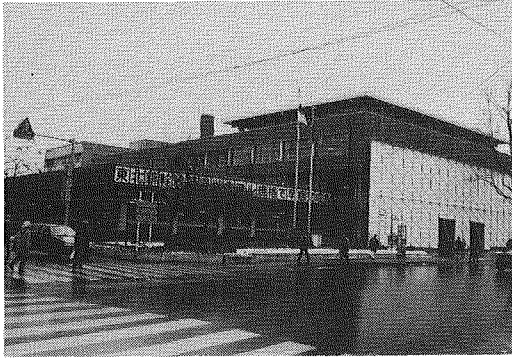
It should be noted that damage was again observed in buildings that had been retrofitted following 1968 Tokachi-oki Earthquake as shown in Photos 13 through 16. Photos 13 and 14 show a general view and damage to a column and wall panel at the entrance of Hachinohe City Main Office. The damage was attributed to a poor detailing between an existing column and a new wall element. Photos 15 and 16 show damage to columns in upper story of Hachinohe Technical College. This damage resulted from irregular distribution of strength since the first story that had severe damage during 1968 Tokachi-oki Earthquake had been retrofitted after the event. These results revealed that retrofit detailing and the distribution of strength were key factors in retrofitting buildings.

Photo. 13 General view of Hachinohe City Main Office.

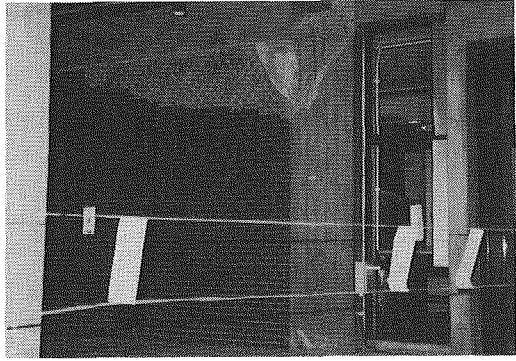
Photo. 14 Damage to a column and wall panel at the entrance. The wall had been installed after 1968 Tokachi-oki Earthquake.

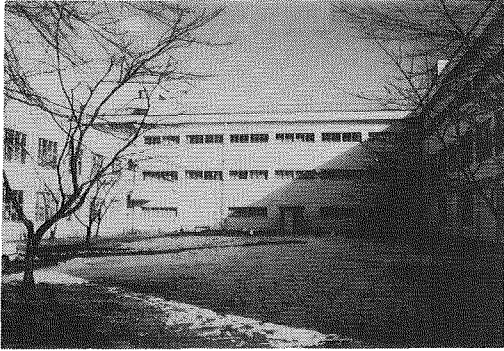
Photo. 15 Damage to Hachinohe Technical College.
(Photo by Sangho Lee, Tokyo Metropolitan University)

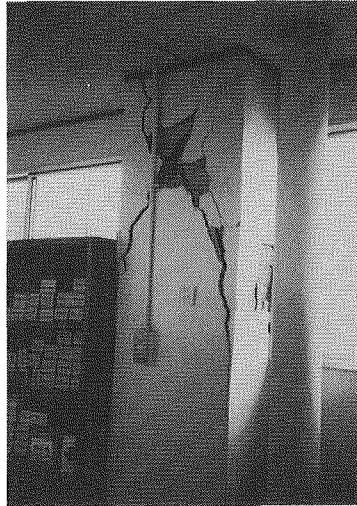
Photo. 16 Shear failure of column at the second story. Shear walls had been installed only in the first story after 1968 Tokachi-oki Earthquake.
(Photo by Masaki Maeda, Yokohama National University)

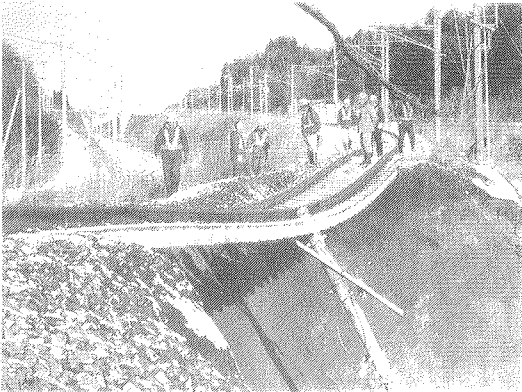
Sliding of the embankment for railways occurred on the JR Tohoku-line between Hachinohe and Mutsu-Ichikawa stations. A fill section of about 50 m in length collapsed and a circular failure surface emerged. The rail then became suspended in midair as shown in Photo 17. The height of the fill embankment was about 10 m and the slope about 2 horizontal to 1 vertical. The total volume of the collapsed soil was about 2,600 cubic meters. The line resumed service on January 1, just four days after the collapse, following rushed repairs. Photo 18 shows the reconstruction of the damaged fill on December 31 .

Photo.17 Damage to railways in the Kawaragi area
(Photo by Tooh-Nippo)

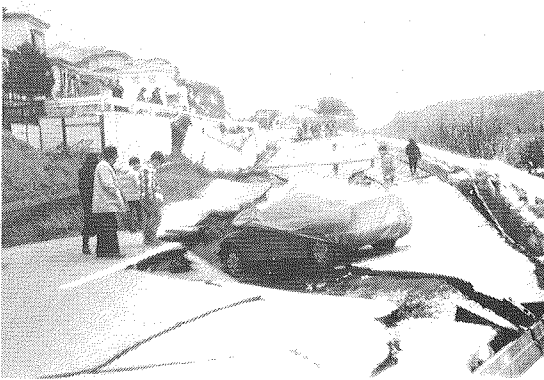
Road damage occurred in the Matsugaoka area in Hachinohe city. A double-lane road at the slope of reclaimed fill broke down due to sliding down of the slope as shown in Photo 19. Some dwelling houses on the top of the hill also sustained severe damage (Photo 20).

Photo.19 Damage to road in the Matsugaoka area

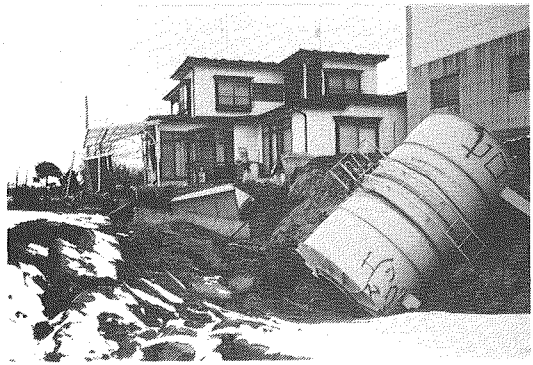
Photo.20 Damage to the reclaimed fill

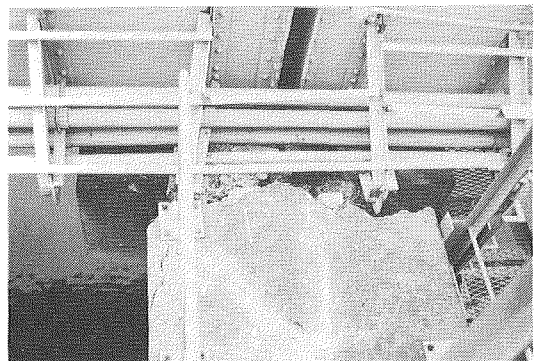
The Ohashi bridge is about 230 m long with 10 piers crossing the Mabuchi river. This bridge is composed of two structurally different bridges; a main bridge and a pedestrian bridge as shown in Photo 21. The main bridge is supported by concrete piers and the pedestrian bridge by steel piers. The bridges were connected with concrete and steel bars at the edges of their piers. Those connections were damaged as shown in Photo 22 due to the difference of response motions between these component bridges. Pier 3 of the main bridge sank and tilted into the Mabuchi river on the upstream side (Photo 23).

Photo.22 Breakage of the connections between two structurally different bridges

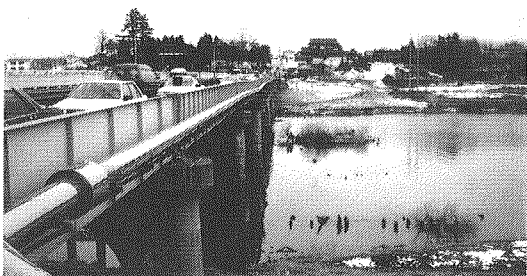
Photo.23 Sunk and tilted pier 3 of the Ohashi bridge

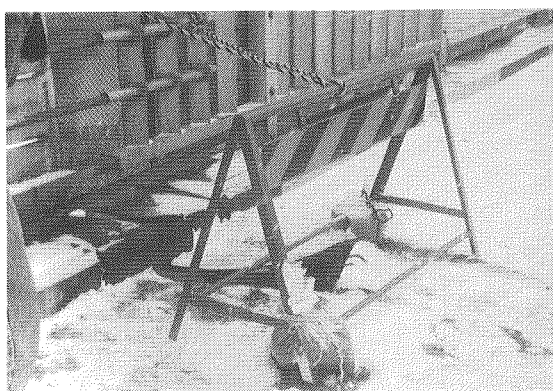
The Hachinohe-Ohashi is a bridge of over 1300 m in length (Photo 24). Damage to the steel deck plate of the bridge was found at the joint of the decks above pier 12 (Photo 25). It is suspected that the decks temporarily moved to separate, then the decks came to collision when these deck plates returned to their original positions. Pier 12 supports two different types of girders; an I-type girder and a box-type girder of longer span as shown in Photo 26. It is suspected that the damage occurred due to the different motions of the different types of structures. A handrail of the bridge was expanded about 17 cm in length as shown in Photo 27. A guardrail of the bridge was suspected to be fractured by the large transverse displacements of the bridge (Photo 28).

Photo.25 Damage to the steel deck plate of the Hachinohe-Ohashi bridge

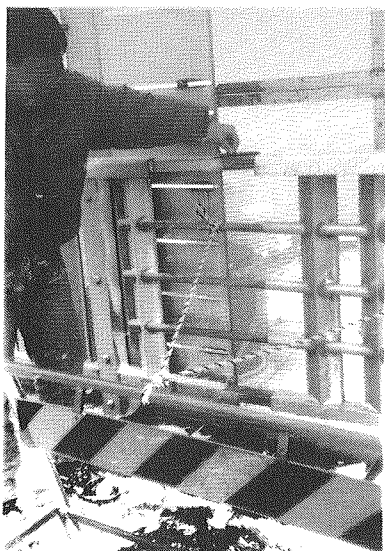
Photo.27 The expanded handrail of the Hachinohe-Ohashi bridge

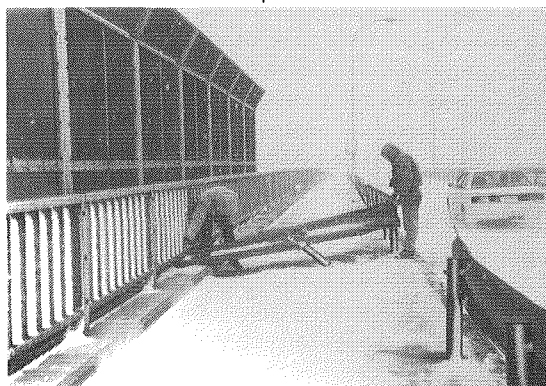
Photo.28 Damage to the guardrail on the Hachinohe-Ohashi bridge

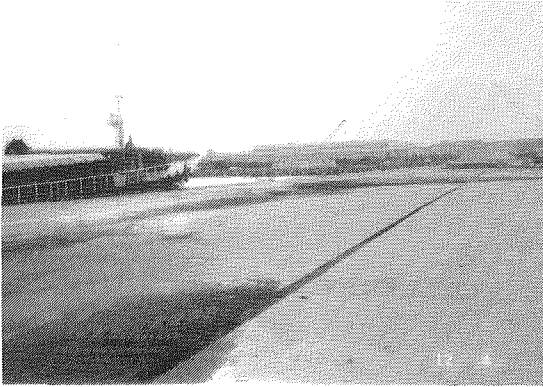
The Ports of Hachinohe experienced widespread liquefaction (Photo 29). Gravity-type quaywalls displaced laterally by several tens of centimeters toward the sea due to the liquefaction of the fill material behind the walls or by their inertia force (Photo 30).

Photo.29 Traces of liquefaction at the Hachinohe port

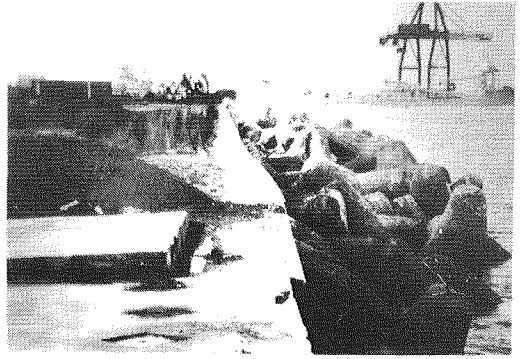
Photo.30 Movement of gravity-type quaywalls at the Hachinohe port
