# QUICK INSPECTIONS OF DAMAGED BUILDINGS DUE TO 1995 HYOGO-KEN-NAMBU EARTHQUAKE

#### Yoshiaki NAKANO

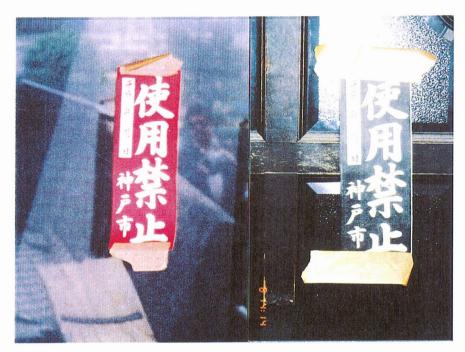
photo 1: Tags showing "DO NOT USE" (left: original / right: copied)
