Report of the Damage caused by the Mid-North Iwate Earthquake of September 3, 1998

Kazuo KONAGAI, Atsushi MIKAMI, Toshihiko KATAGIRI, Raquib AHSAN
and Daisuke MARUYAMA

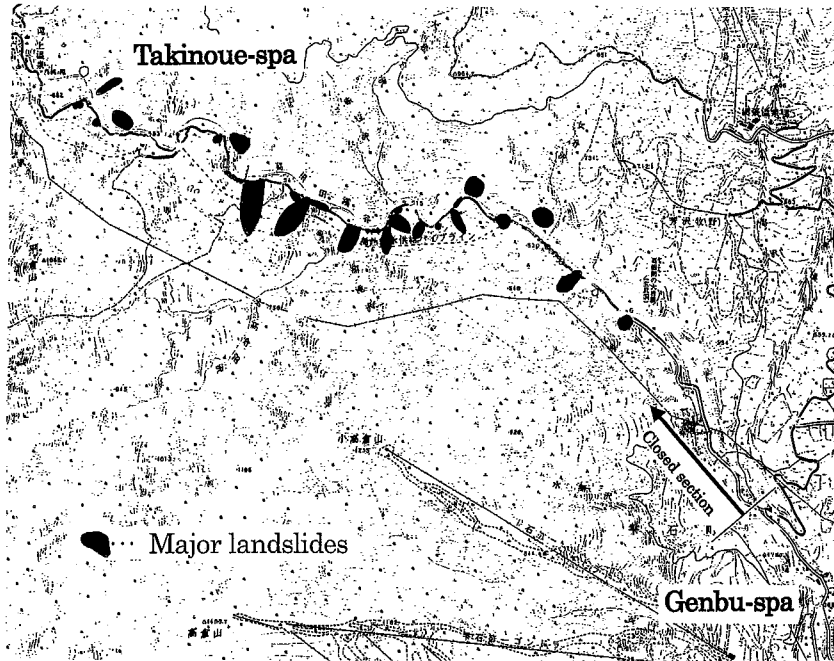
Fig.4 Location of major landslides

Traffic on the prefectural route 100, called Nishiyama-Ononai Line, was suspended by a number of earthquake-induced landslides along the Kakkonda glen, causing about 100 people at Takinoue Spa to be held up for a night. Total 55 landslides took place between Takinoue and Genbu spas. Locations of major landslides are shown in **Fig. 4** along with a pair of photographs of a typical slide (**Photo 6**). When the photographs are viewed side by side through a stereoscope, they are perceived as a single image in three-dimensional space. When used to focusing both eyes on these photographs, these separate perceptions of the two eyes can be combined and interpreted in terms of depth even without a stereoscope. On the visualized 3D

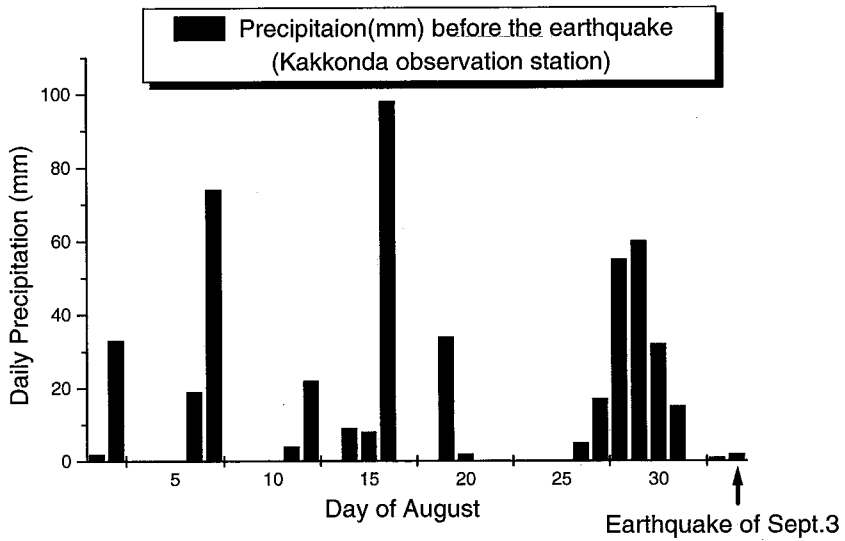
Fig.5 Precipitation record (Kakkonda meteorological observatory)

Needless to say, slope failures and precipitation closely correlate to each other. **Fig. 5** shows the precipitation record at Kakkonda meteorological observatory, which is very close to the dislocated fault planes. It is clear from this figure that a spell of 6 days rain was followed by the earthquake of Sept. 3. **Fig. 6** shows the number of tremors observed at the Mt. Iwate observation station of JMA. A great number of volcanism-related tremors preceded the earthquake of Sept. 3, and thus might have been another cause of making the loamy soils loose.

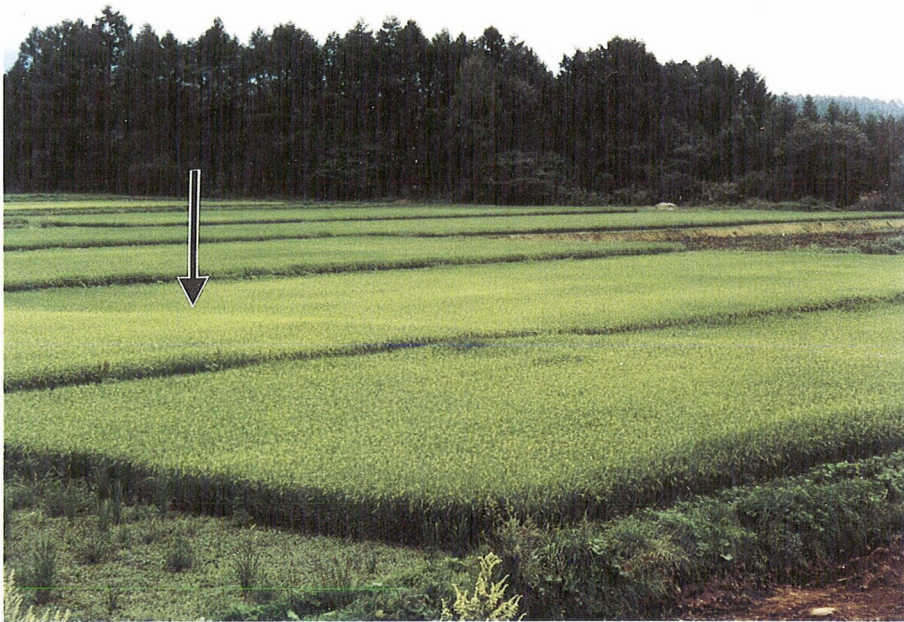
The activated fault planes were found roughly lined up at random intervals near a scarp formed along the Kakkonda glen. One of the faults which appeared in a paddy field was a straight raised mark extending a couple of hundred meters' distance, clearly showing a compressional dip-slip movement of this fault (**Photo 1**). The averaged upward movement of the soil caused by the reverse faulting reached or exceeded ten centimeters in this paddy field. This movement of the fault caused concrete walls covering up a drain to be cracked and dislocated (**Photo 2**). A fault plane branching off the lined major fault planes crossed the Kakkonda river and buckled the pavement of the prefectural route 100 (**Photo 3**).

Photo 1 Fault that appeared in paddy field

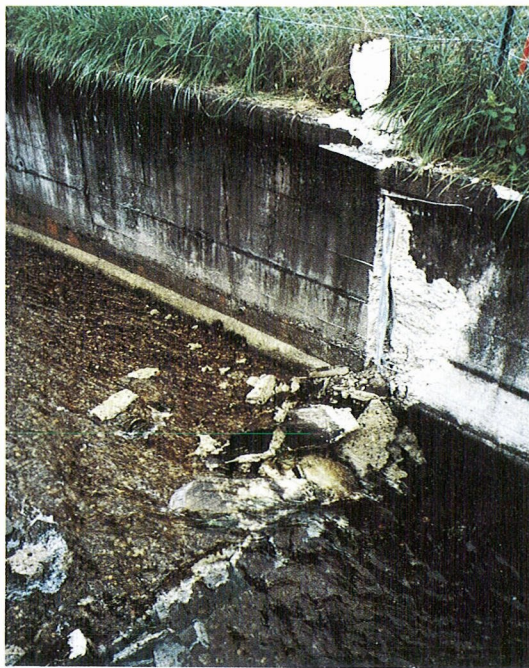
Photo 2 Damaged concrete wall of drain

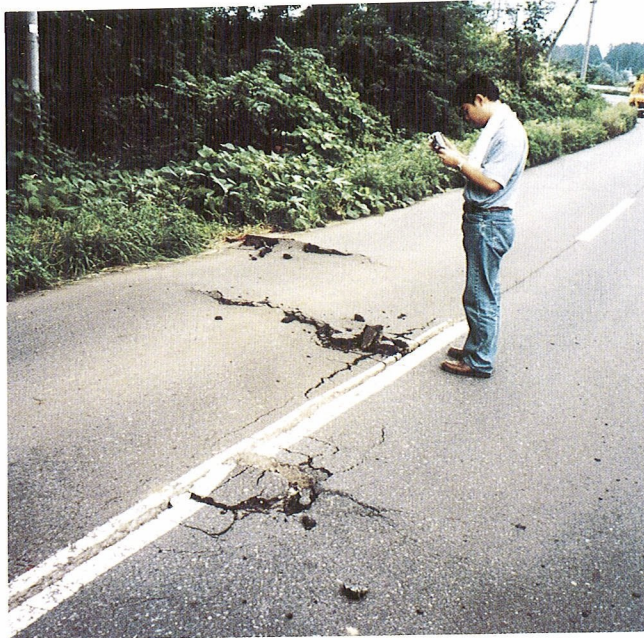
Photo 3 Buckled pavement

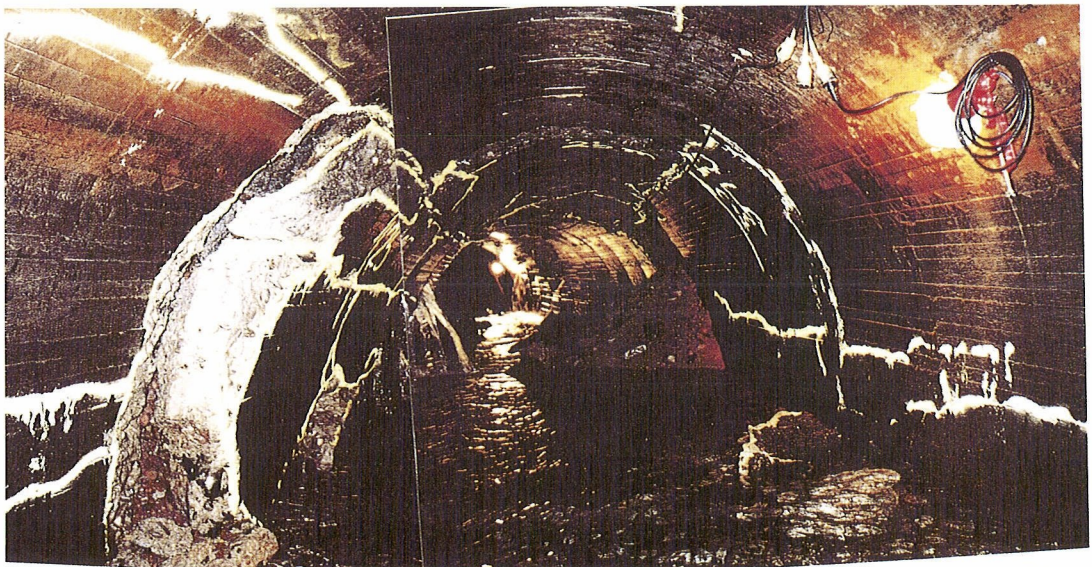
These faults observed on the ground surface form a part of Shizukuishi-Seien fault belt whose presence has been suggested by many geologists¹⁾. Continual movement of this fault belt has formed the scarp along the Kakkonda river, and by virtue of this configuration, some hydroelectric power stations were constructed along the Kakkonda river. A concrete outlet tunnel of the second Kakkonda hydroelectric power station runs across one of the fault planes that appeared as the straight rising mark in the paddy field mentioned already. It was, thus, inevitable that the circular tunnel wall was cracked up into several large pieces and smaller fragments (**Photo 4**). Some pieces of the cracked wall were pushed in the tunnel reducing the tunnel's cross-section²⁾. One cracked piece of about 2 m high and 2 m wide completely fell down onto the invert allowing the soil with big boulders (30 ~ 50 cm) to be squeezed into the tunnel. An open aqueduct leading to this hydroelectric power station was also damaged (**Photo 5**). Diagonal cracks found on its concrete walls are suggestive that the aqueduct might have experienced compressional force in its axial direction. No clear evidence of the motions of the surrounding soil was found there. It is, however, quite probable that there were some fault planes that reached the ground surface causing this damage, and yet could not be clearly seen.

Photo 4 Damage to outlet tunnel (provided by Tohoku Electric Power Company)

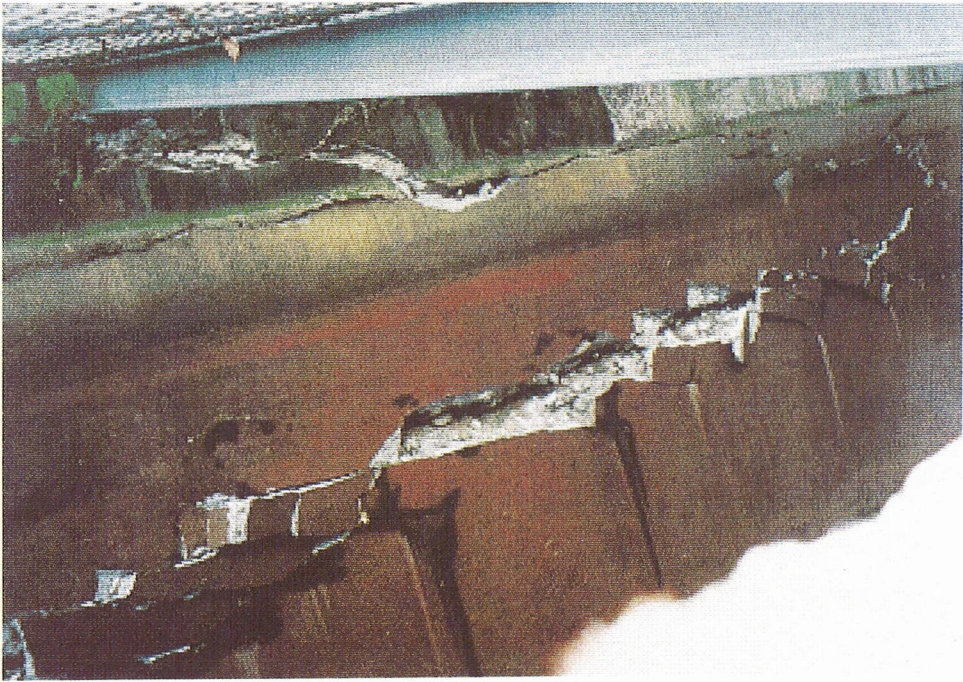
Photo 5 Damage to open aqueduct

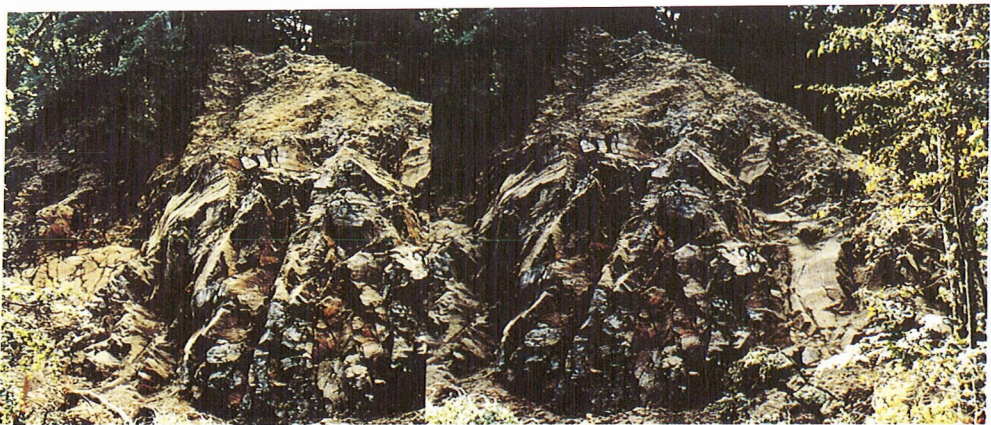
Photo 6 Basalt rock that appeared on a failure surface

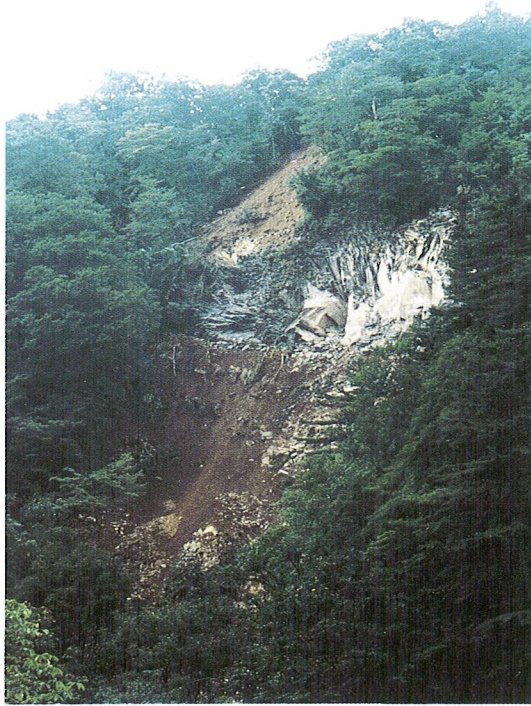
failure surface, one would see the mass of tightly-joined basalt rocks half embedded in surface soil. **Photo 7**, showing a basalt rock layer sandwiched in between loamy soils, suggests that molten rock forced its way into the soft volcanic soil deposit. The soft soils might have been responsible for amplifying the seismic motion to such extent that the soils with basalt rocks were shaken off the slopes.

Photo 7 Basalt rock layer sandwiched in between loamy soils
