Preliminary Report on Damage to Retaining Walls Caused by the 1999 Chi-Chi Earthquake

J. Koseki¹ and K. Hayano²

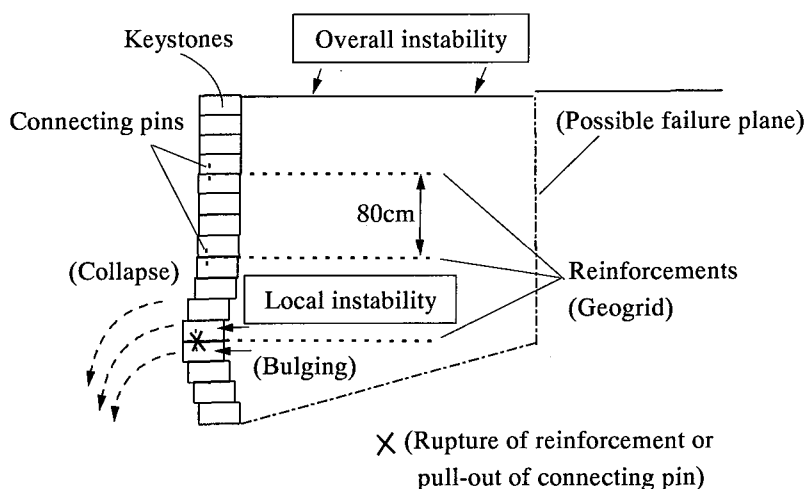
Fig. 2. Schematic figure on damage to reinforced-soil retaining walls using keystone blocks for facing

- 1) Since the lower part of the facing was subjected to larger earth pressures, this part suffered bulging deformation.
- 2) The bulging deformation caused rupture of reinforcements and/or pull-out of connecting pins, resulting into local instability by loss of connection between reinforcements and facing.
- 3) Collapse of the lower part of the facing due to the local instability triggered complete failure of facing.

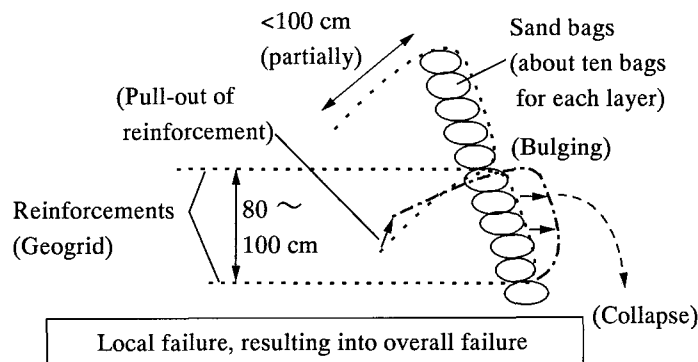
Fig. 3. Schematic figure on damage to wrapped-around type reinforced-soil embankments

- 1) Since the lower part of the stacked sand bags was subjected to larger earth pressures, this part suffered bulging deformation. Resistance of this part against bulging was low, due to excessive vertical spacing of reinforcements. In addition, the degree of compaction of backfill during construction process may have been low, due to low contribution of these reinforcements in reducing the horizontal tensile strain of backfill.

- 2) At a section with insufficient anchoring length of wrapping reinforcements, the bulging deformation caused pull-out of reinforcements, resulting into local failure by loss of anchoring resistance.
- 3) The local failure triggered collapse of upper embankment, resulting into overall failure including collapse of lower embankment due to extensive loads applied from the collapsed upper embankment.

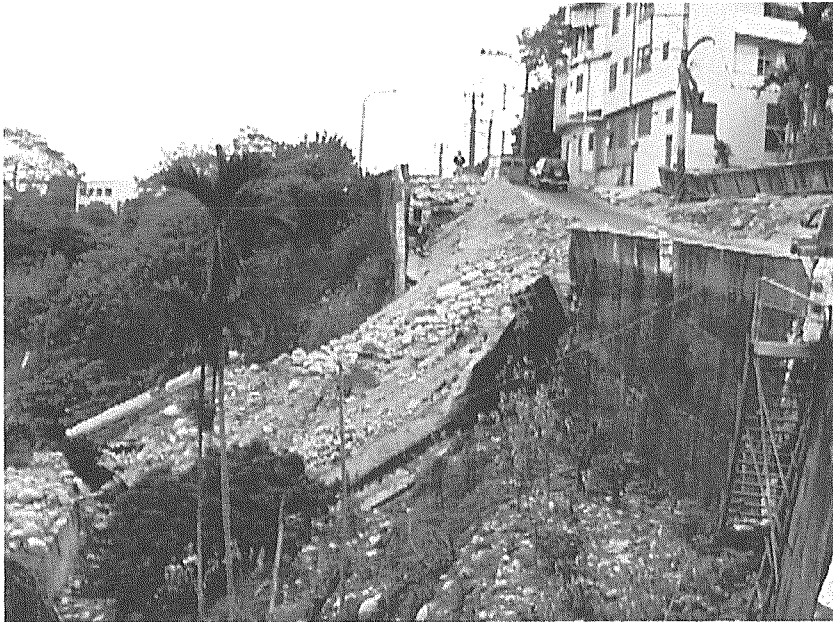
Plate 1 shows collapse of a reinforced concrete (RC) retaining wall with a height of about 7 m at site 1 in Fig. 1, located along a road which leads to the southern side of the Chang-Geng Bridge. Interestingly, adjacent RC walls with similar dimensions survived the earthquake. Since uneven vertical displacement of about 30 cm, possibly caused along a surface fault, was observed in a field located in the neighborhood of the damaged wall, it was estimated that the damage to the wall was caused by this uneven displacement. It should be noted that extensive damage was also observed to houses which were located along the extended line of the boundary of the uneven displacement.

Plate 1. Collapse of RC retaining wall due to permanent ground displacement along fault (along a road on the south of Chang-Geng Bridge; site 1 in Fig. 1)

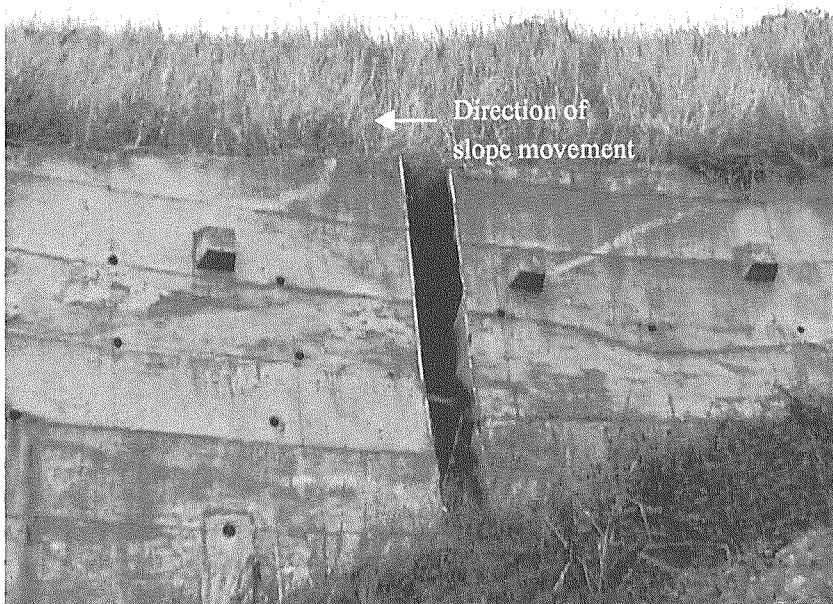
Plate 2 shows damage to an anchored RC retaining wall with a height of about 4 m at site 2 in Fig. 1, located near the top of an embankment for possible housing lots along District Road No. 129. It suffered an opening of about 30 cm at one of the construction joints. Since continuous cracking in the ground surface and other retaining walls located in the lower part of the embankment was observed, a large-scale slope movement, which was induced by the earthquake, was estimated to have caused the damage to the wall shown in Plate 2.

Plate 2. Opening at construction joint of anchored RC retaining wall due to large-scale slope movement (at an embankment along District Road No. 129; site 2 in Fig. 1)

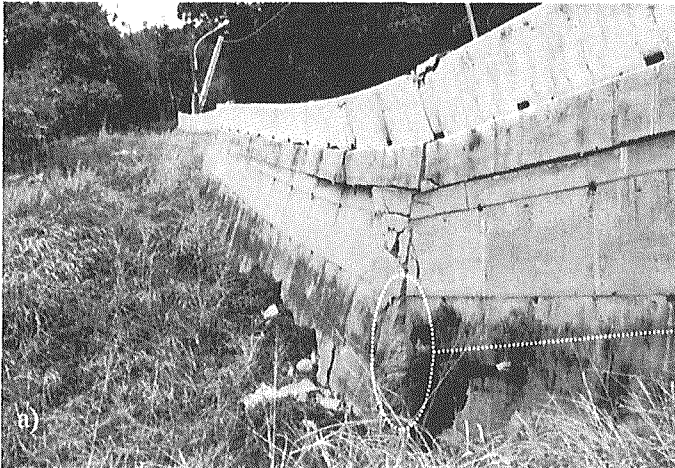
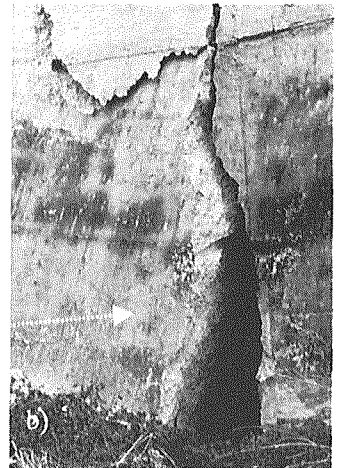
Plates 3a and 3b show damage to a gravity-type concrete retaining wall at site 3 in Fig. 1,

located along District Road No. 129. It had been constructed on a small valley, and its height was about 4 m at its tallest section. The whole wall suffered outward permanent displacement and settlement. In particular, the tallest section suffered the largest settlement, which caused a large cracking at the lower part of this section. At the time of the investigation, free ground water level could be observed in the crack (Plate 3b). Therefore, it was estimated that the bearing capacity of subsoils, possibly under saturated condition, was not enough to support the load from the wall during the earthquake. It seems that, although a transversal drainage pipe to evacuate surface water on the road through a side ditch had been installed in the adjacent backfill at a higher elevation, it may not have been effective in lowering the ground water level.

Plate 3. Damage to gravity type retaining wall due to failure of subsoil layers
(along District Road No. 129; site 3 in Fig.1)

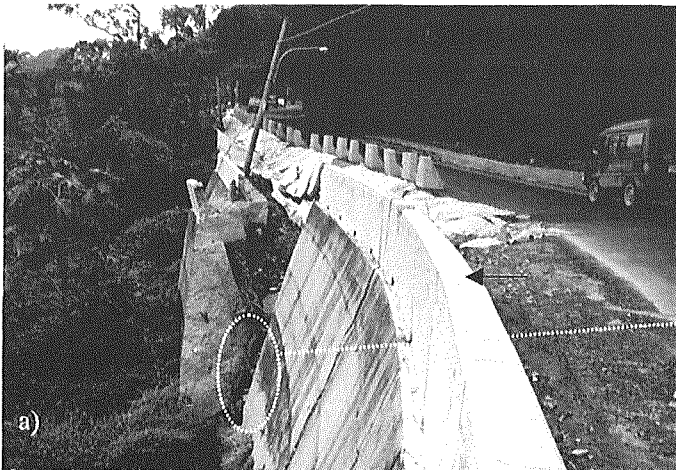
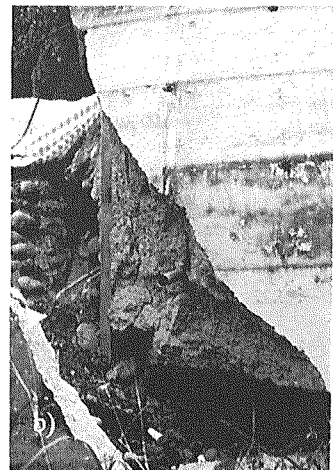
Plates 4a and 4b show damage to another gravity-type concrete retaining wall at site 4 in Fig. 1, located along District Road No. 129. It had been constructed on a small valley, and its height was about 4 m. The concrete wall partly suffered outward displacement, while an old masonry wall that had been located at the back of the gravity type wall was found to be free from any damage. Since the amount of the backfill between the concrete wall and the old masonry wall was limited, the earth pressure exerted on the concrete wall from the backfill may not have been very large during the earthquake. It was, therefore, estimated that the damage to this concrete wall was due to excessive inertia force of the wall and/or loss of bearing capacity in the subsoils. In relation to this, it should be noted that undamaged portion of the concrete wall had been supported by an H-shaped steel rod (Plate 4b), which may have resulted into such a good performance.

Plate 4. Damage to gravity type retaining wall due to excessive inertia force and/or loss of bearing capacity (along District Road No.129; site 4 in Fig.1)

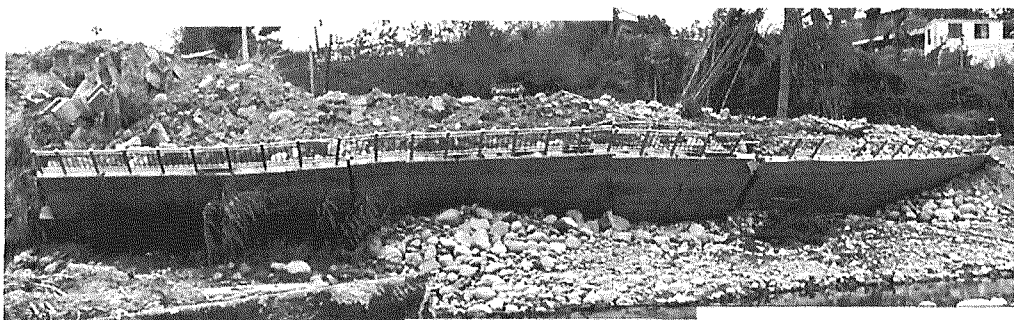
Plate 5 shows extensive tilting of a RC retaining wall with a height of about 5 m at site 5 in Fig. 1, located at the downstream side of Shih-Wui Bridge. Since the backfill was found to be under relatively loose state at the time of the investigation, an excessive seismic earth pressure due to insufficient compaction of the backfill was estimated to have caused the damage. Loss of bearing capacity in the subsoils may have caused the damage as well. Further, it is reported that thrust up of the south bank of Shar-Lian Creek and the instability of the river bank caused collapse of Shih-Wui Bridge (SGRDF, 1999). This may also have caused the damage to the retaining wall although no evidence of permanent ground displacement could be observed at the time of the investigation.

Plate 5. Large tilting of RC retaining wall (near Shih-Wui Bridge; site 5 in Fig.1)

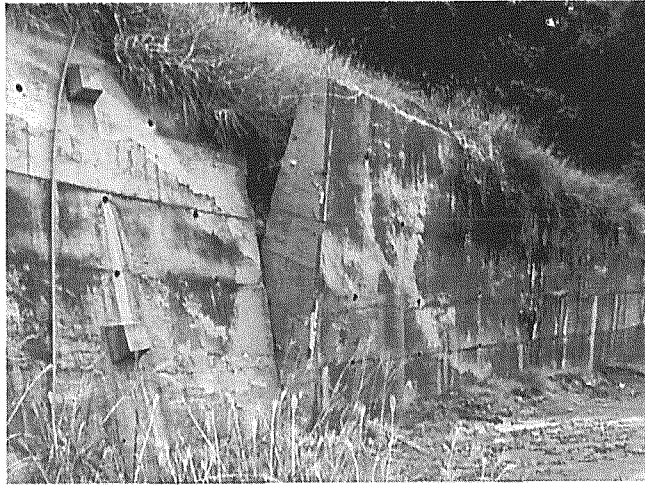
Regarding different performances of different types of retaining walls, a comparison between that of a gravity-type wall and that of an anchored wall could be made at site 2 in Fig. 1. As shown in Plate 6, the gravity-type wall tilted largely, while the anchored wall suffered no damage. It should be noted that these walls were located outside of the area where the aforementioned large-scale slope movement took place. It was, therefore, estimated that the damage to the gravity wall was due to excessive inertia force of the wall and/or loss of bearing capacity in the subsoils, similarly to the case with the gravity wall shown in Plate 4. On the other hand, the anchored wall behaved well, demonstrating the effectiveness of anchoring against seismic loads.

Plate 6. Tilting of gravity type retaining wall neighboring undamaged anchored retaining wall
(at an embankment along District Road No. 129; site 2 in Fig. 1)

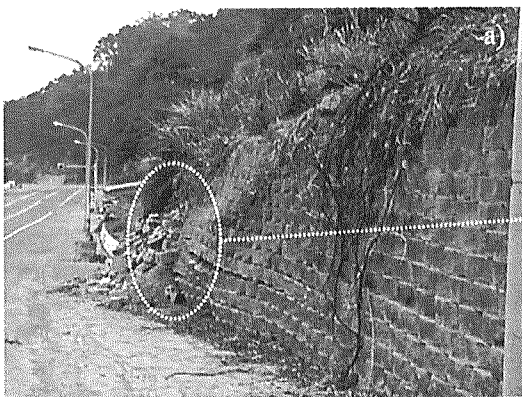
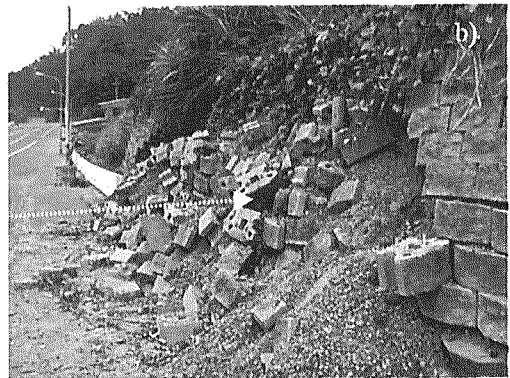
Plates 7a and 7b show partial collapse of a reinforced-soil retaining wall located along District Road No. 129 at site 2 in Fig. 1, which was located outside of the area where the large-scale slope movement as described in the previous chapter took place (Plate 2). The total height of the wall was about 3 m. Adjacent to this wall, another reinforced-soil retaining wall having a total height of about 3.5 m also partly collapsed in a similar manner. As schematically shown in Fig. 2, reinforcements were placed in the backfill at a vertical spacing of 80 cm, and it was estimated that the stiffness of the facing and the vertical spacing of reinforcements were not sufficient to resist against seismic earth pressures. The estimated failure mechanism is as follows (Fig. 2):

It should be noted that differential vertical settlement of about 30 cm was observed at the surface of backfill, located at a horizontal distance of about 6 m from the facing. Note also that, at the adjacent wall which suffered partial collapse as described above, cracking with an opening of about 30 cm was observed in the surface of backfill at a horizontal distance of about 5.4 m from the facing. It was, therefore, estimated that overall instability, inducing larger failure zone in the backfill with forming a failure plane, may have been triggered by the complete failure of facing as described in 3). Since the length of the reinforcements is reported to be 2.7 to 3.0m (Huang, 2000), the location of the possible failure plane may be in the unreinforced zone as shown in Fig. 2.

Plate 7. Damage to reinforced-soil retaining wall using keystones as a facing
(along District Road No. 129; site 2 in Fig. 1)

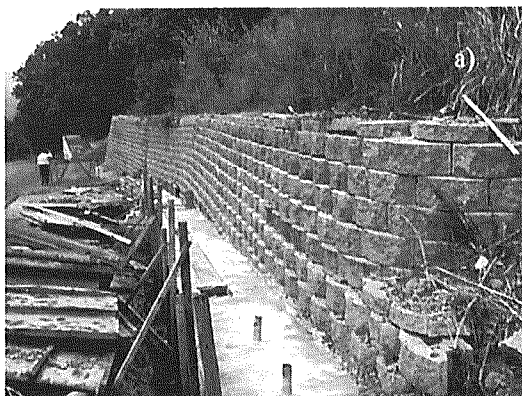
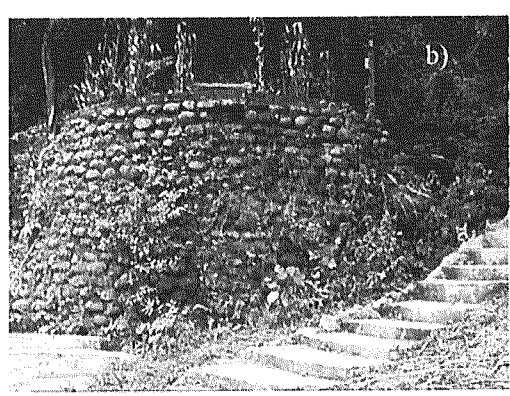
Plates 8a and 8b show, respectively, an undamaged reinforced-soil retaining wall with a height of about 3 m and a masonry wall with a height of about 2.5 m, which were located at site 6 in Fig. 1 along District Road No.129 near the damaged reinforced-soil retaining walls as mentioned above. Since the undamaged reinforced soil retaining wall had reinforcements at a vertical spacing of 60 cm, it was estimated that the different performances of these reinforced-soil retaining walls shown in Plates 7 and 8 are due mainly to different vertical spacings of reinforcements. If these walls were under otherwise similar conditions, the critical value of the vertical spacing to induce a marginal condition of failure was possibly between 60 and 80 cm. It can be also inferred that the seismic stability of these reinforced-soil retaining walls was almost comparable to that of the masonry wall shown in Plate 8b, which suffered only minor cracking.

Plate 8. Undamaged reinforced-soil retaining wall and adjacent masonry wall
(along District Road No. 129; site 6 in Fig. 1)

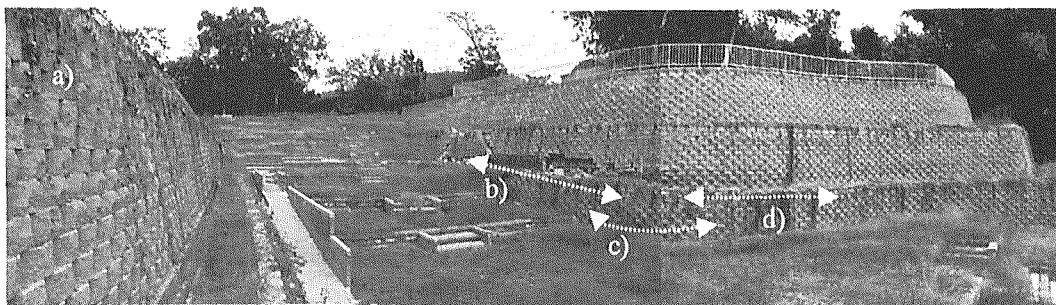
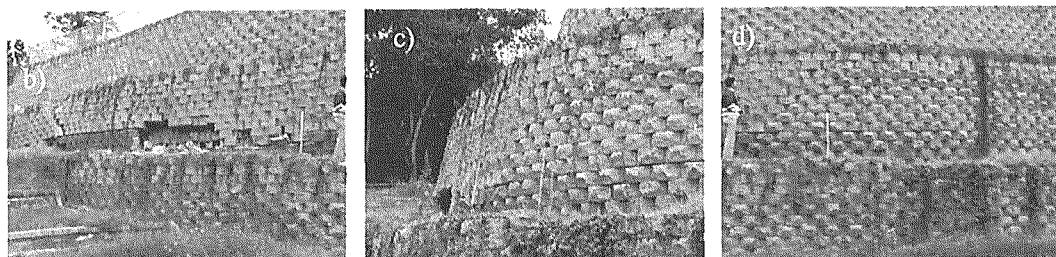
Plates 9a through 9d show reinforced-soil retaining walls at Chang-Chiu Park in Chung-Hsin New Village, site 7 in Fig. 1. Each section consisted of three facings with an individual height of about 3 m. At one section, part of the middle facing collapsed (Plate 9b). At an adjoining section, the middle facing suffered residual deformation due to bulging at its lower part (Plate 9c). Adjacent to this, there existed an undamaged section (Plate 9d). The conditions of reinforcements at these sections were as follows:

- 1) At the back of the collapsed facing (Plate 9b), no reinforcement could be found. On the other hand, H-shaped steel rods were found in the backfill, which were estimated to have been used as temporary supports during construction of the facing.

- 2) At the back of the bulged facing (Plate 9c), reinforcements were placed at a height of 120 cm from the bottom of the wall; i.e., the vertical spacing of reinforcements was 120 cm. One of the reinforcement was estimated not to have been connected to keystones, where the extent of facing deformation was relatively large. On the other hand, the adjoining reinforcement was found to have been connected to keystones, where the extent of the facing deformation was relatively small. In addition, at the latter section, another reinforcement was found to have been placed partly at a height of 200 cm from the bottom of the wall and was connected to keystones.

- 3) At the back of the undamaged facing (Plate 9d), reinforcements were placed at a height of 40, 120, and 200 cm from the bottom of the wall and were all connected to keystones; i.e., the vertical spacing of reinforcements was 80 cm.

Note also that at another section which was located opposite to the collapsed facing, reinforcements were placed with a vertical spacing of 60 cm. It was, therefore, inferred that the extent of damage was related with the amount of the vertical spacing of reinforcements, similarly to the cases shown in Plates 7 and 8a.

Plate 9. Different performances of reinforced-soil retaining walls
 (at Chang-Chiun Park in Chung-Hsin New Village; site 7 in Fig. 1)

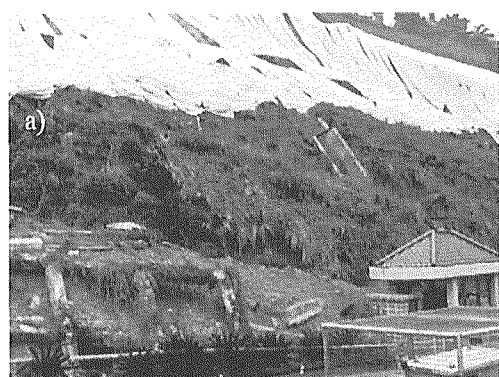
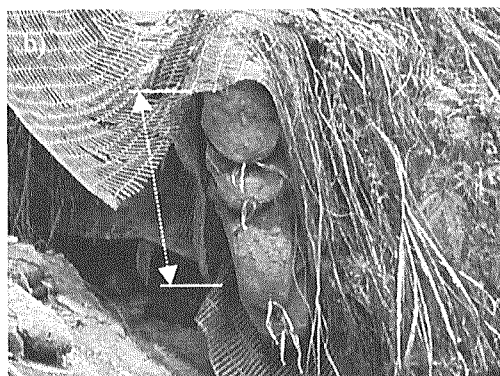
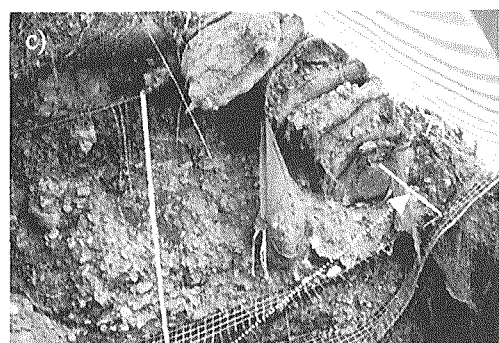
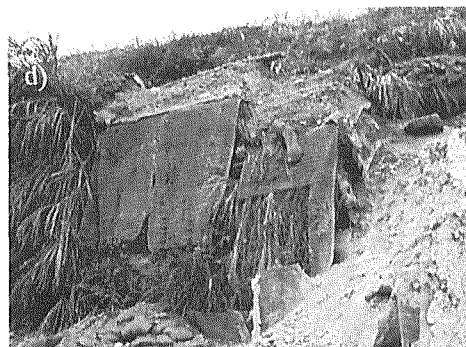
Plates 10a through 10d show damage to a reinforced-soil embankment at National Chi-Nan University. It consisted of four 10m-high reinforced-soil slopes with three 2m-wide berms (Huang, 2000). As reinforcements, geogrids were placed at a vertical spacing of about 80 to 100 cm. To form the surface of slope, about ten sand bags were stacked and wrapped in the reinforcements as schematically shown in Fig. 3.

At a section that suffered extensive failure (Plate 10a), the anchoring length of wrapping reinforcements was partially smaller than 100 cm (Plate 10b). On the other hand, at another section that suffered limited amount of deformation, being located adjacent to the undamaged one, the anchoring length of all the wrapping reinforcements that were investigated by the authors was larger than 100 cm (Plate 10c).

Plate 10. Damage to wrapped-around type reinforced-soil embankment
 (at National Chi-Nan University; site 8 in Fig. 1)
