## Deformation Build Up in Soils and Damage to Viaduct Foundations

### 1. INTRODUCTION

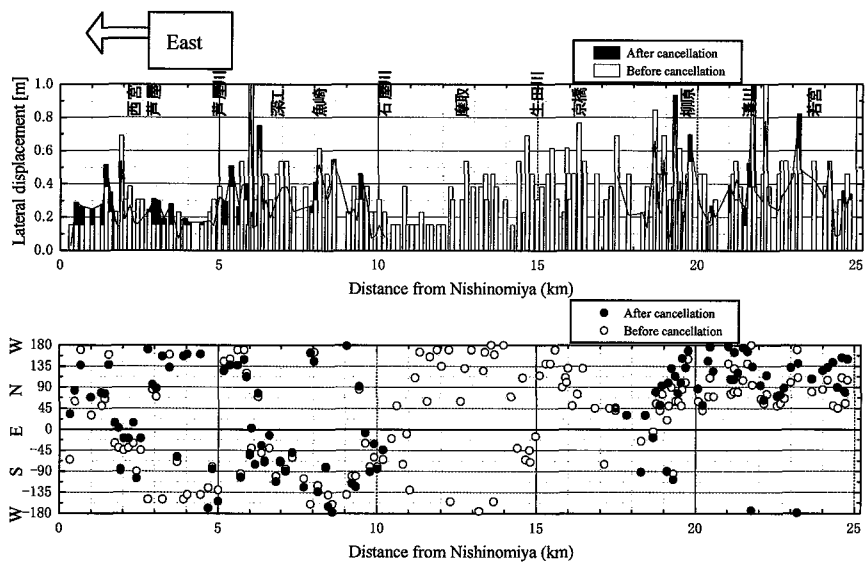
Figure 1 Displacements remaining on ground surfaces

Except for Zone 1, a clear general ground movement in the north direction is recognized (**Figure 1**).

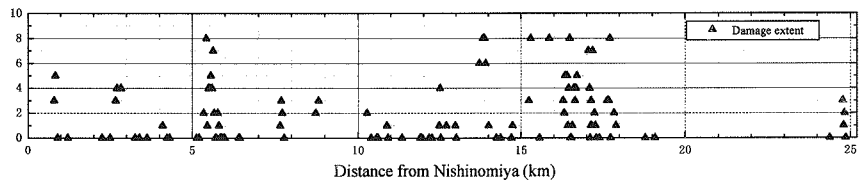
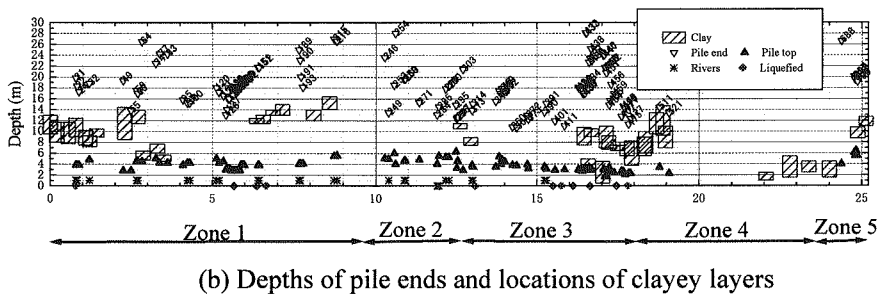
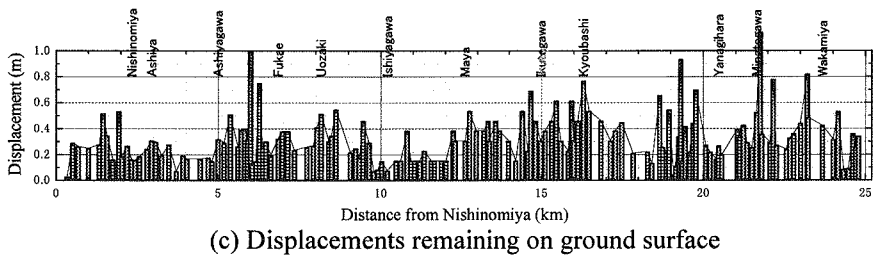
**Figure 5** Damage to piles and displacements remaining on ground surface

The Route 3 of the Hanshin expressway, a long viaduct with the entire extent of about 25 km through Kobe, has total 718 piers, and 84% of the piers are pile-supported. Among them, 91% are bored cast-in-place piles. Three plots in **Figure 3** show, from the top respectively, types of foundations, numbers of grouped piles and pile lengths with respect to the distance along Route 3. The lengths of the piles vary in accordance with the thickness of the alluvial soil deposit (**Figure 4**). Borehole pictures of cracks on the piles were taken at 122 piers. The piers investigated are shown in **Figure 2**. Average crack openings per pier were then categorized into 10 ranks (**Figure 5a**), and were compared with the embedment depths of the piles (**Figure 5b**) and the absolute values of ground surface displacements as well (**Figure 5c**). In **Figure 5b**, hatched bars show the locations of the clayey layers that exhibit some flexible natures. The extent of damage indicated with the crack openings seems to be consistent with the spatial distribution of the displacements remaining on the ground surfaces. This tendency becomes

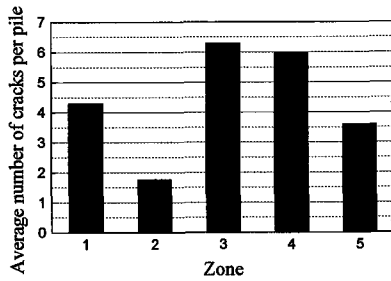
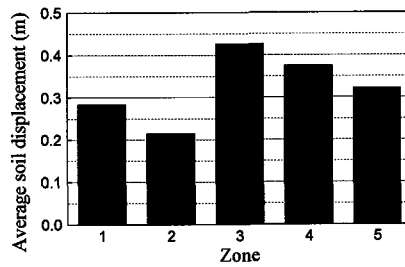
Figure 6 Soil deformations and damage to piles in different zones

(a) Average number of cracks per pile

(b) Average displacement remaining on ground surface

clearer when the average numbers of cracks per pier were summarized for the different zones (1-5) of the Route 3 (**Figure 6a**), and compared with the average surface ground displacements (**Figure 6b**).

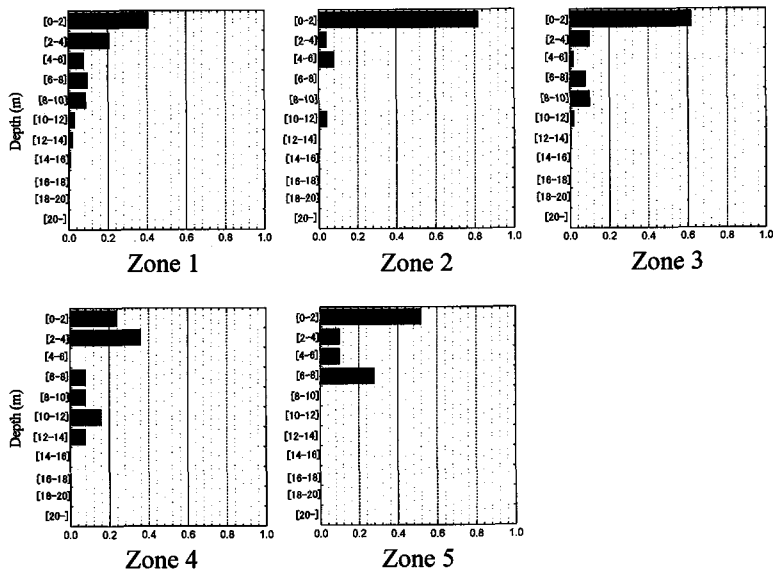
Figure 7 Crack distribution along depth

There are two primary causes of cracking of piles beneath a viaduct pier; the dynamic response of the viaduct and the free-field ground motion that forcibly deforms the piles. The former is liable to cause the upper part of piles to be cracked, whereas the latter is responsible for the cracking of piles where the soil strain is the most pronounced. Crack distributions with respect to depth were summarized for the five zones of the Route 3 (**Figure 7**). In all these zones, piles were liable to be cracked at their top ends. In Zones 3-5, however, the second densest clusters of cracks are found at some deeper locations where clayey layers appear most frequently. This fact suggests that these clayey layers might have amplified the ground motion to a considerable extent, and the displacements remaining on the ground surface retain the displacements built up in these layers.

This paper described the distributions of the remaining soil displacements along a viaduct, the Route 3 of the Hanshin expressway, and discussed the correlation between the soil deformations and the spatial variation of damage to the pile foundations of the viaduct's piers. The entire extent of the Route 3 was divided into 5 zones based on a rough categorization of subsoil conditions. The extent of damage to pile foundations seems to be consistent with the spatial distribution of displacements remaining on the ground surfaces. This tendency becomes clearer when the average numbers of cracks per pier were summarized for the different zones. There are two primary causes of cracking of piles beneath a viaduct pier; the dynamic response of the viaduct and the free-field ground motion that forcibly deforms the piles. The former is liable to cause the upper part of piles to be cracked, whereas the latter is responsible for the cracking of piles where the soil strain is the most pronounced. Crack distributions with respect to depth were summarized for the five zones of the Route 3. In all these zones, piles were liable to be cracked at their top ends. In Sections 3-5, however, the second densest clusters of cracks are found at some deeper locations where clayey layers appear most frequently.
