## **Buildup of Soil Deformations and Damage to Subway Tunnels \***

## 2. DAMAGE TO YAMATE LINE

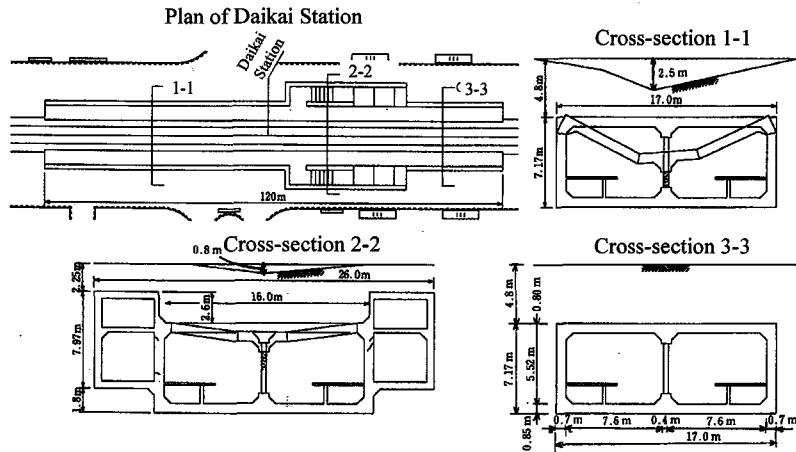
Both the damaged and not damaged sections must be equally discussed in the course of this study in order for the damage to be objectively viewed. From this viewpoint, the Yamate line of the Kobe City Rapid Transit Bureau, with a thorough investigation report available, will be suited for this purpose. This line did not suffer such a crushing damage as that to Daikai station (Figures 1 and 2).

Figure 1. Damage to Daikai subway station of the Kobe Rapid Transit line

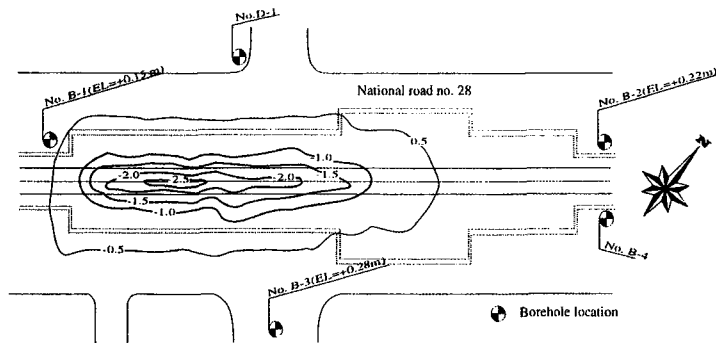
Figure 2. Contours of ground subsidence at Daikai station

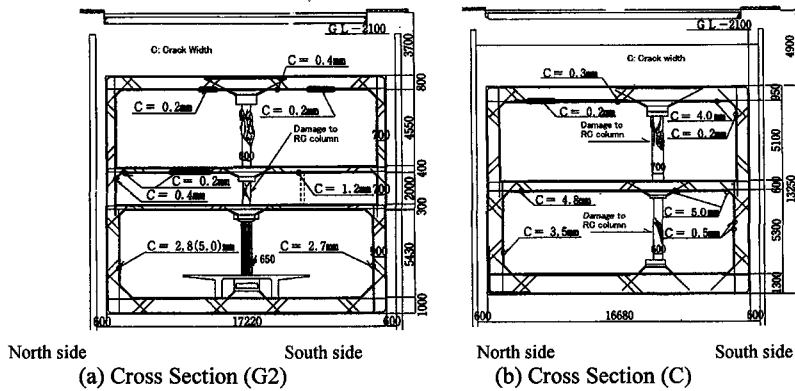
Kamisawa station suffered the most serious damage on this line. **Figure 4(a)** shows a cross-section (G2) of this station, a three-story RC box with a platform located on the bottom. The roofs of the first and the second basements were supported by RC columns, whereas steel pipes sustained the roof of the bottom basement. The upper parts of the RC columns in the first basement were cracked on a slant causing concrete fragments to have come off, and eventually, exposed reinforcing bars were outwardly buckled. These shear cracks were all slanting down to the south causing the ceiling to subside a couple of centimeters. Shear cracks were also found on the columns of the second basement, but no serious deformation was found on the steel columns. **Figure 4(b)** shows the cross-section (C), 100 m west of the G2 cross-section, a two-level RC box divided out of the symmetric proportion with RC columns into sea-side (south) and mountain-side (north) ducts for the double tracks. These RC columns were also cracked seriously, and major cracks were mostly slanting down to the south, resulting in the subsidence of the ground surface exceeding 1 cm.

Figure 4. Cross sections of Kamisawa station

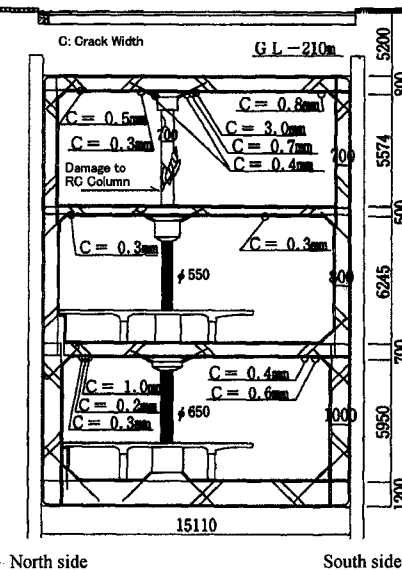
Figure 5 Cross section (I3) of Sannomiya station

Figure 5 shows a cross-section (I3) at Sannomiya station, a three-level box with the two-level platforms located on the second and the bottom basements. RC columns supporting the roof of the first basement were cracked, but the major cracks were on the slant down to the north, differing from those at Kamisawa and Shin-Nagata stations.

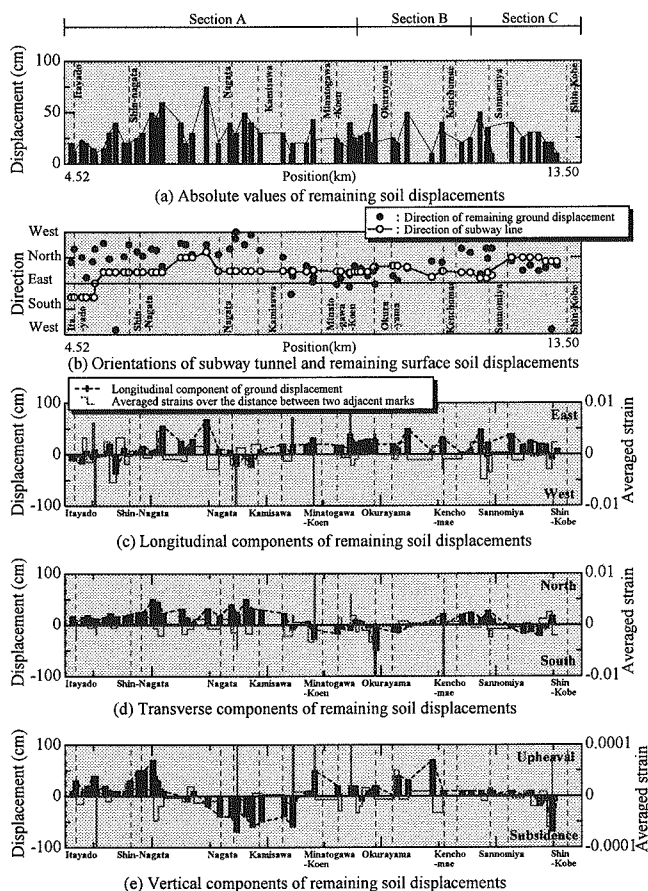
readings on 1/500 scale maps included, may cause some 0.2 to 0.25 m errors in terms of standard deviation. **Figure 6** describes the distributions of the remaining soil displacement along the subway. It is noted here that solid circles in **Figure 6(b)** indicate a clear general northward movement of the ground, whereas the subway line through the long-spread city inevitably runs from north-east to south-west. Therefore, the general soil deformation can be resolved into two orthogonal components with respect to the subway line, the components in the north-east longitudinal and north-west transverse directions (**Figures 6(c)** and **6(d)**). **Figure 6(e)** shows vertical components of the ground surface displacements. The section between Itayado and Shin-Nagata seems to have heaved up by about 20–30 cm, whereas the Nagata—Kamisawa section has subsided to a similar extent. No clear general upheaval nor subsidence was seen in the section for the two-level tracks extending from Kenchomae to Sannomiya, and a sudden subsidence reaching 70 cm was found near Shin-Kobe station.

**Figure 6** Distribution of remaining soil displacements along Yamanote subway line

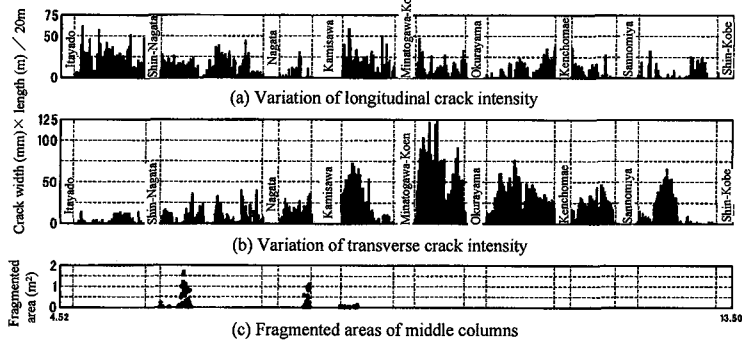
Transverse cracks, which were found over the entire extent of the subway line, are considered to have a close correlation with longitudinal strains induced within a tunnel. It is, however, noted that the cracks were mostly found on the roofs as shown in **Figures 7 and 8**; the fact may evidence that these tunnel sections were bent up as well. As for the longitudinal cracks, relatively many cracks were found at sections where the tunnel goes through clays and/or the sections for the two-level tracks with the down-train track pulled up on the other.

**Figure 7.** Damage to Yamate line

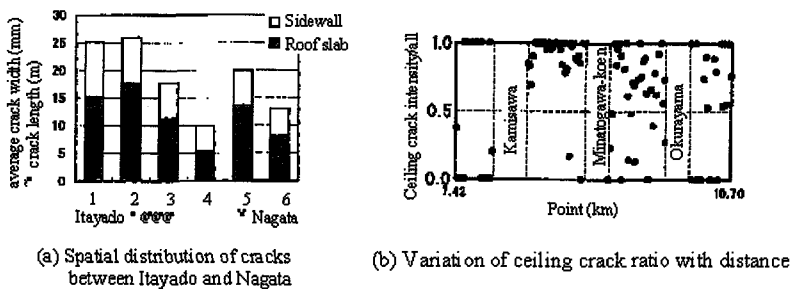
**Figure 8.** Ratio of transverse ceiling cracks to all
