Provisional Report on the Oct. 6, 2000, Western Tottori Prefecture Earthquake*

Jörgen JOHANSSON¹, Paola MAYORCA¹, Kazuo KONAGAI²,
Toshihiko KATAGIRI³ and Daisuke MARUYAMA¹

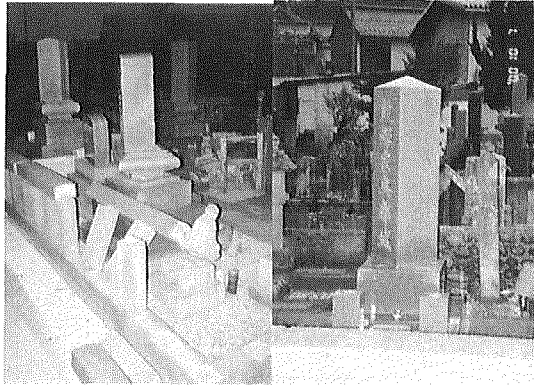
Location 1, 133°19.9'E, 35°25.1'N.

Visit to the cemeteries at the Keijuji- and Sousenji-temple (**Fig. 2**): A few gravestones were toppled. The gravestones slipped on the average about 1 cm and some 70 % of them rotated clockwise. As first estimate one can assume that to topple the gravestones an acceleration of 0.33g is necessary since the height to width ratio is 1:3. For the rotation to occur one can assume that the gravestone where slightly tilted in a vertical plane at the same time as accelerated horizontally in a direction perpendicular to the vertical plane. From the slippage observations, assuming a friction ratio of 0.5 (μ), and using the formula: $(1/2)mv^2=mg\mu\Delta$ it is possible to estimate a velocity of 30 cm/s corresponding to the average slippage, Δ of 1 cm.

Fig. 2 Cemetery of Keijuji temple

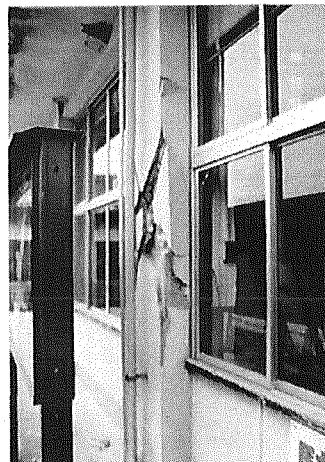
Location 3, 133°26.4'E, 35°20.6'N Mizoguchi city hall

The building is closed because of the severely damaged columns of the 1st story and large cracks in the stair between the 1st and 2nd story. Longitudinal rebars were of plain type and stirrups were widely spaced about 30 cm. A concrete block wall next to the building was also damaged probably due to too few and corroded reinforcement bars. Many of the buildings in the city had damaged roof tiles.

Fig. 3 Cracked column, Mizoguchi city hall

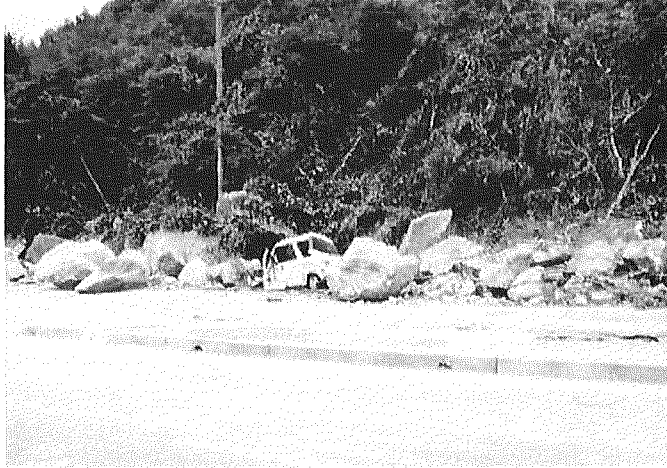
Location 4, 133°26.2'E, 35°19.9'N Rock fall at Nakaso area.

A volcanic (igneous) rock wall of Pliocene Epoch (5 - 2 million years old) was cracked up along its joints into a number of large (about 1-2 m sized) pieces. The intact part of the stone is gray with tiny fragments-inclusions of separate substances (most probably Mica). Originally exposed parts are rather brownish with small clusters of moss sticking to the surfaces. The broken rock pieces rolled down the steep slope (40 degrees). One piece bounced on the pavement of Prefecture Route rolled into a ditch breaking the concrete wall of the ditch. The front part of a car was squashed, but fortunately the driver survived.

Fig. 4 Rock fall at Nakaso area

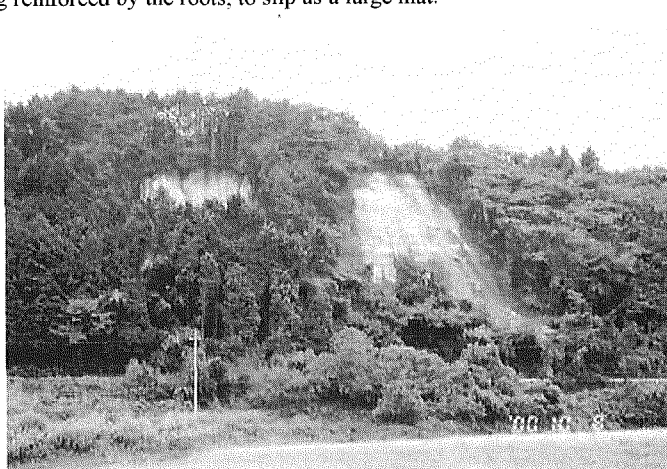
Location 5, 133°26.2'E, 35°19.1'N Slope failures at Furuichi.

There is a multi-stepwise configuration in Furuichi. The slope failure took place at the northern slope of the highest (second major) terrace. The terrace consists of weakly-cemented sediments of volcanic soils and rocks. Cedar trees growing on the slope face have a shallow root system and causing the soil mass, being reinforced by the roots, to slip as a large mat.

Fig. 5 Landslide at Furuichi

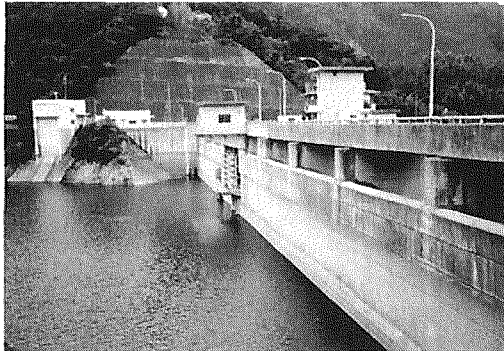
Location 9, 133°19.9'E, 35°18.0'N: Kashoo dam

The concrete gravity dam withstood exceptionally high accelerations, 530 gal at the base in the North-South direction and 2200 gal at the crest in the North-South direction. Only some minor damage was observed. The machine room of the outlet sub-gate in the center of the picture (photo taken from east abutment) had some diagonal cracks in the concrete and the windows were broken. The west abutment parking lot settled about 10 cm causing cracks in the asphalt pavement. An engineer in the control room located at the west abutment told that he could not remain standing during the shake.

Fig. 6 Kashoo dam

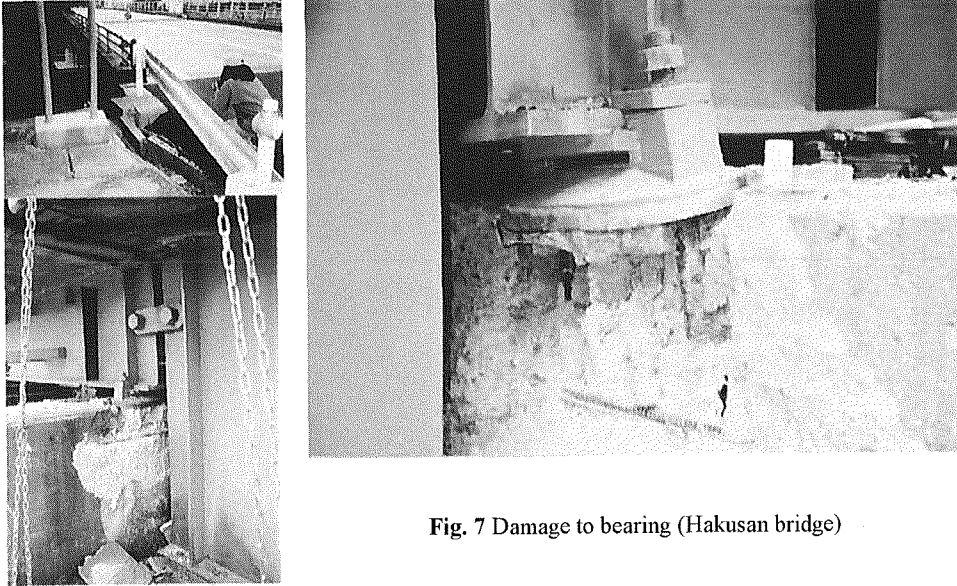
Location 10, 133°19.6'E, 35°17.9'N: Hakusan bridge.

A two-span simply supported steel girder bridge located on the west side of the Kashoo dam reservoir. Two abutments and one wall-type reinforced concrete pier in the middle support the bridge. The heights of girders differ reflecting the difference in length of the two spans. The top of the pier thus has a stepwise shape. The road, and the bridge, is slightly inclined upward to the upstream side of the Kashoo dam. The backfill of the southern end abutment subsided by about 18 cm causing the girders for the upstream span of 18m to be pushed downstream towards the middle pier. This seems to have caused the bearings of the girders at the pier to be pushed outward in such a way that the parapet between lower and upper decks of the pier cracked and large pieces of concrete spalled off, which were found remaining on the lower deck of the pier. This damage caused the bridge girders to settle a few centimeters as can be seen from the nut on the bearing bolts. The expansion joints of the bridge deck were almost closed.

Fig. 7 Damage to bearing (Hakusan bridge)

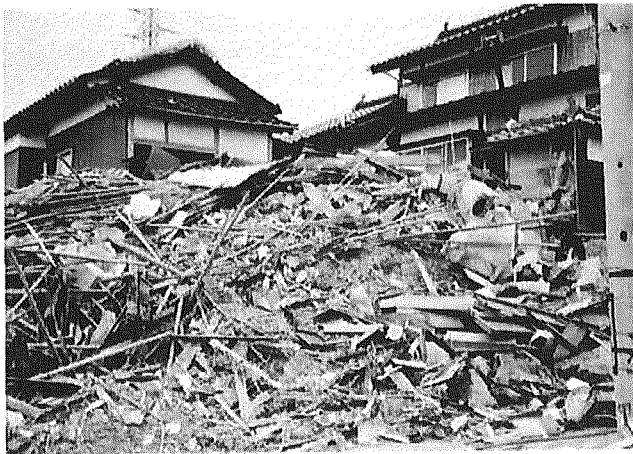
Location 11, 133°20.1'E, 35°21.1'N: Collapsed house and Cemetery at Aga, Saihaku town.

One of the few collapsed buildings. At the nearby cemetery almost all graves were destroyed. One gravestone rotated more than 135 degrees without toppling. Ground acceleration was estimated to more than 500 gal and velocity to some 90 cm/s.

Fig. 8 Flattened house at Saihaku town:

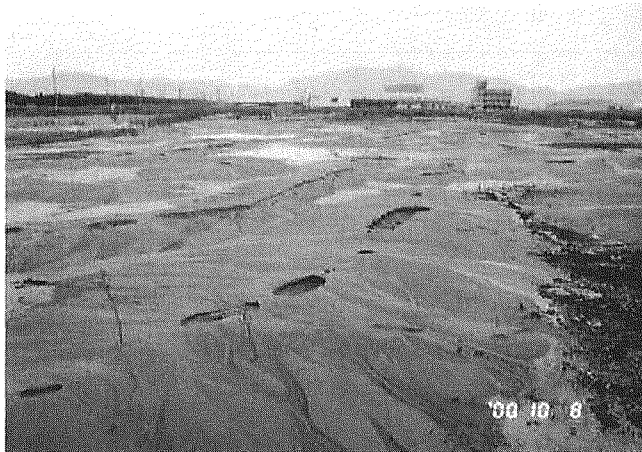
Location 12, 133°15.3'E, 35°31.4'N: Sakai Minato dream port park.

Widespread liquefaction causing lateral spreading and sand boils. Quay walls moved slightly outward causing joints between concrete pavement slabs to open up. Some cracks could be seen in the pavement. Numerous large sand boils in parking lot as seen below in the photo. Retaining walls along channel moved towards channel due to heaving failure. The soil was gray very fine silty sand.

Fig. 9 Sand boils at Sakai Minato dream port park

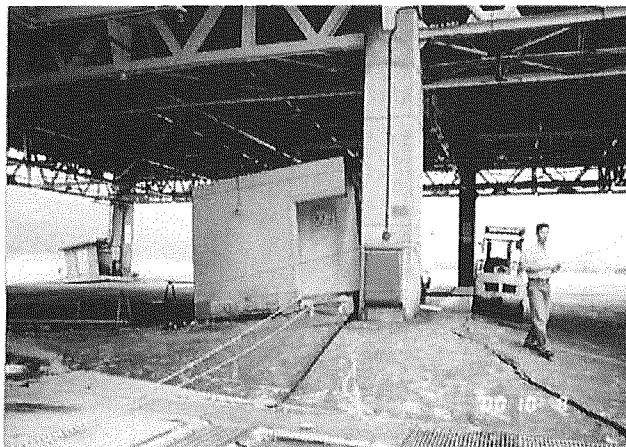
Location 13, 133°15.1'E, 35°32.6'N: Sakai Minato fisherman's wharf.

The wharf has a roof along its sides, each side being supported by a two row of concrete columns. The concrete pavement slabs settled up to 1 meter due to liquefaction, while the pile supported columns did not settle. Lateral spreading pushed quay walls towards the water and causing one of the columns to tilt. The area is closed off from use. A large amount of liquefied sand could be seen in drainage channels along the wharf. The two lower photos show the large opening of the joints between the concrete slabs caused by the lateral spreading.

Fig. 10 Sakai Minato fisherman's wharf

Settlement of subsoil caused the concrete pavement to be bulged by the pile foundation

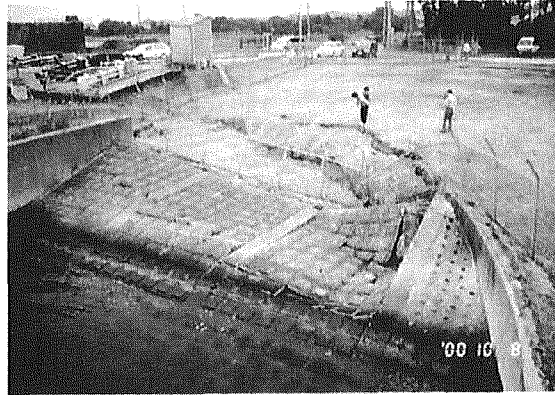
Location 14, 133°12.2'E, 35°30.8'N: Nakaura water gate.

Quay wall failure at the Nakaura water gate. A possible scenario could be: The liquefied backfill soil squeezed through openings between quay wall blocks causing settlement behind the quay wall and subsequent failure of the quay wall because the backfill was "eroded" away. Another scenario could be: Lateral spreading caused the quay walls to fail allowing the liquefied soil run out into the water, with subsequent settlement/slope failure behind the quay wall.

Fig. 11 Lateral flow at Nakaura water gate

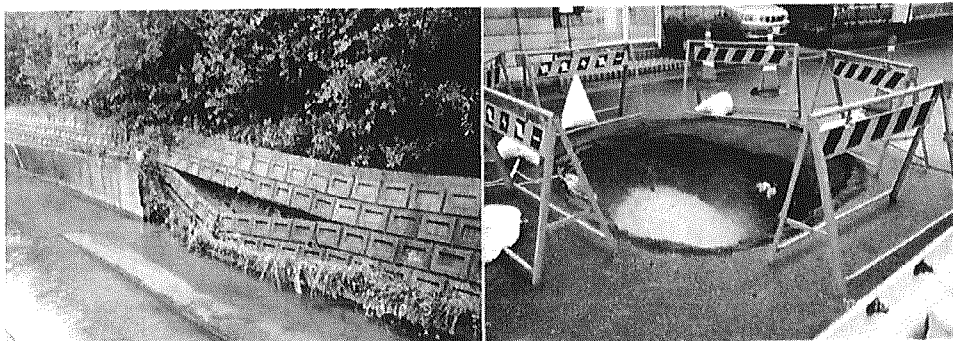
Location 15, 133°18.2'E, 35°26.2'N: Abe-Hikona residential area.

Extensive liquefaction. Pile supported apartment buildings suffered no structural damage, but post liquefaction settlement of about 25 cm of surrounding soils caused sewage pipes to break and entrance staircases to be offset. Many one or two story houses were tilted and had cracked walls. Almost all houses were assigned yellow "cards", meaning people can still remain in the house but should be careful. A green card means that the building suffered no or little damage, while a red card building has to be evacuated. The photos show how the retaining walls along a channel suffered damage due to liquefaction. A large sinkhole caused by the main shock on Friday the 6th had been repaired but the large aftershock on Sunday evening caused the same sinkhole again. The doors in the gate were offset some 20 cm. An electric pole settled almost 3 meters.

(a) Toppled retaining wall along a channel

(b) A large sinkhole

Fig. 12 Abe-Hikona residential area
