Provisional Report of the June 23, 2001 Atico Earthquake, Peru¹

Kazuo KONAGAI², Kimiro MEGURO¹, Junichi KOSEKI¹, Kenichi OHI¹, Hiroshi SATO³, Junichi KOSHIMURA², Miguel ESTRADA¹, Jorgen JOHANSSON¹, Paola MAYORCA¹, Ruben GUZMAN¹ and Tomihiro KIMURA⁴

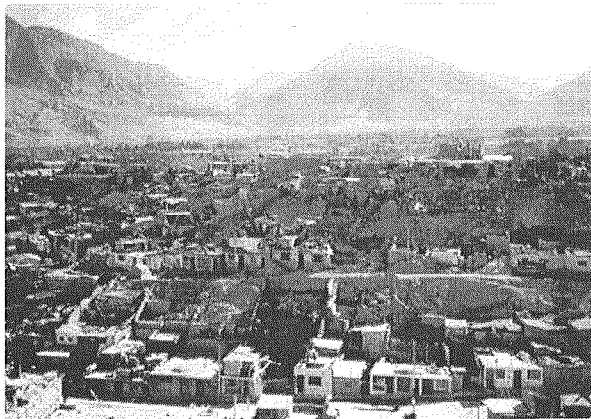
Moquegua was the hardest hit city by this earthquake. A number of adobe buildings collapsed in the downtown area and many others sustained heavy damage. A thin mountain ridge, the northeast extension of a sand rock terrace rising behind the central area of Moquegua city, dips gently towards northeast. This ridge is densely covered with adobe dwellings, and the damage to dwellings was the severest there (**Figure 4**).

Figure 4 View of the terrace next to San Francisco hill

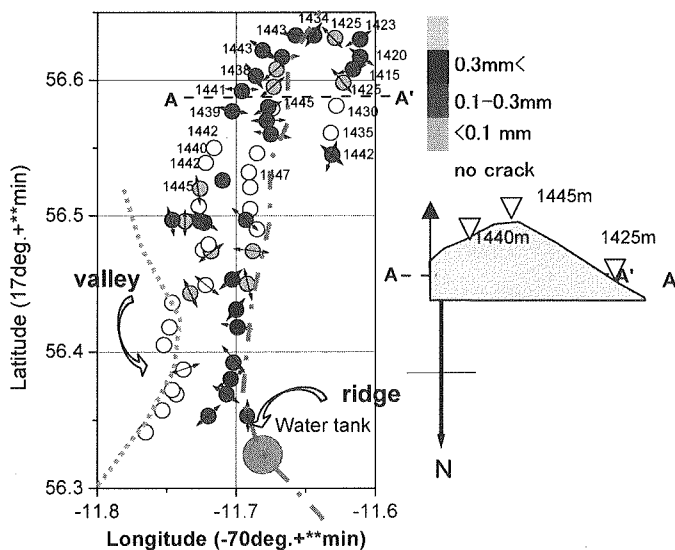
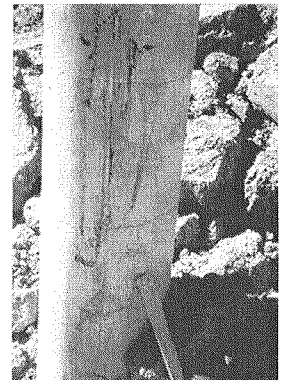
Figure 5. Distribution of cracked utility poles in San Francisco area, Moquega: Numbers put by circles show elevations of utility poles measured by using a GPS receiver.

Figure 5 shows the observed distribution of crack intensities. Arrows indicate the inferred directions of strong ground motions. In this figure, the first, second and third lines from left to right lined up with the inspected utility poles are streets along a narrow valley, along the ridge and on the other hillside, respectively. It is noted that no utility pole along the valley was cracked while those around the highest peak of the ridge near a water tank were severely cracked. This contrast suggests that some topographical effect must have been responsible for amplifying ground motions. The arrows along the ridge show that the effect was more pronounced in the transverse direction of the ridge.

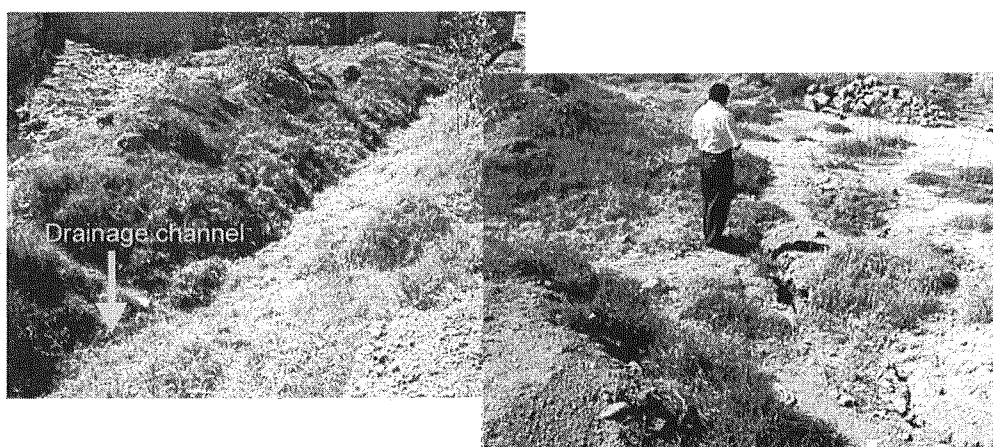
Liquefaction occurred in a lowland of Arequipa (at Lara, Socabaya district; latitude of $S16^{\circ}27.271'$, longitude of $W71^{\circ}32.148'$, and elevation of 2288 m). It induced lateral spreading of ground as typically shown in **Figure 8**. The plan of the affected area is shown in **Figure 9**. The lateral spreading caused collapse of brick walls (**Figure 10a**) and clogging of drainage channels that had an original opening width of about 50 cm (**Figure 10b**). Several cracks were also formed in almost level ground at a horizontal distance of about 25 m from the closed drainage channel (**Figure 3.3c**). It should be noted that there was no damage to concrete pipes with a diameter of about 50 cm used for the drainage channel to under-pass an unpaved road (**Figure 9**).

(a) Lateral spreading toward drainage channel

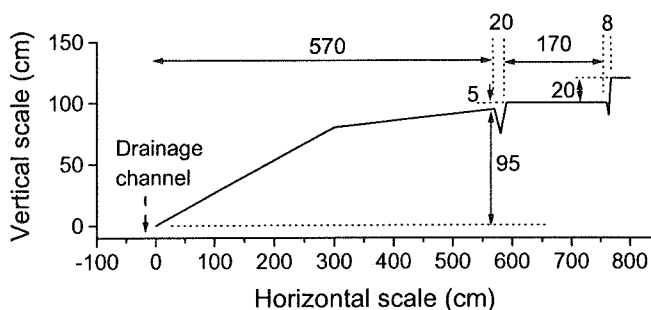
(b) Cross-section of lateral spreading at line A-A' in Figure 3.2

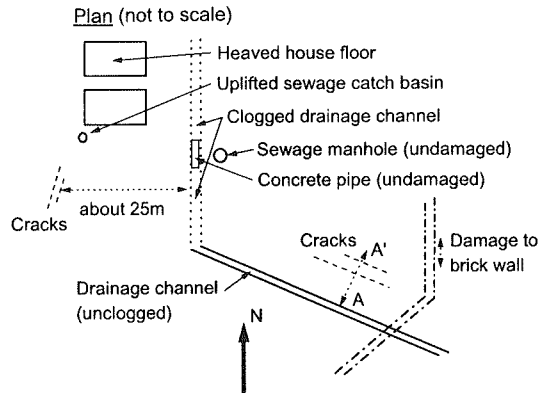
Figure 9 Plan of affected area (Lara, Socabaya District, Arequipa)

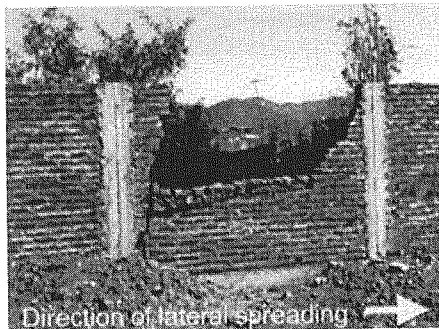
(a) Collapsed brick wall

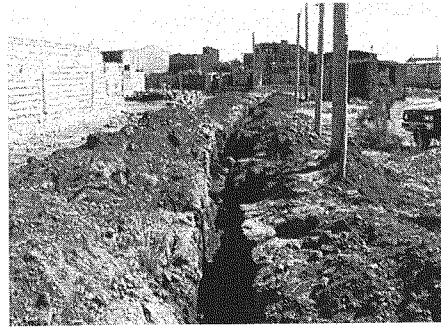
(b) Re-excavated drainage channel that was clogged with spread soil

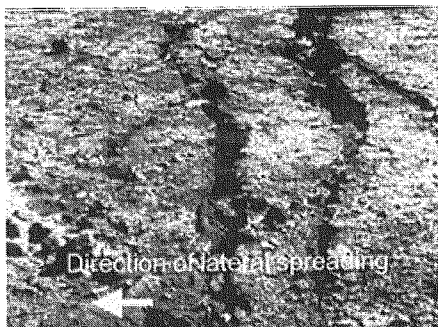
(c) Cracking in ground surface located at horizontal distance of about 25 m from drainage channel

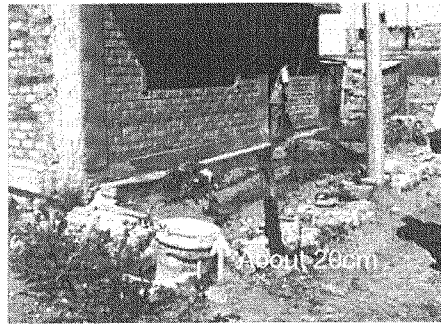
(d) Uplift of sewage catch basin

In the affected area, one house suffered uplift of sewage catch basin by about 20 cm (**Figure 10d**) and heaving of house floor due to sand boils (**Figure 10e**, next page). The boiled sand was black under wet state and white under dry state, possibly containing some volcanic or organic components, which also contained coarser particles having a maximum diameter of about 5 mm. It is reported that the heaving took place during the earthquake shaking. It was accompanied by additional ejection of water that lasted for about 1 day, which may have been affected by the re-excavation work of the closed drainage channel.

It should be noted that a sewage manhole with a diameter of about 60 cm located near the undamaged concrete pipe (**Figure 9**) did not suffer any damage or uplift. In contrast to this, the uplifted sewage catch basin (**Figure 10d**) had a diameter of about 40 cm and an original depth of about 50 cm below the ground surface, suggesting that its bottom was located above the ground water table even before the earthquake. In addition, it is reported that extensive sand boiling took place around the uplifted catch basin. This uplift damage was, therefore, estimated to have been caused by the upward forces exerted by the boiling sands, not by the loss of stability against uplift due to generation of excess pore water pressures in the liquefied soils.

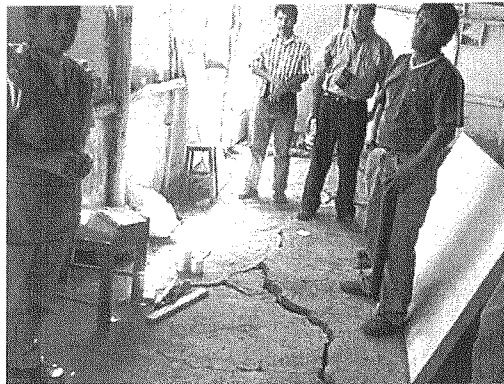
(e) Heave of house floor due to sand boil
Figure 10 Liquefaction-related damage (continued)

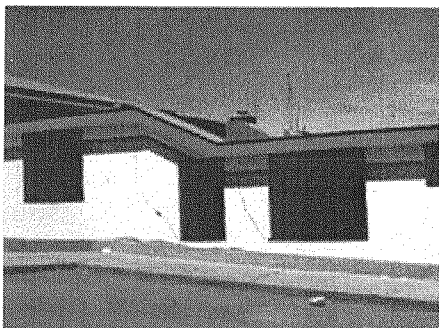
At San Antonio in Moquegua, one health center constructed on expansive soil layers suffered extensive cracks in the walls and floors (**Figure 11**). They had been formed before the earthquake, which were not worsened by the earthquake. Similar damage to adjacent houses was also observed. It is reported that the expansive soil layers were activated by water leaking from sewage pipes installed in the affected area.

(a) Cracking in side wall

In Moquegua, a plan of developing a new residential area for those who lost their houses in the severely damaged area (San Francisco) is under way. In order to avoid any damage in the newly developed area due to the expansive soils, it is required to establish procedures for detecting the existence of expansive soil layers and for evaluating their effects on buildings and underground pipes.

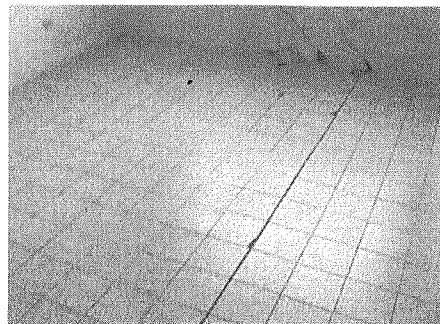
(b) Cracking in floor

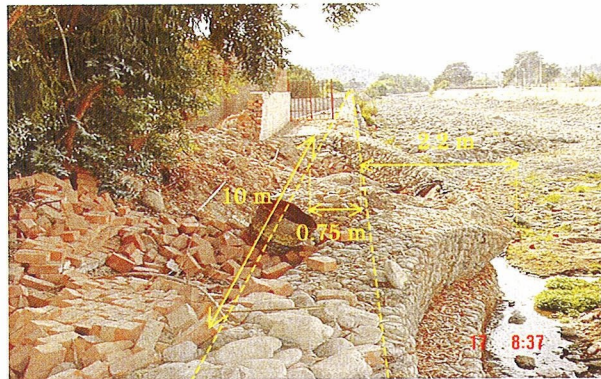
Figure 12 shows a gabion wall that even after undergoing around 44 % (2.2/5) shear strain in the vertical plane still has not ruptured. This is good example of the ductility of Mechanically Stabilized Earth structures. (Photo taken at the masonry factory in Moquegua, below the hotel El Mirador).

Figure 12. Deformed Gabion wall

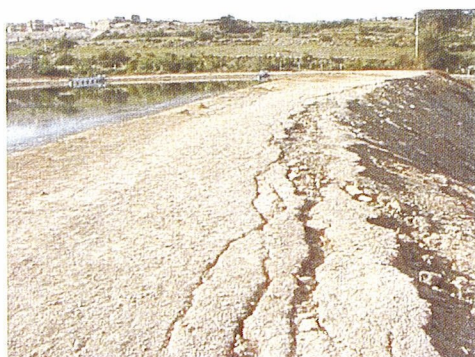
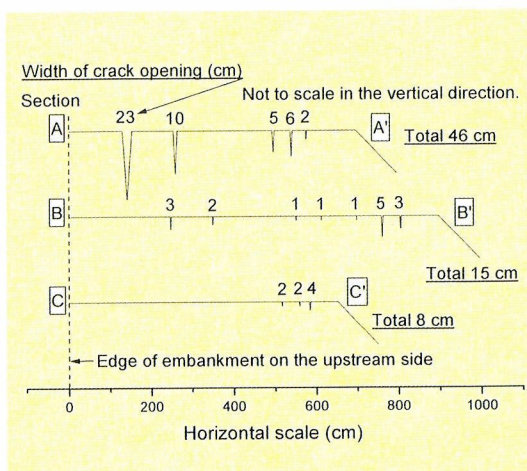
By the earthquake, the embankment on the downstream side of the lower pond suffered cracking in its crest (**Figure 14, left**). The total opening width of the cracks amounted up to 46 cm at maximum (**Figure 14, right**), and the residual settlement at the embankment shoulder was about 10 to 20 cm. In addition, the embankment between the upper and lower ponds became partly wet (**Figure 15**), suggesting a sign of piping. This location corresponds to a boundary between the original embankment constructed 40 years ago and the newer embankment re-constructed 6 years ago.

Figure 14. Longitudinal cracks

After the earthquake, in order to avoid instability of these embankments, the water level in both ponds were lowered by about 1 m. In order to cope with the current influent flow rate of 120 liters per second, which exceeds the design flow rate of 38 liters per second, the oxidation period had to be reduced down to 5 hours from the design value of 10 hours. These operations resulted into poor quality of treated water, which was used for irrigation purposes. Because the pipes to distribute the treated water were also damaged by the earthquake, it leaked into the adjacent Osmore River, affecting the quality of the river water.

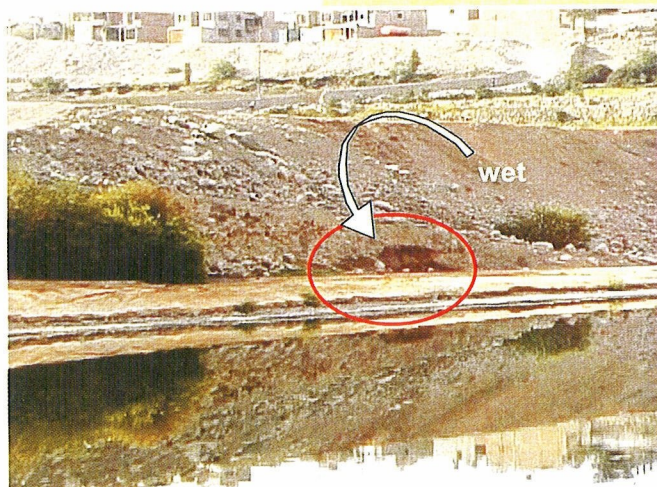
Figure 15. Embankment between the upper and lower ponds

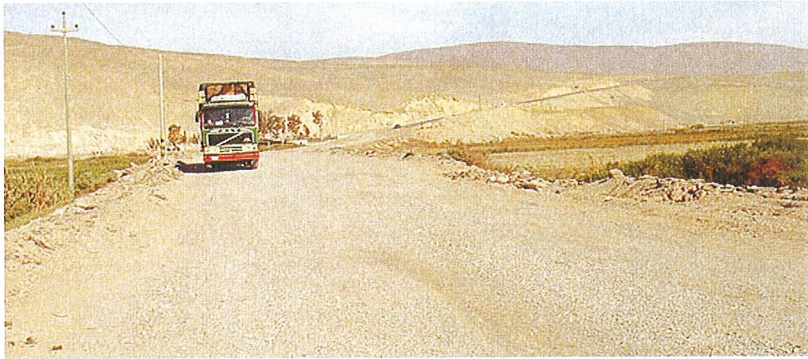
At the 1213 km of the Pan American Highway the ground shaking damaged the pavement so much that it had to be removed to allow the traffic to pass (**Figure 16**) and heavy traffic was redirected to another route. The white rail side guard along the road buckled severely due to the large soil deformations as seen on the right side of **Figure 17**. The large ground deformations may have been a combination of a basin effect and soft soil layers. The damaged part of the road is situated in an alluvial valley and similar road damage was observed in other alluvial valleys along the Pan American highway between Tacna and Moquegua.

Figure 16: Pan American Highway Pavement removed after damaged due the earthquake (looking in Southbound direction).

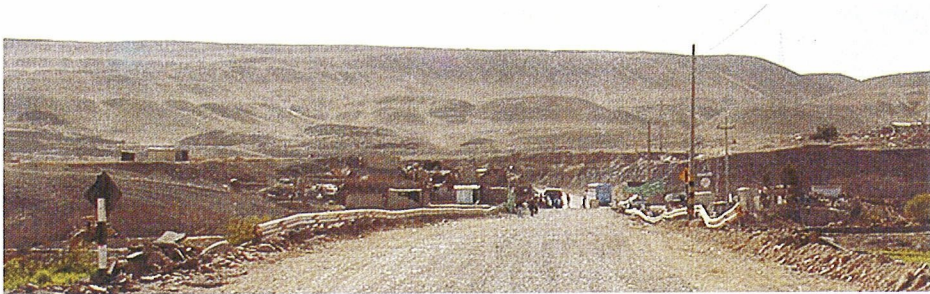
Figure 17: Buckled side guard (looking in Northbound direction).

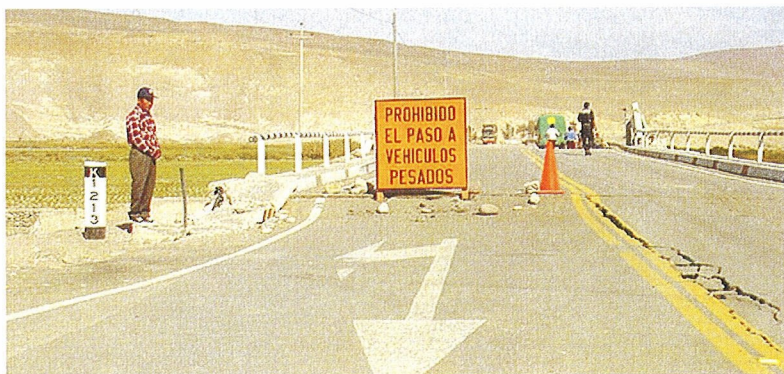
Figure 18: Settlement of bridge approach and cracking of road. Only one lane is open for traffic (looking in southbound direction).

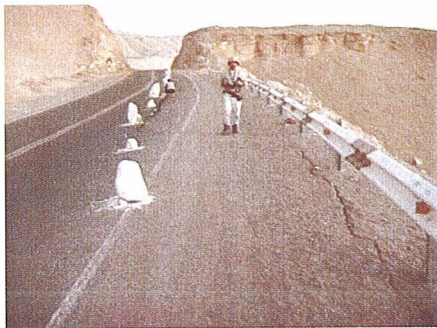
Some road embankments along the Pan American Highway between Moquegua and Tacna, and between Arequipa and Moquegua were damaged. The embankment shown in **Figure 19** had a height of about 30 m, which suffered residual settlement of about 5 cm over a length of 72 m with cracking in the pavement having a maximum width of about 30 cm.

(a) Settlement of embankment crest

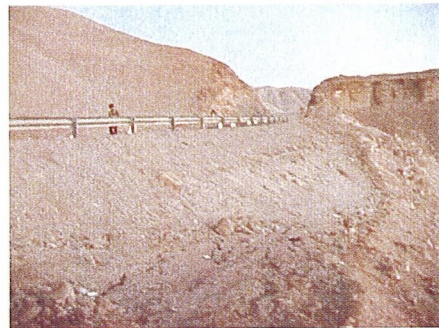
(b) Side view of embankment

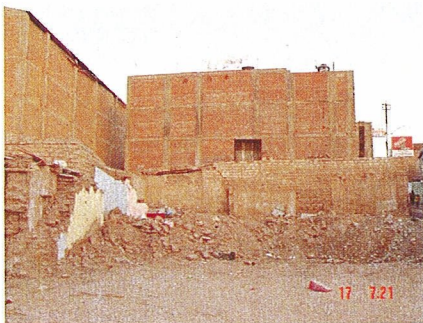
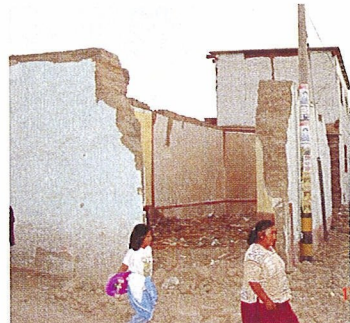
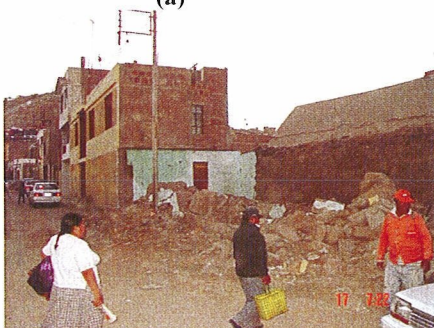
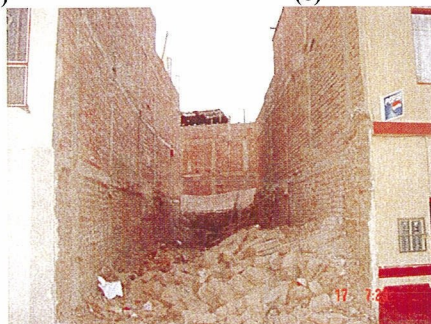
Structures of adobe performed in general badly as observed in many other earthquakes. Below follows a sketch and some figures showing collapsed adobe structures whereas neighboring reinforced masonry structures suffered on only minor damage (**Figure 20**). **Points (b) and (c)** show that a corner of an adobe structure is a weak point.

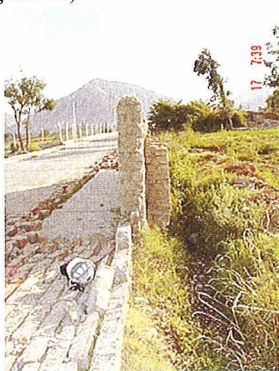
In **Figure 21** and **22** an adobe wall with side support still stands after the shake while the brick wall next to it fell over. This type of side support could be a simple but effective strengthening technique for adobe houses (**Figure 23**).

Figure 21: Standing adobe wall and fallen masonry wall.

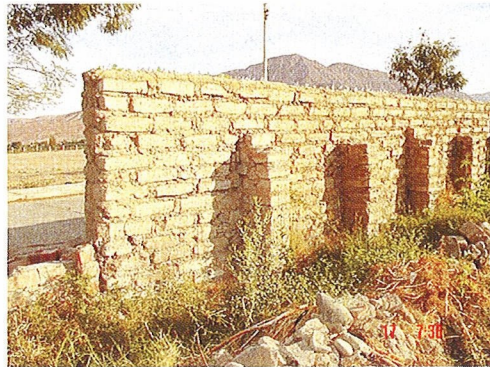
Figure 22: Close up of side support

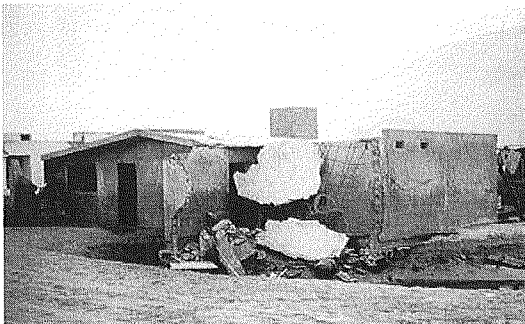
The dark colored zone in **Figure 24** is considered to have been inundated with water. The surges destroyed a great number of dwellings, hotels and restaurants there (**Figures 25** and **26**). The inundated zone was covered thin with wet fine silty soils suggesting that the water surged over the zone was stopped there for a while as is shown in **Figure 27(c)**. From a number of RC columns pushed down (**Figure 27(a)**), possible directions of tsunami surges were estimated (**Figure 27 (b)**).

Figure 25. Destroyed dwellings by tsunami

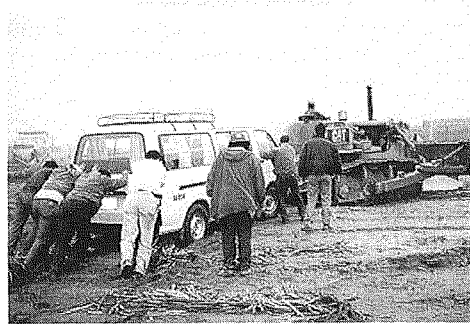
Figure 26. A car caught in soft silty soils

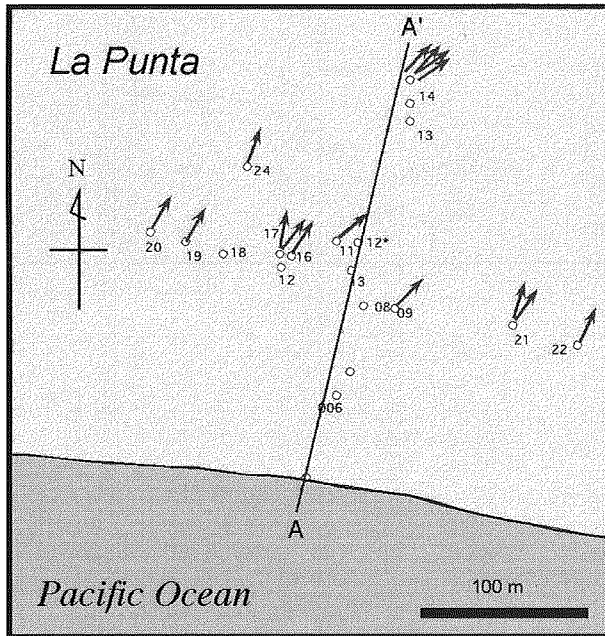
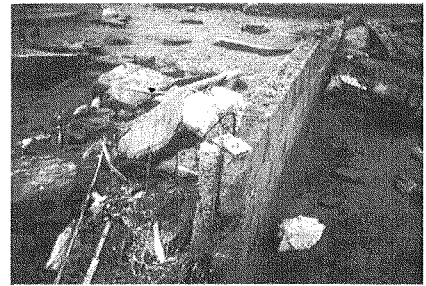
↑ (a) reinforcing bars bent by tsunami

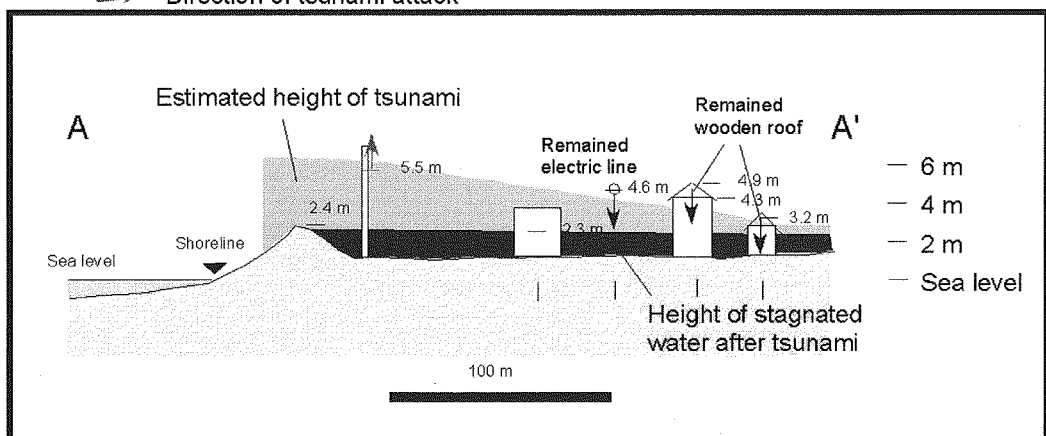
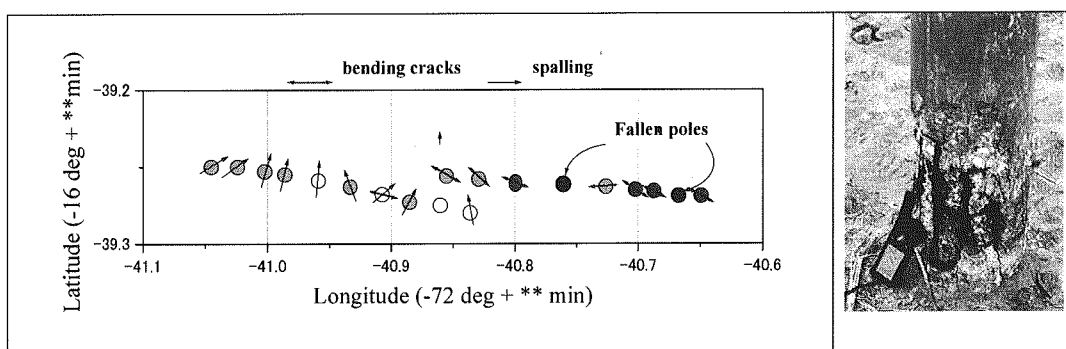
Direction of the surge was also estimated from spalled utility poles (**Figure 28**). Two lines of utility poles along the coast were examined. Most poles on the front were still standing almost upright while those about 100m inland were more or less tilted because their foot soils were scoured by the surge. Probably for this reason, spalled poles were mostly found on the front (one-head arrows). Lateral hair cracks were found on some poles, which seemingly suggest that the poles have experienced lateral shake before the area was inundated. The two-heads arrows show inferred directions of strong ground motion, which seem to have been intense in about EW direction.

Figure 28. Spalled and cracked utility poles
