## PROVISIONAL REPORT OF THE DECEMBER 26, 2003 BAM EARTHQUAKE, IRAN

**ABSTRACT:** The Bam earthquake of December 26, 2003 (Mw6.5) occurred around the city of Bam in the southeast of Iran. Since the earthquake happened early in the morning at 01:56:56 (GMT, 05:26:26 local time), most of the reported victims of 43,100 were killed in their dwellings. A joint team covering both social and engineering aspects of this killer earthquake was organized among the Japan Association for Earthquake Engineering, Japan Society of Civil Engineers (JSCE) and the Ministry of Education, Culture, Sports, Science and Technology (MEXT), with the International Institute of Earthquake Engineering and Seismology (IIEES) as the major Iranian counterpart. This is a quick report prepared by the ERS members covering physical features of the earthquake and damage to dwellings.

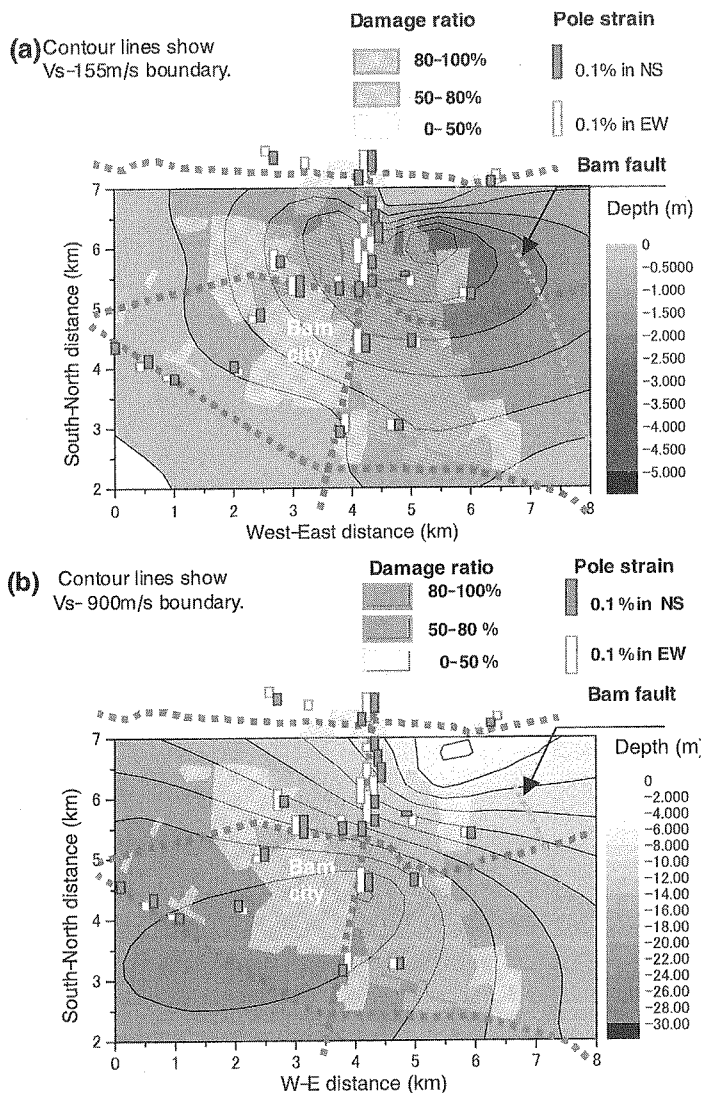
Fig. 8 Strains remaining in poles: (Damage distribution mapped by NCC, Iran [3])

For this reason, crack openings on pole sides without holes were taken to minimize the effect of transmission lines, the cracks caused by poles' motion in Y direction. For each pole, crack openings were added up over about 2m distance near the lower pole end, and then the total openings were divided by the distance to obtain average strain remaining on the pole. Total 270 poles were taken both in the city and its suburbs. The poles were then divided into several tens clusters in such a way that each cluster includes at least one crossing in it. Since the poles in one cluster line up at least two roads crossing each other, both north-south (NS) and east-west (EW) average strains were obtained cluster-wise. Fig. 8(a) and 8(b) show the distribution of remaining average strains in the city. Contour lines in Figs. 8(a) and (b) show inferred layer boundaries of shear wave velocities  $V_s = 155m/s$  and  $V_s = 900m/s$ , respectively (see Fig. 3), and colored zones show percentages of damage mapped by the National Cartographic Center of Iran [3]. Though the strain distribution seems to be consistent with the overall damage distribution pattern, the strains do not tell directly anything about seismic intensity. A calibration is necessary for this discussion, and it will come up in future publication.

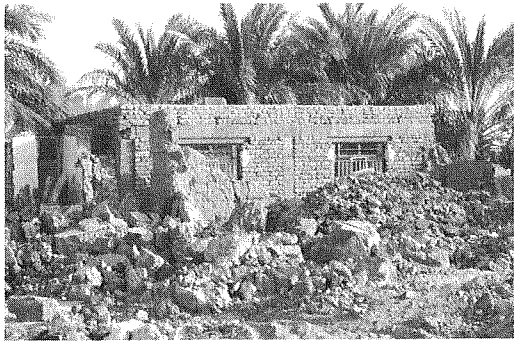
Adobe structures were badly damaged as in many previous experiences. Fig. 11 shows a completely collapsed adobe house in the front whereas in the back, a confined masonry structure stands almost undamaged. Some masonry structures are provided with horizontal ties only, i.e. collar beams, as shown in Fig. 12. Although the complete collapse is prevented, the lack of vertical ties causes the failure of the wall corners.

Figure 11. Completely collapsed adobe house

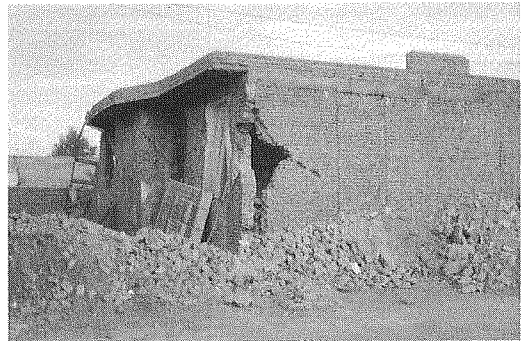
Figure 12. Heavily damaged partially confined masonry house

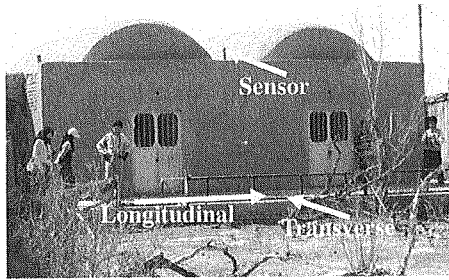
Figure 13 shows one of the surveyed adobe houses in Darzin City. The structure height is approximately 3.8m and the average wall thickness 800mm. The sensor was placed on top of the roof coinciding with a wall alignment. Figure 14 illustrates the analysis results. The blue lines show the spectra of different measurement windows whereas the red line represents the average. The fundamental periods in the longitudinal and transverse directions are 0.1 and 0.09sec, respectively. It is clear that the structure is slightly stiffer in the transverse direction along which several walls were aligned. The transverse direction spectrum shows a peak at 0.1sec, which coincides with the vibration period in the longitudinal direction. This may suggest some torsional vibrations in the structure.

Figure 13. Completely collapsed adobe house

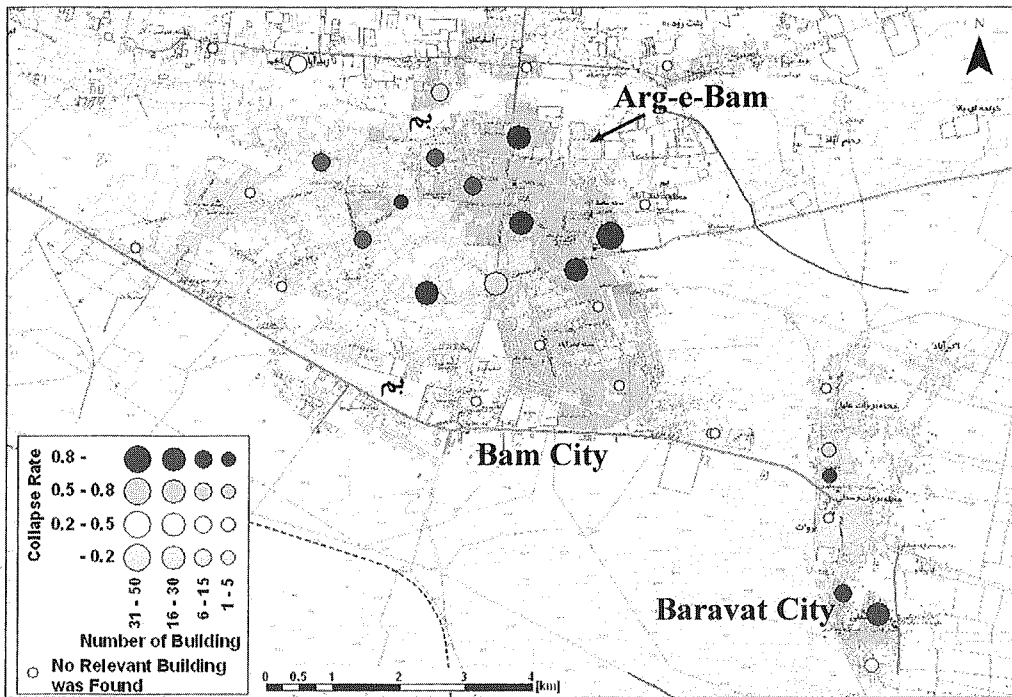
Similar measurements were carried out at other structures. Generally, adobe predominant periods varied between 0.09 and 0.11 sec. On the other hand, masonry houses had typical periods of 0.07 to 0.09sec. Figure 15 shows the results of the adobe house damage evaluation plotted on the damage distribution map published in [2]. From the graph it is clear that the adobe construction predominance is related to the city evolution. The closer the surveyed point is to Arg-e-Bam, the city origin, the larger the number of adobe houses. It can also be observed that the newer the structure, i.e. further from Arg-e-Bam, the lower the collapse rate. As expected the adobe performance was poor. Among 18 observed points where these structures were present, 13 sustained more than 80% collapse rate and 16 sustained more than 50% collapse rate. Very few adobe houses survived the earthquake in the city downtown. Figures 16 to 18 show the damage distribution for unreinforced masonry, confined masonry and steel structures, respectively. From these figures, it is clear that the best performance was achieved by the confined masonry houses. If soundly constructed, steel structures should also have very good performance during earthquakes. Unfortunately, in the case of Bam City, the lack of qualified construction workers led to numerous failures at the welded connections. Poor detailing was also observed in the small size of the plates used for connecting steel elements.

Figure 15. Adobe house damage distribution

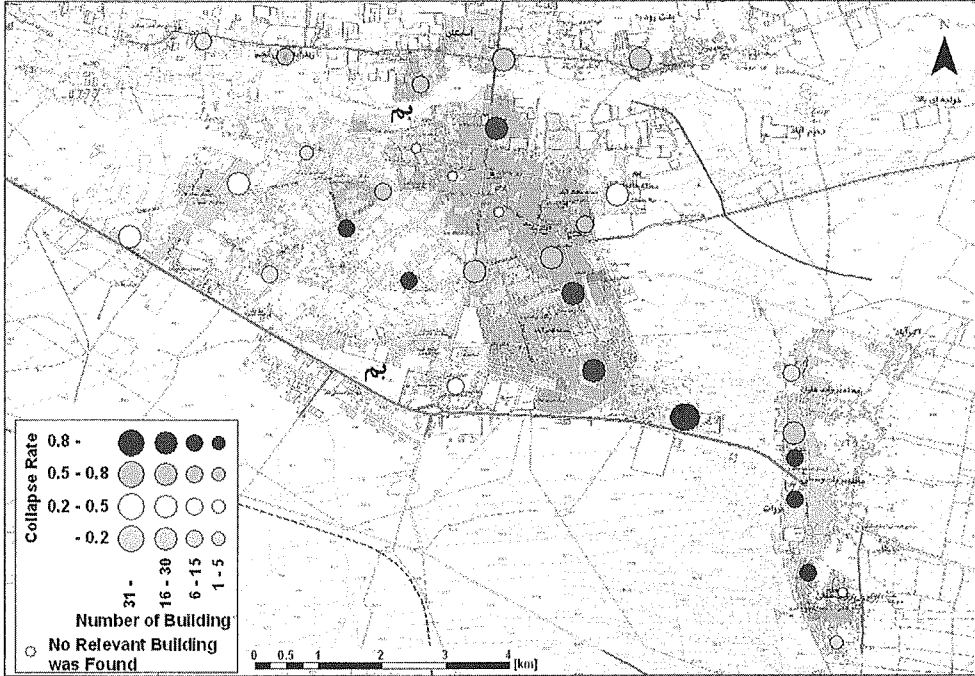
Figure 16. Unreinforced masonry damage distribution

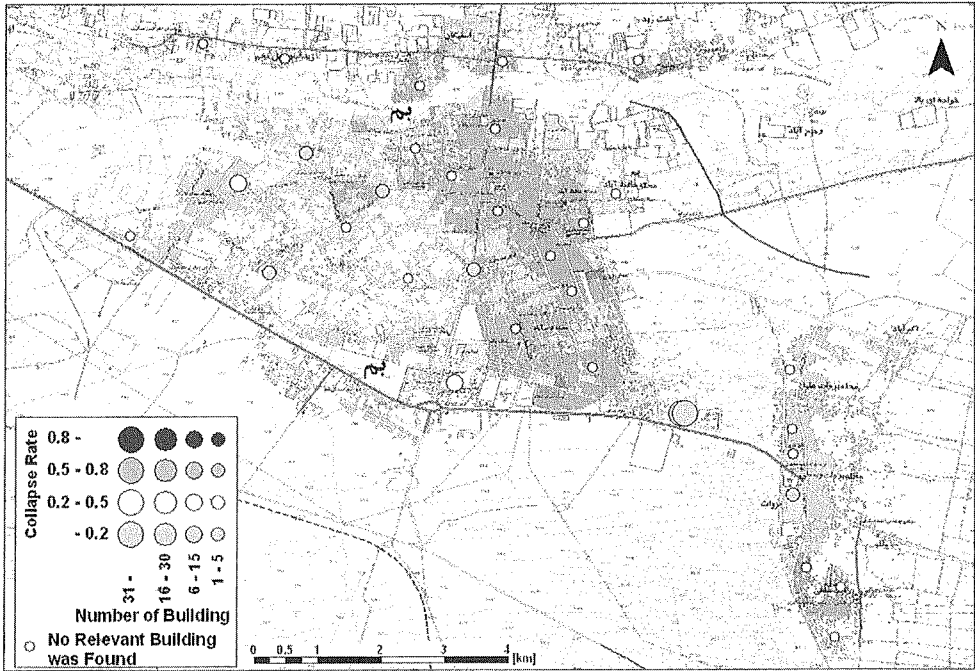
Figure 17. Confined masonry damage distribution

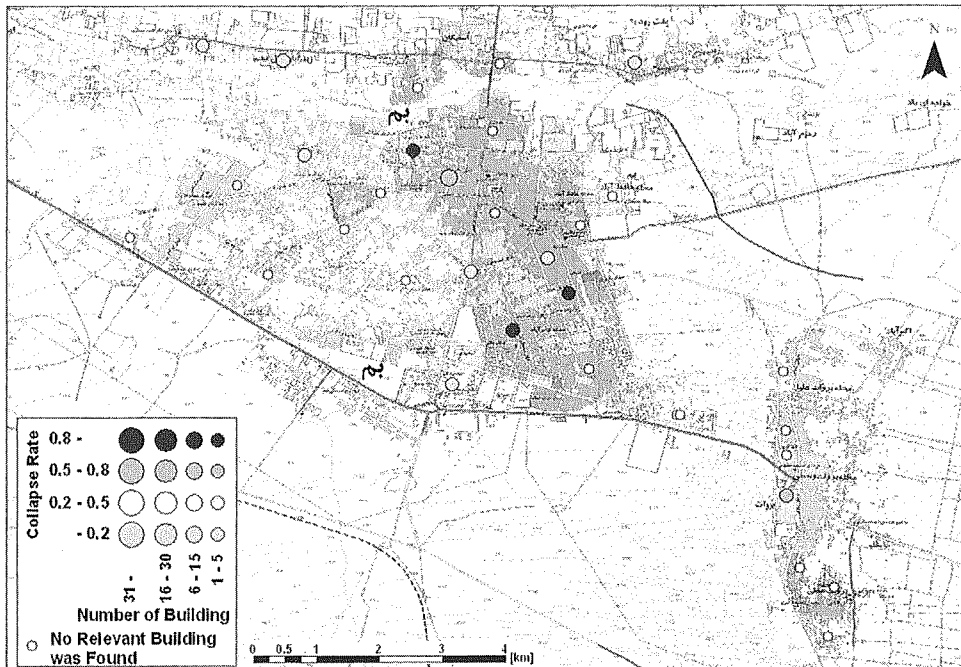
Figure 18. Steel building damage distribution
