# GEOTECHNICAL HAZARD FOR CIVIL INFRA-STRUCTURES IN THE OCTOBER 23, 2004 NIIGATA CHUETSU EARTHQUAKE, JAPAN

**Key Words:** Chuetsu earthquake, landslides, active folding, tunnels

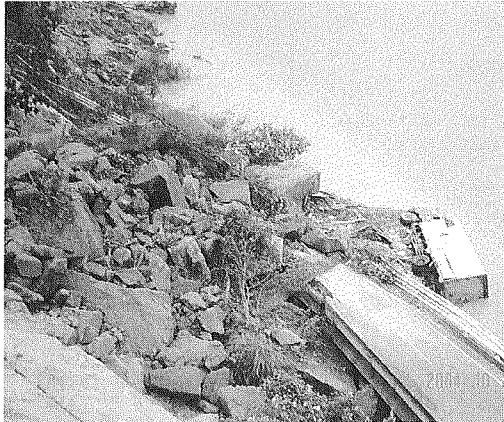
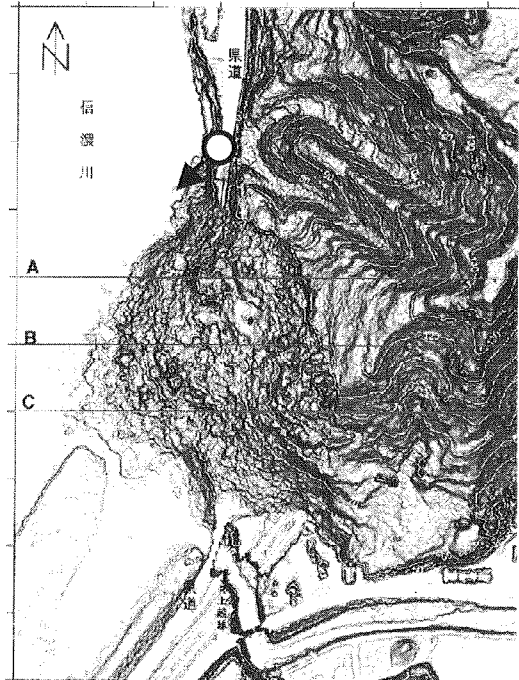
Fig. 4. Landslide at Myoken (Landslide #1 in Fig. 6)

Shortly after the earthquake, a team of expert researchers of the Japan Geological Survey interpreted locations of landslides in the Higashiyama mountain district from aerial photographs (Sato, et al. [3]). They had found 1353 slides as of October 27. Various types of landslides occurred on both sides of cuestas of sedimentary rocks. A large-scale landslide can take place along a joint on a gentle dip slope of cuesta. In the Chuetsu earthquake, such kind of landslides included the Higashi-Takezawa landslide, in which a sedimentary rock mass slid down a 17 to 22 degrees-dipping joint of Shiroiwa (White rock) formation of sandy mudstone and dammed Imokawa River. A cliff failure of sandy mudstone of Shiroiwa formation at Myoken destroyed a segment of Prefecture Route 589 (Fig. 4, Landslide #1 in Fig. 3). The landslide mass was broken up into a number of large blocks, and buried three vehicles. Some part of the exposed surfaces of the broken rocks had a red-brown color, indicating that they had been air-corroded, while the greater part was bluish gray, indicative of corrosion-free surfaces of cracks formed during the landslide. The Shinano River, developing a little bend at Myoken, has been laterally eroding the rock of Shiroiwa formation, exposed on this cliff, over the centuries, increasing the probability of landslide.

**Right:** Laser profiled topography of Myoken landslide area (Aero Asahi Co.) shows that the slide took place on a gentle dip slope of cuesta.

**Left:** Conveyed segment of National Route 291. Photo was taken at Point A in the map right.

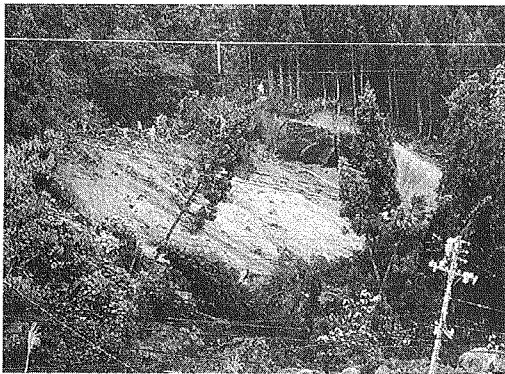
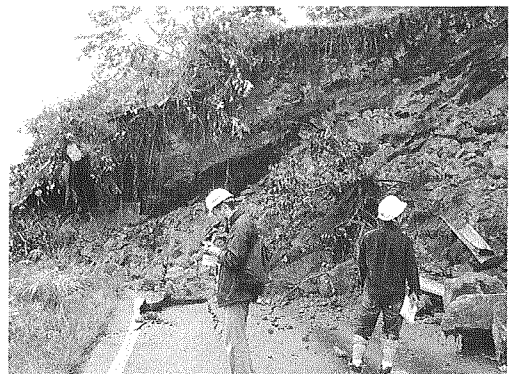
Fig. 5. Landslides at Yokowatari

(a) Landslide #2 in Fig. 4

(b) Landslide #2 in Fig. 4

Similar landslides are found at Yokowatari region, about 300-400 m south of the Myoken slide (Fig. 5, landslides #2 and #3 in Fig. 3). A poorly consolidated sandy mud rock plane slipped along its joint leading to Nobe River, and buckled upward as shown in Fig. 5(b). Nobe River at this location is an old-age stream of the Shinano River, and is considered to have eroded the toe of this dip slope. The landslide mass stopped the flow of Nobe river, and consequently, rice fields along the river were all flooded.

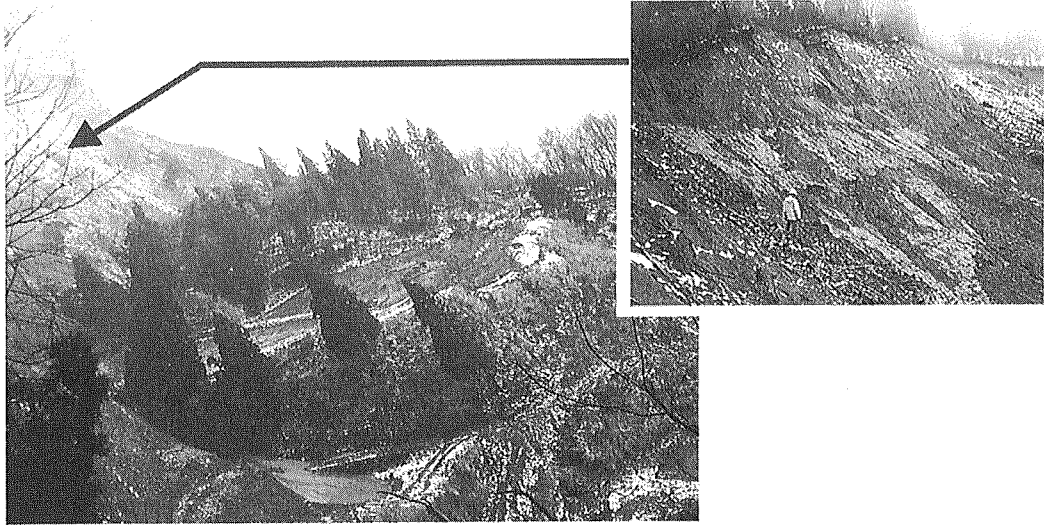
Fig. 6. Landslide at Dainichi-yama

Old landslide masses were reactivated in the earthquakes. The largest landslide (Fig. 6(a)) took place on the southeastern mountainside of a 400m-elevation peak near Dainichi-yama (see its location in Fig. 1). The escarpment shows stratified mud rock profile with sand rock films bedding in. The mud rock surface exposed on the escarpment was wet and shiny (Fig. 6(b)). The geological map of Ojiya District [4] suggests that the layers on the east wing of Toge Anticline dip 10 to 20 degrees southeast, and the landslide mass may have slipped along one of these bedding planes. Luckily, the landslide at Dainichi-yama caused no serious damage to civil-infrastructures just because it took place off major roads in mountains.

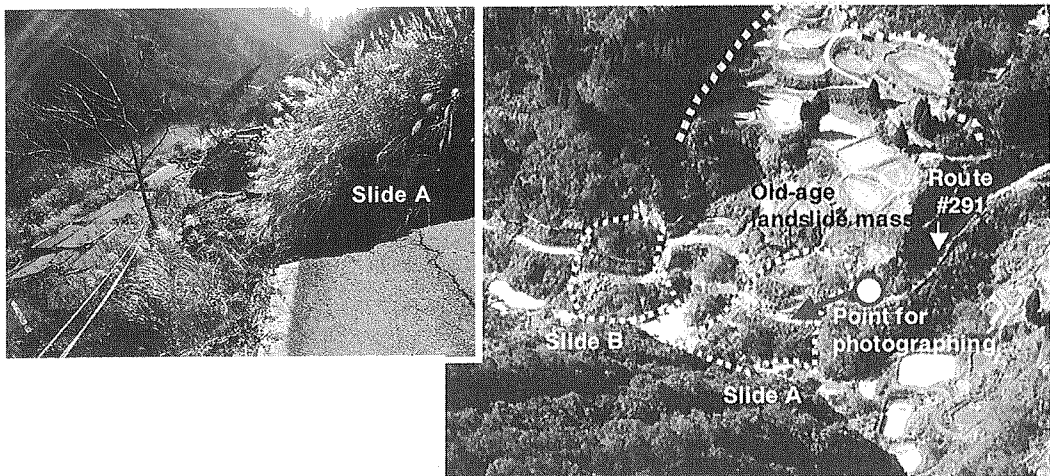
Fig. 7. Segment of National Route #291 carried down by a landslide at Nityono

Some smaller-size slope failures took place near toes of large existing landslide masses, which toes had been gradually scoured by river streams. Fig. 7 shows a broken segment of National Route #291 carried down 20m towards Dodome River. The soil mass that failed seems to be the lower part of an old landslide mass whose 250 m wide and 300 m long surface was covered with some 10 carp ponds.

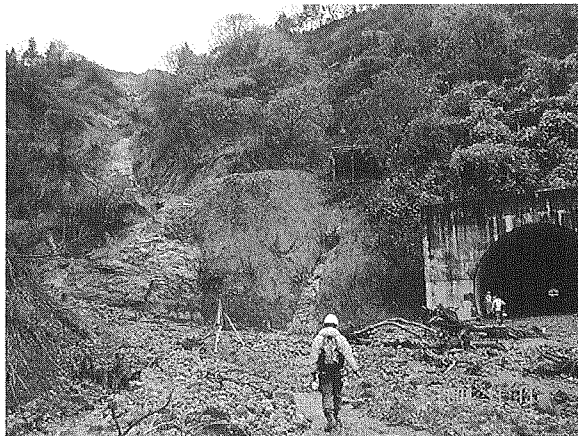
(a) Debris flow bed exposed by the tunnel mouth

A small debris flow took place near the northwestern mouth of Shiotani tunnel (Fig. 8(a)). Fig. 8(b) shows a part of the southern wall near the tunnel mouth. The remaining mud traces on the wall show that the 1.5m-thick debris flow hit the wall and splattered up on the tunnel wall by 2.8 to 3 m above its surface (broken line). Assuming that the entire kinematic energy is used up to increase the potential energy of mud droplets, these splatters suggest that the horizontal speed of the flow reached about 5.5 m/s. This velocity value is an estimation of the velocity at the edge of the flow profile. Judging from boulders and other suspended materials that were carried down (Fig. 8(a)), flow velocity of the mainstream may have been about twice as big as its velocity at the edges.

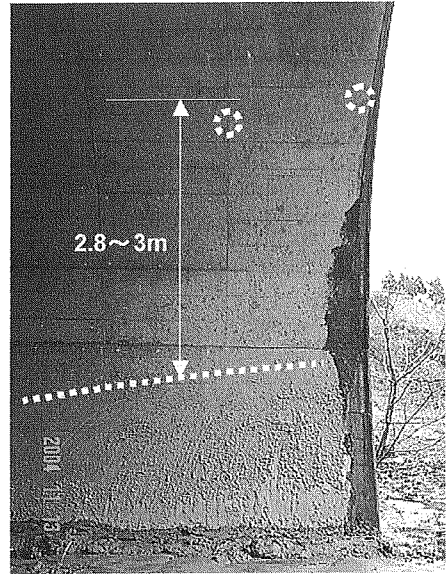
(b) Mud splatters on the tunnel wall

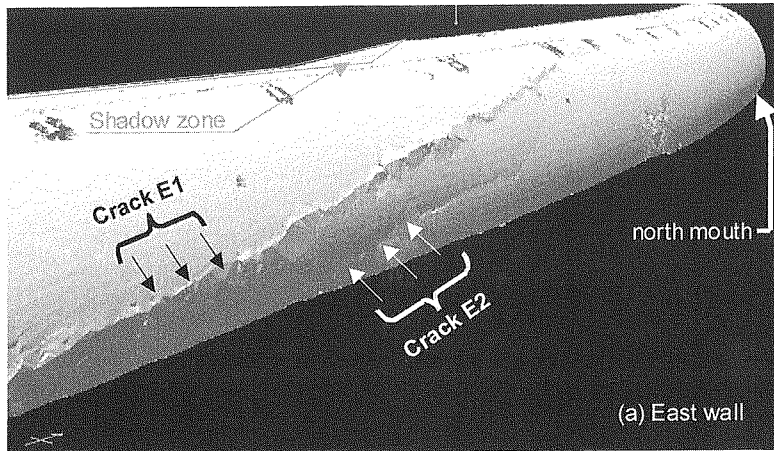
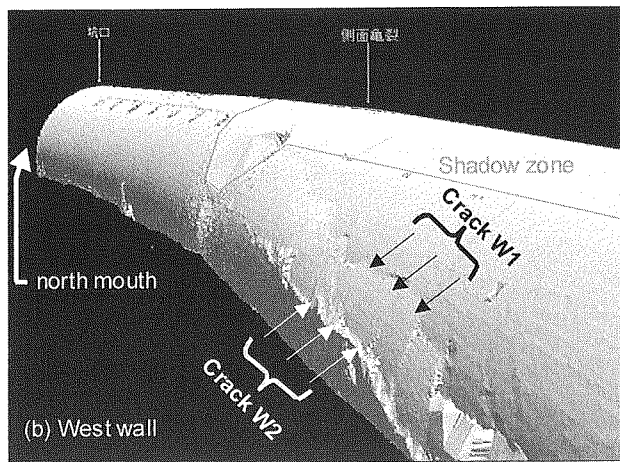
The Northern 120m segment of Kizawa tunnel (Fig. 10) was laser-profiled. Fig. 12 shows that two pairs of major cracks, E1, E2, and W1, W2, go diagonally up through the tunnel (see Fig. 13). The cracks, E1 and E2 on the east wall (Figs. 12(a) and 13(a)), extend over the 45 to 83m distance from the north tunnel mouth, while W1 and W2 (Figs. 12(b) and 13(b)) over 38m to 88m distance on the west wall. Fig. 14 shows three cross-sections at 51, 55 and 59m points together with an intact cross section measured at 100m point. It is clear from this figure that the pairs of cracks on the wall became hinges for the upper half of the tunnel cross-section that was pushed 40 to 50 cm east and about 10 cm down.

Fig. 12. Laser-profiled north segment of Kizawa tunnel: Laser-profiling was conducted after a steel frame was put up in the damaged section for protection of vehicles against possible danger. Therefore, there was a shadow zone where a laser beam did not reach.

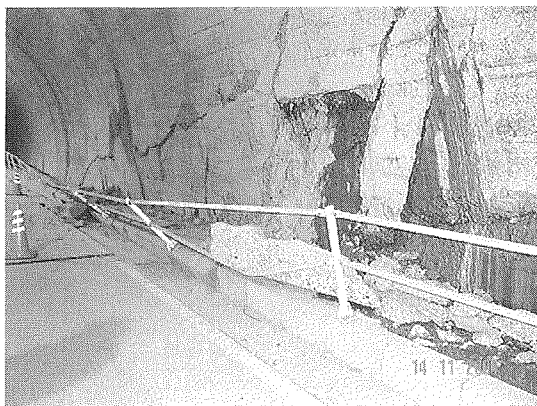
As has been mentioned, the northern part of the tunnel crosses at two locations, P1 and P2, a severely cracked and/or weakened mud rock layer (Fig. 11). The cracks E1, E2, W1 and W2 shown in Fig. 12 seem to have appeared in this weakened mud rock zone P1 near the north tunnel mouth. On the other hand, Cracks that appeared on the concrete lining (downward thin line arrows in Fig. 11) over some longer distance (100-180m) covering P2 zone, cut the tunnel axis upright and diagonally crosswise. This pattern of cracking seems to suggest that the tunnel was slightly bent towards the east-sloping mountainside. A lot of water reportedly came out of boreholes through the rock zones P1 and P2 before the tunnel construction. The soil profile along borehole #9 in Fig. 11 indicates that the underground water level is about identical to the upper surface of this weakened rock zone.

(a) Cracks W1 and W2 on west wall

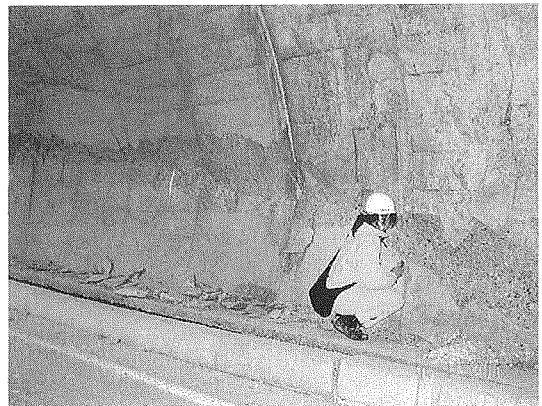
(b) Crack E1 on east wall

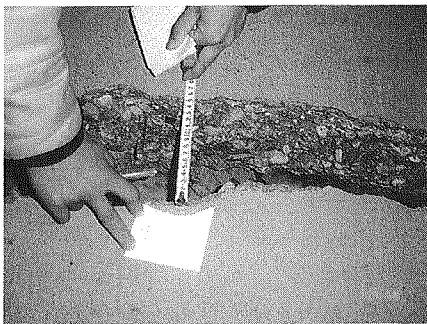
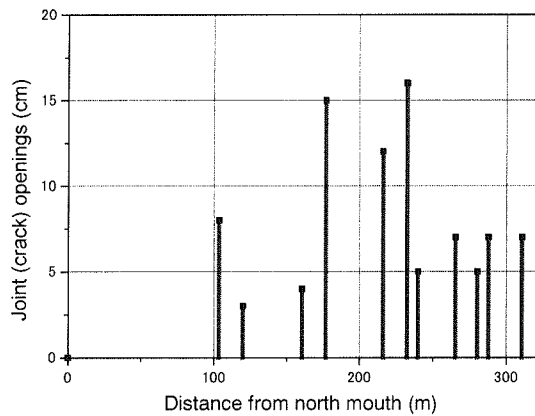
Fig. 16. Openings of the joints with respect to their distances from the north tunnel mouth

Expanded pavement joints were mostly found over a segment 100 to 305m from the north tunnel mouth, namely, southern two thirds of the tunnel. Fig. 16 shows the openings of the joints with respect to their distances from the north tunnel mouth. The figure says that the tunnel was expanded 89 cm axially. Figs. 9 and 10 suggest that the expansion of the tunnel axis may have caused partly by the motion of the surrounding soil near Escarpment XX'.

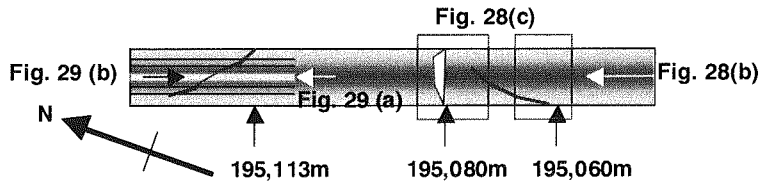
(a) Damaged segment of Uonuma tunnel. Boxes correspond to location of photos in c) and d)

Due to the tunnel depth at the damage location, the shallow landslides above the tunnel could have nothing to do with the damage. Most likely the tunnel was damaged due to a minor slip on a possible small fault segment crossing the tunnel and/or the overall horizontal compression due to movements of a nearby fault. This should have been responsible for the apparent shear plane failure pattern as shown in Figure 21(a).

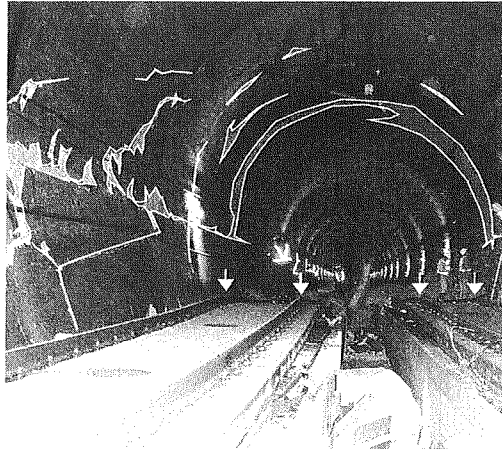
Cracks and a development photo of the damaged tunnel segment (Fig. 21(a)) between 195,060 and 195,080 m (distance measured from Tokyo station) are given in Figures 21 (b) and (c). Several cracks cut the tunnel diagonally from the south to the center of the damaged area. These diagonal cracks merge at their southern ends to form a thrust dislocation showing about 13 cm shortening of the lining at this point. At the center of the damaged segment, the concrete crown broke up into large pieces, and fell in onto the rails and their slabs. The spalled part of the tunnel crown in Fig. 21(c) exposes steel supports. In Figure 21(c), the south part of the damaged area is to the right and the central part to the left. The northern part of the damaged segment (195,113m -) has lighter damage and the rail foundation was not deformed as much as in the south part (see Figure 22(a)). However the center ditch along the rails shows a clear right-lateral shift of about 10-15cm where it is crossed by crack. NW-SE trending diagonal cracks were prevalent there (Fig. 22(b)).

(b) Southern part of the damaged tunnel segment (from south to north)

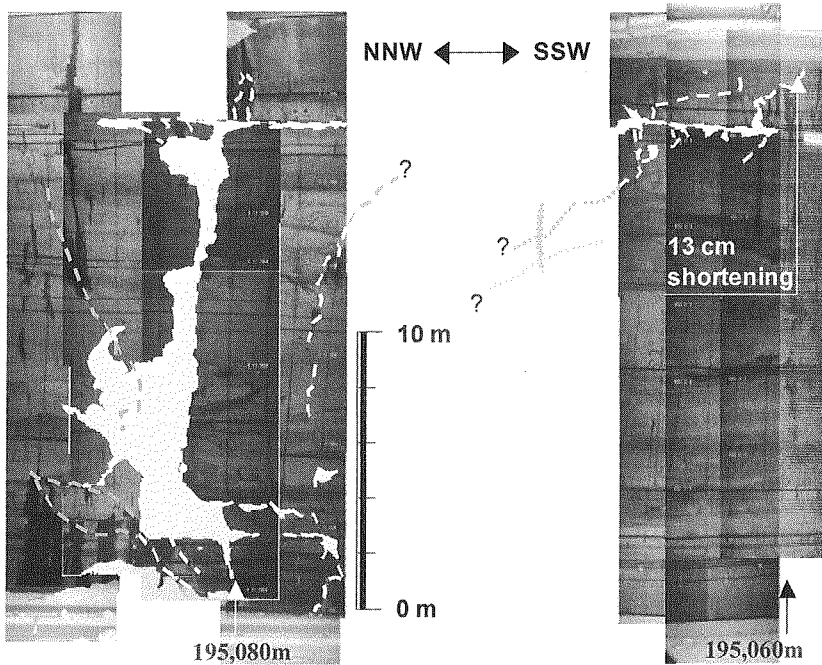
(c) Development of cracks

**Fig. 21.** Cracks in the southern part of the damaged segment of Uonuma tunnel (195,060-195,080 m)

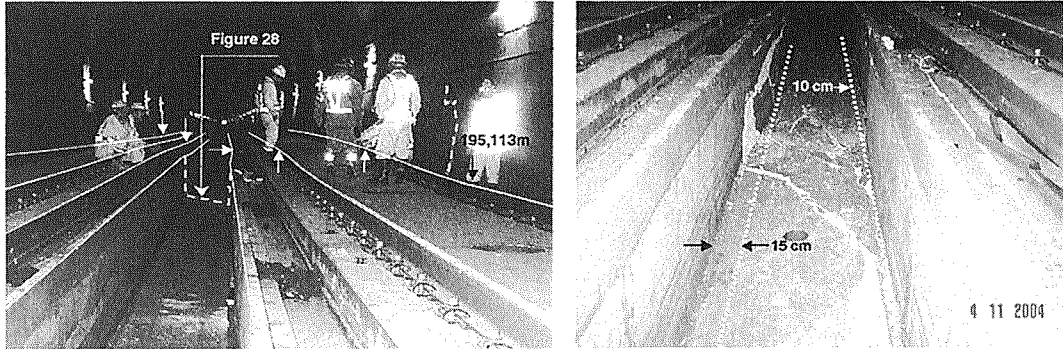
Fig. 22. Diagonal cracks on the tunnel slab showing right-lateral offset

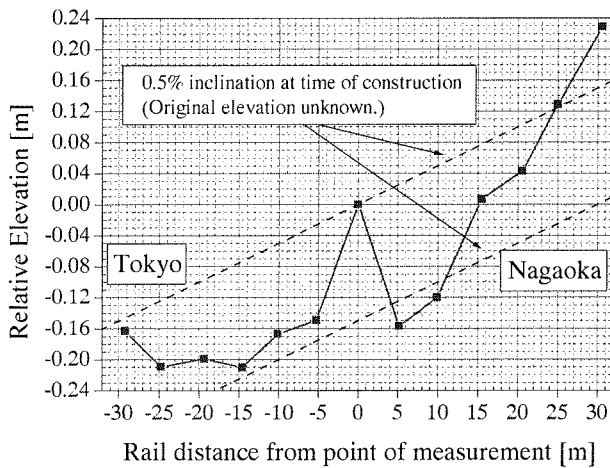
Fig. 23 Relative elevation of the down-traffic rail (origin = 195,070m from Tokyo)

Figure 23 shows the relative elevation of the rail measured with the help of laser range-meter, which was put on the high point in the damaged area about 10 meters south of downfallen concrete block (white arrows in Figure 21(b)). Buckling deformation of the rail slabs is clear from the figure. Between 0 and 5 meters there was a maximum vertical difference of 18cm compared to the 2 cm difference due to the 5% inclination at the time of construction.
