DAMAGE TO EARTH STRUCTURES CAUSED BY THE 2004 NIIGATA-KEN CHUETSU EARTHQUAKE

Junichi KOSEKI¹, Yukika TSUTSUMI², Takashi KIYOTA³,
Susumu NAKAJIMA³ and Sajjad MAQBOOL³

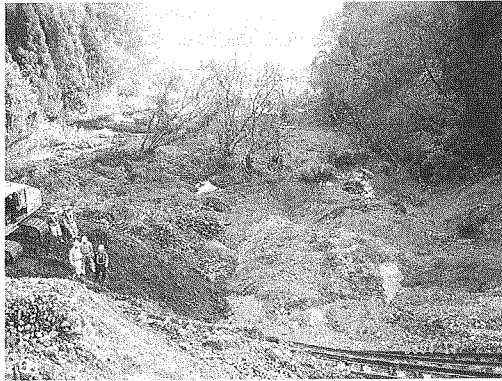
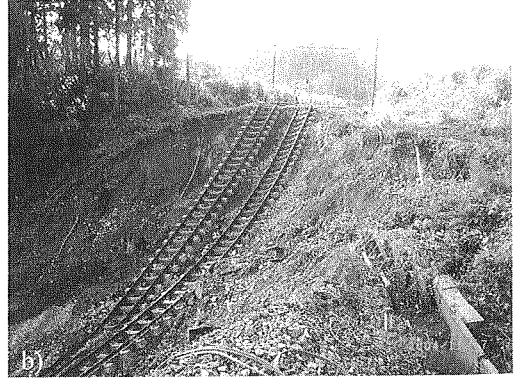
Figure 2 shows collapse of a railway embankment along JR Joetsu line at Hiu, Ojiya city (site 1 in Figure 1). It had been constructed by filling a valley facing the Shinano river. In the earthquake, the fill material, possibly with a part of the original soil deposit, slid extensively to the downstream of the valley. After the earthquake, it was reconstructed by using a reinforced soil retaining wall with a full-height rigid facing as shown in Figure 3b. It employs geogrid as reinforcements, which are placed at a vertical spacing of 30 cm in the backfill. This type of reinforced soil retaining wall was adopted for the reconstruction, since it exhibited an excellent performance during the 1995 Hyogoken-Nanbu earthquake (Tatsuoka et al., 1996). Refer to Figures 4b and 6b for the same type of reinforced soil retaining walls that are under construction.

Figure 2. Collapse of an embankment along JR Joetsu line (between Echigo-Kawaguchi and Ojiya stations; at Hiu, Ojiya city; site 1 in Figure 1)

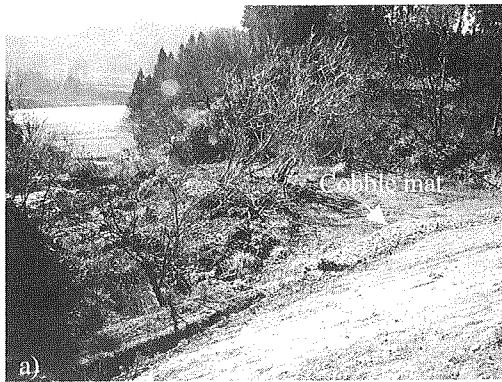
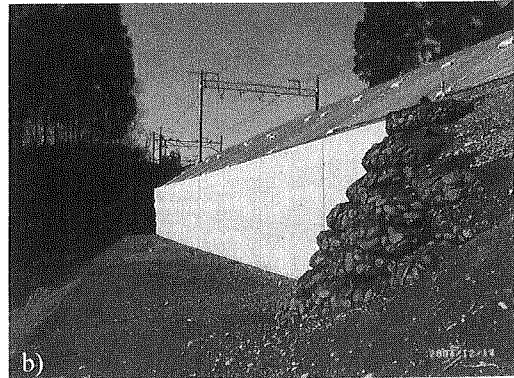
Figure 3. Reconstructed embankment and reinforced soil retaining wall along JR Joetsu line (site 1 in Figure 1)

In addition, as noted in Figure 3a, a cobble mat was newly placed at the base of the reconstructed embankment below the reinforced soil retaining wall in order to enhance its drainage capability. As a result, steady flow of ground water from the cobble mat could be observed even without any significant precipitation during the survey period. This suggests possible causes for the collapse that concentration of ground water flow in the subsoil layer may have taken place and/or the fill material may have been partly saturated at the time of the earthquake.

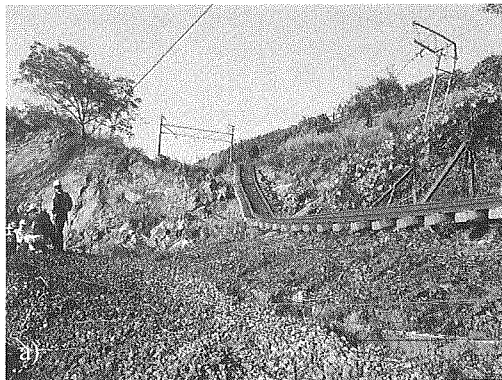
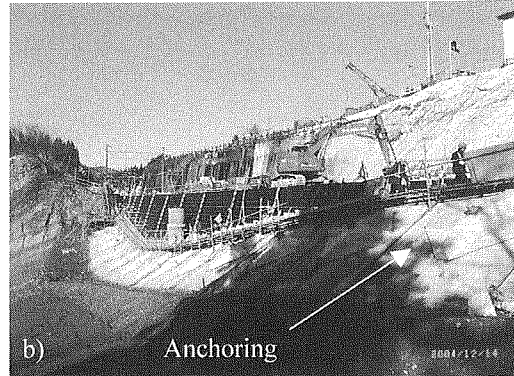
Figure 4a shows another collapse of a railway embankment along JR Joetsu line at Aikawa, Kawaguchi-machi (site 2 in Figure 1). It had been also constructed by filling a valley facing the Shinano river, and suffered from a similar type of failure to the one shown in Figure 2. As shown in Figure 4b, its reconstruction after the earthquake was executed by using the reinforced soil retaining wall with a full-height rigid facing. At the same time, reinforcement of the existing original soil deposit below the wall was also executed by anchoring.

Figure 4. Collapsed embankment along JR Joetsu line and its reconstruction (between Echigo-Kawaguchi and Ojiya stations; at Aikawa, Kawaguchi-machi; site 2 in Figure 1)

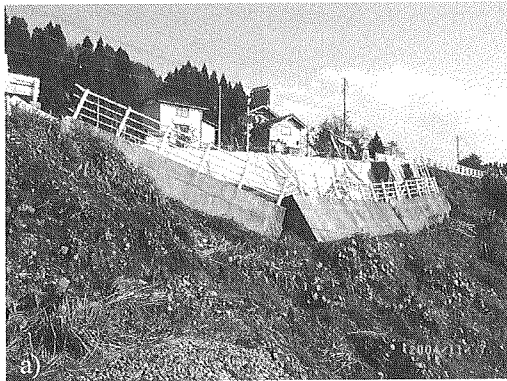
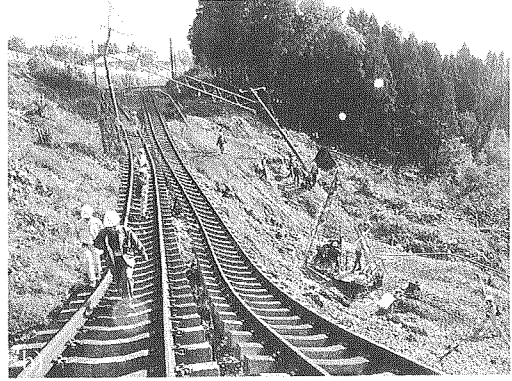
Figure 5a shows failure of a gravity type retaining wall along National Highway Route 17 at Kamikatagai, Ojiya city (site 3 in Figure 1). This wall had been constructed in parallel with a railway embankment, which also suffered from sliding failure as shown in Figure 5b. The latter embankment was reconstructed by using the same type of reinforced soil retaining wall as mentioned above (Figure 6b), while the former retaining wall was reconstructed by using another type of reinforced soil retaining wall with segmental facings (Figure 6a).

Figure 5. Damage to a retaining wall along National Highway Route 17 and an adjacent embankment along JR Joetsu line (at Kamikatagai, Ojiya city; site 3 in Figure 1)

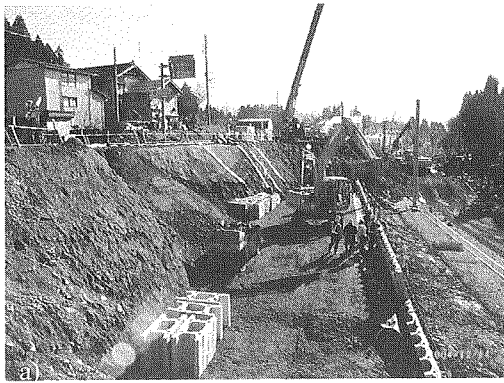
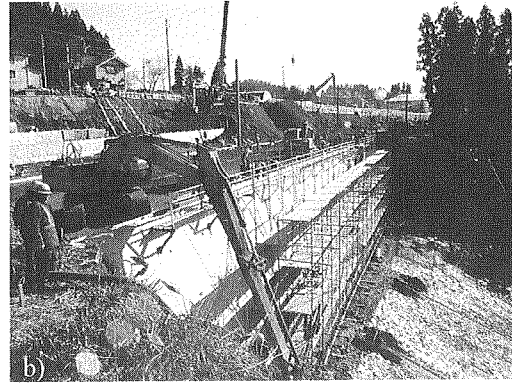
Figure 6. Reconstruction of damaged retaining wall along National Highway Route 17 and the adjacent embankment along JR Joetsu line (site 3 in Figure 1)

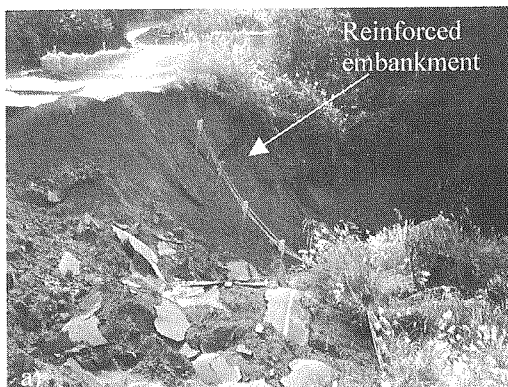
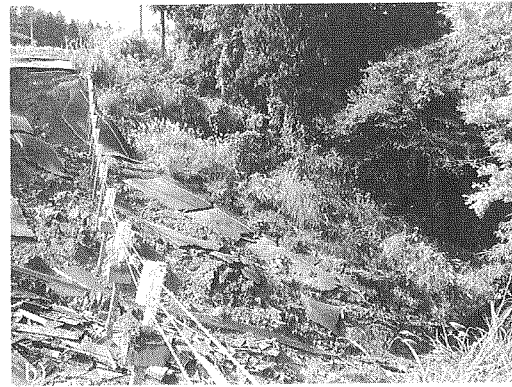
As shown in Figure 7, road embankments constructed by filling valleys in mountainous areas along National Highway Route 290 (at Kuriyama-zawa, Tochio city; site 4 in Figure 1) suffered from extensive sliding. It should be noted that, as shown in Figure 7a, a reinforced embankment that had been constructed next to the collapsed unreinforced embankment was also damaged in the earthquake. Reportedly, the latter reinforced embankment had been constructed as a part of rehabilitation works for damage caused by previous heavy rainfall.

Figure 7. Collapsed embankments along National Highway Route 290 (at Kuriyama-zawa, Tochio city; site 4 in Figure 1)

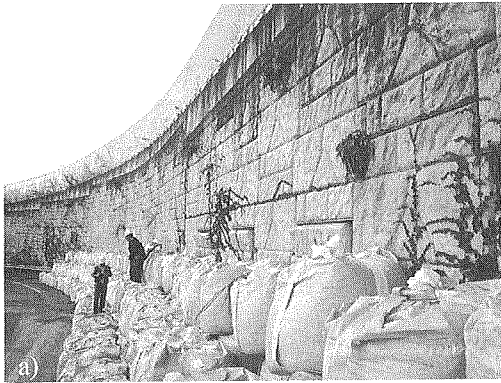
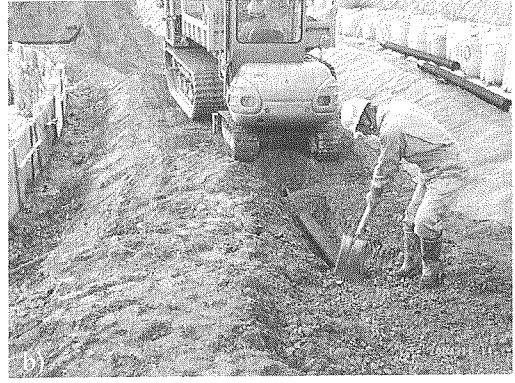
Figure 8a shows damage to a reinforced soil retaining wall with segmental facings and metal strips as reinforcements at Horinouchi Parking Area of JH Kan-etsu Expressway (site 5 in Figure 1). The facings suffered from overall bulging or overturning, with some of the lower facings tilted locally. Since leaching of ground water from the lower facings was also observed at the time of the survey, it was inferred that the lower part of the backfill material may have been saturated at the time of the earthquake, possibly causing liquefaction-like phenomena and subsequent deformation of the facings. Figure 8b shows temporary rehabilitation work by installing pipes in the backfill, in order to drain ground water from the backfill.

Figure 8. Damage to a retaining wall reinforced with metal strips and its temporary rehabilitation along JH Kan-etsu Expressway (at Horinouchi Parking Area; site 5 in Figure 1)

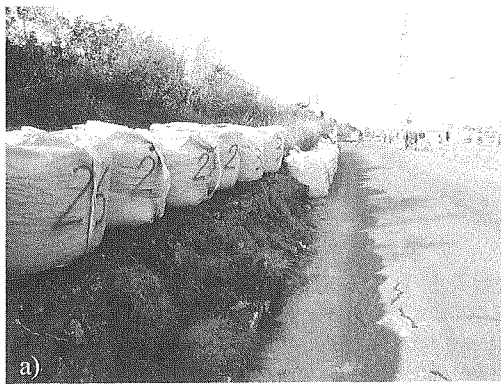
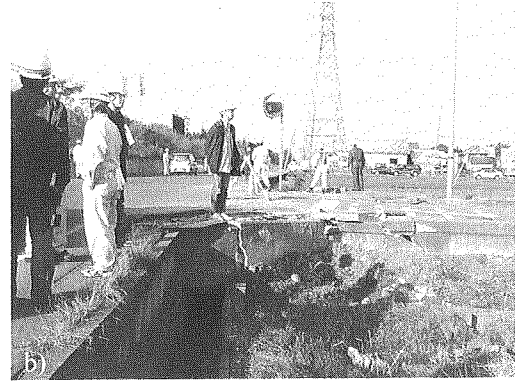
Figure 9a shows damage to an embankment along JH Kan-etsu Expressway at Sakura-machi, Ojiya city (site 6 in Figure 1). The embankment suffered from settlement and lateral spreading, and the latter caused overturning or failure of retaining walls that had supported the lower part of the embankment (Figures 9a and 10a). Lateral spreading took place not only in the embankment but also in the subsoil layers, causing damage to an adjacent regional road as well (Figure 9b). In addition, there were several culvert boxes constructed across the embankment, and the above lateral spreading caused opening of their joints at the centerline of the embankment, as typically shown in Figure 10b.

Figure 9. Damage to an embankment along JH Kan-etsu Expressway and an adjacent regional road (at Sakura-machi, Ojiya city; site 6 in Figure 1)

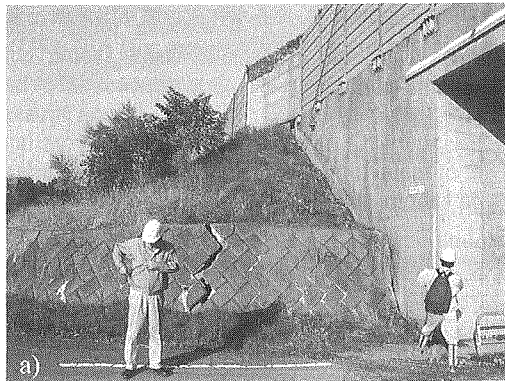
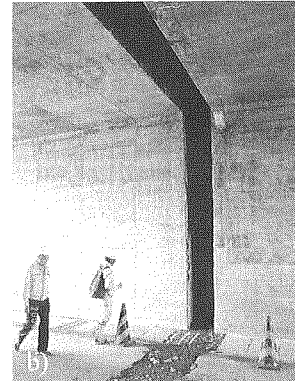
Figure 10. Opening of a joint of culvert box and damage to an adjacent embankment along JH Kan-etsu Expressway (site 6 in Figure 1)

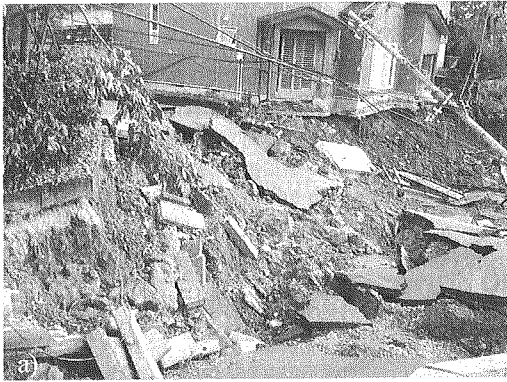
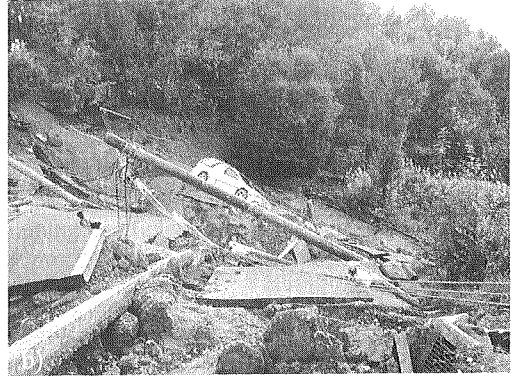
Figures 11 through 13 show collapse of embankments for regional road around newly-developed building estates at Taka-machi, Nagaoka city (site 7 in Figure 1). These estates had been constructed by cutting hills and filling valleys. In the earthquake, the filled portions below the regional road as an outer ring road of the estates slid extensively to the downstream of the valleys, causing damage to the neighboring houses on the upstream side as well. At two sites as shown in Figures 12 and 13, gravity type retaining walls that had supported the upper part of the embankments moved along with their subsoil layers and tilted largely.

The fill materials were either clayey gravel (Figures 12 and 13) or volcanic clay (Figure 11). They are with relatively low permeability, and thus their full compaction had possibly been difficult to conduct at

Figure 11. Collapse of an embankment for regional road around newly-developed building estates (at Taka-machi 4-chome, Nagaoka city; site 7 in Figure 1)

Due attentions, such as the use of proper fill materials, their full compaction and possible combination with the reinforced soil methods, should be paid in the reconstruction work of the severely damaged embankments.

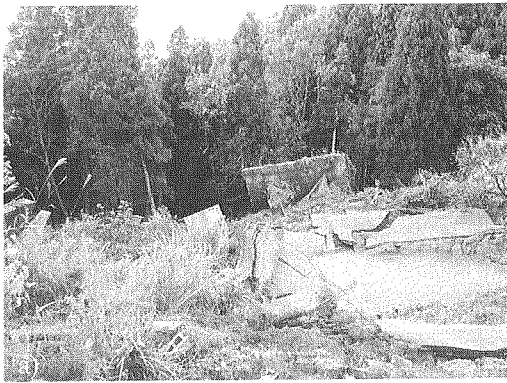
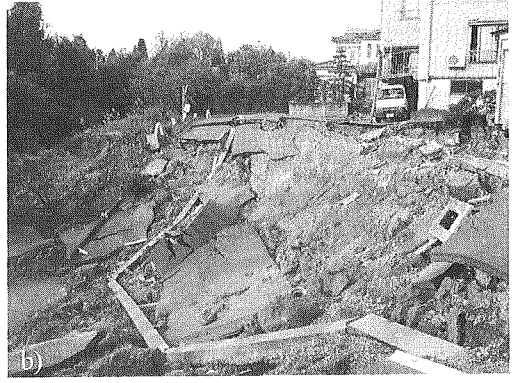
the time of the filling work. Since leaching of ground water was observed at the time of the survey, as can be typically seen in Figure 12b, it was inferred that the filled portion at the damaged sites was under loose and wet states at the time of the earthquake. Although the above-mentioned retaining walls had drainage holes at the bottom and non-woven sheets for drainage at the back, their capacities may have been inadequate.

Figure 12. Collapse of an embankment for regional road around newly-developed building estates (at Taka-machi 3-chome, Nagaoka city; site 7 in Figure 1)

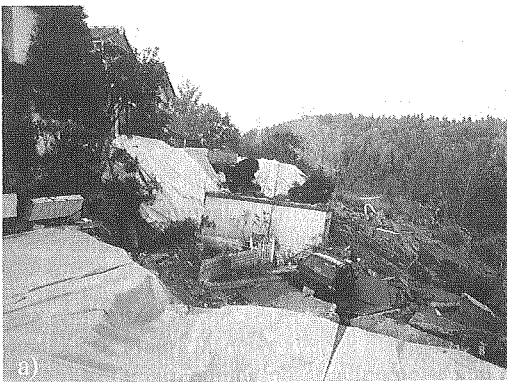
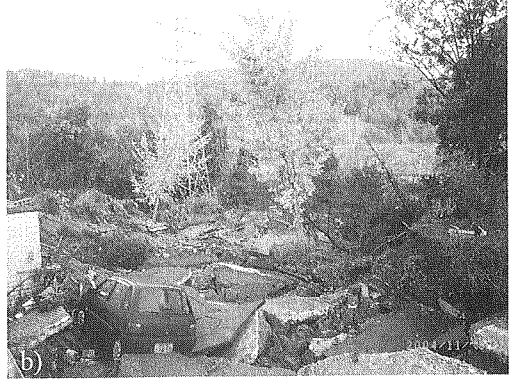
Figure 13. Collapse of an embankment for regional road around newly-developed building estates (at Taka-machi 1-chome, Nagaoka city; site 7 in Figure 1)

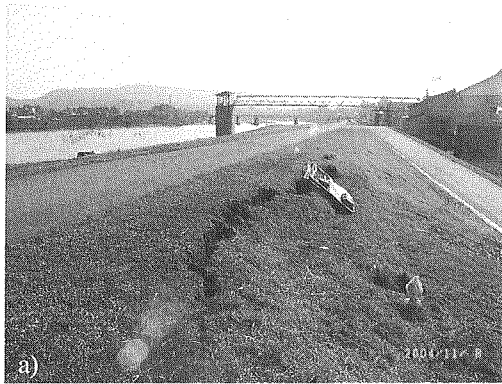
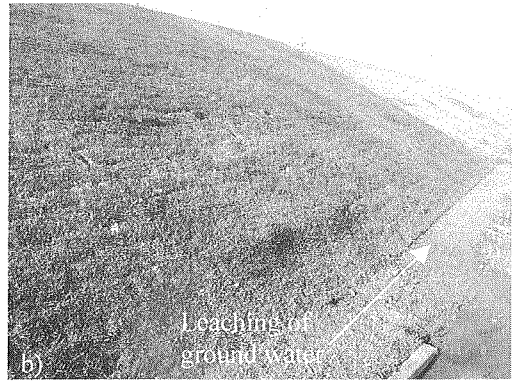
Figure 14 shows damage to a dike along the Shinano river at Chiya-gawa, Ojiya city (site 8 in Figure 1). Unlike other river dikes, leaching of ground water from the bottom of the dike as shown in Figure 14b was observed at the time of the survey. This suggests a possible cause for the damage that the fill material may have been partly saturated at the time of the earthquake.

Figure 14. Damage to a dike along the Shinano river (at Chiya-gawa, Ojiya city; site 8 in Figure 1)

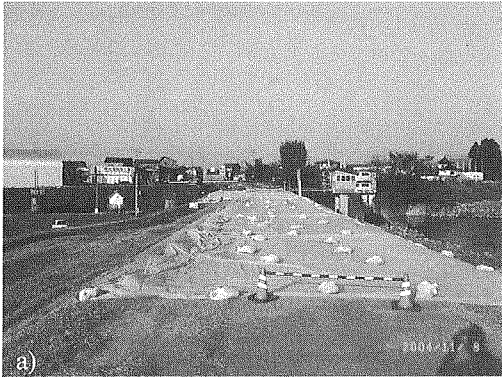
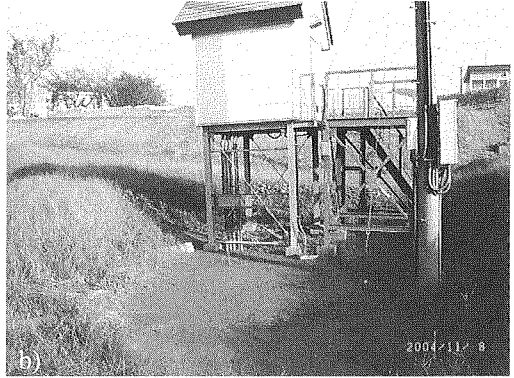
Figure 15a shows a temporarily rehabilitated dike along the Shinano river at Chiya, Ojiya city (site 9 in Figure 1). Reportedly, it suffered from settlement up to 50 cm at the shoulder of the embankment for a length of about 50 m. Since a large-scale sand boil was observed in adjacent ground (Figure 15b), it was inferred that the above damage was caused by liquefaction of subsoil layers below the embankment. It should be noted, however, that liquefiable subsoil layers (i.e., saturated loose sandy deposits) below river dikes exist to a limited extent in the regions that were severely shaken by the earthquake (e.g., along the Shinano and Uono rivers in Ojiya city and Kawaguchi-machi), due to the geologic processes that are specific to the regions. Therefore, the above case as shown in Figure 15 should be regarded as one of the exceptional cases.

Figure 15. Temporarily rehabilitated dike along the Shinano river and a sand boil on adjacent ground (at Chiya, Ojiya city; site 9 in Figure 1)

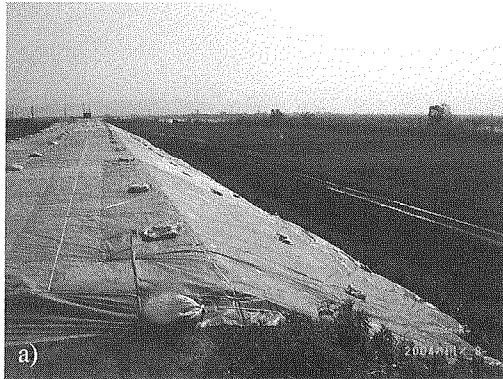
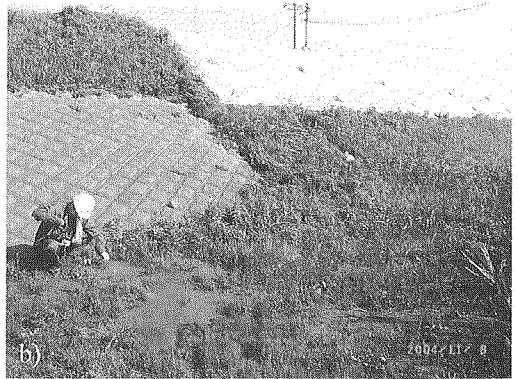
Figure 16a shows another temporarily rehabilitated dike along the Shinano river at Namiki-shinden, Nakanoshima-machi (site 10 in Figure 1). Reportedly, it suffered from crest settlement up to 100 cm for a length of about 200 m. Since sand boils were observed in adjacent ground, as typically shown in Figure 16b, this damage can be also attributed to the occurrence of liquefaction in the subsoil layers. It can be seen from Figure 1 that, as compared to the aforementioned two sites (sites 8 and 9), this site is located to the downstream side of the Shinano river with longer epicentral distance. Therefore, this site was possibly subjected to an earthquake motion which was not strong enough to cause complete failure of the dike, although liquefiable subsoil layers may exist more widely than in the severely-shaken regions.

Figure 16. Temporarily rehabilitated dike along the Shinano river and a sand boil on adjacent ground (at Namiki-shinden, Nakanoshima-machi; site 10 in Figure 1)

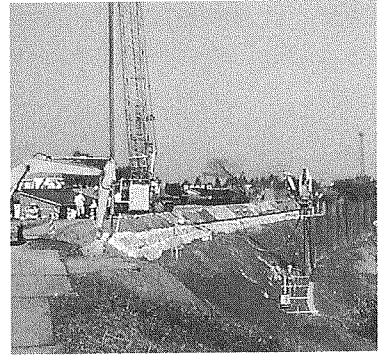
Figure 18. Rehabilitation work of a dike along the Kariyata river (at Gohyaku-kari, Nakanosima-machi; site 11 in Figure 1)

Based on the data reported by MLIT (2004a), progress of temporarily rehabilitation work on damage to river facilities including dikes is summarized in Figure 17 in terms of the number of sites. In ten days after the main shock, temporarily rehabilitation work was completed at about 70, 85 and 75 % of the damaged facilities along the Shinano river, the Uono river, and the other smaller rivers, respectively. In nineteen days after the main shock, it was completed at all the damaged dikes along the Shinano and Uono rivers (MLIT, 2004a). On the other hand, much longer time was required for rehabilitating severely damaged dikes in the other smaller rivers and natural dams that were created by earthquake-induced landslides in mountainous areas. For example, Figure 18 shows rehabilitation work on a severely damaged dike along the Kariyata river at Gohyaku-kari, Nakanosima-machi (site 11 in Figure 1), where cut-off sheet piles had been driven on the river side before executing the partial reconstruction work of the dike.

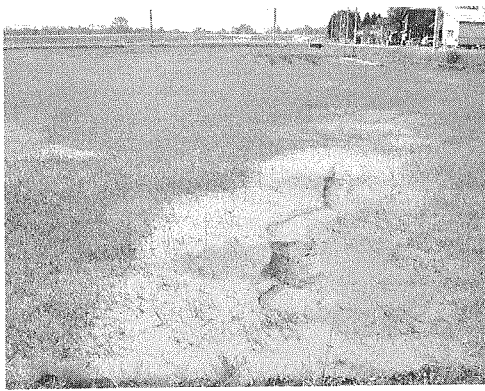
In general, liquefaction of original soil deposits did not occur extensively, except for the limited number of cases as mentioned above on damaged river dikes. It should be noted that, as typically shown in Figure 19, extensive sand boils on the ground behind a dike along the Shinano river were observed at several sites. However, the surface soil layers had been replaced by borrowed soil after excavating the original deposits to retrieve materials for concrete aggregate. Therefore, these sand boils can be regarded as those caused by liquefaction of backfill soil. As mentioned immediately later, significant damage to underground structures was also caused by liquefaction of backfill soil.

Figure 19. Sand boils on ground behind a dike along the Shinano river (at Iwano, Koshiji-machi; site 12 in Figure 1)

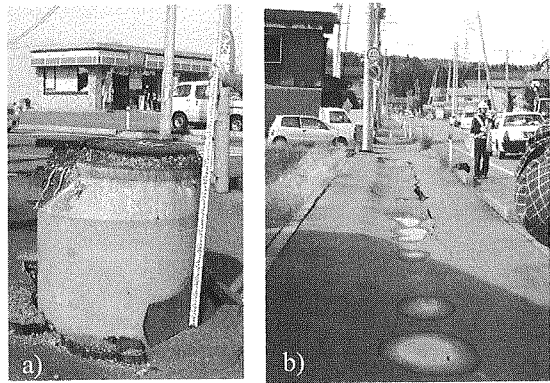
Figure 20a shows uplift damage to a sewage manhole at Sakura-machi, Ojiya city (site 13 in Figure 1). In the neighboring section, as shown in Figure 20b, settlement of pavement above backfill soil for sewage pipes was observed, while deformation of original soil deposits surrounding the backfill soil was insignificant. Therefore, only the backfill soil should have liquefied during the earthquake and caused the uplift damage to sewage manholes. Based on relevant case histories in the past earthquakes (Koseki et al., 1997; 1998; 2000), it is inferred that the sewage pipes as well were damaged by the liquefaction of backfill soil.

Figure 20. Uplift of sewage manhole and settlement of pavement above backfill soil for sewage pipes (at Sakura-machi, Ojiya city; site 13 in Figure 1)

In order to avoid similar damage in the future, the government recommended employing one of the following countermeasures against liquefaction of backfill soil in the reconstruction work of the damaged sewage facilities (MLIT, 2004b).

1. In using sands as the backfill material for sewage pipes, they should be compacted to a value of degree of compaction exceeding 90 %.
2. To maintain high permeability, crushed gravels that have D_{50} not less than 10 mm and D_{10} not less than 1 mm should be used as the backfill material, while compacting them to a value of degree of compaction exceeding 90 %.
3. The backfill material should be solidified by adding cement or other cement-origin hardening additives to have an unconfined compressive strength in the range of 100 to 200 kPa after curing for 28 days in the laboratory. This range corresponds to an in-situ strength of 50 to 100 kPa.

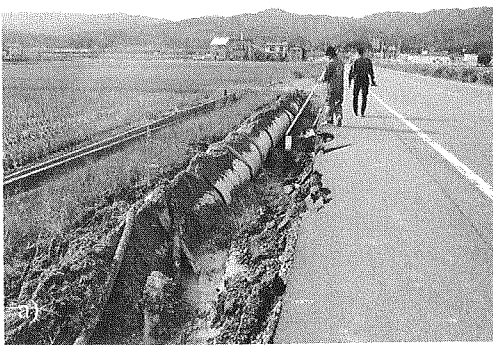
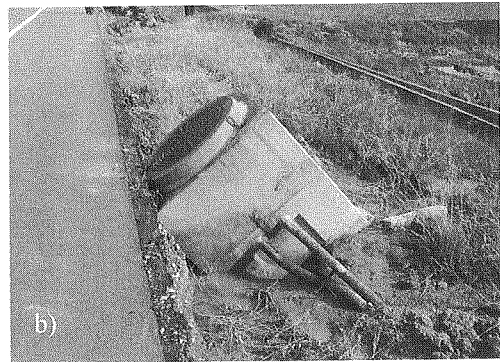
Figure 21 shows complete uplift of buried pipes for providing ground water to thaw snows in winter time and tilting of an uplifted manhole for information cables along National Highway Route 117 at Yachi, Ojiya city (site 14 in Figure 1). They were also caused by the liquefaction of backfill soil. Therefore, in the reconstruction work of not only the sewage facilities but also the other underground structures, due attentions should be paid on countermeasures against the liquefaction of backfill soil.

Figure 21. Complete uplift of buried pipes and tilting of an uplifted manhole along National Highway Route 117 (at Yachi, Ojiya city; site 14 in Figure 1)
