DAMAGE INVESTIGATIONS of PUBLIC HALLS IN NAGAOKA CITY AFTER NIIGATA-CHUETSU EARTHQUAKE

ABSTRACT: This paper reports the results of damage survey to some public halls in Nagaoka city, the closest urban area to the epicenters of Niigata-Chuetsu earthquake. Because of the distance from the epicenter less structural damage to them was found. However the damage that these facilities were suffered, damage to suspended facilities especially to suspended ceilings, was so serious that they could not continue their functions after the earthquake.

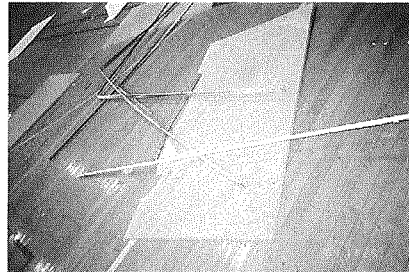
This public hall is located most south area in the city and close to the epicenter. However the damage to the structure was rather minor. Some minor cracks on seismic walls and crash of grout under beam base were found. Many ceiling panels have fallen off near the boundary age area, where the horizontal ceiling panels connected to inclined ceiling, of the arena. Some panels have also fallen in the middle part of the arena. Ceiling panels were made of glass wool. Slide, deformation and cut of connections between cross furrings or hooks between cross furring and main runners were observed. No brace member was seen in the hanger bolt systems.

(e) Ceiling panels, cross furring and main runners fallen off

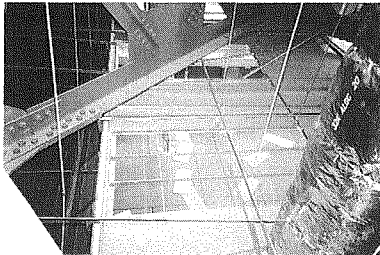
(f) Upper side of the ceiling system

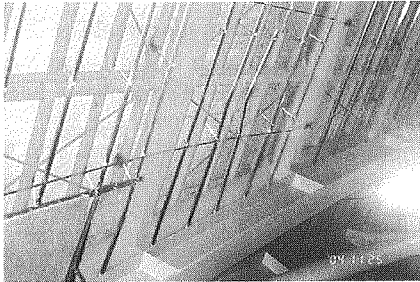
(c) Runners and furrings for the ceiling system

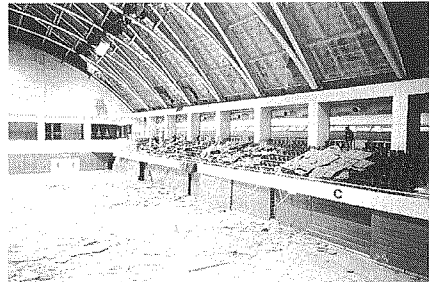
Structural skeletons are non-conventional system combining space truss and arch principle. No structural damage was found in the skeletons. Heavy suspended ceiling panels in the north side of the roof have fallen off in a wide scale. A large part of the north gallery seats were buried under the wreck of ceilings. A lot of hooks, which connect the furrings to the main runners, were deformed and removed with the furrings. During the earthquake the arena was in use and a student was badly injured by the fallen ceilings. The arena has been closed since soon after the earthquake.

(d) Ceilings fallen onto the gallery seats

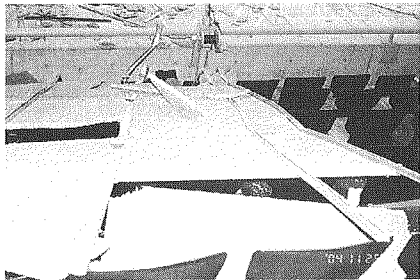
(e) Ceiling panels with the furrings

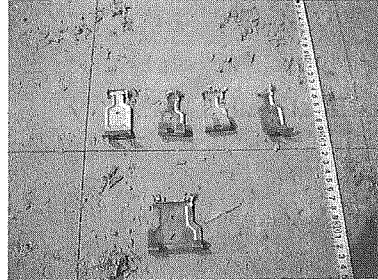
(f) Deformed hooks

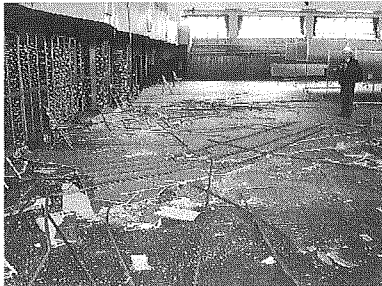
Some cracks were found on the RC seismic walls. No structural damage was found in the roof structures. The ceilings with plasterboards were designed in an arch shape with wavy pattern. The ceiling panels have fallen off in a wide scale, especially at the top of the both gable ends, probably because of collision with the end walls. Again many cross furrings and deformed hooks were also found on the floor. Fortunately nobody was using the arena during the earthquake.

(c) Ceilings fallen off

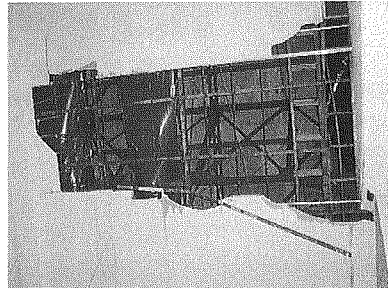
(d) Ceiling furring left

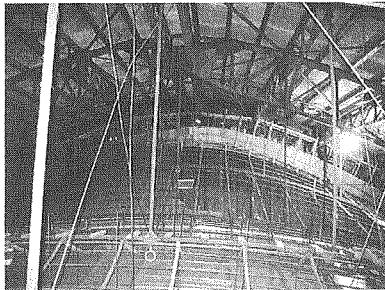
(e) Over the ceiling systems

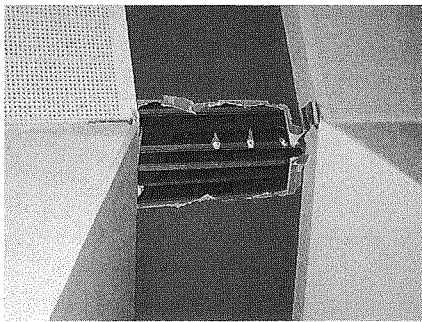
This public hall is located in north area of the city comparatively far from the epicenter. Minor cracks were found on the RC seismic walls. No damage to the roof structure nor roof bearings were found. For architectural finishing, ceiling panels of plasterboard were removed at the edge area of the arena, where inclination of the ceiling changes. The removals are also comparatively small. The arena could open as the relay point of the commodities for refugee.

(c) Location of the fall

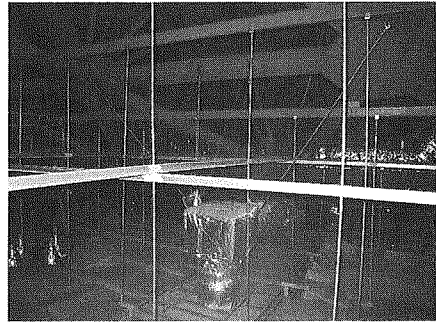
(d) Ceiling systems from upper side

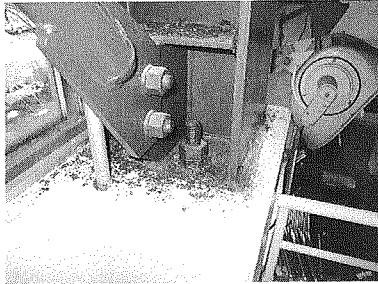
(c) No damage to the structural elements

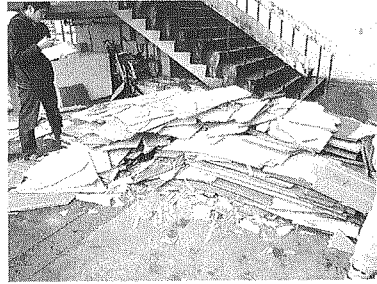
Location of this swimming is closer area to the epicenter. No structural damage was found in the structures of the swimming pool while some major cracks could be observed in the structures of smaller annex rooms attached to the buildings. In the swimming pool arena, a large part of the ceiling panels have fallen off. Larger removal could be found at edge area where suspended ceilings might have collided against walls. Panels around opening for air-conditionings were also removed. Metal work for openings have also fallen off. The ceiling panels were made of rather highly hygroscopic material, which seemed not appropriate for swimming pools. Although many pupils were in the pool during the earthquake, nobody was injured, fortunately.

(d) Piled up fallen ceiling members

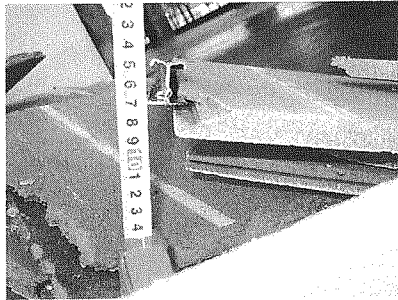
(e) Detail of a ceiling panel connection

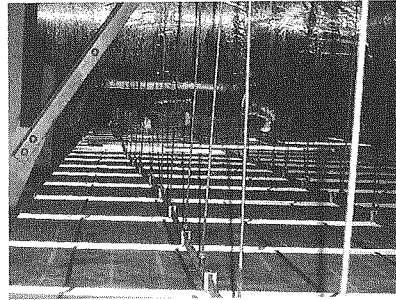
(f) Dislocation of main runners
