Damage to Building Structures due to 2005 October 8 Pakistan Earthquake

Yoshiaki NAKANO¹, Takao NISHIKAWA², Yoshihiro TSUCHIYA³,
Yasushi SANADA⁴, and Hiromi SAMESHIMA⁵

Key Words: Pakistan Earthquake, Building damage, Seismic capacity, Quality of materials, Reinforcement details

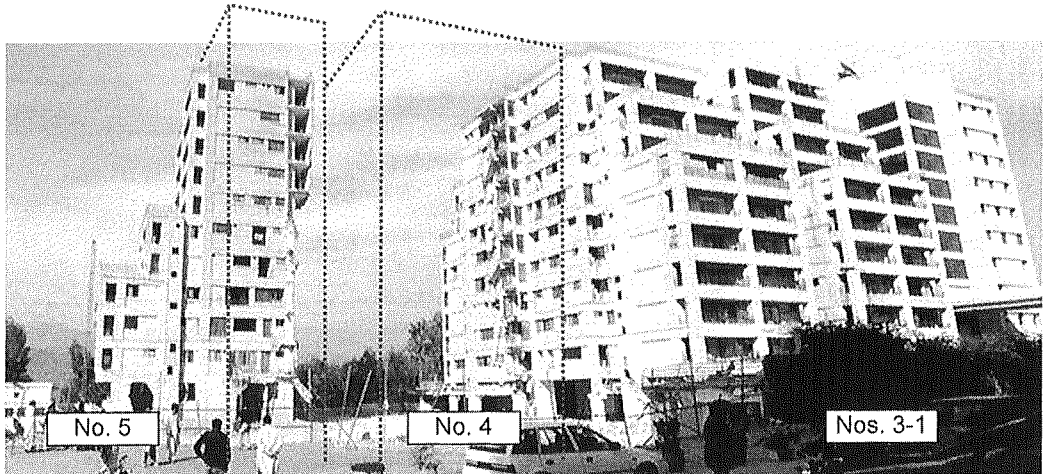
The apartment house consisted of 5 building (**Photo 1-1**). Expansion joints were provided between each building. One building (No. 4) was completely fell down, destroying a part of building No. 5. Although other buildings well survived the shaking and had little major structural damage, URM walls had extensive cracks in the interface between wall and boundary RC frame (beam and column) as well as shear cracks in the wall (**Photo 1-2**). It should be pointed out, however, that these towers were the only buildings that were severely damaged in Islamabad.

Photo 1-1. General view of Margala Towers

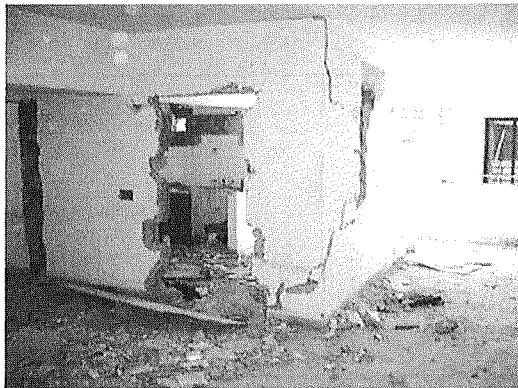
Photo 1-2. Damage to URM walls

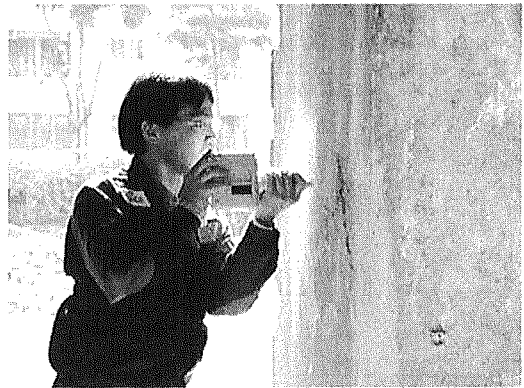
Schmidt hammer tests were made on RC columns (**Photo 1-4**) and the estimated strength was in the range of 12 to 17 N/mm² (reaction factor $R = 29$ to 36).

Photo 1-4. Schmidt hammer test

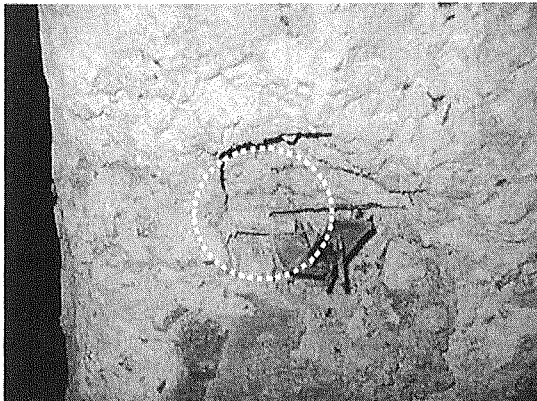
The arrangement of hoops of an RC column was investigated with a rebar detector in the survived building No. 2. They were provided at a space of 30cm in the mid-span and of 15cm at both ends. Their hooks were found 90-degree from exposed hoops although the structural drawing specified 135-degree hooks (**Photo 1-3**).

Photo 1-3. 90-degree hook in RC column (structural drawing specifies 135-degree hooks)

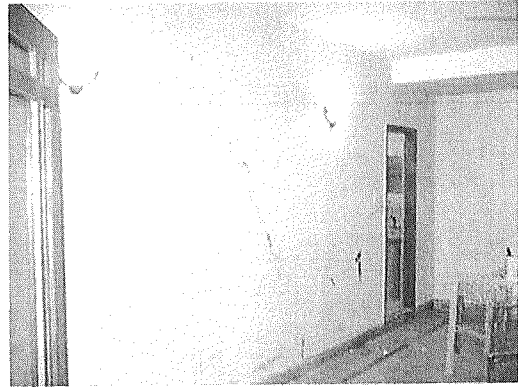
The towers were located neighboring Margala Towers (**Photo 2-1**). Some visible cracks were observed in URM (solid cement block) walls but no structural damage was apparently found in RC columns and shear walls. They were under repairing at the time of the investigation (**Photo 2-2**). The spacing of lateral and vertical reinforcement of an RC wall investigated with a rebar detector was 20cm and 12cm, respectively. According to the structural engineer who designed the building, the diameter of the lateral and vertical reinforcement of the wall was 13mm and 10mm, respectively.

Photo 2-2. Damage to URM wall

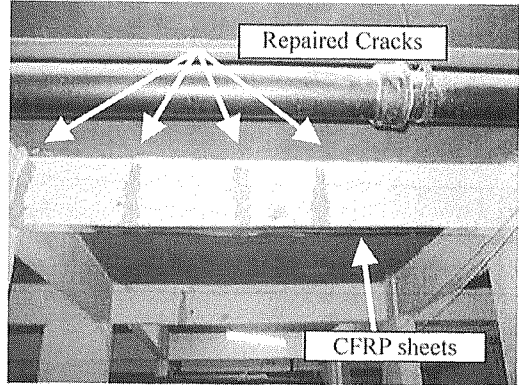
In the basement, cracks were mainly observed in the mid-span of beams (**Photo 3-2**), which implied that they were caused by vertical loads and were likely initiated before the earthquake. More cracks were found in the west building than in the east building. Some of them were repaired with CFRP sheets applied on the bottom of beam and epoxy mortar at the cracks.

Photo 3-2. Cracks in mid-span beams

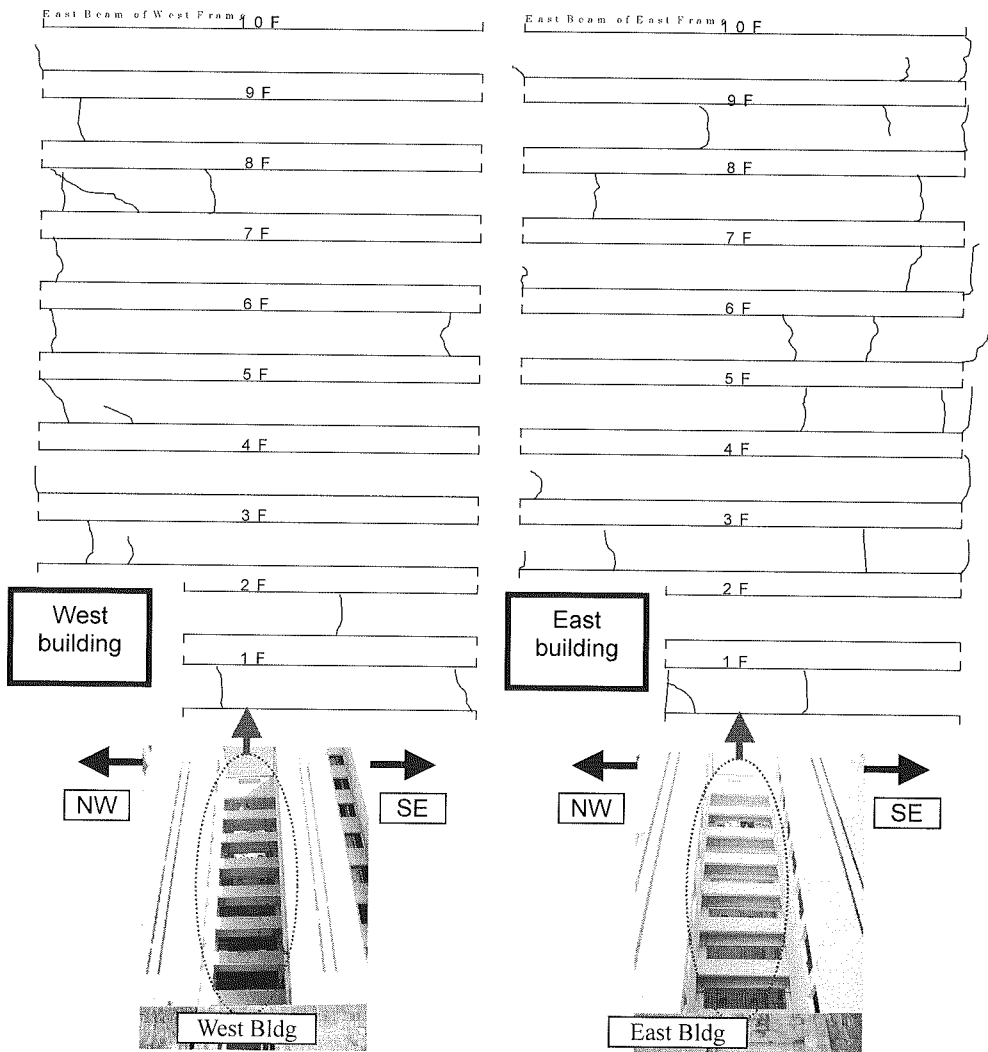
In most upper stories of the west and east buildings, cracks were found in beam-ends of open corridor in the NW-SE direction. They were repaired with epoxy mortar with epoxy injection (**Photo 3-3**). Since their crack patterns traced from the repaired evidence were almost identical in both buildings (**Figure 3**), the two buildings therefore were considered to have behaved in the same manner.

Figure 3. Crack patterns observed in beams of open corridor

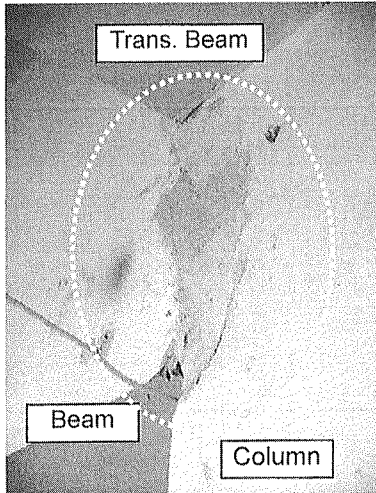
Photo 3-3. Repaired beam end

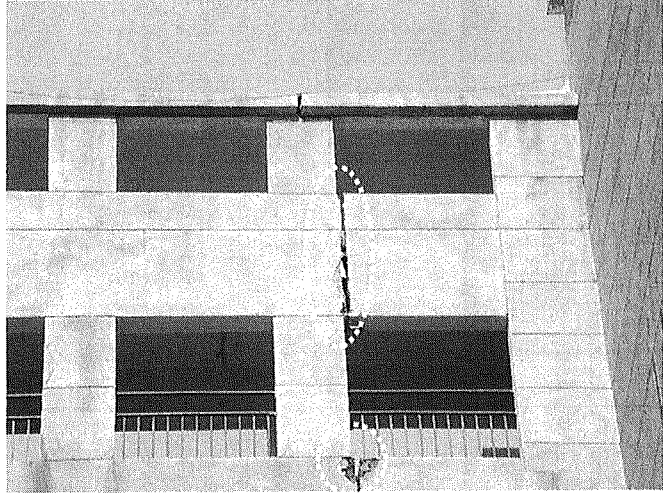
Expansion joints between each building were also damaged due to pounding resulting from their insufficient gaps (**Photo 3-4**). Narrow gaps were often found in other buildings and wider gaps were strongly recommended to prevent pounding damage during strong shaking.

Photo 3-4. Damage to expansion joints (east building)

(6) Pounding: Closely neighboring buildings with narrow gaps at expansion joints sustain pounding damage. Expansion joints should be therefore designed and constructed properly considering deformations expected during shaking.

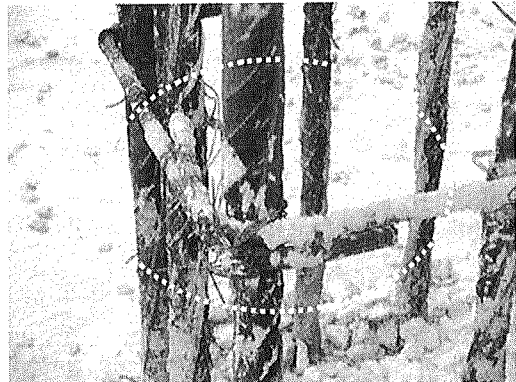
The building was under construction at the time of investigation (**Photo 4-1**). The typical column section was rectangular with 30cm width and 70cm depth. The hoops had 90-degree hooks (**Photo 4-2**). According to the structural engineer who designed the building, the width-to-depth ratio of typical RC columns in Islamabad was 1/2 to 1/3, and URM (hollow cement block) walls were 20cm thick for exterior walls and 15cm thick for interior walls. Some longitudinal rebars of beams were placed out of beam-column joint core concrete. Honeycombs were found in some concrete members. No structural damage was, however, apparently found in the building.

Photo 4-2. 90-degree hooks

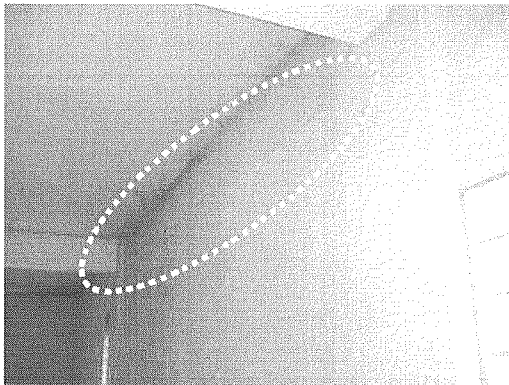
Photo 5-1 shows the general view of the building. The building had some minor cracks in URM walls. Cracks were also found in the interface between URM walls and boundary RC frame (beam and column) (**Photo 5-2**). Most of them were likely initiated before the event and widened due to shaking.

Photo 5-2. Horizontal cracks between URM and beam

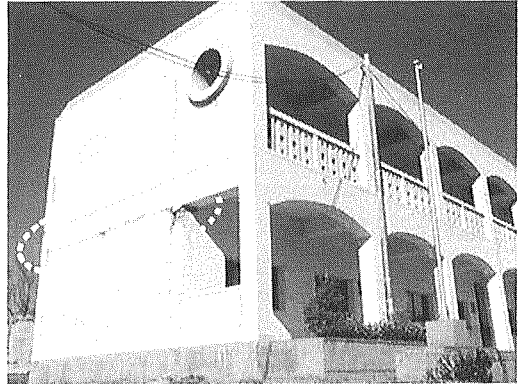
This building was situated on a hillside in Battal along the National Road N-35 running through the village (**Photo 6-1**). The building was designed and constructed in accordance with the Japanese building code since its construction was financially supported by the Japanese Government. It had flexural cracks at the top of a column with exposure of reinforcing bars (**Photos 6-2** and **6-3**). The shear reinforcement of 2-D10 (#3) was provided at a spacing of 10cm with 135-degree hooks (**Photo 6-4**). Although some cracks were found in the core concrete of the damaged part, no buckling of main bars was observed. The damage level of the column was identified to be level III in accordance with the Japanese Damage Level Evaluation Guidelines^{*1}. Minor flexural cracks were also found in almost all other columns in the corridor side ranging from damage level I to II.

Photo 6-2. Damage to column top and URM

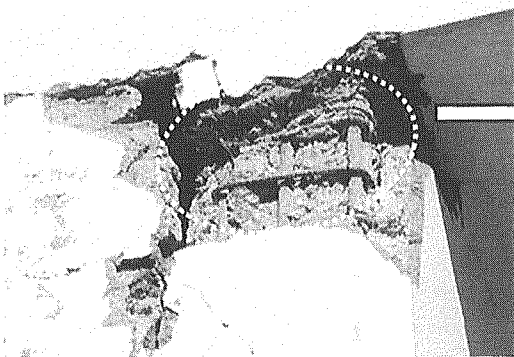
Photo 6-3. Close-up view of damage

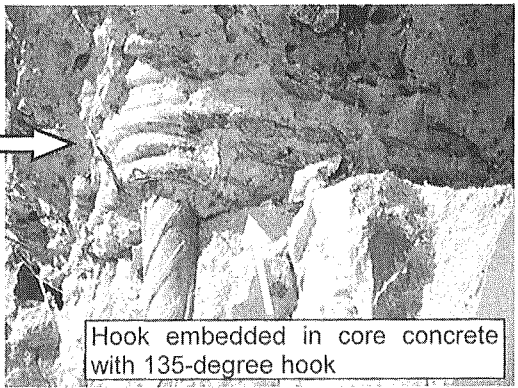
Photo 6-4. 135-degree hook

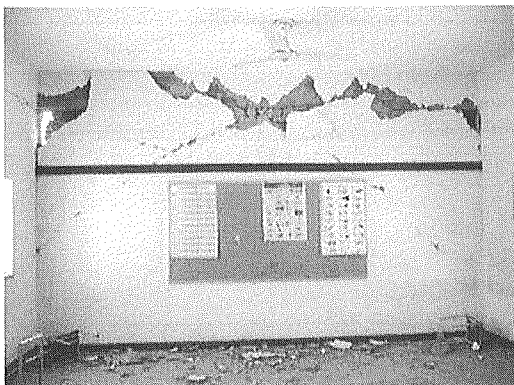
In the URM wall adjacent to the column with major flexural damage stated earlier, extensive shear cracks were found (**Photo 6-5**). Minor cracks were also found in other URM walls. Some furniture in classrooms was found toppled down (**Photo 6-6**), and buildings close to the school had serious damage. Although such strong ground shaking evidence, the school building was identified to be *Light Damage* in accordance with the Damage Level Evaluation Guidelines.

Photo 6-5. Damage to URM wall

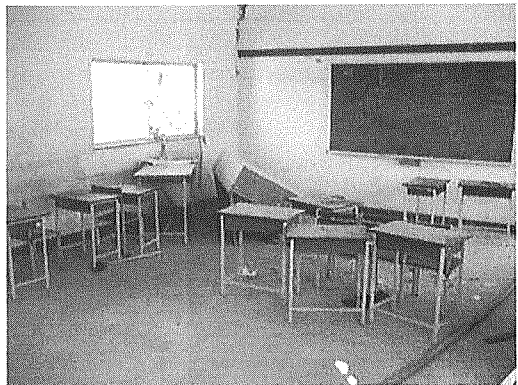
Photo 6-6. Aftermath of quake

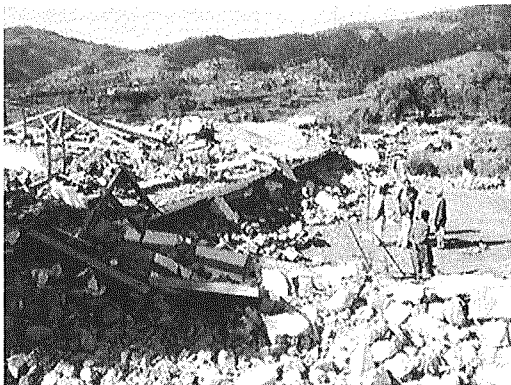
The two-story primary school was completely devastated, showing pancake collapse (**Photo 7-1**). The single-story high school buildings were seriously damaged with extensive cracks and out-of-plane failure of URM walls, although it did not result in total collapse primarily due to light building weight (single story) and tin roof system (**Photo 7-2**). The building collapse reportedly killed 37 students out of some 500 students.

Photo7-1. Collapsed primary school

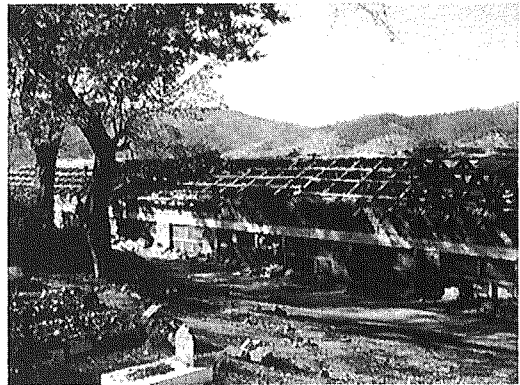
Photo 7-2. Damaged high school

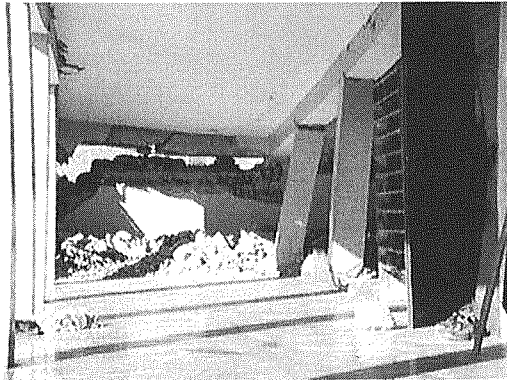
Photo 8-3. Interior damage

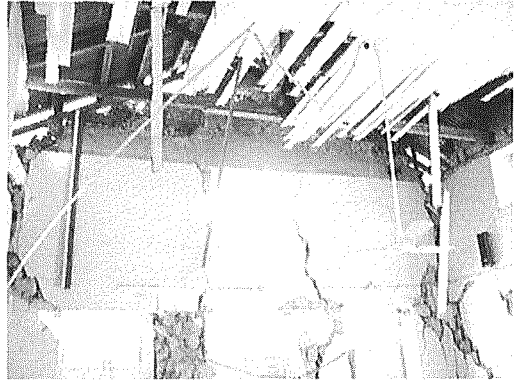
Photo 8-4. Damage to URM wall

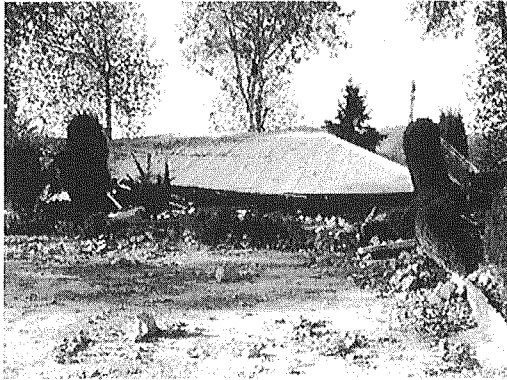
The school consisted of several URM buildings (**Photo 9-1**). Two of them were completely destroyed (**Photos 9-2 and 9-3**). The building collapse reportedly killed 35 and injured 150 out of 450 students.

Photo 9-2. Collapsed school

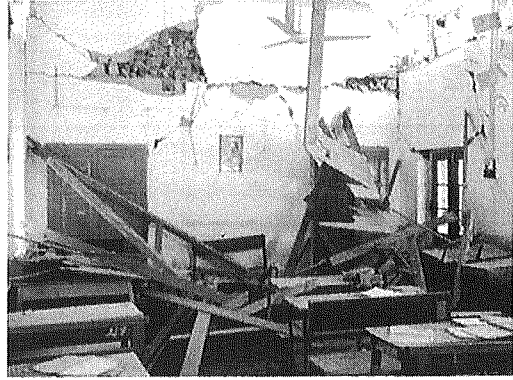
Photo 9-3. Interior damage to classroom

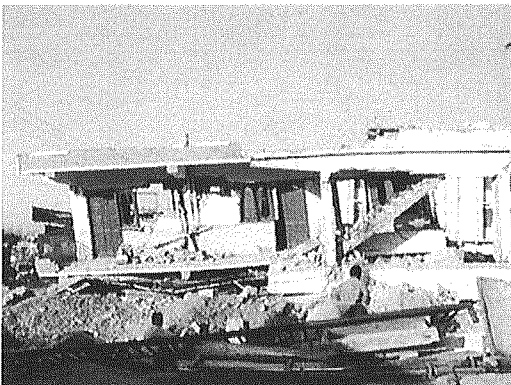
This building was located on the National Road N-35 (Abottabad-Mansehra Road) and lost its first and second stories (**Photo 10-1**). Beam reinforcement was straightly anchored in exterior columns and was not bent and embedded into beam-column core concrete (**Photo 10-2**). Beam-column joints did not have lateral reinforcement. Such detailing did not form rigid connections and moment resisting frames, and it could easily lead to beam-column connection failure.

Photo 10-1. General view of collapsed restaurant

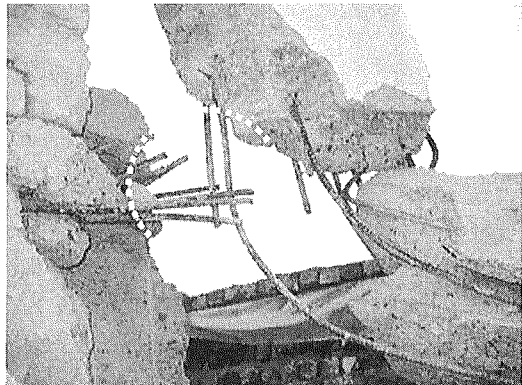
Photo 10-2. Poorly detailed beam rebars

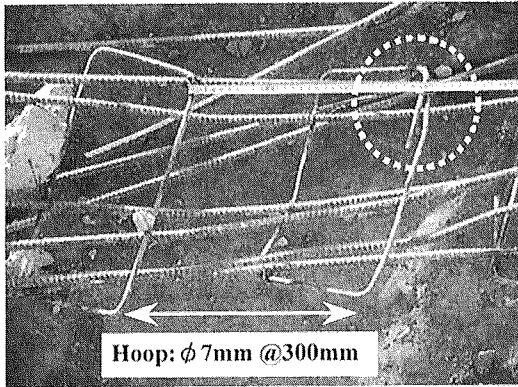
Typical column sections were 25cm x 40cm. Their lateral reinforcement having a diameter of 7mm was provided at a space of 30cm with 90-degree hooks at ends (**Photo 10-3**).

Photo 10-3. Small and widely spaced hoops

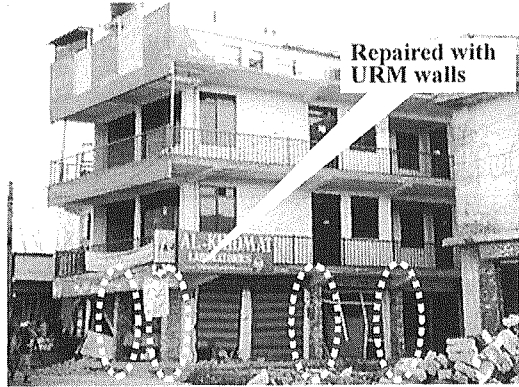
Damage was also found in some neighboring buildings (**Photo 10-4**). They were, however, simply repaired with replacement of bricks in damaged URM walls and/or newly providing narrow URM brick walls underneath beams (**Photo 10-5**), although the structures were still tilted and rebars in columns were buckled (**Photo 10-6**).

Photo 10-4. Damaged neighboring building

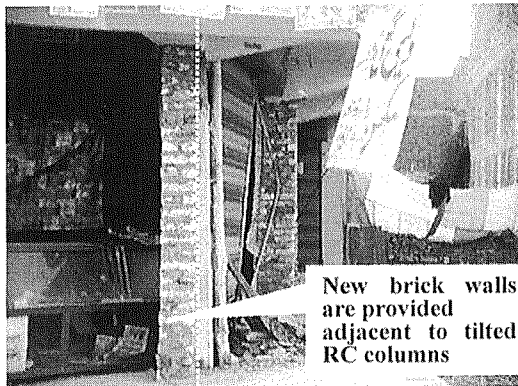
Photo 10-5. Newly provided arrow brick wall

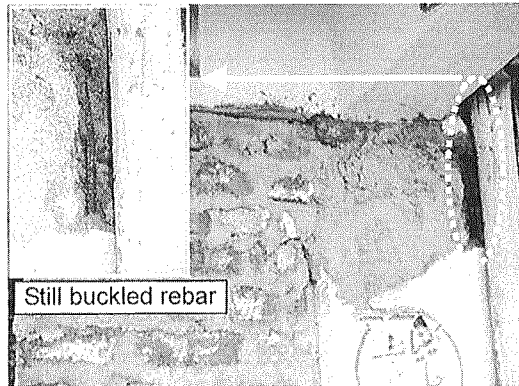
Photo 10-6. Inadequate repair at column top

- * Damaged members are not repaired to have the same section size and/or performance prior to damage.
- * Buckled rebars are not replaced nor additionally confined.
- * Tilted buildings are not re-centered nor no additional members are provided to avoid further inclination.

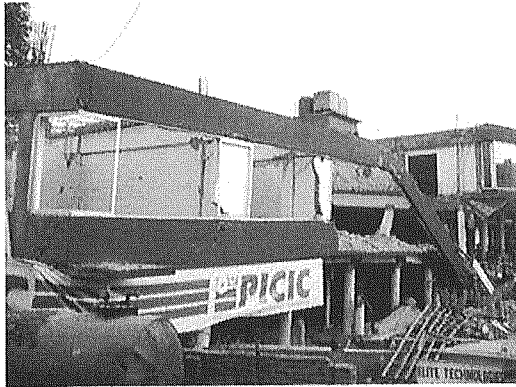
This building was located on the National Road N-35 and failed in the first story (**Photo 11-1**). Beam reinforcement was straightly anchored within a narrow column. Beam reinforcement in the transverse direction straightly went through the beam-column connection and terminated at the column surface without any bent anchorage into the core concrete (**Photo 11-2**). Since no lateral reinforcement was provided in the beam-column joints as was the common practice in Pakistan, the concrete cover spalled off the joint exposing buckled column rebars (**Photo 11-3**). Reinforcing bars failed in a brittle manner without showing necking at the fractured section (**Photo 11-4**).

Photo 11-1. General view

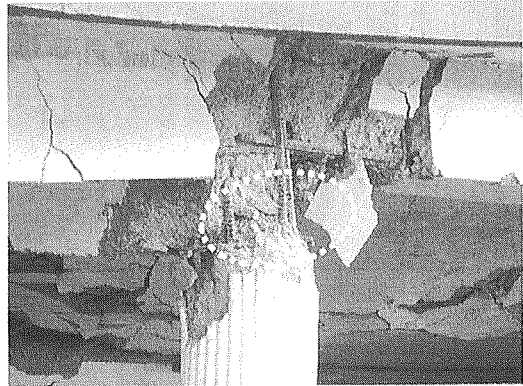
Photo 11-2. Beam rebar terminated at column surface

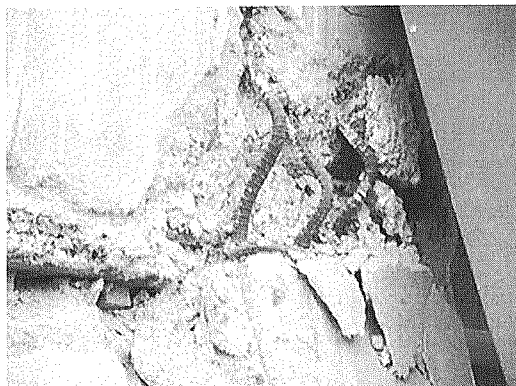
Photo 11-3. Buckled column rebar

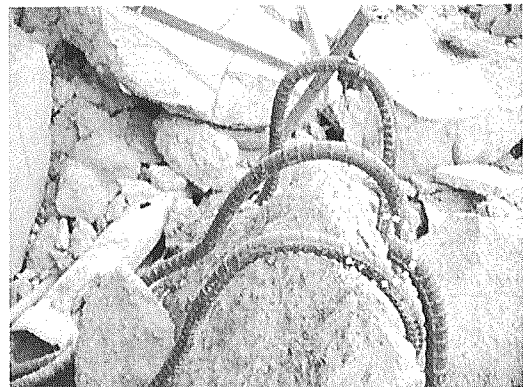
Photo 11-4. Fractured rebar

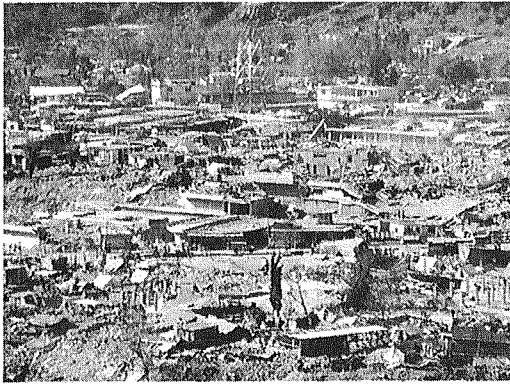
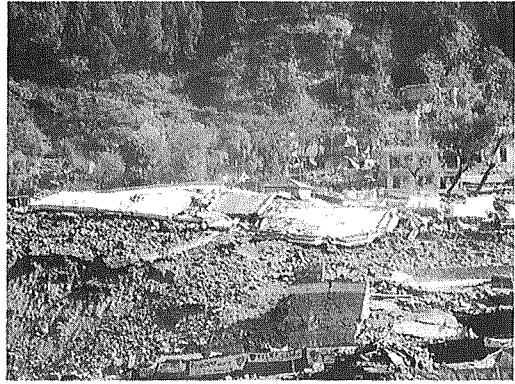
Balakot is located about 25km NW from the epicenter. In central Balakot, 70% to 80% (visual survey) RC buildings and houses were totally destroyed (**Photo 12-1**). Damage was especially devastating on the hillside areas, and almost all buildings there were totally destroyed due to landslide and shaking (**Photo 12-2**). Poor reinforcement details were generally found in beams such as: (a) beam rebar running outside the column reinforcement cage as shown in **Photo 12-3**; (b) beam rebar straightly terminated at the surface of exterior columns without bent anchorage into core concrete; (c) no shear reinforcement at beam-column joints; (d) insufficient overlap length at rebar splice joints in beams and slabs, leading to their pull-out failure.

Photo 12-1. Damage to buildings and houses in central Balakot

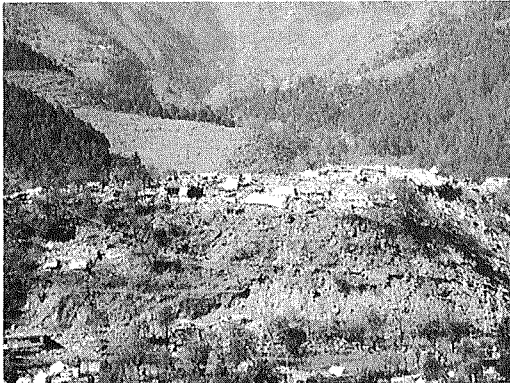
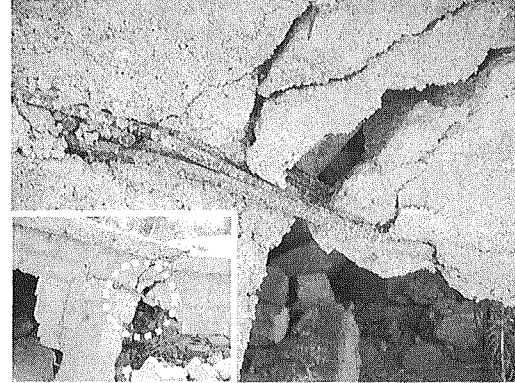
Photo 12-2. Damage to hillside area

Photo 12-3. Beam rebars outside reinforcement cage

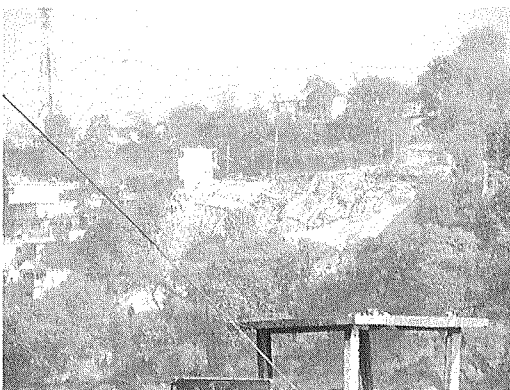
Muzaffarabad is located about 10km SW of the epicenter. Buildings and houses were often constructed on steep slopes and they were eventually devastated associated with slope failures (**Photo 13-1**). Other structural damage to RC houses and buildings was attributed to the poor anchorage at beam-column connections as was found in other cities (**Photo 13-2**). Since beam rebar were straightly developed and terminated in the connection, they were easily pulled out of the connection and did not form RC moment resisting frames. Reinforcement was often found less ductile, and

Photo 13-1. Collapsed buildings on steep slope

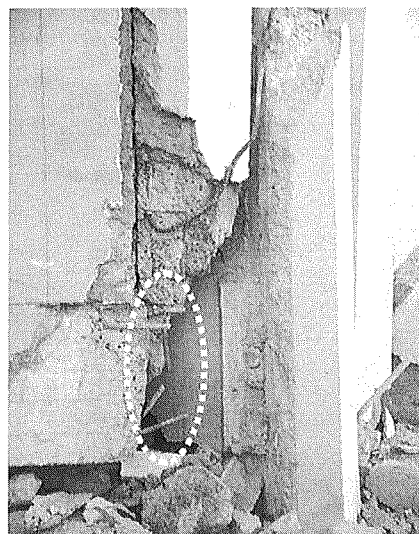
Photo 13-2. Poor detail at connection

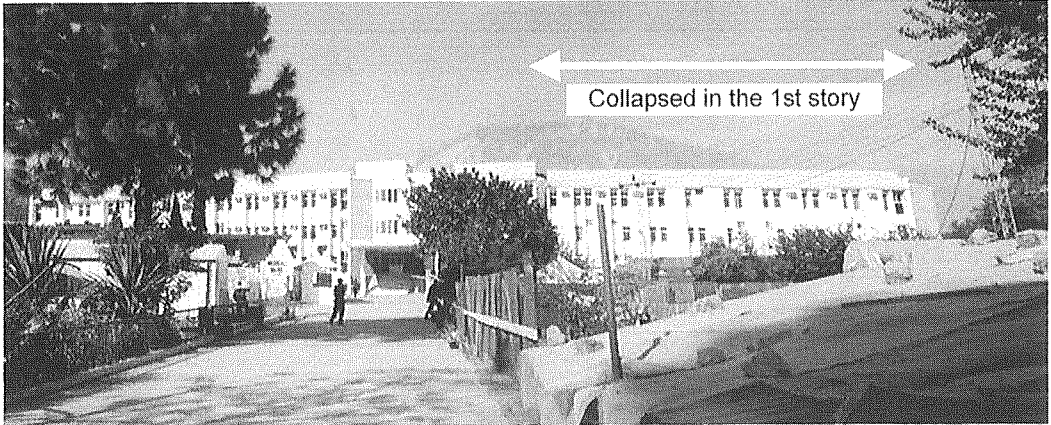
Schmidt hammer tests were made on a survived ward of the Combined Military Hospital (**Photo 13-3**) which partially lost the first story and the estimated strength was 20 N/mm^2 ($R = 39$).

Photo 13-3. Combined Military Hospital

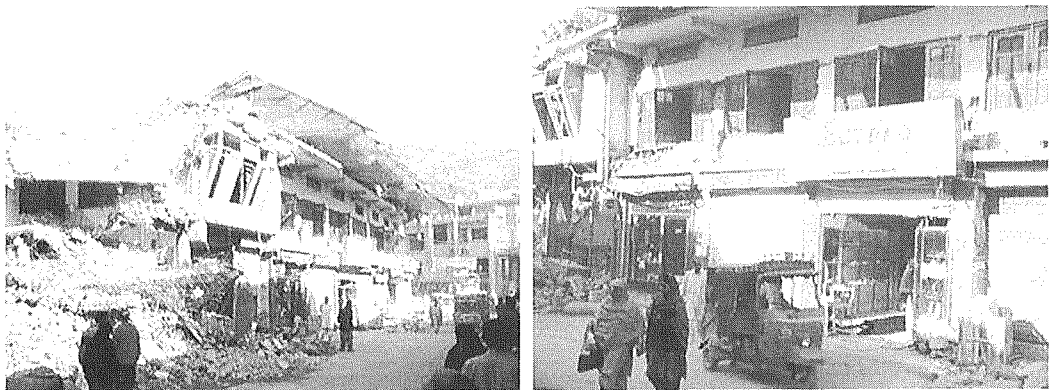
It should also be noticed that some buildings with serious damage and tilting were occupied as they were before the quake, although they were potentially vulnerable to aftershocks (**Photos 13-4 and 13-5**). Development of quick inspection system and technical guides to identify buildings potentially vulnerable to aftershocks was needed in this city.

Photo 13-4. Continuously occupied vulnerable buildings

(9) Quantitative Post-earthquake Damage Inspection: Some seriously damaged buildings are still in continued use before properly rehabilitated. One may find such examples in commercial buildings and shops in Muzaffarabad. To mitigate life-threatening hazard of damaged buildings due to aftershocks, quick inspection system and inspection engineers are most needed.

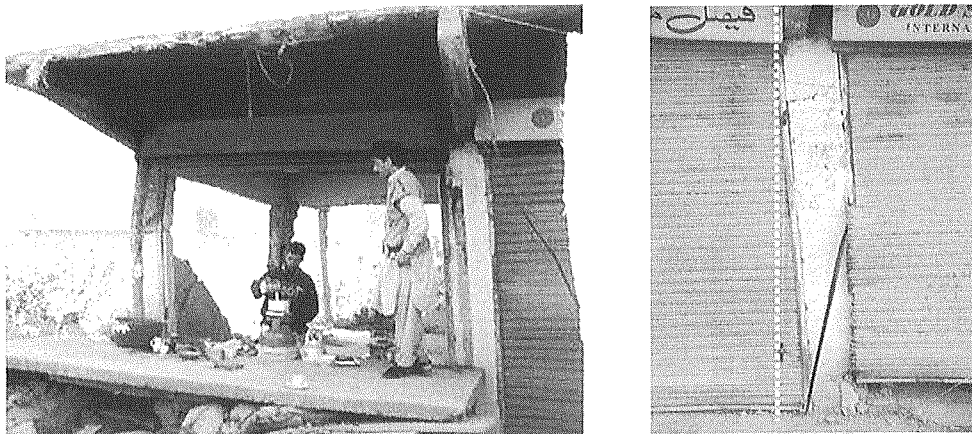
Photo 13-5. Vulnerable building in continued use (residual drift: 10%)

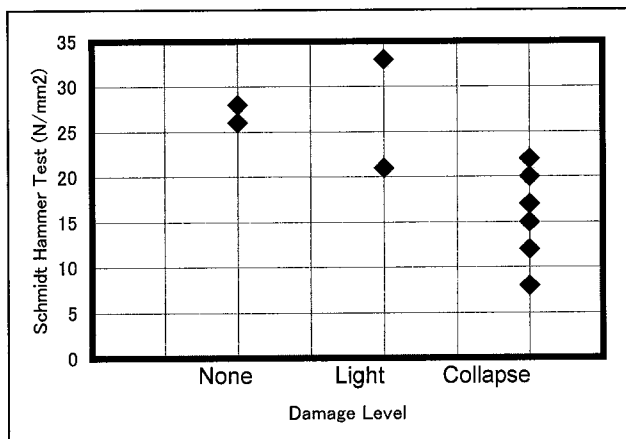
Comparison of damage level and Schmidt hammer test results

As can be found above, buildings with lower concrete strength generally have more serious damage. Good quality of concrete should be therefore achieved for a better seismic performance.
