DAMAGE TO ROADS CAUSED BY OCT. 8, 2005 NORTH PAKISTAN EARTHQUAKE

Obaid Hassan QURESHI ¹ and Junichi KOSEKI ²

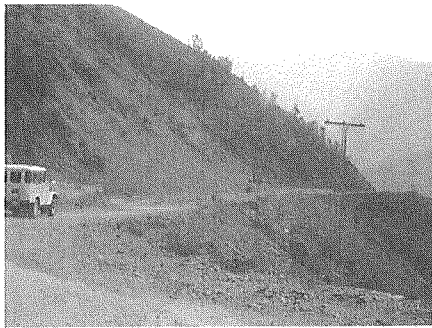
Fig. 4: Road No.1, Site No. 1

Fig. 4 shows the slope failure at Site No. 1 (marked in Fig. 2) located at about 10 km from Muzaffarabad. The failure was surficial nature and the road was cleared quickly after the incident.

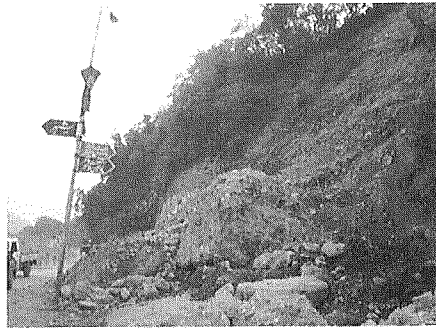
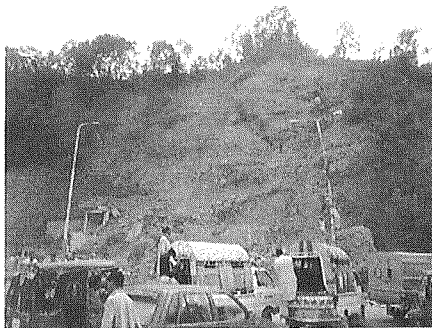
Figs. 5(a) and 5(b) show the failure of a steep cut slope in the city of Muzaffarabad. This slope has been posing threat for many years. Some shops were constructed right against the slope and were completely damaged by the fall of huge conglomerated alluvial deposit. Similar slope failure is most likely for the slope on local road near Tonga Adda in Muzaffarabad as shown in Fig. 6.

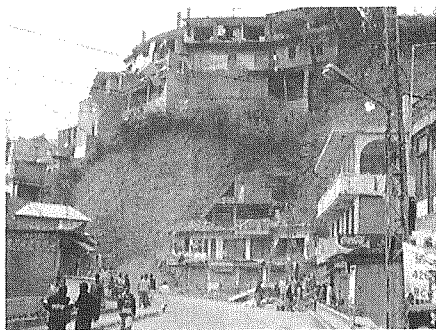
Fig. 6: A local road near Tonga Adda, Muzaffarabad

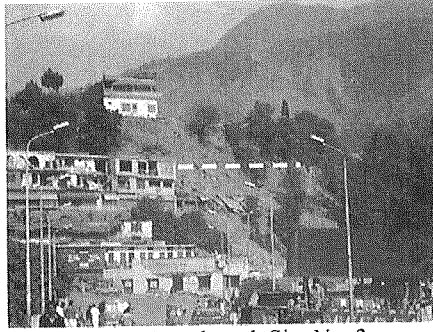
Fig. 7: Local road, Site No. 3

Fig. 7 shows the disappearance of a local road leading to Dhakki Adda in Muzaffarabad. Some buildings on its valley side have also been collapsed.

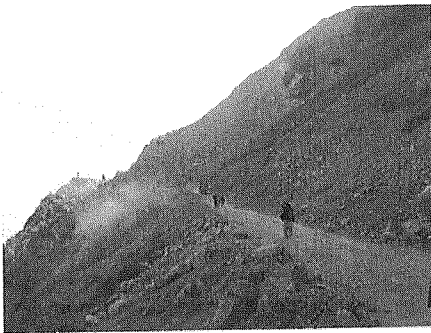
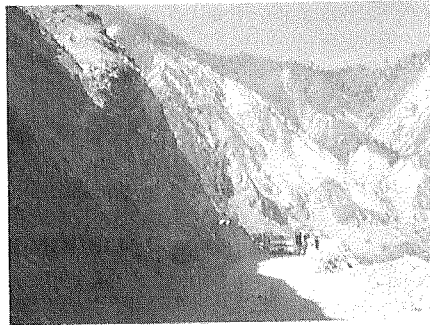
Figs. 8 and 9 show that the roadway (Road No. 2) practically disappeared after the earthquake and had to be cleared and realigned. The shown road was paved prior to the earthquake and is now has merely a gravel top layer. Most of the length of this road was closed for traffic at the time of visit.

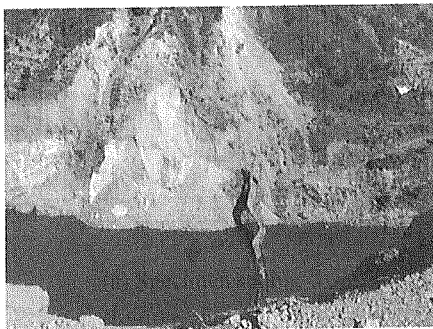
Fig. 10: Road No.2, Site No. 5

A suspension bridge on a local road leading to Dhani Maece, slightly off the Road No. 2, to the north of Muzaffarabad was completely collapsed as landslides toppled the suspension towers as shown in Fig. 10.

A suspension bridge on a local road leading to Dhani Mae, slightly off the Road No. 2, to the north of Muzaffarabad was completely collapsed as landslides toppled the suspension towers as shown previously in Fig. 10.

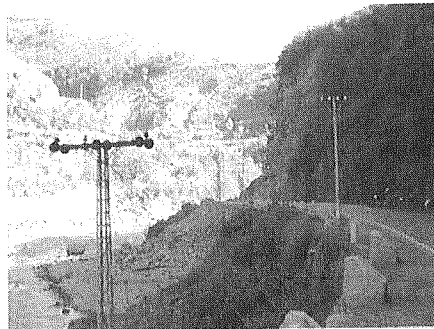
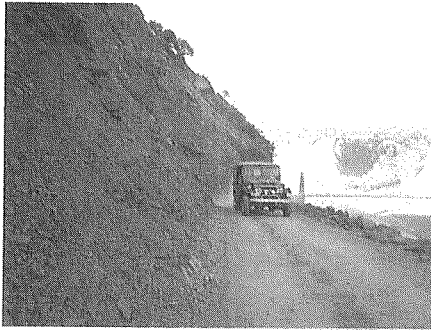
Figs. 11 and 12 show the failure of steep natural and cut slope on Road No. 3, in the west of

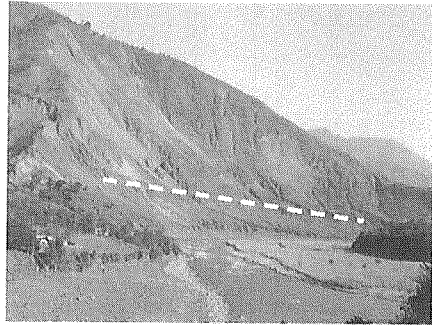
Fig. 13: Local road, Site No. 9

Muzaffarabad, whereas Fig. 13 shows the complete collapse of a local road, located opposite to Road No. 3, due to slope instability.

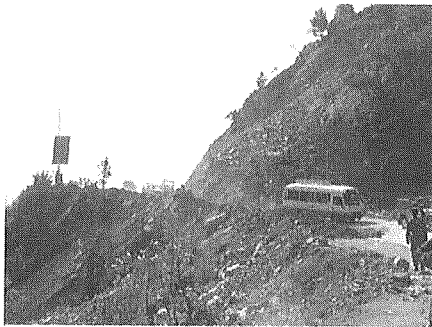
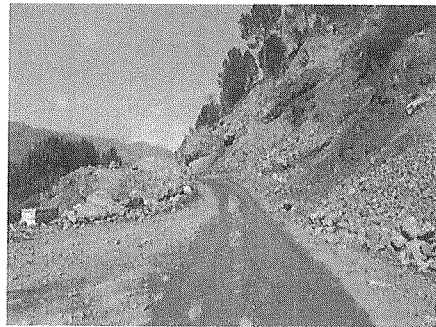
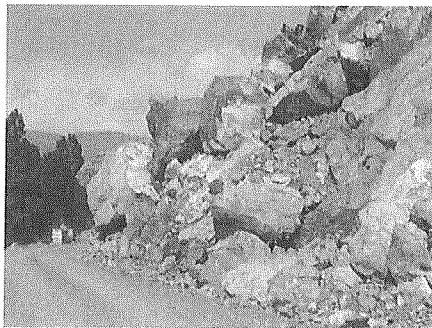
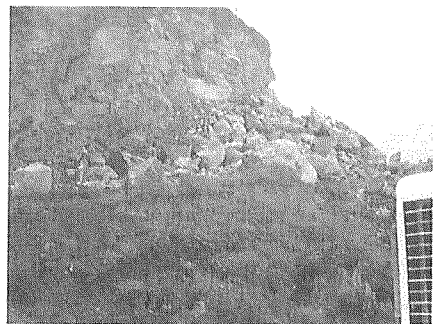
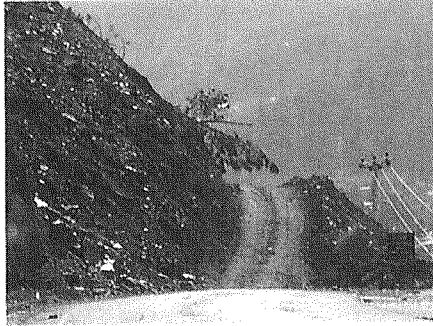
Figs. 14 through 18 show the slope failures on Road No. 5 and 6 around Balakot. These roads were upgraded in the recent years and were performing well until the catastrophe. It is to be mentioned that the wet surface of the road visible in Fig. 15 is artificial sprinkling at the roadway done for the convenience of passengers in order to avoid dust.

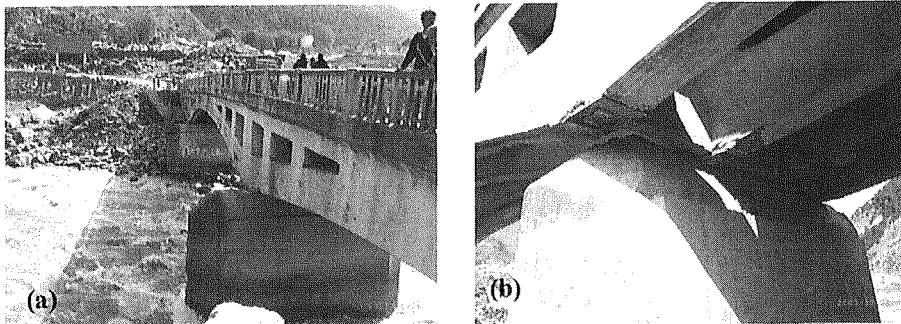
Fig. 19 shows the Balakot Bridge on the Kunhar River, which was knocked off its bearing supports. Lack of lateral restraints allowed displacement of the bridge that resulted in one outer girder hanging freely and other girders left with minimal bearing over their supports.

Fig. 19: Displacement of deck of Balakot Bridge towards south and east.

Vertical motion may have played a significant role in reducing the vertical force on the bearings, leading to the large observed lateral displacement.

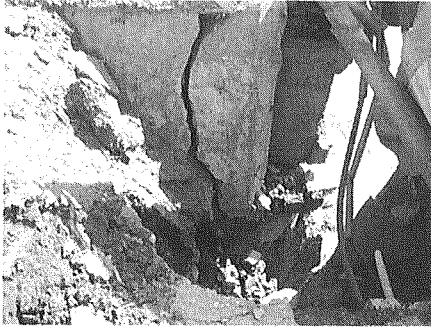
Fig. 20: Abutment failure of Balakot Bridge

Only a few cases of abutment and culvert failure were observed. Figs. 20 through 23 present those cases.

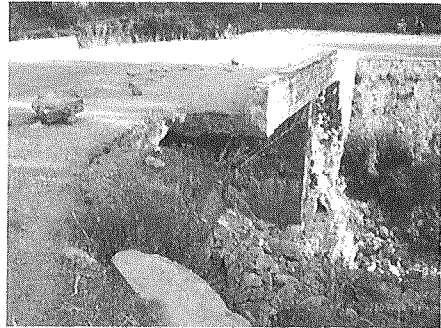
Fig. 21: Abutment failure of a bridge on a local road in south of Balakot

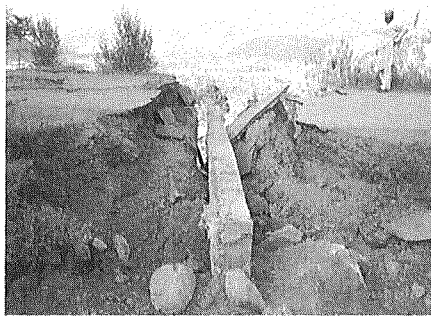
Fig. 22: Collapse of a culvert on a local road in south of Balakot

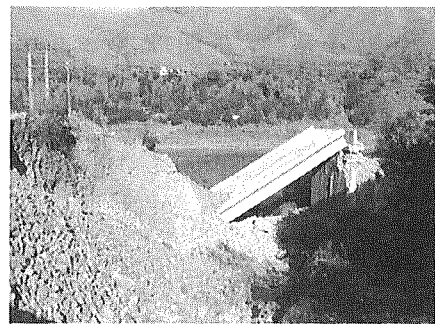
Fig. 23: Abutment failure of a bridge on Road No. 3, east of Muzaffarabad

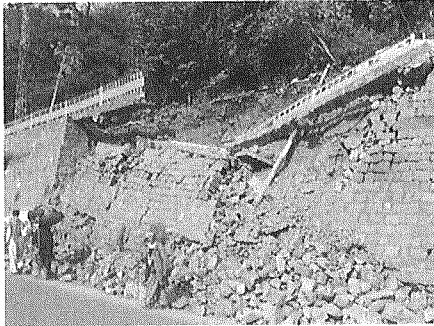
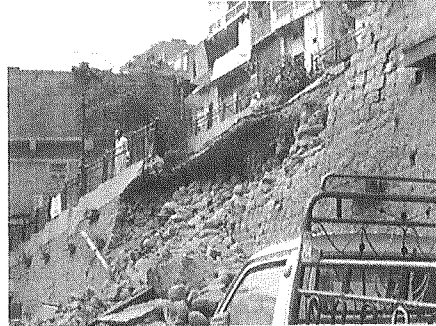
Figs. 24 and 25 show the collapse of retaining walls of local roads in the city of Muzaffarabad. The backfill material in these two cases is sub-rounded to rounded cobbles with very small fraction of fine material, rendering an inadequate backfill both in terms of material specifications and compaction.

Inadequate backfill both in terms of material specifications and compaction was observed in some cases of damaged retaining walls in Muzaffarabad region.

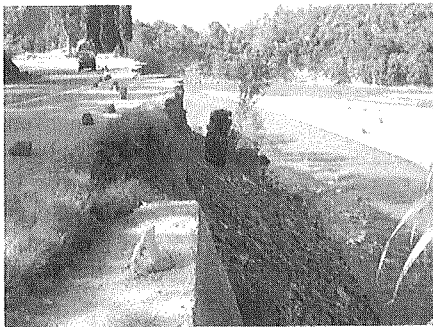
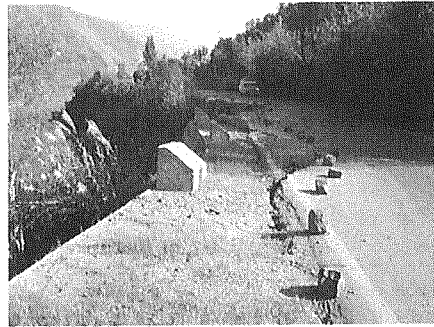
Figs. 26 and 27 show the collapse of a retaining wall and backfill material on Road No. 3, east of Muzaffarabad. A truck met an accident during this collapse and can be seen standing vertical in the collapsed debris. Erosion from the river Jhelum water helped in the collapse.

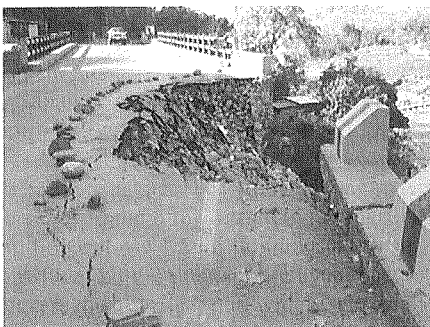
Fig. 28: Road No. 3, east of Muzaffarabad

Fig. 28 shows the collapse of the gravity retaining wall adjacent to abutment of bridge on Road No. 3, east of Muzaffarabad, near Garhi Dopatta. The retaining wall on the other side of the bridge also collapsed in a similar manner. As were the cases with the retaining walls shown in Figs. 24 and 25, the backfill material as seen in Fig. 28 is rounded to sub-rounded cobbles with very small fraction of fine material.

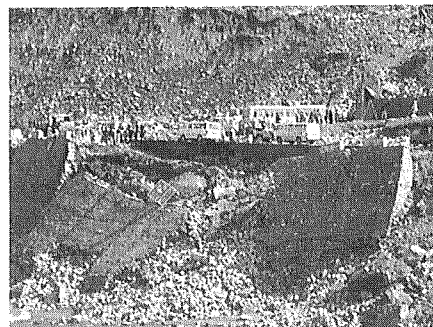
Fig. 29: Road No. 6, Balakot

In Balakot, a gravity retaining wall made of stone masonry was severely damaged (Fig. 29) due to massive ground deformations associated with landsliding.

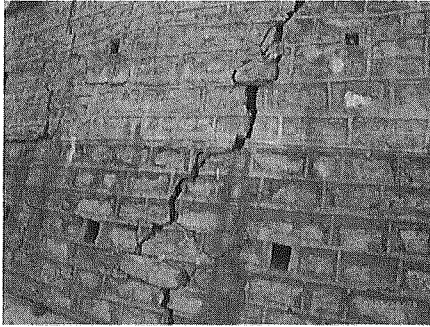
Fig. 30: Road No. 6, north of Balakot

Fig. 30 shows massive tensile cracks in a masonry breast wall on Road No.6, north of Balakot, whereas Fig. 31 shows the collapse of a road segment (Road No.5, south of Balakot) due to combined effect of the earthquake and erosion by the river Kunhar thereby emphasizing the use of properly designed retaining structure.

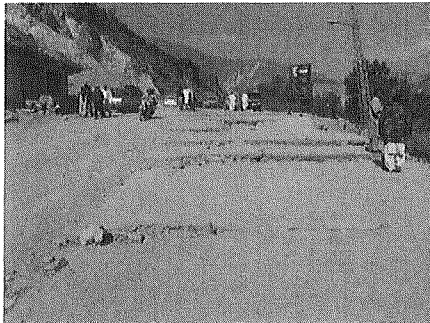
Fig. 32: Road No. 2, north of Muzaffarabad
(Site A in Fig. 36)

Numerous transverse and longitudinal road ruptures were observed in the affected area. Figs. 32 and 34 indicate that the measured horizontal and vertical movements of road ruptures were about 30 cm.

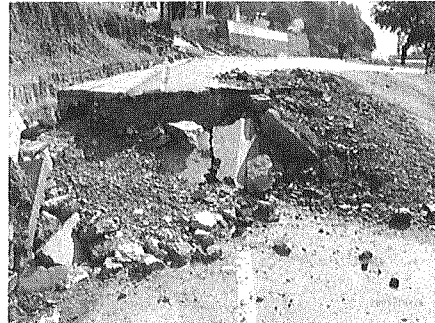
Fig. 33: Road No. 6, north of Balakot
(Site B in Fig. 36)

Fig. 33 shows huge dislocation of Road No. 6, north of Balakot. The vertical displacement is about 90 cm.

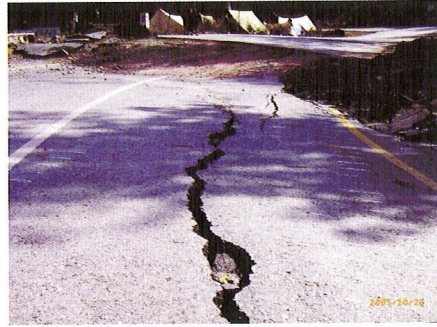
Fig. 35: Road No. 6, north of Balakot (Site D in Fig. 36)

Tobita et al (2005) presented the deformation map of the area during this earthquake (Fig. 36). The sites shown in Figs. 32 through 35 are plotted on the deformation map here, which gives a hint that the ground ruptures at the above-mentioned sites can be the surface effects of underlying fault. But the detailed field investigation is necessary for reaching to a conclusion.
