# STRONG GROUND MOTIONS AND SOIL DEFORMATIONS IN THE MAY 27, 2006, MID-JAVA EARTHQUAKE\*

**ABSTRACT:** A devastating earthquake occurred in Mid-Java, Indonesia on May 27, 2006. Japan Society of Civil Engineers (JSCE hereafter) dispatched its first investigation/technical support team including ERS members to the severely damaged areas; south of Yogyakarta in Indonesia by this earthquake during the period from June 10 to 17, 2006 in a close cooperation with the Indonesian Institution of Engineers (PII) and the Ministry of Public Works, Indonesia. This report describes briefly findings obtained through the authors' reconnaissance, highlighting some geotechnical issues for better rehabilitations.

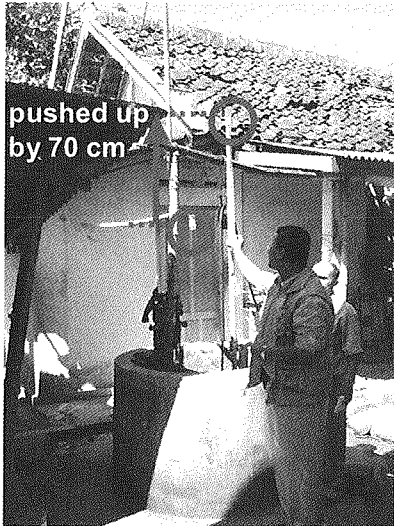
(a) S7deg. 57.416 min,  
E110deg. 18.291 min  
plastic pipe was pushed 0.7m up.

surrounding the wells were seemingly less serious than in other areas with no clear evidence of liquefaction. Examples of this contrast are shown in Fig. 3. Liquefaction can be the cause of serious destructions to be sure, but it is often observed that liquefied soil isolate the upper soil mass from intense seismic motions. As long as a surface soil mass above the liquefied sand remains coherent, damage to dwellings on the soil mass can be slight. Further studies will be needed.

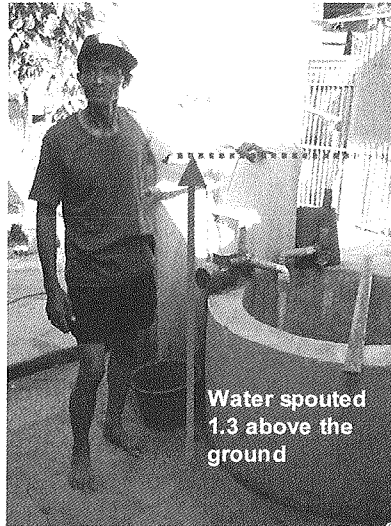
(b) S7deg. 53.706 min,  
E110deg. 22.995 min  
dark colored water spouted about  
1.3 m up above the ground level.

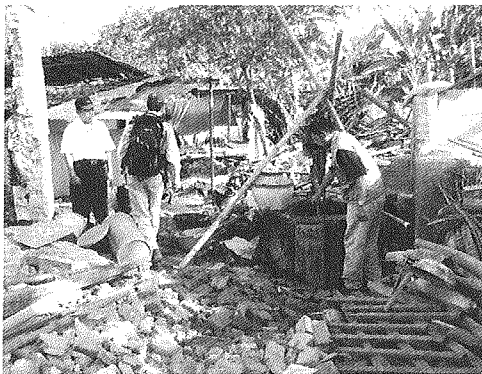
(c) S7deg. 53.458 min,  
E110deg. 23.186 min  
no change in water level of -5.0 m.

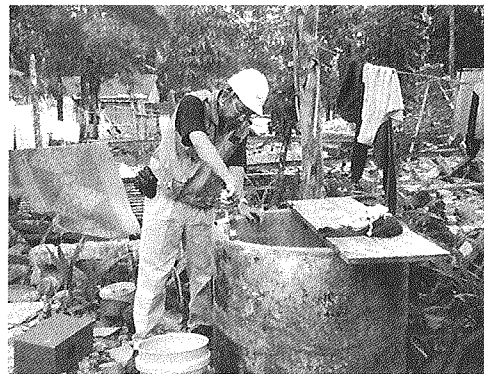
(d) S7deg. 51.044 min,  
E110deg. 20.031 min  
water level decreased by about 0.25 m.

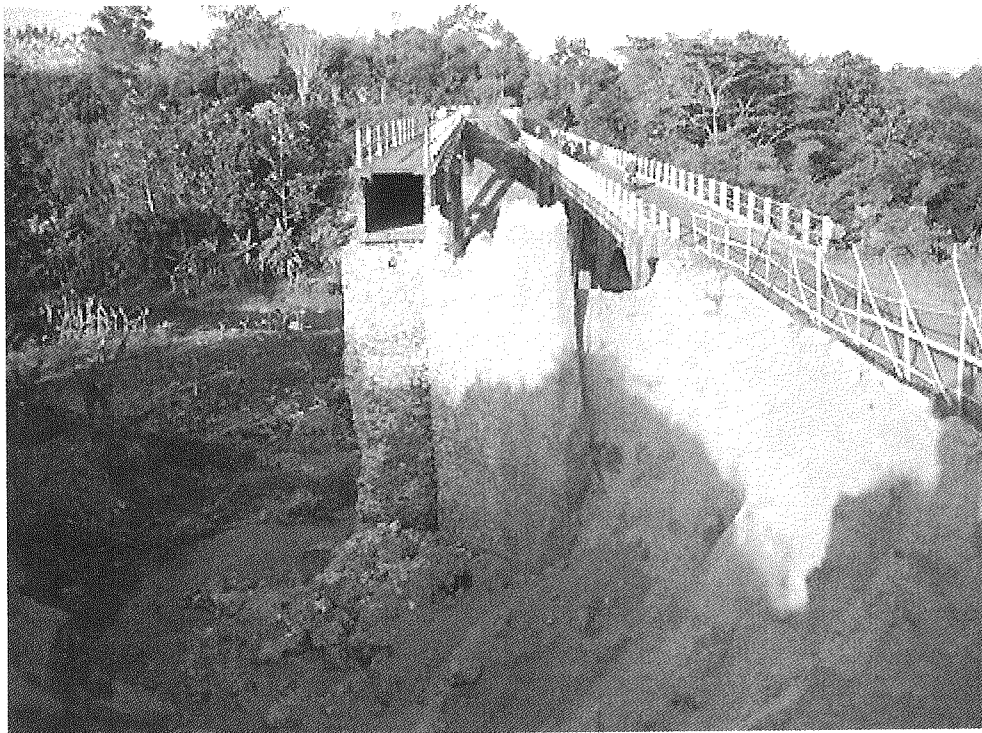
A bridge of Mataram canal, supplying drinking water and irrigating 19,000 ha of land extending the lower basin of Progo and Opak river, was damaged as shown in Fig. 4. Two masonry abutments and four RC piers support a steel box aqueduct of 80m long. RC open channels on both riversides resting on embankments narrow to this aqueduct. The sandy soil mass of the right embankment behind the masonry abutment of about 10m high slid down towards the river. The scar was formed 26 m west behind the abutment immediately beneath a construction joint of the open channel, suggesting that water might have been seeping through the joint into the embankment soil (Fig. 5).

Fig. 4. Mataram canal bridge: Soil mass of right embankment behind masonry abutment has gone.

Quick restoration of the bridge is a must because of the canal's important functions. Moreover, a road running along the canal resting on the remaining soil mass of the same embankment is under a threat of subsidence. However, a complete reconstruction of the embankment will be just a stop-gap measure, and won't mitigate its geotechnical hazard potential. Even an inch settlement of the embankment will cause cracking of concrete joints, and water will leak again through the joints. A possible and efficient measure may be to replace the embankment with some piers.

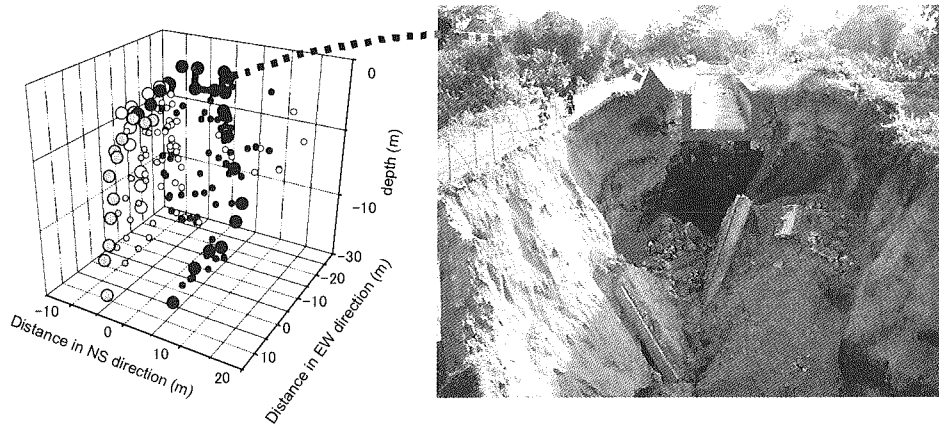
Fig. 5 Measured cave: The cave of the embankment was laser-scanned for its 3D image. Total soil volume about 2,000 m<sup>3</sup> has gone. Scar did appear immediately beneath the construction joint.

It is seemingly often that gritty sandy loam of volcanic products (tephra<sup>\*</sup>) is used as fill materials. These soils often have inclusion of porous fragments of pumice. When they are dry, they loose cohesion. But when moist, they are plastic, and retain water easily. When porous wet pumice fragments are crushed, porewater pressure increases causing the entire soil to fluidize<sup>\*\*</sup>. But they yet can drain well where the surface configuration allows. Fill materials with the features mentioned above, requires appropriate drainage works. (See APPENDIX for the action taken)

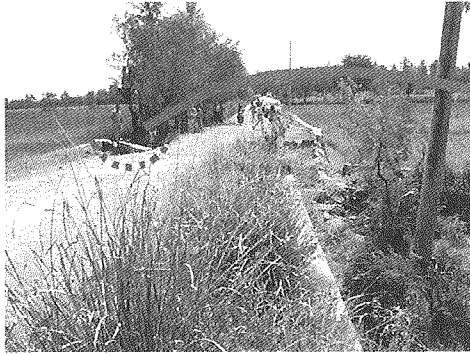
A skewed simply supported RC bridge (4 beams) of 3.5 m wide fell down due to embankment soil subsidence. The sunken soil mass seems to have pushed bottom of a stream flowing near by the embankment.

(a) Location of skewed bridge: Edge lines of road are seemingly dislocated right-lateral. However no clear dislocation was found in rice paddies.

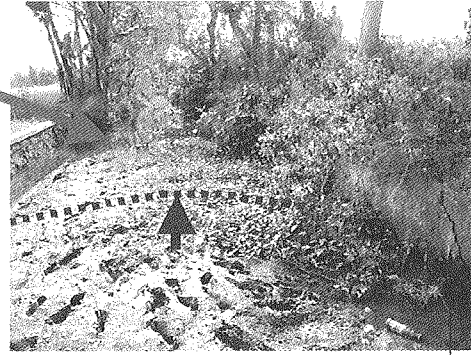
(b) Bottom of stream along the road has been pushed up

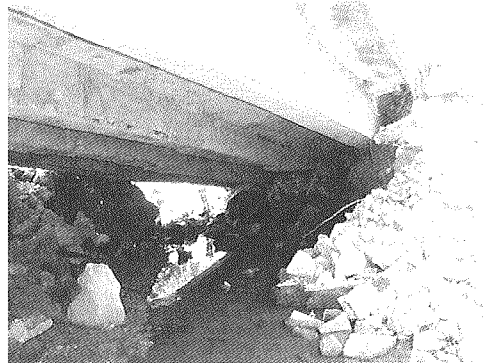
(c) Four simple beams support the deck.

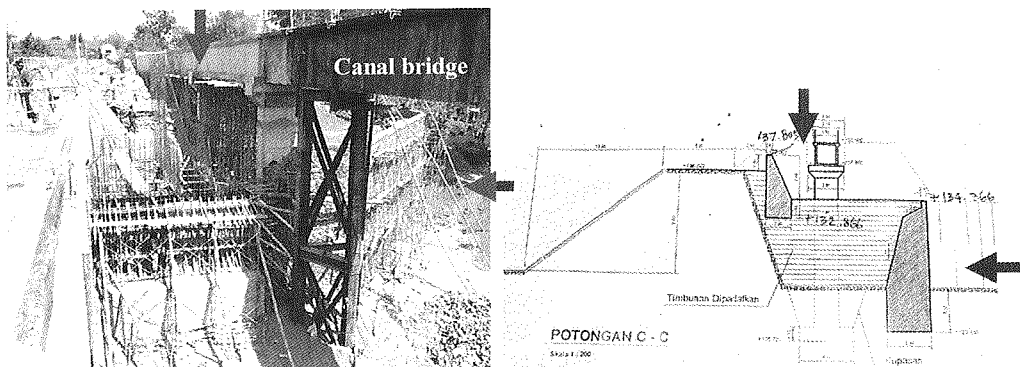
Fig. A1. Reconstruction of Mataram Canal Bridge (Photo taken on Sept. 17, 2006)

some clearance between the road embankment and the canal bridge, a massive retaining wall is being constructed in between the canal and the road (See Fig. A1 below). If the 9.5m high masonry retaining wall with no reinforcement breaks and/or displaced, the piers for the canal bridge can move with the loading berm, causing some damage to the concrete open channel of the canal.

The approach of the canal bridge, an open concrete channel, is now supported by three piers, and therefore this part seems to be rationally reconstructed avoiding possible repetition of embankment erosion due to water leakage (See Fig. A1 left).

However difficult problem seems to be lying in that a road runs along the canal on the embankment. To fully utilize the remaining embankment, a loading berm is being put at the toe and on the canal bridge side of the embankment to stabilize the slope. This loading berm is retained by about 9.5m high masonry wall standing upright. Eventually piers of the bridge are half embedded in the loading berm. Moreover to make
