GEOTECHNICAL SURVEY REPORT ON 2006 YOGYAKARTA (MID-JAVA) EARTHQUAKE

Ruta Ireng WICAKSONO¹, Junichi KOSEKI², and Takashi KIYOTA³

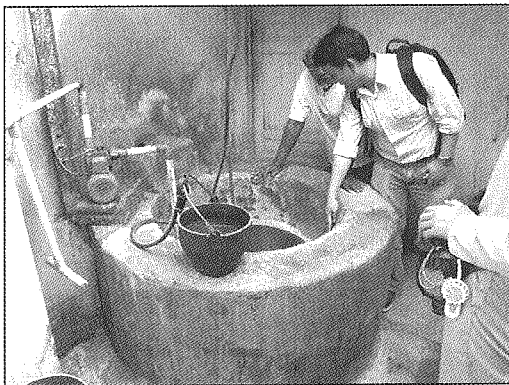
Photo 1. Plugged well at Site A

At site A at Bintaran Kidul in Yogyakarta city, several wells were plugged by sandy soil due possibly to liquefaction. According to the owner of a well (Photo 1), muddy water followed by sudden rise of water level in the well was observed immediately before the earthquake. Then during the earthquake, water

spouted out to a height about 2.5 m. The thickness of sandy soil which plugged the well was about 3 m. The plugged sandy soil was re-excavated and was used to re-fill around the well casing which suffered from the relative settlement of about 5 cm.

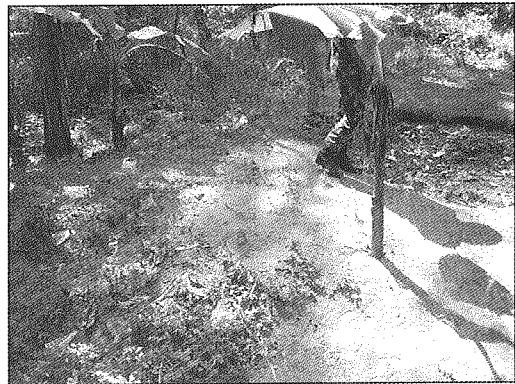
Photo 2. Evidence of sand boiling in banana field at Site B

At site B at Jagalan village, Tegal Tirto, Berbah in Sleman District, sand boiling occurred in banana and paddy fields as shown in Photos 2 and 3, respectively. As shown in Photo 4, one of the residents showed his water pump system that had been replaced with new pipe line, since the previous pipe line was plugged by sandy soil after the earthquake. At this site, a dynamic cone penetration test was conducted measuring number of blow count, N_d that is converted into equivalent N_{SPT} value (Atarashi, 1986). As shown in Figure 3a, soft soil deposit with N_{SPT} values less than 10 could be found at maximum 3 m in depth, where the ground water level was about 2 m from the ground surface.

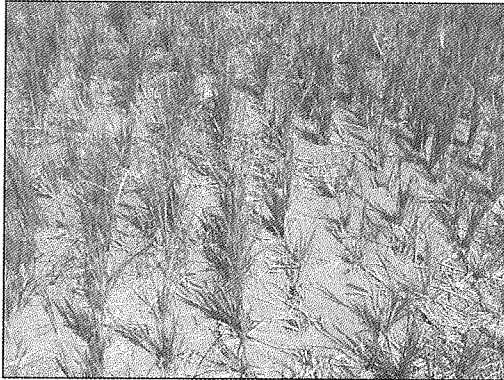
Photo 3. Evidence of sand boiling in paddy field at Site B

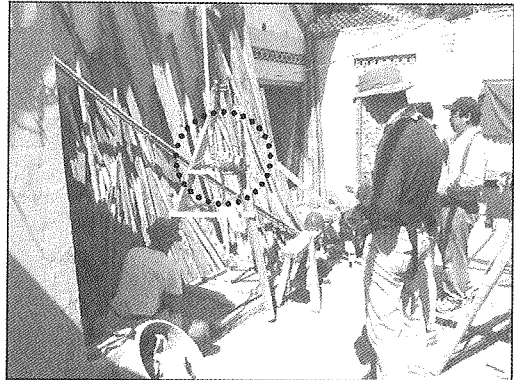
Photo 4. Water pump at Site B

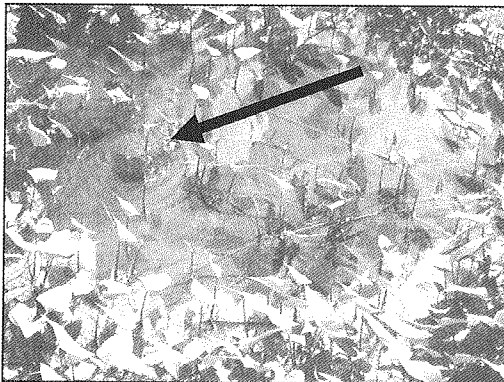
At site C at Candirejo village, Tegal Tirto, Berbah in Sleman District, spouting out of groundwater at maximum about 1 m in height for about 24 hours after the earthquake was observed. Even at the time of the survey that was conducted in one month, water was still springing out (Photo 5). At this site as shown in Figure 3b, soft soil deposits with N_{SPT} values less than 10 having thickness of about 3 m were identified.

Photo 5. Springing water at Site C

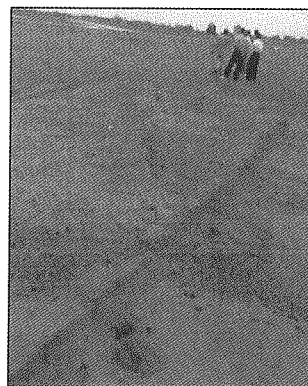
Photo 6. Evidence of sand boiling at Adi Sucipto Airport (by courtesy of Dr. Fitri Mardjono, Gajah Mada University)

As shown in Photo 6, sand boiling occurred at Adi Sucipto Airport (Mardjono, 2006). This location is close to the Site C as mentioned above.

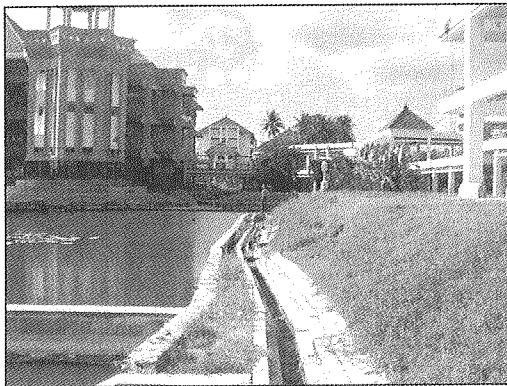
At Site D at Muhammadiyah University in the suburb of the Yogyakarta city, as shown in Photo 7, a revetment surrounding a pond failed. A dynamic cone penetration test was conducted on the embankment. As shown in Figure 3c, rather stiff soil deposit with N_{SPT} values more than 10 could be found at about 0.5 m depth.

Photo 7. Damaged revetment at Site D

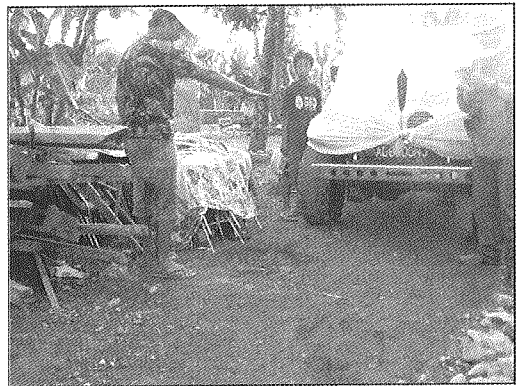
At Site E at Mutihan in Klaten district, spouting of groundwater to a maximum height of about 1 m was observed after the earthquake (Photo 8). In this region, high collapse ratio of houses was observed. As shown in Figure 3d, soft soil deposit with N_{SPT} values less than 5 was observed until about 1.75 m depth, where the groundwater level was about 1 m from the surface. In addition, another soft soil deposit with N_{SPT} values of about 10 was observed at deeper than about 2.5 m from the ground surface.

Photo 8. Location of the spouting of groundwater at Site E

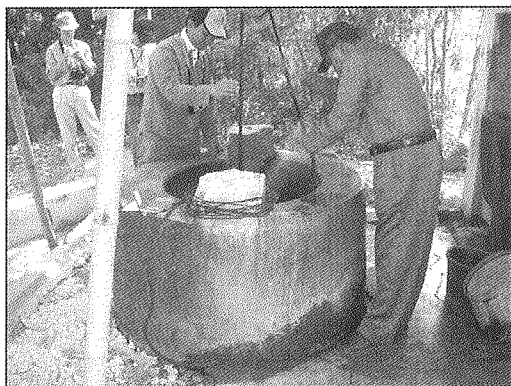
At Site F at Katekan village in Klaten district, several wells were plugged by sandy soil (Photo 9). Several days after the earthquake, the inhabitants repaired the wells by re-excavating the sandy soil. As shown in Photo 10, the re-excavated sandy soil was collected to be used as material for re-constructing their houses.

Photo 9. A plugged well at Site F

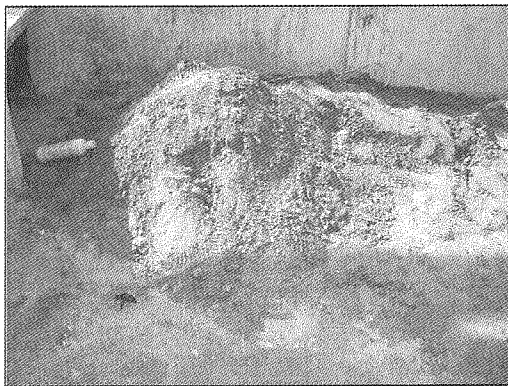
Photo 10. Re-excavated sand from a well at Site F

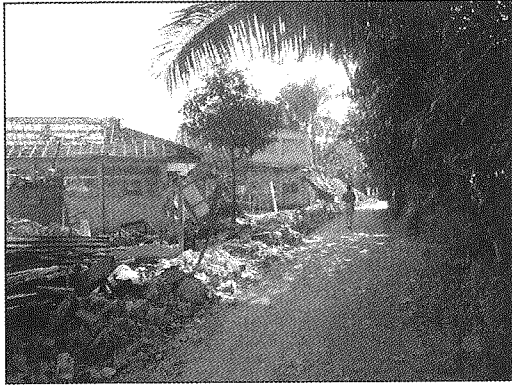
At Site I in Patalan, Bantul district, a primary school building and its surroundings were damaged as shown in Photo 13. At Site J that was about 1 km from Site I towards the north, a housing lot was under construction on a paddy field as shown in Photo 14. Results of dynamic penetration tests at Sites I and J are shown in Figures 4a and 4b, respectively. At both sites, the groundwater level was shallower than 1 m from the ground surface, below which soft soil deposits with N_{SPT} values less than 10 could be found for a thickness of about 2 to 3 m.

Photo 13. Damaged primary school at Site I

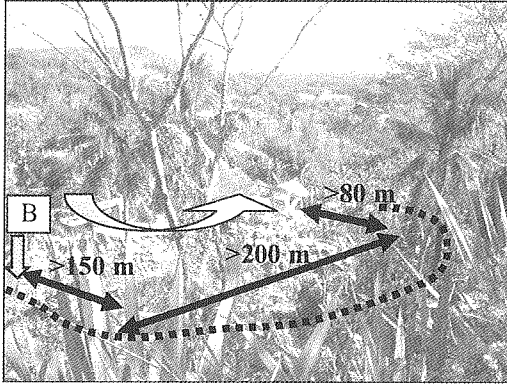
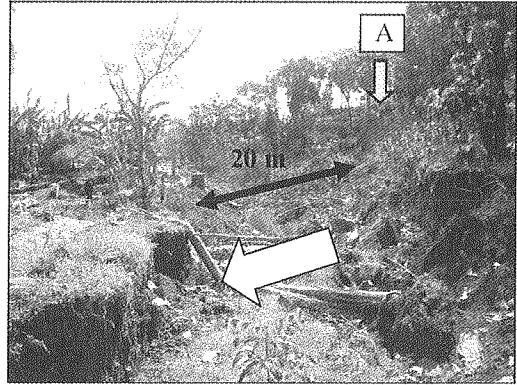
At Site K at Lepen – Sengir village (Sumberharjo) in Sleman district, a large scale landslide occurred as shown in Photo 15 and 16. The landslide body that having an area of about 100 x 200 m slid downward by 20 m at maximum. At the time of the earthquake, at least 14 households lived on the landslide mass. Although the large landslide caused complete collapse of 6 houses, no one was killed. Reportedly, after feeling the earthquake motion, they could run out from their houses before their collapse.

Photo 15. Landslide area that was viewed from Position A (Photo 16) at Site K

Photo 16. Landslide area that was viewed from Position B (Photo 15) at Site K

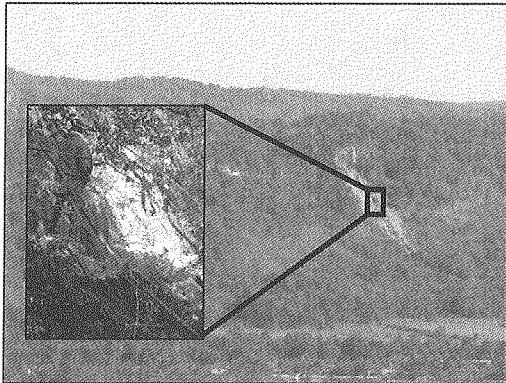
At Site L at Bangkel village, Srimulyo in Bantul district, several rock masses fell down as shown in Photo 17. In addition, a scar due to slope failure/rock failure on hilly area of Mountain Blencong at Site M was viewed from top of Bangkel hill at Bangkel village as shown in Photo 18.

Photo 17. Rock fall at Site L

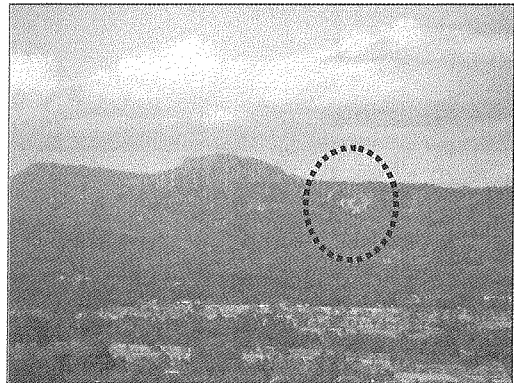
Photo 18. A scar on hilly area at Site M

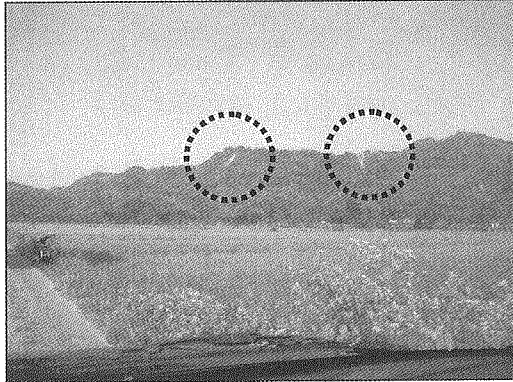
Two scars on a part of Southern Mountains were observed at Site N as shown in Photo 19. These scars were viewed from Katekan village in Klaten district.

Photo 19. Two scars on Southern Mountain at Site N

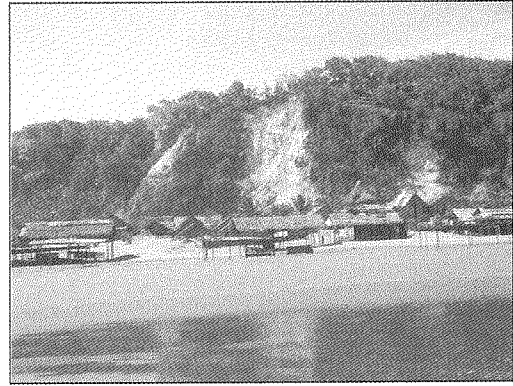
At Site O at Parangtritis beach in Bantul district, several rock-falls occurred in the hilly side as shown in Photo 20. In this area, most of the hills consist of limestone as shown in Photo 21.

Photo 20. Slope failure at Site O

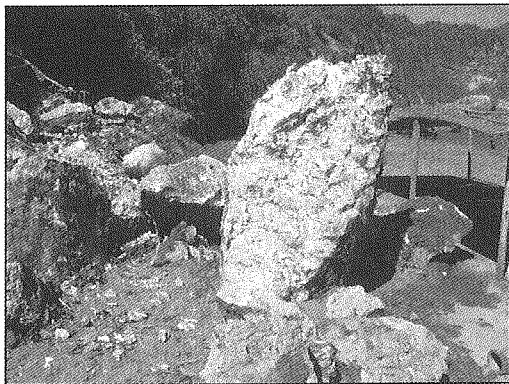
Photo 21. Chunks of rock fall at Site O

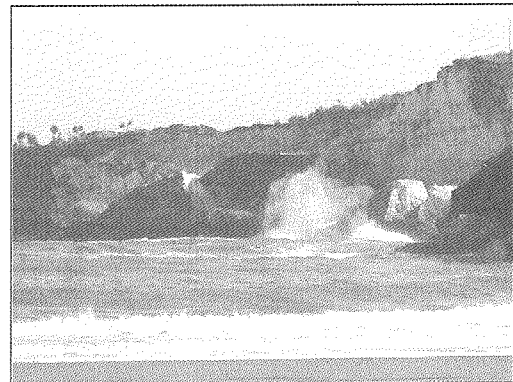
At Site P at Baron beach in Gunung Kidul district, large rock falls occurred along the coastline as shown in Photo 22. Before the earthquake, position of the rocks was overhung due possibly to that the foot part of the rock slope was eroded by wave action as typically shown in Photo 23. Reportedly, plugging of well and spouting of groundwater were not observed in this area at the time of the earthquake.

Photo 22. Rock fall at Site P

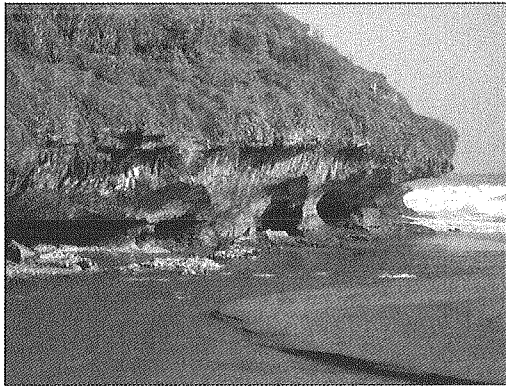
Photo 23. The overhung rock at Site P

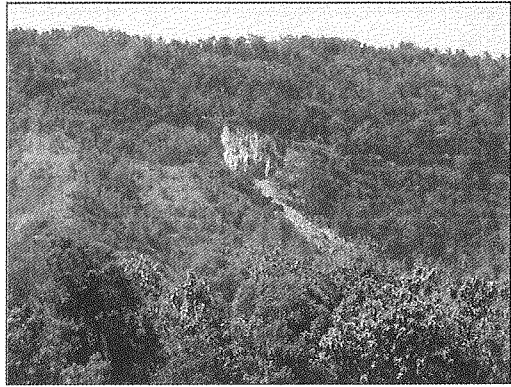
At Site Q at Wonolelo village in Bantul district, a scar on hill was observed as shown in Photo 24. Several households lived at the middle and top parts of the hill. Reportedly, the water level of wells that were owned by the households decreased after the earthquake.

Photo 24. A scar on hill at Site Q

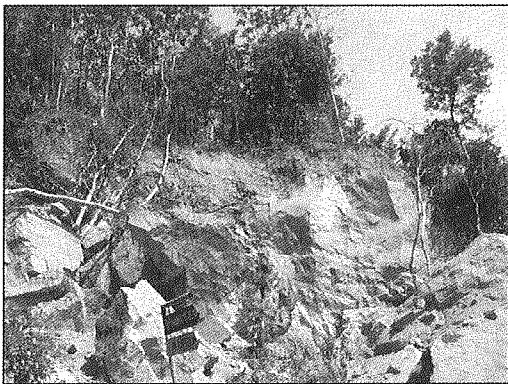
At Site R at Trimulyo village in Bantul district, a rock slope adjacent to a village failed and the debris blocked the road (Photo 25). At the time of the survey, the road had been cleared of the fallen rock as shown in Photo 26. Reportedly, the failure was caused by the aftershock, not by the main shock, and thus the local inhabitants could evacuate safely before the failure occurred.

Photo 25. Rock fall at Site R

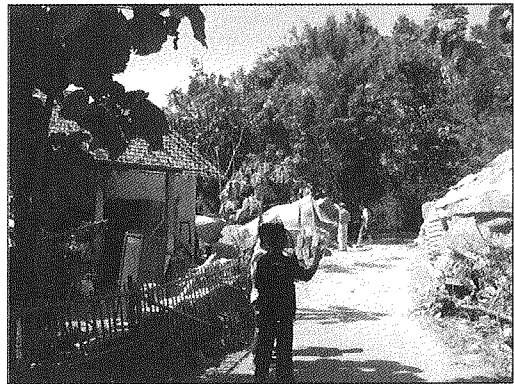
Photo 26. Road that was cleared of the fallen rock at Site R

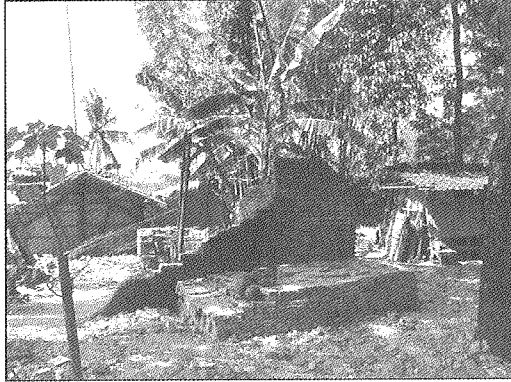
Photo 27. A collapsed house at Site S

At Site S at Pundong in Bantul district, severe damage to houses was observed as shown in Photo 27. Meanwhile, in the adjacent area at Camden village at site T, a traditional wooden house suffered from damage as well.

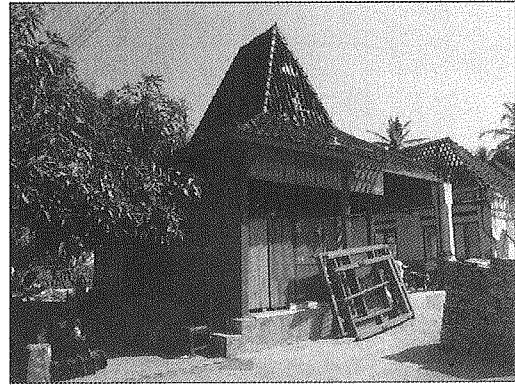
Photo 28. A damaged traditional house at Site T

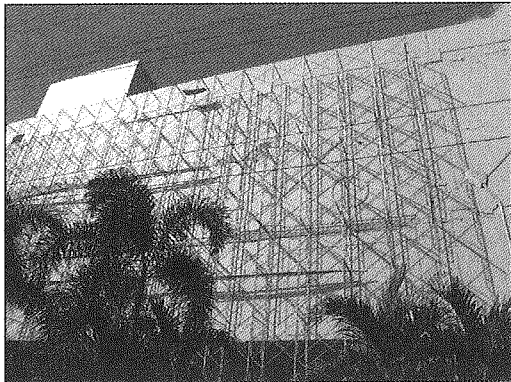
At Site U in the Yogyakarta city, a shopping mall was damaged as shown in Photo 29. Failure at the connection between wall and slab of floor occurred. At the time of the survey, the building was under repair. Meanwhile, business activities inside the building had already resumed.

Photo 29. A damaged shopping mall at Site U

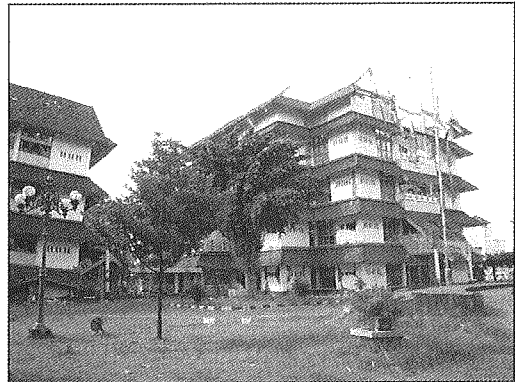
Photo 30. Severe damage to university building at Site V

At Site V in the suburb of the Yogyakarta city, multi-story university buildings of STIE (university of economic) Kerja Sama were severely damaged (Photo 30). The building on the left hand side suffered from collapse of the first floor, while the other on the right hand side suffered from damage to roof and other upper structure.

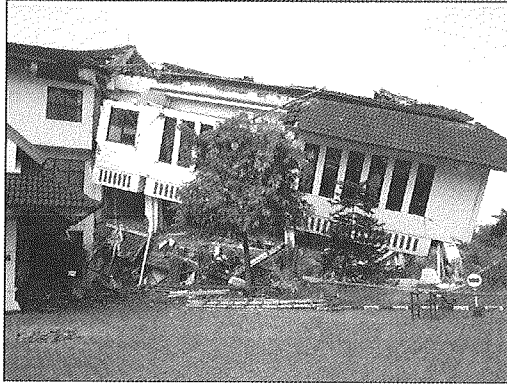
At Site W in the suburb of the Yogyakarta city, a building that belongs to BPKP (Controller of Financial and Development Agency) suffered from extensive damage. The first and second floors of this three-story building were collapsed.

Photo 31. A damaged government building at Site W

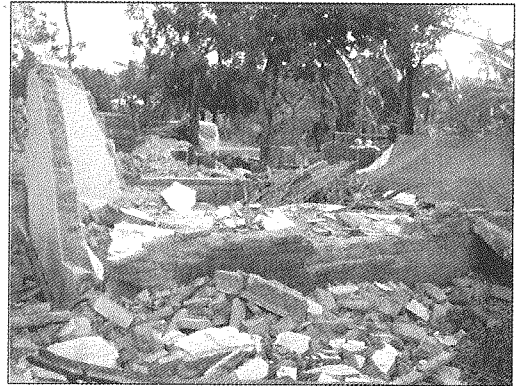
Photo 32. Severe damaged to houses at Site E

At Site E at Mutihan in Klaten district, houses were severely damaged as shown in Photo 32. As the result of cone penetration tests as shown in Figure 3d, these houses were built on soft soil deposits.

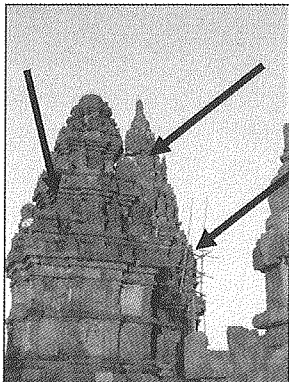
At Site X at Prambanan in Sleman district, the Prambanan temple suffered from dropping and tilting of its masonry (Photo 33). At the time of the survey, some parts were under repair. In addition, as shown in Photo 34 several top parts of the fence wall suffered from dropping and tilting as well.

Photo 33. Damage to Prambanan temple at Site X

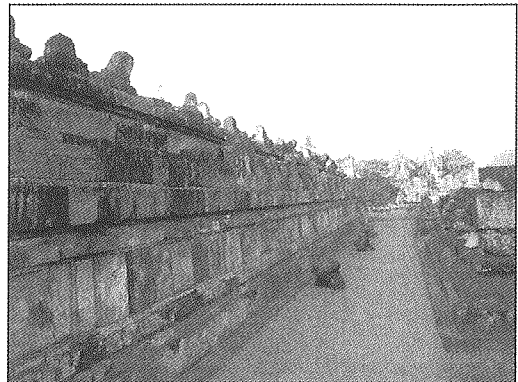
Photo 34. Dropped and tilted masonry of the fence wall of Prambanan temple at Site X
