DAMAGE IN AREAS AFFECTED BY THE AUGUST 15, 2007 PISCO EARTHQUAKE, PERU*

Jörgen JOHANSSON¹, Paola MAYORCA²,
Edwin LEON³ and Tatiana TORRES³

Key Words: Pisco Earthquake, liquefaction, adobe, confined masonry

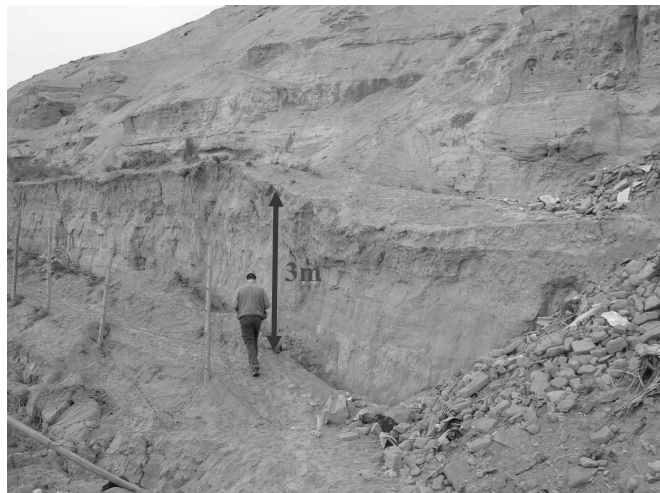
Figure 4. On the border between the Canete formation and the marine deposit, there is a 3 meter differential vertical offset.

level is very shallow in the marine deposit, surfacing at some locations. In the northern part, a lot of over 20 meter long cracks with grayish sand ejecta were observed. Cracks and up to 3 meter differential settlements (see Figure 4) were seen closer to the Canete formation. Here, light brown/beige seemingly liquefied soil covered parts of some of the vertical scarps. The liquefied area extends from the central park (Plaza de Armas) of Tambo de Mora all the way to the Pan-American highway in the north, which is distance of more than 7 km.

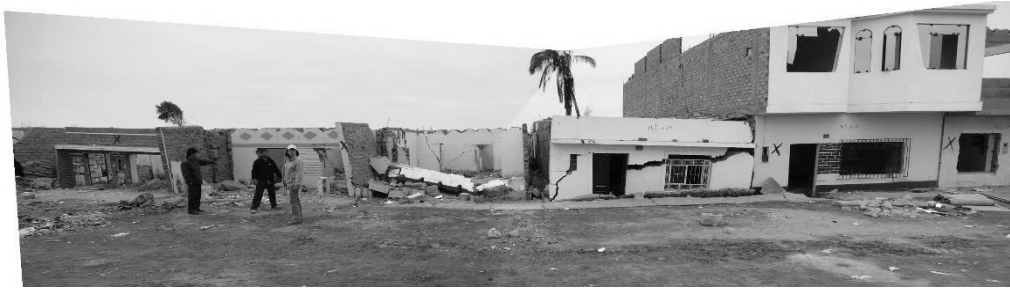
Figure 5. Settlement of 0.7 m of building in front of palm tree.

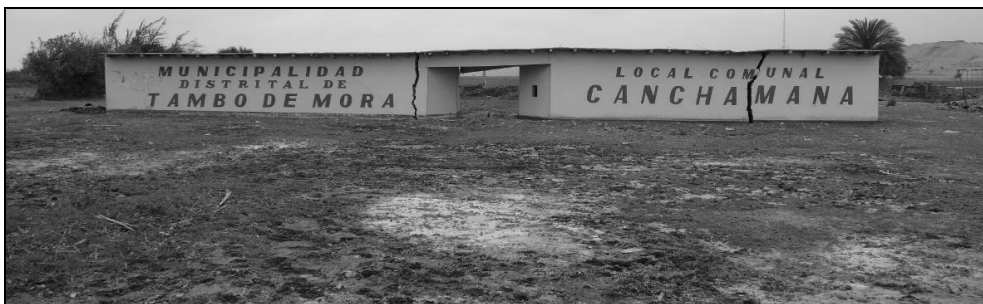
Settlement of buildings and foundation damage due to liquefaction induced ground failure and lateral spreading, caused the collapse of adobe houses and severe cracking of walls of confined masonry buildings. At Canchamana in the northern part of Tambo de Mora, a masonry community building (Figure 6) was severely damaged by lateral spreading and an adobe school building was partially collapsed, while a newer school building with proper foundation behaved well. The Chinchá Prison, located North of Tambo de Mora, suffered extensive damage due to liquefaction. The surrounding wall collapsed (see Figure 7) and the prison cells exhibited large settlements. Due to the risk of additional damages, the local government decided to set free the prisoners. This fact suggests that location of this public building deserve further review since the social consequences of its failure were also considerable. A common and important problem in this earthquake was the lack of foundation reinforcement in important public buildings or complete lack of foundations for adobe houses, both reducing considerably the earthquake resistance.

Figure 6. Severely damaged community building in Canchamana, with liquefaction traces in the foreground.

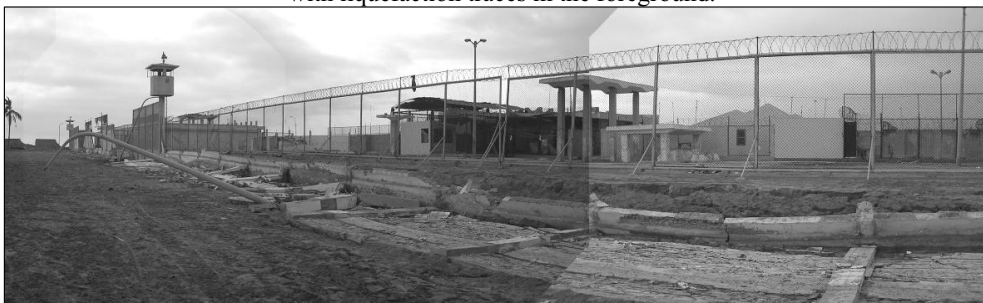
Figure 7. Collapsed wall at Chinchá Prison due to large ground deformation

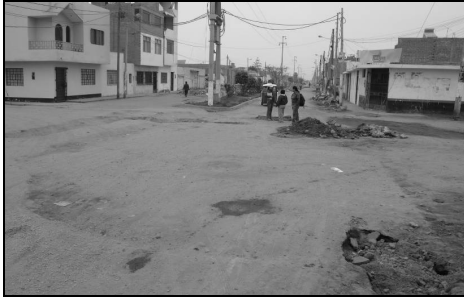
Evidences of soil deformation were clearly seen along the coast at Pisco. It also affected some buildings and other constructions in the city. Areas close to the coastline particularly suffered extensive damage due to the shake but also, to the effects of the tsunami that hit the area minutes later. The sewer system in Pisco, whose conditions were already poor before the earthquake, was drastically affected due to ground deformation and liquefaction. As shown in Figures 8 and 9, central and northwest areas of Pisco had broken sewer pipes due to ground settlements and dislocated manholes were wide spread.

Figure 8. Central Pisco. Settled ground as evidence of broken sewer pipes.

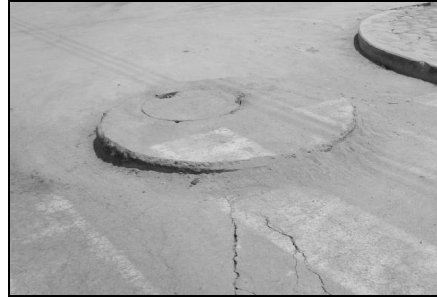
Figure 9. Manhole pushed up and surrounded by ejected fine sand, northwest of Pisco

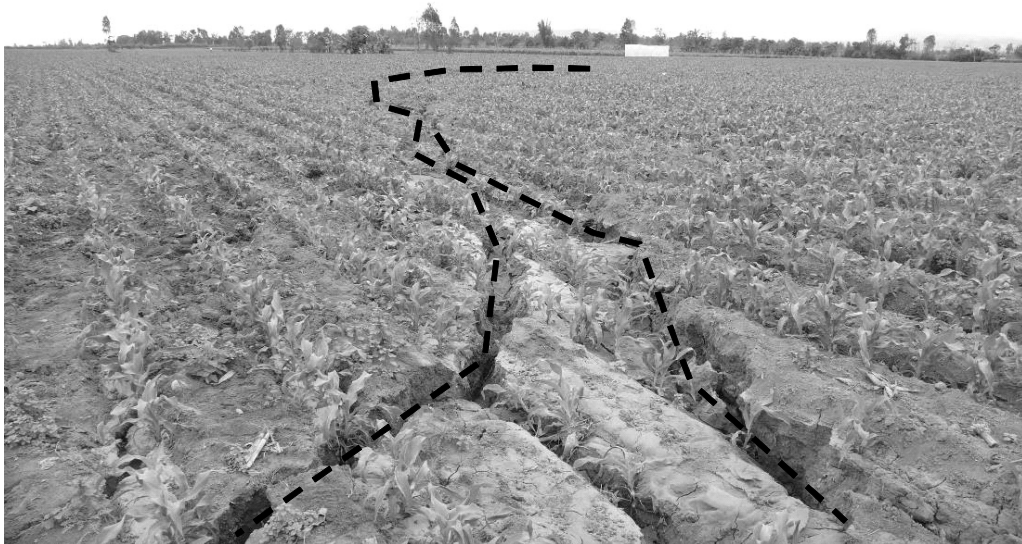
Shaking is not the only cause of earthquake damage; permanent ground deformation can also cause extensive damage. In the San Luis annex Nuevo Monterrico, several large and long ground cracks were observed in an area of 1km² size. Nuevo Monterrico is located on an alluvial plain spreading between a granitic formation in the north at San Francisco and a tertiary sandstone formation (Paracas Formation) in the south [5]. The ground cracks caused damage to buildings, agriculture, and also, according to the local people, three wells went dry in the area. We do not know presently if the cracks were caused by liquefaction induced lateral spreading, or if large scale tectonics might have created extension in this area. Such extension often occurs on the continental plates near subduction zones. The effects of such deformation and cracks need further investigation.

Figure 10. Photo of large ground cracks in Nuevo Monterrico agriculture field.

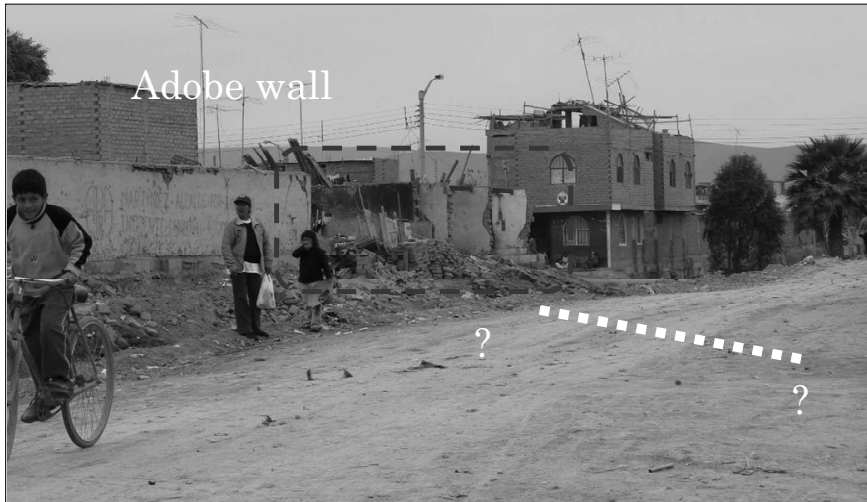
Figure 11. Collapsed adobe house due to large ground cracks in Nuevo Monterrico. The local people told us the crack crossed the street. The adobe wall to the left did not collapse.

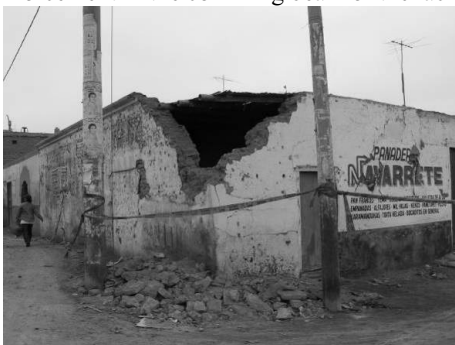
Damage to adobe houses, i.e. made of sun-burned bricks, was widespread and may be categorized, in order of severity as: plaster spalling, wall separation, corner collapse (see Figure 12), partial collapse of walls and total collapse of walls (see Figure 13). Important factors increasing the vulnerability of adobe structures were: wall slenderness, construction age, and roof layout. Walls supporting light roofs, which are predominant in the region, were less likely to collapse than those not supporting it due to the restraint at the top that the roof joists provided them. It was observed that in many locations, these houses did not have any foundation. This contributed to the moistening of the walls, where the ground water table was high, with the consequent strength reduction. A few reinforced adobe houses were surveyed at Ica, Lunahuana, and Pacaran. All of them performed very well.

Figure 12. Corner collapse in adobe house (San Luis, Canete)

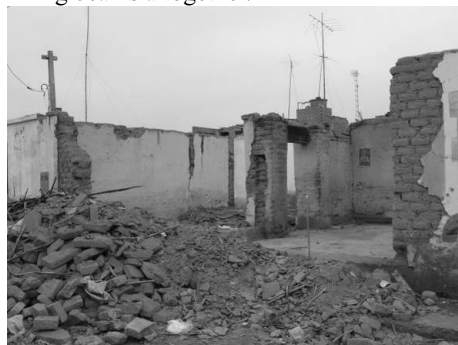
Figure 13. Collapsed adobe house (Nuevo Monterrico, Canete)

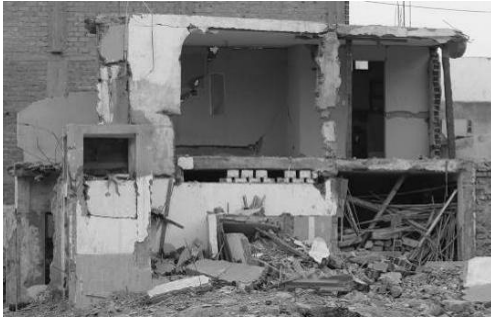
Confined masonry houses designed and built according to the building code did not suffer major damage. All the damaged structures had some type of deficiency. The most common were the use of bricks with horizontal alveolus (hollow bricks) for load bearing walls (locally called *pandereta* and prohibited by the code in this region, see Figure 14), lack of confinement of parapets and façade walls, insufficient wall density, badly distributed stiffness (in plan and elevation), and a poor understanding of the confined masonry construction procedure. Another deficiency was the lack of steel reinforcement in the confining beam or the lack of confining beams altogether.

Figure 14. Load bearing wall made of *pandereta* bricks and poor steel reinforcement in the confinement (Pisco, Ica)

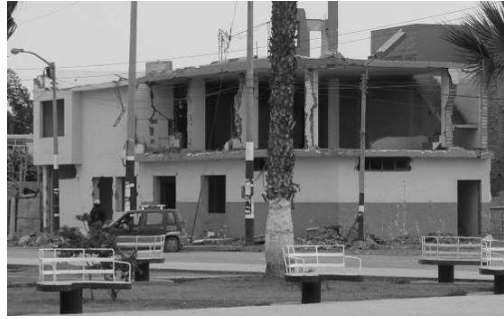
Figure 15. Collapsed façade wall due to lack of confinement (Sunampe, Chincha)

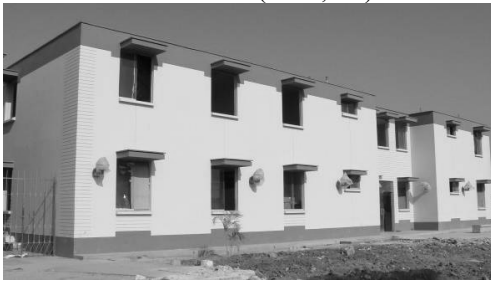
Figure 16. New Emergency Building suffered no damage (San Juan de Dios Hospital)

Public facilities, both governmental and private, performed badly in the 2007 Pisco Earthquake. Figures 16 and 17 show the conditions of the San Juan de Dios Hospital after the earthquake. This facility, which is responsible for the health requirements of approximately 125,000 people, was mostly constructed in the 30's with reinforced concrete and concrete blocks. These structures did not performed well during the earthquake and were either demolished or in process of demolition during the field survey. Two new buildings made of RC were completed in 2007 (Figure 16) suffered no damage suggesting the appropriateness of the current seismic code.

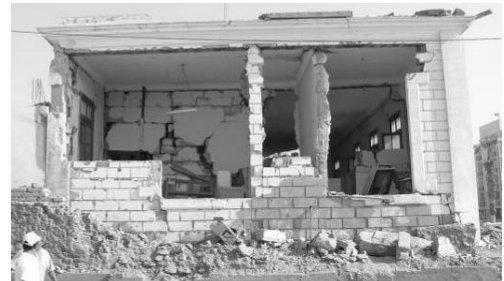
Figure 17. Concrete block wall collapsed out-of-plane (San Juan de Dios Hospital)

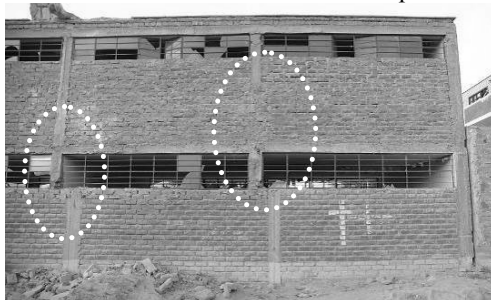
At least 640 school classrooms were destroyed and a similar number were affected. In general, the design/construction quality of the schools visited during the survey was very varied. For example, at Los Molinos in Ica, a very new and well constructed school was found next to another which obviously did not followed any design or construction standard. Figure 18 shows one of this building walls in which it is seen that columns in the 1st floor are not aligned with the columns in the 2nd floor. Furthermore, one of the columns is interrupted. Many classrooms made of non reinforced adobe were also found as well as schools built in places unsuitable for construction due to poor soil conditions,

Figure 18. Bad construction example in Los Molinos, Ica

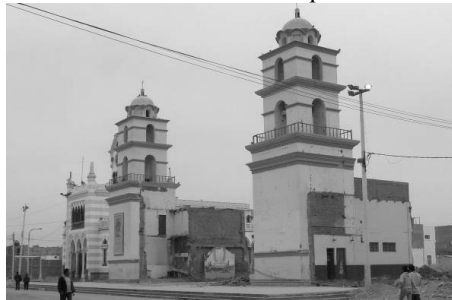
Figure 19. San Clemente Church (Pisco)

This survey did not focus in surveying churches in detail. However, it was obvious from our field work that these structures suffered severe damage. Reportedly, more than 30% of the fatalities due to this earthquake were caused by the collapse of the San Clemente Church in Pisco. In this church, only the portion which had been rebuilt recently did not collapse. A block away from it, only a couple of the 850mm-thick adobe walls of the Compania de Jesus Church were left standing.

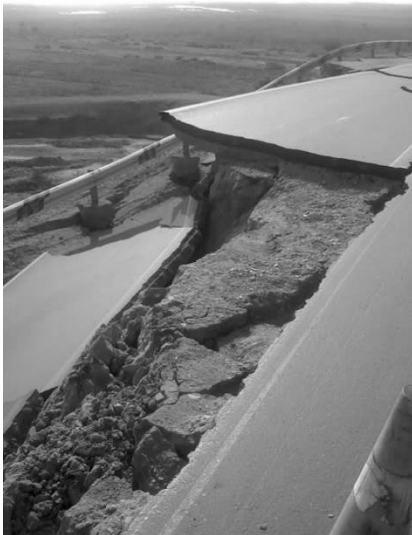
The Pan-American Highway runs parallel to the coastline and crosses Peru from north to south. The South stretch which is located in the earthquake affected areas had widespread damage mainly due to landslides, rock falls, lateral spreading, and liquefaction as shown in Figures 20 and 21.

Figure 20. Slope failure caused by liquefaction induced lateral spreading

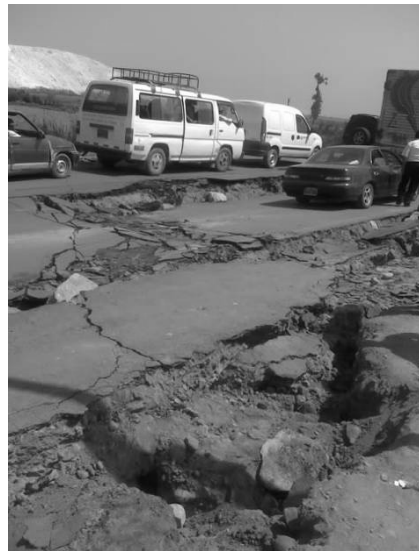
Figure 21. Liquefaction induced embankment failure

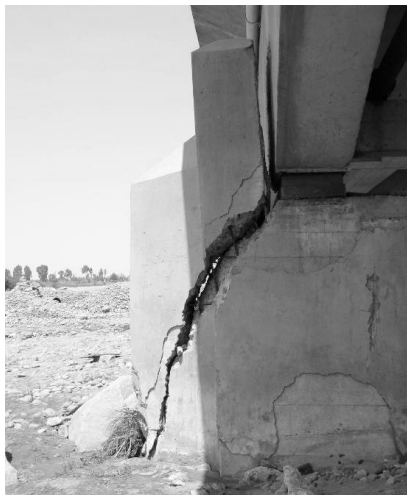
The bridge superstructure permanently moved upstream about 8cm. At the movable bearings on the abutment, the steel fittings separated from the concrete structure. The stoppers, on the pillar's movable support, which were supposed to restrain the transverse movement, were not found. Probably they had been completely corroded away. The lateral movement of the bridge caused damage to the concrete wings of the pillars, especially that with the movable bearing. These wings had very little steel reinforcement (Figure 23 and 24).

Figure 23. Failed wing with poor reinforcement (pillar with movable bearing)

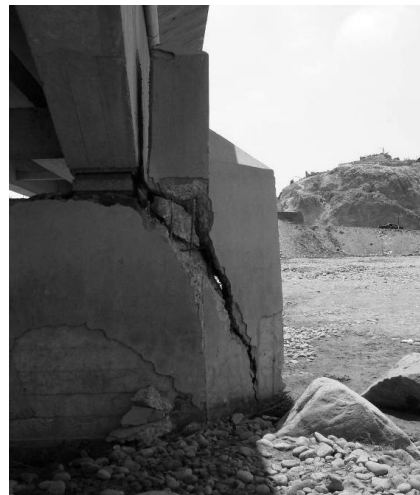
Figure 24. Failed wing with poor reinforcement (pillar with movable bearing)
