BUILDING DAMAGE DUE TO 2008 WENCHUAN EARTHQUAKE AND COOPERATIVE ACTIVITIES ON DAMAGE RESTORATION BY JAPANESE EXPERTS

Yoshiaki NAKANO¹, Masaki MAEDA², Joji SAKUTA³, and Masanobu SAKASHITA⁴

Key Words: Sichuan (Wenchuan) Earthquake, Damage Restoration, Technical Support Liaison Council

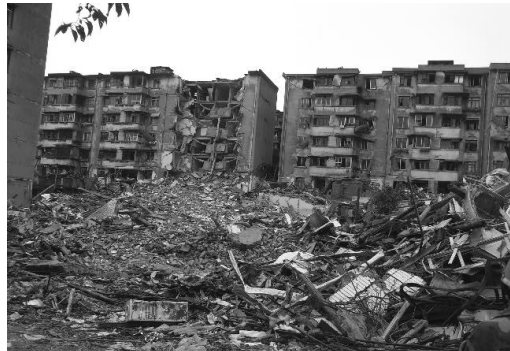
Brick buildings are most seriously damaged and they often sustain partial or total collapse, resulting in the primary source of human damage. They have UR brick walls having RC ring beams and precast concrete hollow-core slabs above the walls. The major cause of the fatal damage is attributed to the low resistance and brittleness of URM walls and poorly detailed joints between precast concrete members and RC beams. Photos 1 and 2 show typical damage to brick buildings.

Photo 1. Seriously damaged brick buildings (Hanwang town of Mianzhu city)

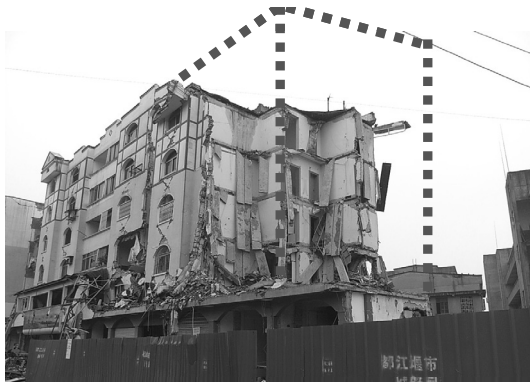
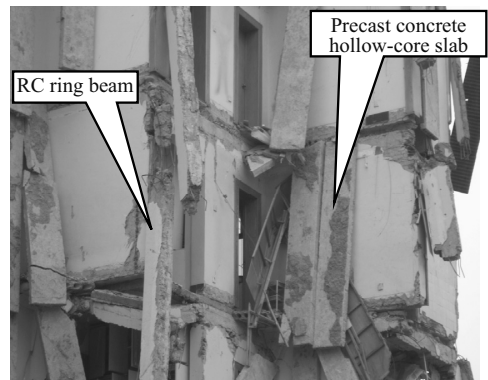
Photo 2. Partially collapsed brick buildings with precast concrete hollow-core slabs (Dujiangyan city)

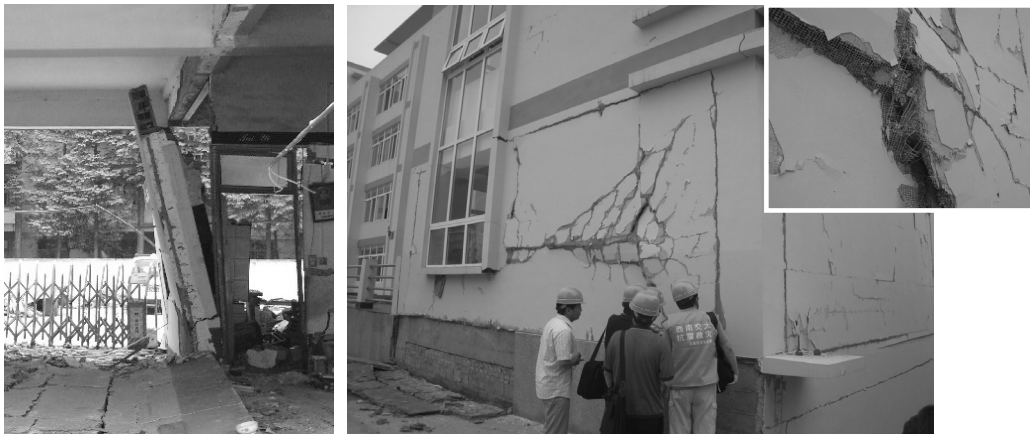
Reinforced concrete shear walls are much less frequently provided in RC buildings than UR brick walls. Lightly reinforced small-sized columns (tie columns) are often placed later between UR brick walls so that the walls should serve as the form in casting concrete of RC tie columns. During the surveys, shear cracks and failure of brick walls are found in many buildings as shown in Photo 3. It

should be noted, however, that lath-mortar finishing on the exterior surface of UR brick walls is found to help avoid their out-of-plane failure, although they are heavily cracked. Such efforts therefore should be encouraged to minimize falling hazard to residents and users during and after major earthquakes.

Photo 3 Failed brick wall (left) and survived brick wall (right)

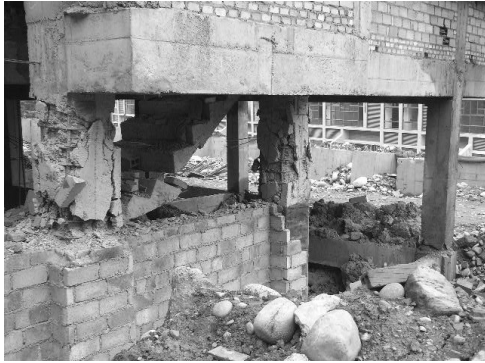
Shear failures in RC columns shortened by partial height UR brick walls are found in several buildings, as have been found elsewhere in the past damaging earthquakes. Photo 4 shows a typical shear failure in the first story of a building in Dujiangyan city. Photo 5 shows another failure, where the column is shortened and failed in shear leaving vertical cracks along the interface between the column and brick wall. The damage is attributed to the presence of partial height brick walls, which are generally neglected in the structural design but significantly affect the building's behavior during strong shaking.

Photo 4. Typical shear failure in RC short columns

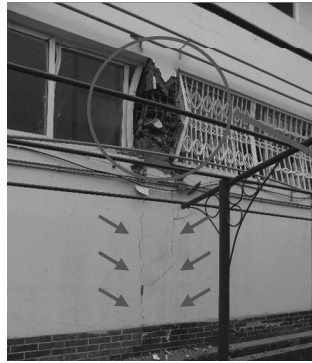
Photo 5. Shear failure in RC column shortened by partial height brick wall

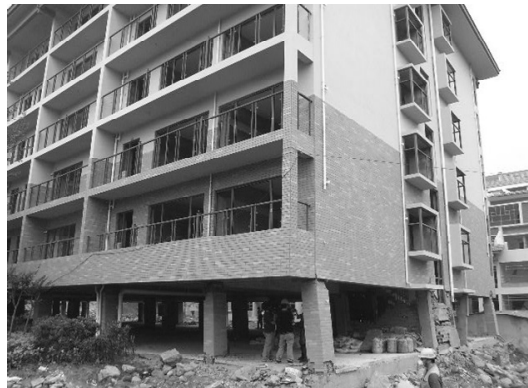
flexural compression failure at the top and bottom of their columns. Photos 6 and 7 show the damage to columns in the first story of a six story apartment building in Dujiangyan city. Hooks of lateral reinforcement are pulled out of crushed concrete core. Main rebars buckle and fracture as shown in the photos. As will be found later in this paper, the building is employed for a sample building to investigate possible restoration schemes and to discuss their feasibility with Chinese engineers.

Photo 6. Soft first story of a 6 story RC apartment house

Almost all columns in the first story form plastic hinges both at their top and bottom, causing concrete crushing and rebar buckling (Photos 6 and 7) resulting in the soft first story mechanism with a residual lateral drift of approximately 10% of the story height. No major damage is, however, found in upper stories.

The observed damage is rated [unsafe] based on the Japanese post-earthquake quick inspection manual (JBDPA1997) and [heavy damage] based on the Japanese post-earthquake damage evaluation guidelines (JBDPA 2001, Nakano et al. 2004). The building therefore is identified to be [no occupancy] and needs to be shored to avoid life-threatening risk and further damage progress due to aftershocks.

Scheme 1 aims primarily to repair the damaged columns after re-centering the building, replacing buckled rebars with new rebars, and re-cast concrete in the damaged region. Since the performance may not be fully recovered to the original due to extensive damage and hence the seismic capacity index I_s after restoration ($\psi=0.7$ assumed) is lower than the original value of 0.67, the restored building is likely to collapse when subjected to the future shaking with intensity similar to the main event on May 12.

Scheme 2 aims to repair and upgrade flexural strength and confinement of columns by RC jacketing after re-centering the building. In Scheme 2, the flexural strength after restoration is estimated neglecting reinforcement in the original section, which is found buckled in the survey, while the whole section including repaired inner (i.e., original) section is assumed effective on the shear strength. As is found in Table 2, the expected performance may be better than the original, but both

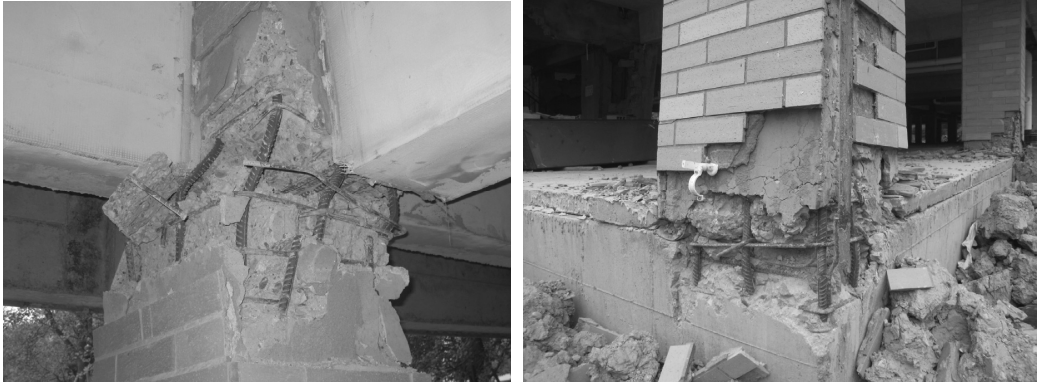
Photo 7. Flexural compression failure at the top and bottom of columns

excitations, anchorage of new reinforcement into existing RC members etc. were of highest priority in re-designing the damaged buildings, although the restoration proposals were made only in the first story for simplified discussions. It was also pointed out that the buckling of column reinforcing bars associated with flexural compression failure could be observed in areas close to their interface between column ends and adjacent beams, and the confinement of beam-column joints using additional lateral reinforcement therefore is recommended to effectively eliminate further damage.

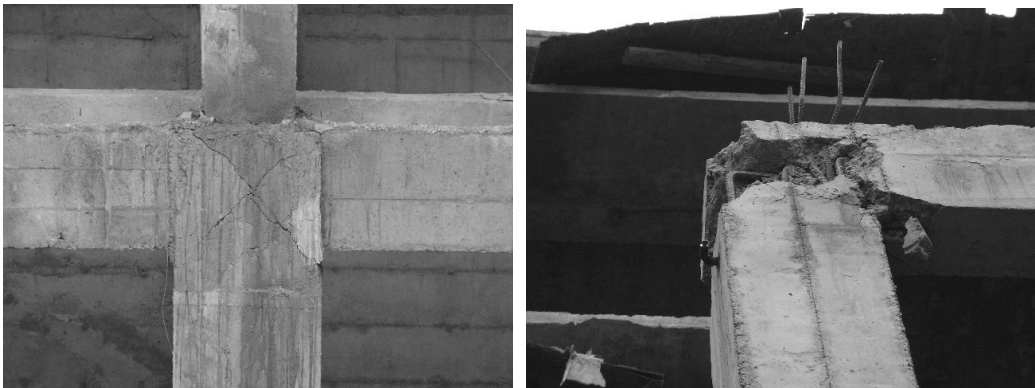
Damage to beam-column joints are less frequently found than other failure patterns such as shear failure in columns, flexural compression failure in columns. Photo 8 shows the damage to beam-column joints of RC apartment buildings, which were under construction at the time of the earthquake.

Photo 8. Failure in beam-column joint

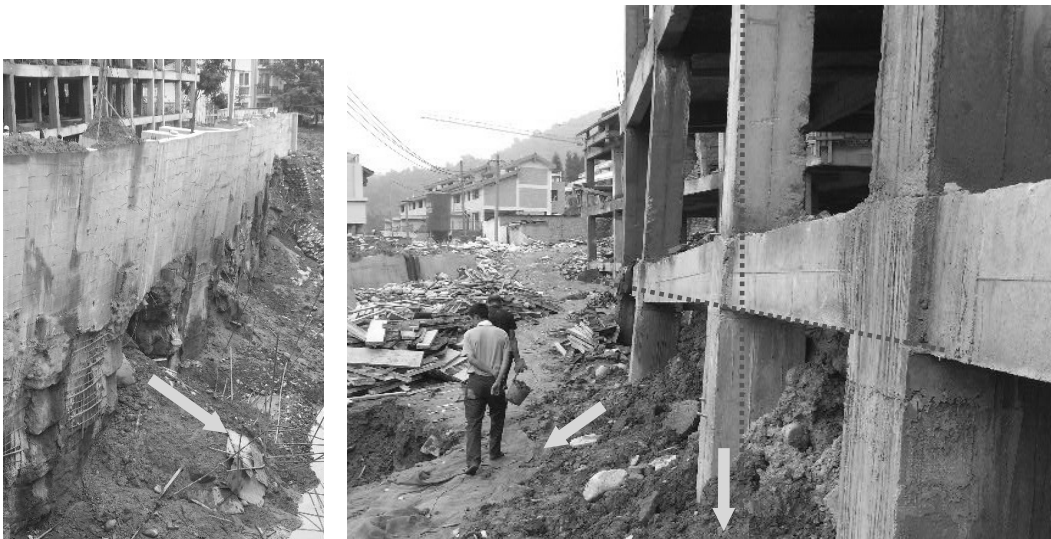
Structural damage due to soil failure underneath a building resulting in the differential settlement is found in some buildings located at the foot of a mountain slope in Dujiangyan city. Photo 9 shows the damage to a retaining wall, causing soil outflow and differential settlement of superstructures.

Photo 9. Structural damage due to failure in retaining wall

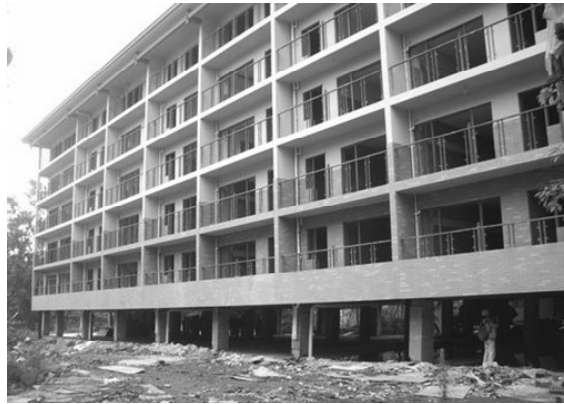
The example building is a six story RC apartment building in Dujiangyan city, which appeared earlier in Photos 6 and 7. The building was under construction but its structural construction was already completed at the time of the earthquake. The first story designed for a parking garage has no walls, while the upper stories have dwelling units with UR brick walls as shown in Photo 10 and Figure 2.

Photo 10. Example six story RC apartment building (See also Photos 6 and 7)

After long and enthusiastic discussions, the Chinese participants concluded that Scheme 3 would be most realistic and practical if the oversized section after repair can be accepted by the residents, and that Scheme 2 may be the second best solution to restore the building if Scheme 3 is not accepted. It was also very interesting for Japanese participants to learn that Schemes 5 and 6 were much less acceptable by the Chinese participants although they might be most likely to be accepted in Japan. This is mainly because the mixture of different structural types (i.e., RC frames with shear walls in the first story and RC moment resisting frames in the upper stories) is not specified in the Chinese structural design code while it may be accepted in Japan if its effects by the change in stiffness and strength distribution along building's height on structural behavior are carefully taken into account.
