# **SURVEY ON DAMAGE TO ROADS IN AKITA PREFECTURE CAUSED BY 2008 IWATE- MIYAGI NAIRIKU EARTHQUAKE**

Yukika TSUTSUMI<sup>1</sup>, Junichi KOSEKI<sup>2</sup>, Reiko KUWANO<sup>3</sup>,  
Takashi KIYOTA<sup>4</sup> and Tomonori MIKAMI<sup>5</sup>

**ABSTRACT:** On June 14, 2008, the main shock of the Iwate- Miyagi Nairiku earthquake with a JMA magnitude of 7.2 hit the mountainous areas in Iwate, Miyagi and Akita prefectures, Japan. Based on a site investigation performed four days after the earthquake, the following damage to roads in Akita prefecture was reported: a road closing caused by slope failure adjacent to a bend of a river, settlement of approach embankments for highway bridges due to large displacement of reinforced soil retaining walls having low stability, a failure of a road constructed by cut and fill, and a large slope failure including road embankment.

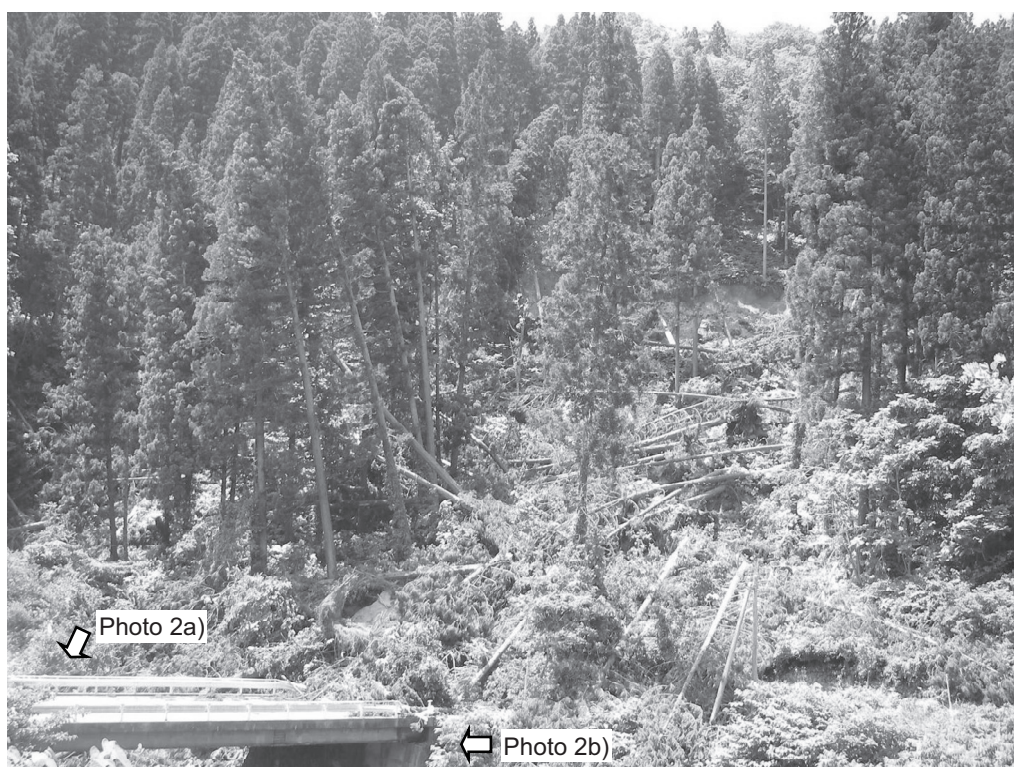
A north facing slope adjacent to a bend of Takamatsu river at west side of Kurotaki bridge along prefectural road No. 51 (N 39° 1' 22.0" latitude, E 140° 35' 10.0" longitude) failed and the road was completely closed due to collapsed soil and trees as shown in Photo 1 (site A in Figure 2). Inclination of the original slope was about 30 degrees and the dimensions of failed area were approximately 30 m in width and 40 m in length. Figure 3 represents detailed locations of the failed slope in Photo 1, Takamatsu river and Kurotaki bridge. Collapsed soil flowed into the south side of Kurotaki bridge and caused a closure of the river course of Takamatsu river, while no damage to abutment of the bridge on the side of the failure was observed as shown in Photos 2 a) and b). By removing the collapsed soil and trees, prefectural road No. 51 was re-opened under two-way alternate traffic condition on August 7, 2008 (Yuzawa city, 2008).

**Photo 1.** Slope failure at west side of Kurotaki bridge along prefectural road No. 51 (site A in Figure 2)

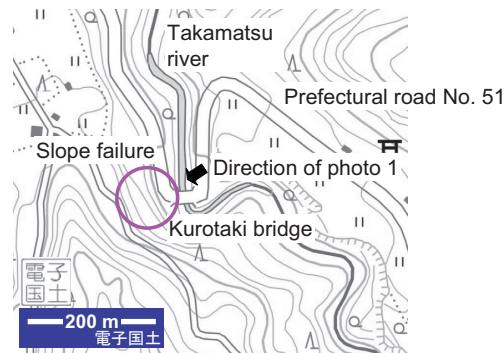
**Figure 3.** Detailed location of slope failure in Photo 1

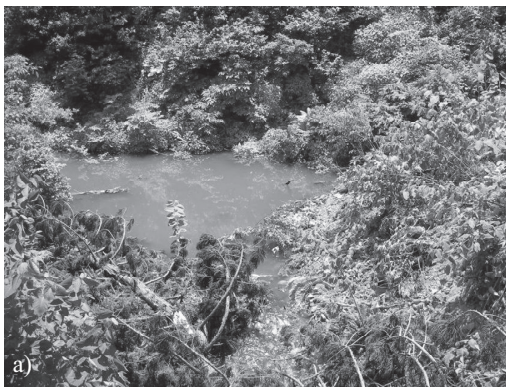
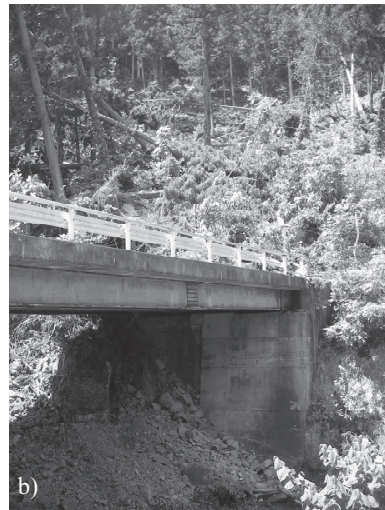
**Photo 2.** a) River course closure of Takamatsu river due to collapsed soil  
b) Abutment of Kurotaki bridge on the side of slope failure

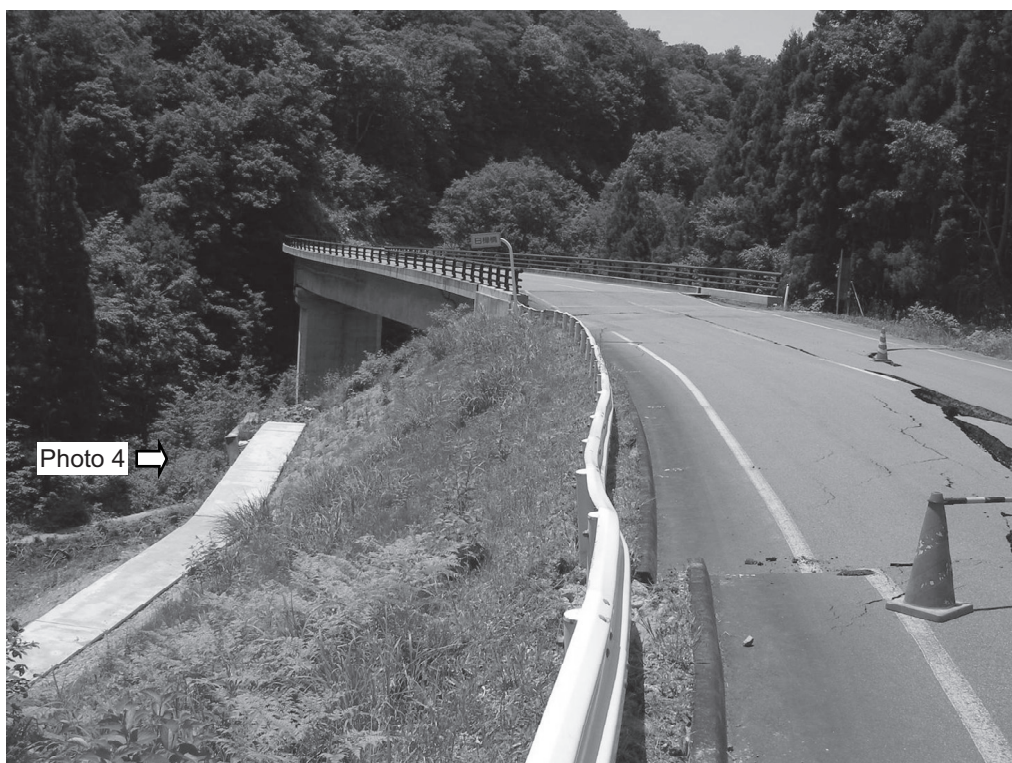
As shown in Photo 3, the settlement of the embankment for Shirakaba bridge was about 10 cm at the maximum, and it was accompanied by horizontal residual displacement with large cracks formed along the center line of the road with the maximum opening width of about 25 cm. The embankment was supported by a newly constructed gravity type retaining wall which did not suffer any damage and an old reinforced soil retaining wall using horizontal steel strips and concrete skins (so-called "Terre Armee" method) which suffered extensive opening of inclined concrete skins at the top (Photos 4 a) and b)). It can be estimated from the existence of vegetation from the opening that the reinforced soil retaining wall had displaced and its stability had been originally low before the earthquake. Accordingly, the damage to the embankment shown in Photo 3 was possibly caused by large displacement of the old reinforced soil retaining wall that exhibited low stability during the earthquake.

**Photo 3.** Settlement of approach embankment for Shirakaba bridge along national highway route No. 398 (site B in Figure 2)

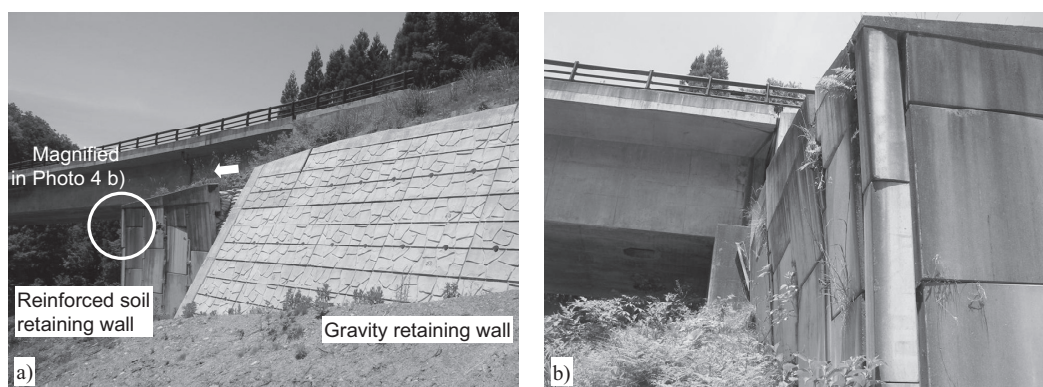
**Photo 4.** a) Retaining walls supporting approach embankment for Shirakaba bridge  
b) Damage to reinforced soil retaining wall in a)

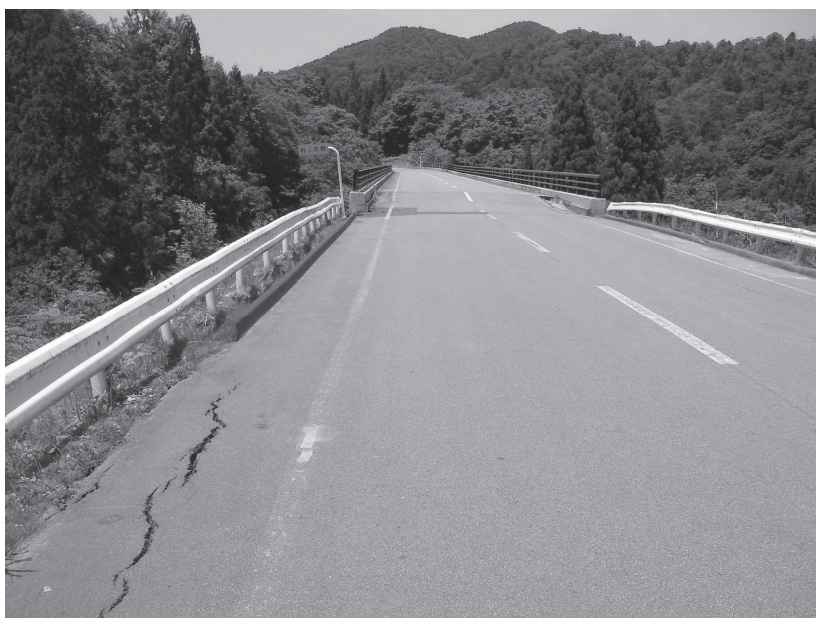
The amount of the maximum settlement of the embankment for Tochinoki bridge in Photo 5 was approximately 20 cm. As shown in Photo 6 a), a reinforced soil retaining wall by “Terre Armee” method having a length of about 30 m supported the embankment. As the retaining wall had already deformed and overhanged largely, additional reinforcement had been executed by using H-shaped steel piles and concrete beams, or tie rod and anchoring at the time of the earthquake. At the foot of the reinforcement concrete beam as indicated in Photo 6 a) with a circle, a crack that was possibly caused due to the earthquake was observed as shown in Photo 6 b). The same type of reinforcement structure was adopted on the opposite side of the embankment, while adding anchoring at the wing of the abutment. Between the reinforcement frame and the wing of the abutment, outflow of backfill soil due possibly to the earthquake was observed as shown in Photo 7. It can be inferred from the above facts that large deformation and displacement of the reinforced soil retaining wall that was under the execution of additional reinforcement work caused the settlement of the embankment with outflow of backfill soil.

**Photo 5.** Settlement of approach embankment for Tochinoki bridge along national highway route No. 398 (site B in Figure 2)

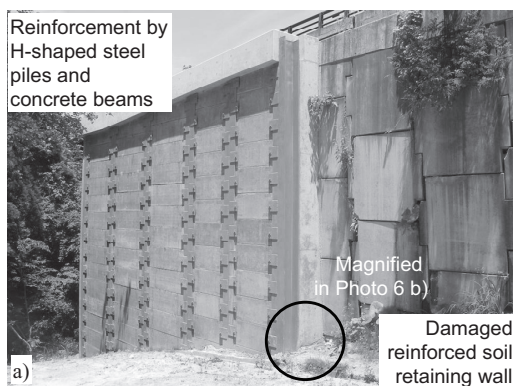
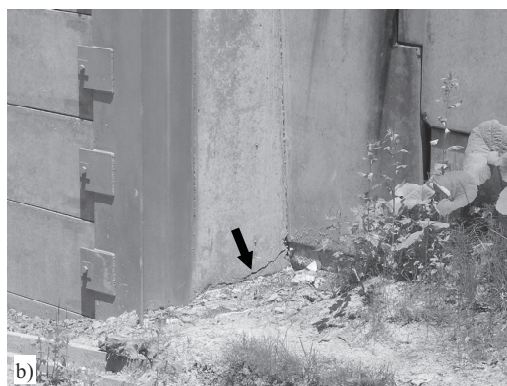
**Photo 6.** a) Reinforcement of approach embankment for Tochinoki bridge and adjacent reinforced soil retaining wall, b) Crack in reinforcement concrete beam of approach embankment

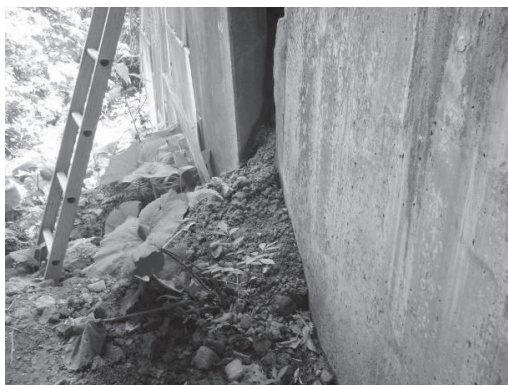
**Photo 7.** Outflow of backfill soil between reinforcement frame and original wing of Tochinoki bridge

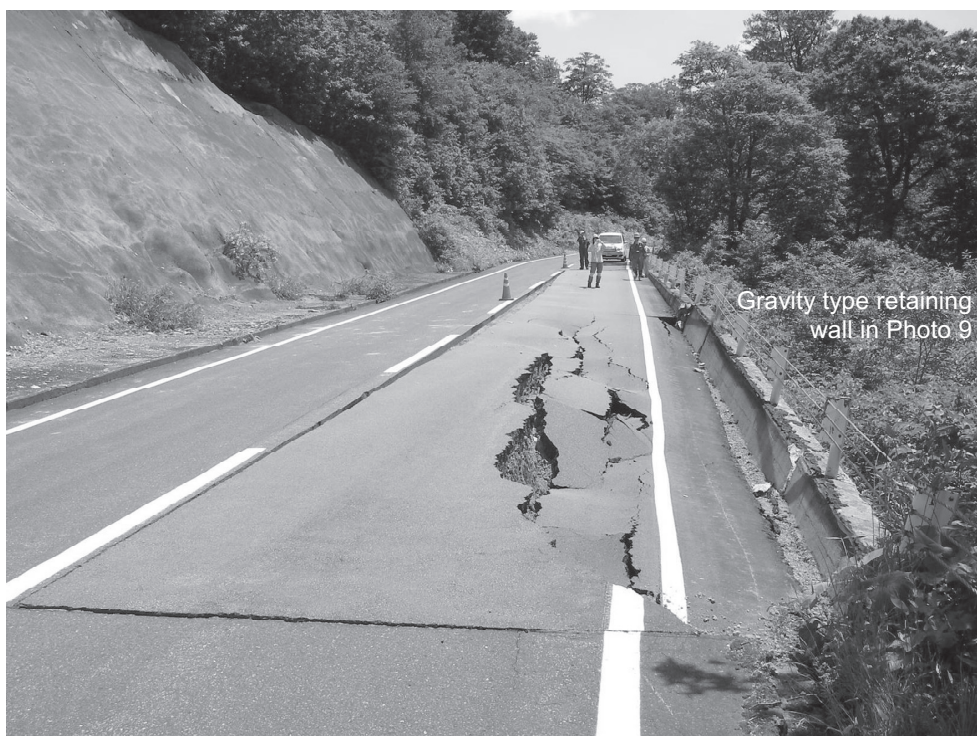
As shown in Photo 8, an embankment supported by a gravity type retaining wall along national highway route No. 398 collapsed at around the border between Akita and Miyagi prefectures (N 38° 56' 33.6" latitude, E 140° 43' 4.2" longitude, site C in Figure 2). Due to the collapse of the embankment, a large gap in the pavement was formed with the maximum width of about 30 cm at the center of the road. Photo 9 shows the tilting and settlement at the shallower part of the gravity type retaining wall that was constructed on slope with the maximum height of 4 m. The amount of maximum horizontal displacement at the top of the retaining wall was approximately 50 cm. On the opposite side of the road, cracks were formed in shotcrete on a cut slope as shown in Photo 10.

**Photo 8.** Collapse of embankment along national highway route No. 398 (site C in Figure 2)

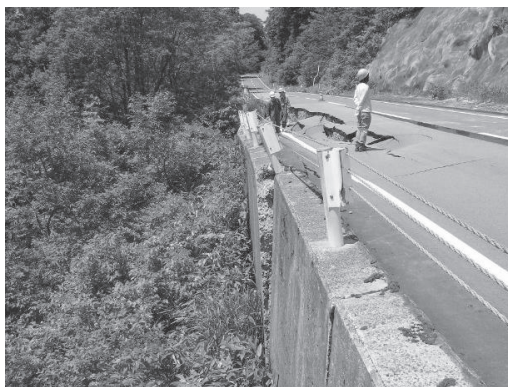
**Photo 9.** Tilting and settlement of gravity type retaining wall in Photo 8

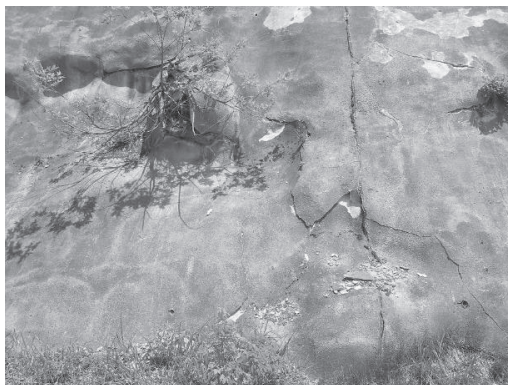
**Photo 10.** Cracks in shotcrete on cut slope

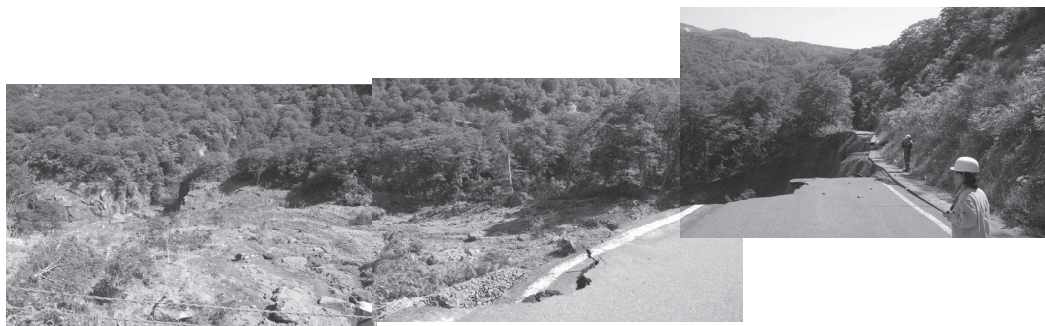
As shown in Photo 11, a large slope failure including a road embankment occurred at an east facing slope along national highway route No. 342 in Ichinoseki city, Iwate prefecture (N 38° 59' 43.5" latitude and E 140° 47' 4.2" longitude, site D in Figure 2). The dimensions of the slope failure were about 90 m in width, 290 m in length and the height of the main scarp was about 30 m. A trace of puddle was observed at the surface of collapsed soil that remained at the north part of the slope. Collapsed soil flowed into Iwai river and made the river course closed as shown in Photo 12.

**Photo 11.** Large slope failure including embankment along National Highway route No. 342 (site D in Figure 2)

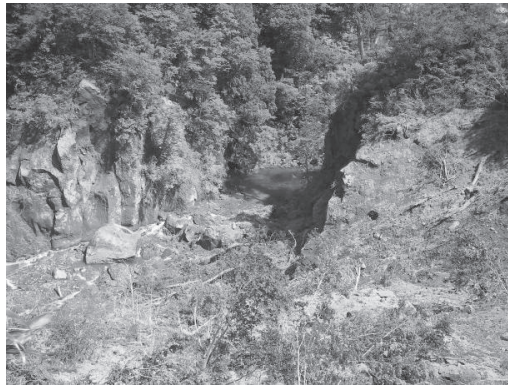
**Photo 12.** River course closure at Iwai river due to slope failure in Photo 11

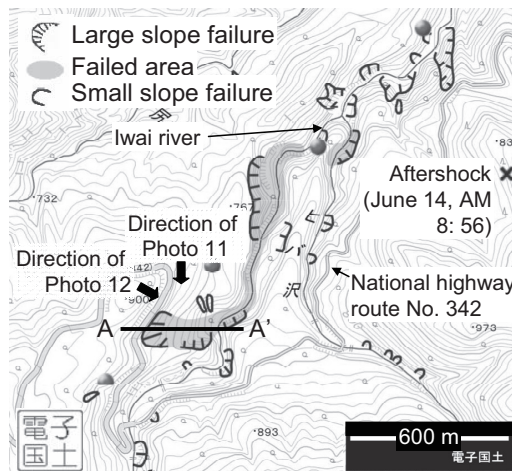
It was observed that the total volume of collapsed soil was rather small, considering the dimension of the slope failure. Figure 4 shows a result of topographical analysis of slope failures including the one shown in Photo 11 based on aerial photo survey (GSI, 2008). According to the above observation and the relevant analysis results, it is estimated that the lower gentle slope was involved in a slope failure which occurred initially at the upper steep slope with partially deep sliding surfaces as schematically shown in Figure 5.

**Figure 4.** Topographical map including slope failure in Photo 11 (modified from GSI, 2008)

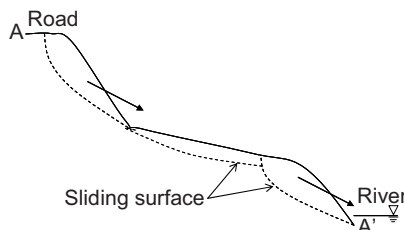
**Figure 5.** Estimated topography of cross section A-A' in Figure 4
