QUICK REPORT OF THE DAMAGE CAUSED BY THE AUGUST 11th 2009, OFF THE COAST OF SURUGA BAY EARTHQUAKE

Kazuo KONAGAI¹ and Takeshi ARITA²

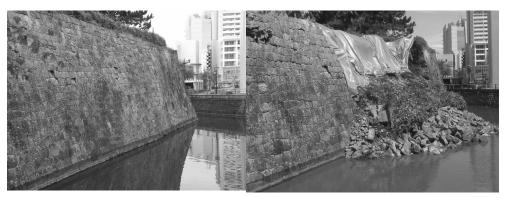
Fig. 2. Broken stone wall (No. 1 in the map below)

(a) One month before the 2009 EQ
(2009.07.12) Location: N34.975931°, E138.383633°

(b)The day of the 2009 EQ (2009.08.11 13:30) Location: N34.975931°, E138.383633°

(c) Broken stone wall in the 1935 Shizuoka EQ [6] Estimated location: N34.976511°, E138.382249°

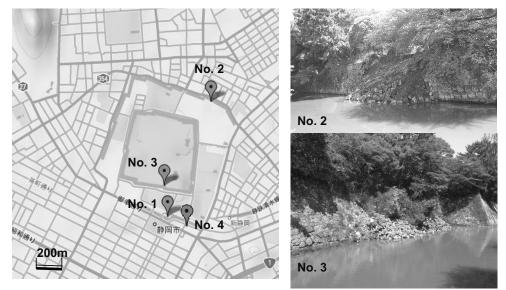
The first author surveyed the areas affected by the 1935 Shizuoka earthquake (M6.4) and took photographs of the locations of damages described in a series of reports that appeared in the Bulletin of Earthquake Research Institute, University of Tokyo (ERI Bulletin hereafter), Vol. 13, No. 4, 1935 [3]-[6]. As it would happen, the date of the survey, namely July 11th, 2009, was exactly one month before the August 11th 2009 Off-the-Coast-of-Suruga Bay Earthquake. The photographed location included a stone wall of Sunpu Castle⁽⁵⁾ showing a slight sign of bulging towards the outer moat of the castle (Fig. 2(a)). As things turned out, this part collapsed in the 2009 earthquake. Sunpu Castle had outer, middle and inner water moats as its original shape in 1607 with the formation of the Tokugawa shogunate government. After the castle grounds became property of Shizuoka city in 1889, much of the inner moat system was filled in, and the 1935 Shizuoka Earthquake was responsible for the collapse of a part of its stone wall facing the outer moat (Fig. 2(c), [6]). In the 2009 earthquake, collapses of stone wall were reported at four locations as shown in Fig. 3.

Fig. 3. Locations of broken stone walls of Sunpu Castle (Photos taken on 2009/08/11). Latitude and longitude for the center of the map: N34.979623°, E138.382287°

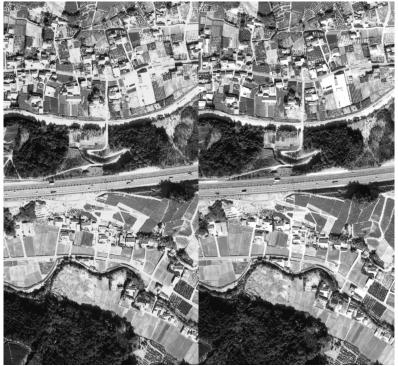
Makinohara diluvium terrace has its major geomorphic surface gently sloping southeast with deeply indented slopes on its northeast and southwest sides (Fig. 1). Tomei Express way runs longitudinally over a thin ridge extending from this terrace to the Oigawa river-plain. This ridge path was constructed by cut-and-fill earth-moving. One of fill sections along this ridge (N34.755506°, E138.191013°) was damaged in the earthquake. Fig. 5 shows a pair of aerial photographs of the damaged fill taken in 1975, namely 6 years after the completion of the express way. When these two photographs are perceived as a single image in terms of depth by either naked eyes or a stereoscope, it is found that the north toe of the embankment is retained by a concrete wall. Highway retaining walls are designed to have proper drainage behind them, and subjected to frequent inspections. However drainage systems can be gradually clogged up with fine substances of weathered soils. Moreover the area was reportedly receiving up to 80mm rain until early morning of August 11th. The Central Nippon Expressway Company (Central NEXCO hereafter) has set up an independent panel for investigation of causes, and officially stated on September 28th that the slope failure occurred within the fill above the retaining wall [7]. NEXCO also stated that the lower toe part of the embankment behind the retaining wall was a fill of crushed mudstones, and weathering of the mudstones has caused clogging of the drainage channels behind the retaining wall. Fig. 5 shows a pair of aerial photographs of the damaged fill section taken in 1988. The fill is covered up with rich vegetation including bamboos. Bamboos often indicate the presence of shallow underground water.

Fig. 4. Stereogram of the fill-section of the Tomei Express way in 1975 before the 2009 earthquake (Photos from Geographical Survey Institute of Japan). Latitude and longitude for the center of each photo: $N34.75577^{\circ}$, $E138.191614^{\circ}$, Width of each photo = 710m.

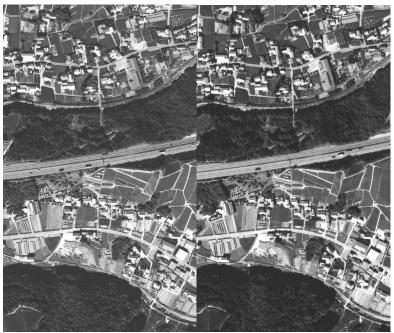
Fig. 5. Stereogram of the fill-section of the Tomei Express way in 1988 before the 2009 earthquake (Photos from Geographical Survey Institute of Japan). Latitude and longitude for the center of each photo: N34.75577°, E138.191614°, Width of each photo = 710m.

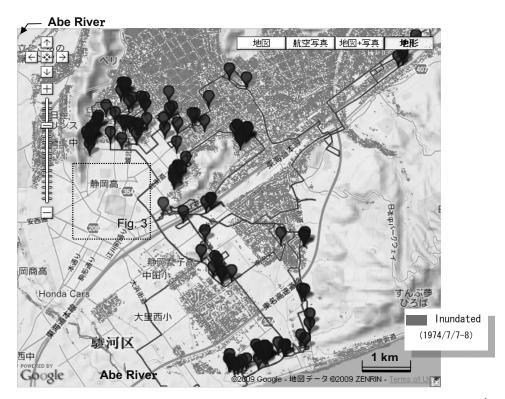
Balloons in Fig. 6 show the locations of damaged roof ridges plot on the inundation map of Shizuoka (Japan River Association, [12]). The dark colored area spreading northeast of the city was inundated in the heavy rain of July 7th, 1974. Shizuoka Observatory of the Japan Meteorological Agency saw its record-high 508 mm rail fall in just 24 hours (9:00 AM, July 7th to 9:00AM, July 8th, 1974). Water topographically stagnated northeast of the city. Shizuoka city spreads over an alluvial fan, which has been formed with sand, boulders, soils and other suspended matters that Abe River has carried over centuries. Abe River flows about 50 km straight through valley walls from north to south along the Itoigawa-Shizuoka Tectonic Line, one of the largest tectonic lines in Japan (see Fig. 1). The mountain ridge on its eastside becomes thinner as it goes south, and dies out at around Shizuoka City. Abe River sediments, which have been confined within valley walls until this point, suddenly spread out over the city area. Beyond the depositional reach, there remain swampy areas. Damaged houses are mostly found along depositional reach of Abe River sediments. The distribution of damaged houses also overlaps the areas damaged by the Shizuoka Earthquake of 1935 (Fig. 7). One exception is found north of the city where the urbanization was quite rapid after the World War II, and therefore few houses were there when the 1935 Earthquake occurred. The second exception is near Kuni-Yoshida, which is now developed as an industrial area and dwelling houses are rather small in number. It is also remarkable that damaged houses are found slightly inland of a sand dune along the coast of Suruga Bay.

Fig. 6. Locations of damaged roofs (Baloons) observed in Shizuoka City (Aug. 17, Sept. 11^{th} and 12^{th}): Dark colored areas were inundated in the heavy rain of July 7th to 8th, 1974⁽¹⁰⁾. The area shown in Fig. 3 is boxed with broken line. Latitude and longitude for the center of the map: N34.979483°, E138.408723°

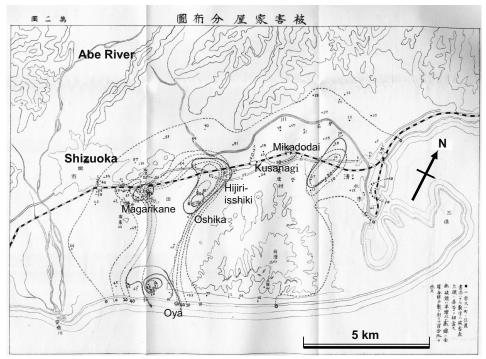
Fig. 7. Distribution of damaged houses in the 1935 Shizuoka Earthquake: Solid and broken contour lines show percentages of half-broken and completely destroyed houses, respectively (from the 2^{nd} Report of the Shizuoka Earthquake, Numazu Observatory of JMA [10]). Latitude and longitude for the center of the map: N34.990629°, E138.450737°

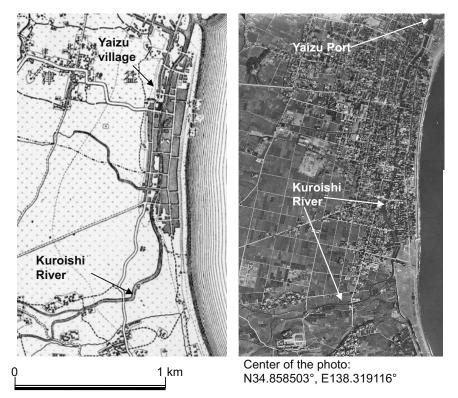
Both the 1:20,000 scale map of Yaizu (Imperial Japanese Army, [14]) and the aerial photo taken by US Army in 1946 [15] show that Yaizu was developed as a fishing village near the mouth of Kuroishi River (Fig. 8). Kuroishi River is a small stream that flows from west to east on a wet flat plane until it reaches the sand dune along the Suruga Bay Coast. Then it takes a sharp turn, and flows north being confined behind the sand dune until it joins Koishi River and finally flows into Suruga Bay.

Fig. 8. 1:20,000 scale map of Yaizu (left, 1891) and the aerial photo taken by US Army (right, 1946)

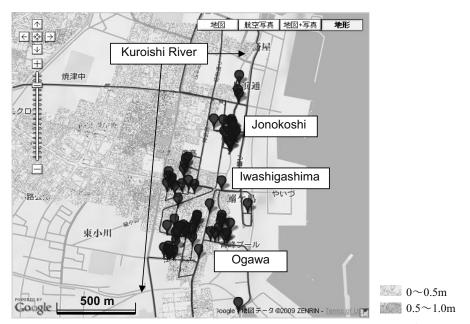
Fig. 9 shows the estimated inundation areas in Yaizu for the scenario rain that we can expect once every 30 years (Shimada Branch Office, Department of Construction, Shizuoka Prefecture). Balloons are locations of damaged roof ridges that the authors observed in their survey of September 12th, 2009. Balloons are found in "Jonokoshi", "Iwashigashima" and "Ogawa" areas; these names are also found in old documents of the 1854 Ansei Tokai Earthquke (Emergency Management Agency, Shizuoka Prefecture, [16]) indicating that these areas have been susceptible to same damage in intense earthquakes.

Fig. 9. Locations of damaged roofs (Baloons) observed in Yaizu City (Sept. 12th 2009): Dark colored areas were estimated inundated areas for the scenario rain that we can expect once every 30 years. Latitude and longitude for the center of the map: N34.859031°, E138.320446°
