SHEAR PLANE FOUND IN THE INTERIOR OF SOIL/ROCK NEAR KIZAWA TUNNEL

Yu Zhao¹, Yuriko Tomiyasu² and Kazuo Konagai³

Key Words: Landslides Tunnel Boreholes Wells Mid-Niigata prefecture Earthquake

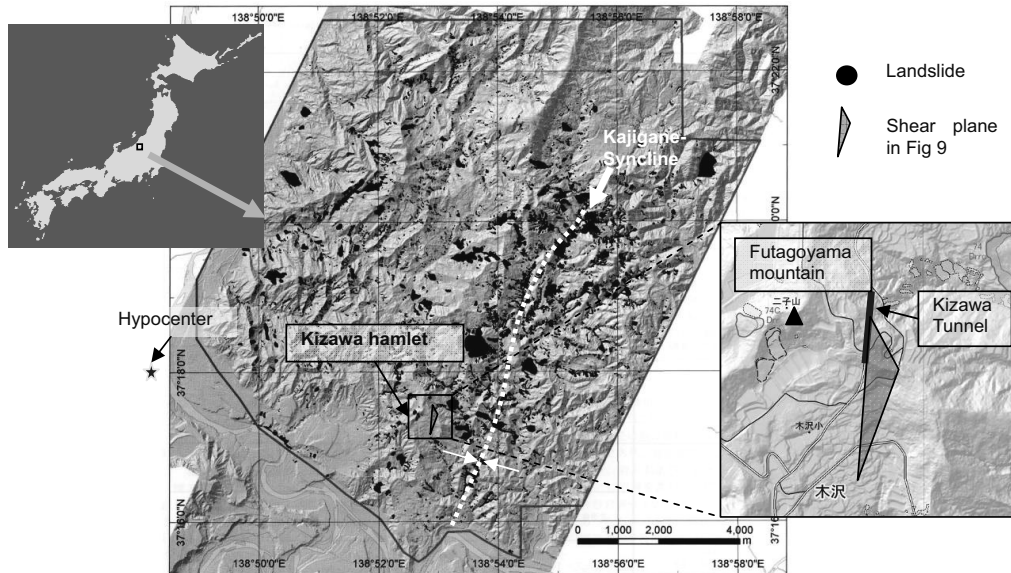
In this figure, a remarkable number of landslides make up an about 1 km wide brush west of Kajigane syncline, which is seemingly a hidden fault projection on the ground surface as indicated by Konagai et al. (2009). Near the southern end of this brush of landslides, there is a “gap” in the vicinity of Kizawa hamlet where landslides are unusually sparse when compared with the other segments.

Figure 1. Distribution map of landslides caused by the 2004 Mid-Niigata Prefecture Earthquake with Kizawa area closed up. Triangle in the close-up shows the estimated shear plane as is discussed later.

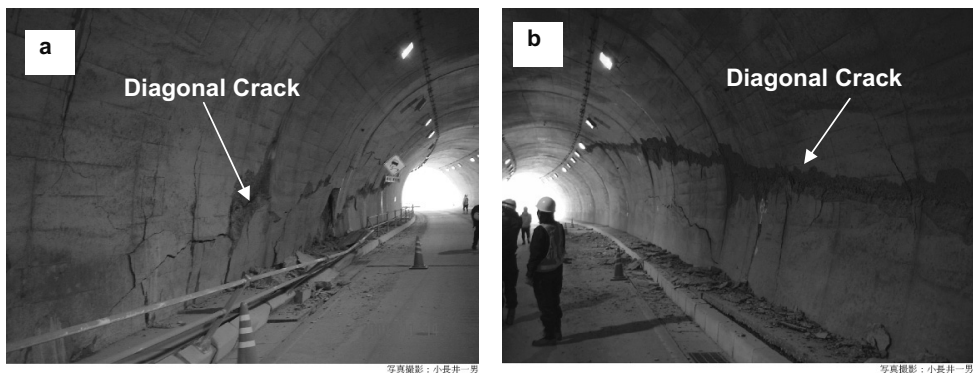
Konagai et al (2009) surveyed this gap area of landslides, and reported that the concrete lining of Kizawa tunnel in this area suffered a serious cracking as described herein below (Fig. 2). Since underground facilities such as tunnels follow closely the motion of their surrounding soils, the damage to

Kizawa tunnel suggests that some dislocation took place within the interior of the ground.

Figure 2. Diagonal cracks on both walls of Kizawa Tunnel (a) The west side of the tunnel (b) the east side of the tunnel (Photo by Konagai, K.)

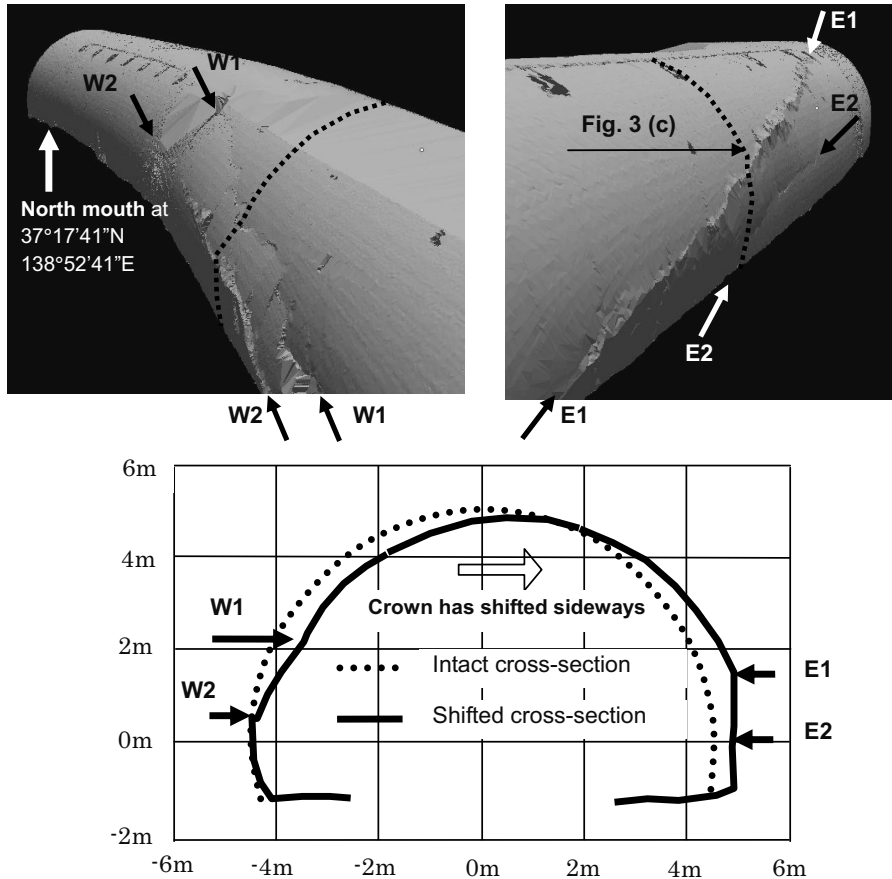
Kizawa tunnel skims the NW-SE trending branch of Futagoyama mountain ridge (Fig. 1). Konagai et al. (2009) performed a laser-scanning to investigate the damage to inner side of the tunnel at a northern 120 m segment of the total 300 m long tunnel. This laser-scanned image (Fig. 3) (Konagai et al., 2009) shows that cracks E1, E2, and W1, W2, run diagonally up through the east and west side walls of the tunnel. The cracks E1 and E2 on the east side wall extend over 45–83 m distance from the north

tunnel mouth, while W1 and W2 appeared over 38–88 m distance on the west wall.

Fig. 3 (c) shows a cross-section of the tunnel at 59 m from the north tunnel mouth. This figure shows that both E2 and W1 were folded inside the tunnel, while E1 and W2 were folded backwards. These axially opposite pairs of zigzag folds just allowed the tunnel crown at this location to shift about 0.5 m sideways with respect to the invert, and there was no sign showing that the tunnel lining was sheared in a longitudinal direction along these cracks.

Figure 3. North segment of Kizawa tunnel. (a) West tunnel wall, (b) East tunnel wall, (c) Tunnel cross-section at 59m distance from the north mouth (looking northward) (after Konagai et al., 2009)

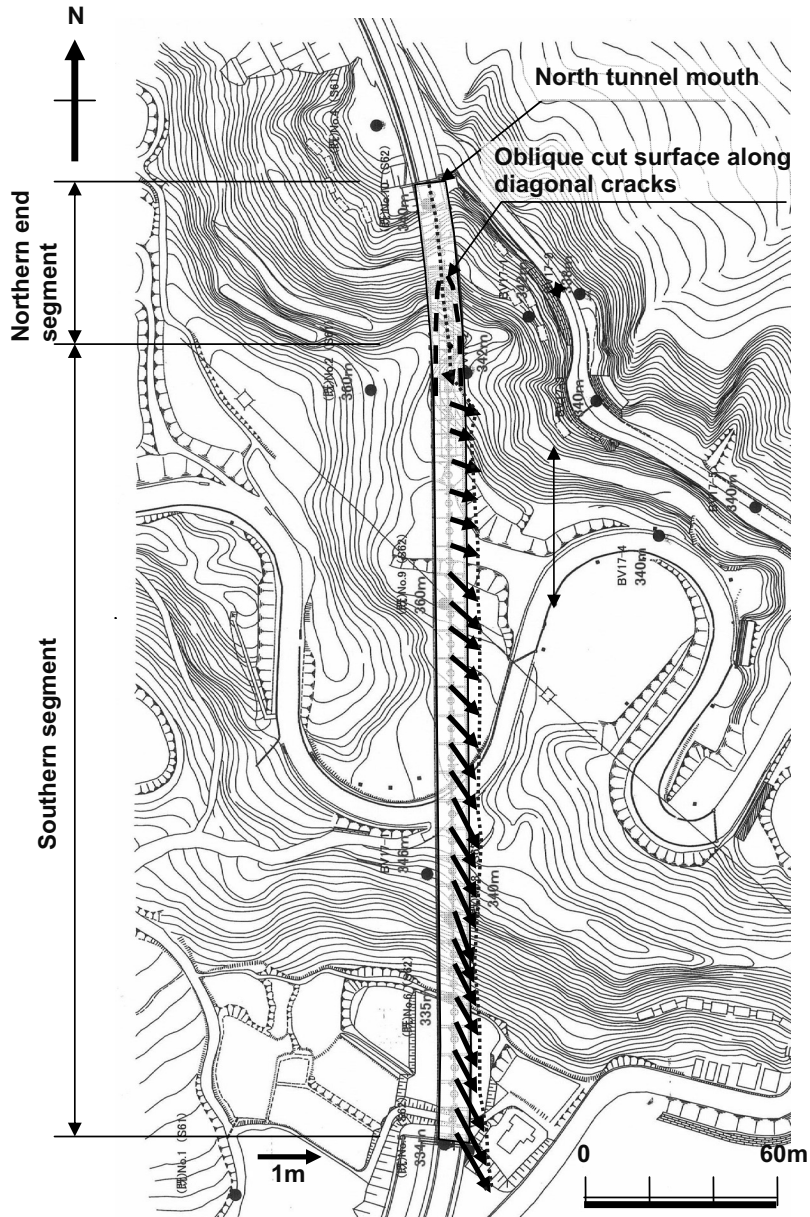
To identify the cause of these cracks, borehole data near the cracked part of the tunnel were first gathered. In addition, two bore holes were drilled for in-situ geotechnical tests (Konagai et al., 2009). The plan view around the Kizawa tunnel and the location of the boreholes are shown in Fig. 4.

These borehole data indicated that a shear plane with a dip of about 20–30° in the northwest interior of the mountain continued to its southeastern extension, dipping about 6 to 10° south. This southeastern extension is roughly parallel with the intact bed stratum of sedimentary rock. The rock mass above this shear plane was generally disturbed.

Kizawa tunnel was thus considered to be obliquely intersected by this shear plane with its 40–80 m long northern end segment and the remaining 220–260 m long southern part being embedded, respectively, in the lower intact and upper disturbed rock masses. We can judge the possible inter-layer slippage happened near the tunnels' dislocation point from the borehole near the tunnels.

Figure 4 Earthquake-induced changes in the alignment of the road center line (Konagai et al., 2009)

The earthquake-induced change in the alignment of the road center-line was measured at every 8.8 m interval (Fig. 4, Nagaoka Regional Development Bureau et al. 2007). The north mouth of the tunnel was taken as a reference, assuming that the north segment of the tunnel was embedded in the intact and stable rock mass. It should be noted that the greater part of southern segment has shifted as a whole by about 0.5 m to the east and that south mouth has shifted nearly 1 m to the south and 0.5 m to the east. In other words, the tunnel was stretched by 1 m along the NW directions.

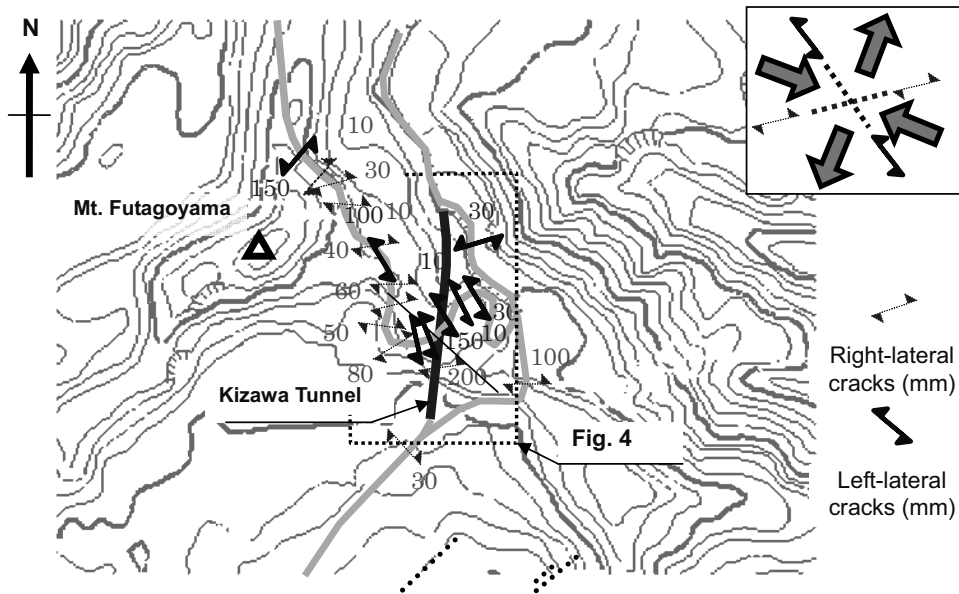
Referring back to past earthquakes, underground facilities and/or foundations closely follow the motions of their surrounding soils/rocks. Mapping cracks on roads' pavements often allow us to capture an entire picture of the soil/rock movement. Nagaoka Regional Development Bureau et al. (2007) has compiled detailed features of cracks that appeared on the pavements of a farm road winding immediately above the tunnel. Many of these cracks did show either left-lateral or right-lateral dislocations as shown in Fig. 5.

Figure 5. Right-lateral and left-lateral cracks on pavements. Figures for arrows denote dislocations in mm. (Konagai et al., 2009. Original data from Nagaoka Regional Development Bureau et al., 2007)

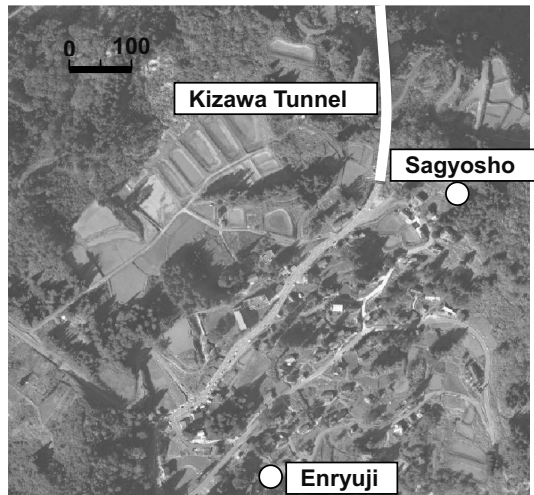
Figure 6. The two dislocated wells at Sagyosho and Enryuji respectively

Coming out south of the Kizawa tunnel, there is a wide spread terrain sloping southeast. This terrain of Kizawa hamlet is considered to be an exposed slip surface of an old landslide. Two wells at Sagosho and Enryuji in this terrain, which were drilled for irrigation and water supplies for carp ponds (Fig. 6) were found dislocated at 32 and 20 meters depths respectively.

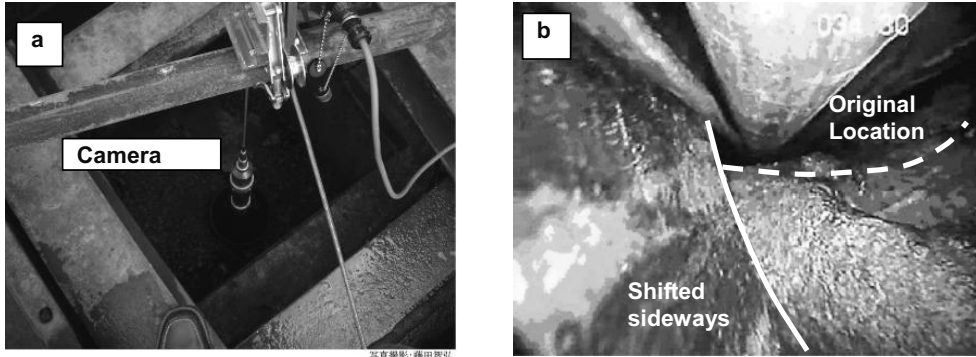
Figure 7. Determination of dislocation depth at Sagyosho well (a) lifting camera into the well (b) image showing the dislocation (looking downward into the well)

At Sagyosho, a borehole camera was slowly lifted down into the well using a windlass (Fig. 7 (a)). With the camera, clear dislocation was found at 32 m below the ground surface (Fig. 7 (b)). This dislocation clearly showed that the upper shaft of the well was shifted about 15 cm sideways in southeast direction. At Enryuji however, the well's inner diameter of 75 mm was too small for the camera, and therefore, its dislocation was roughly estimated as described below.

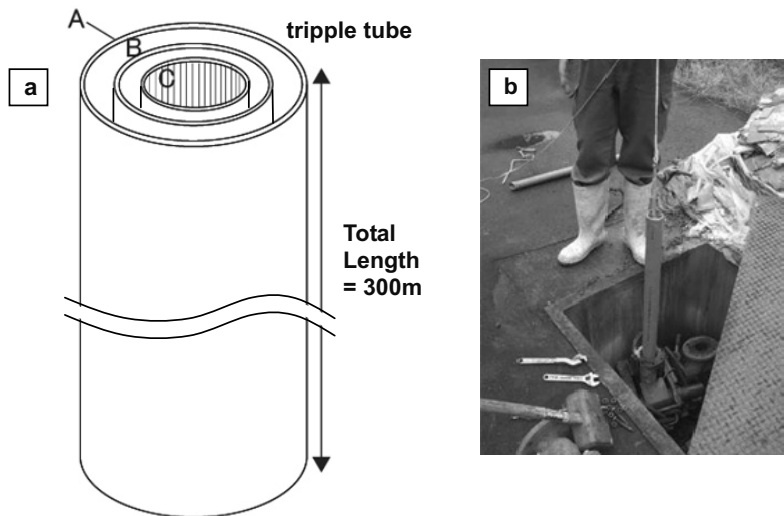
Figure 8. Determination of dislocation depth at Enryuji well (a) the configuration of the well at Enryuji (b) corresponding measuring procedure

This well at Enryoji is a triple-tube as shown in Fig. 8 whose dimensions are given in Table 1. Three PVC pipes of about 1 m long with different diameters (60 cm, 50 cm and 30 cm) were lifted down and up into the well one by one (Fig. 8(b)), and it turned out that only the thinnest pipe (30 cm in diameter)

went below the dislocated point while the others stopped at this point. This indicates that the opening at this bend is smaller than 50 cm and larger than 30 cm. For the innermost pipe to be dislocated, the outermost and middle pipes are to be crushed one by one against the innermost pipe as illustrated in Fig. 8. Therefore the dislocation at this point was estimated to be larger than 140 mm and smaller than 160 mm. However, the direction of this dislocation is not known yet.

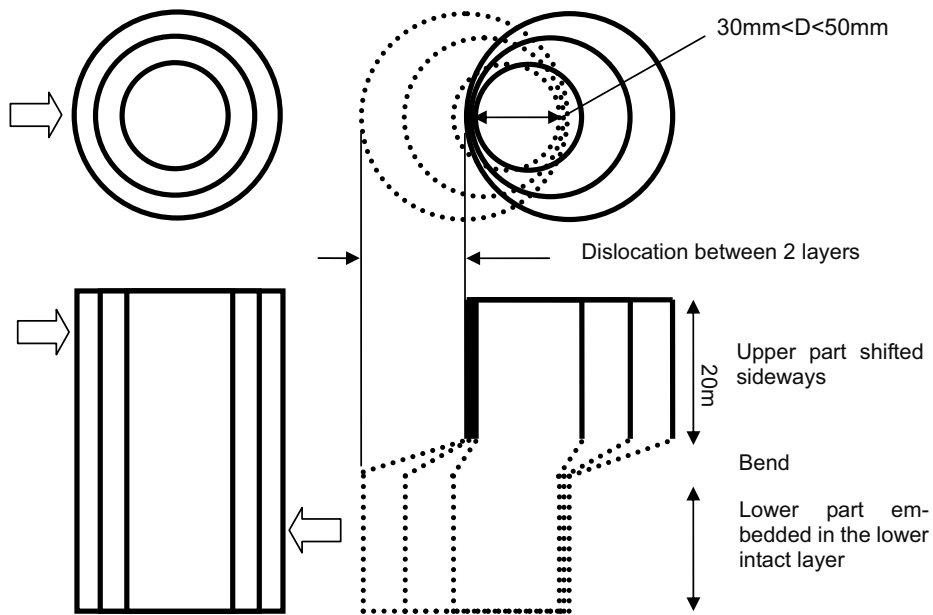
Figure 8. Scheme showing how the Enryuji well was deformed

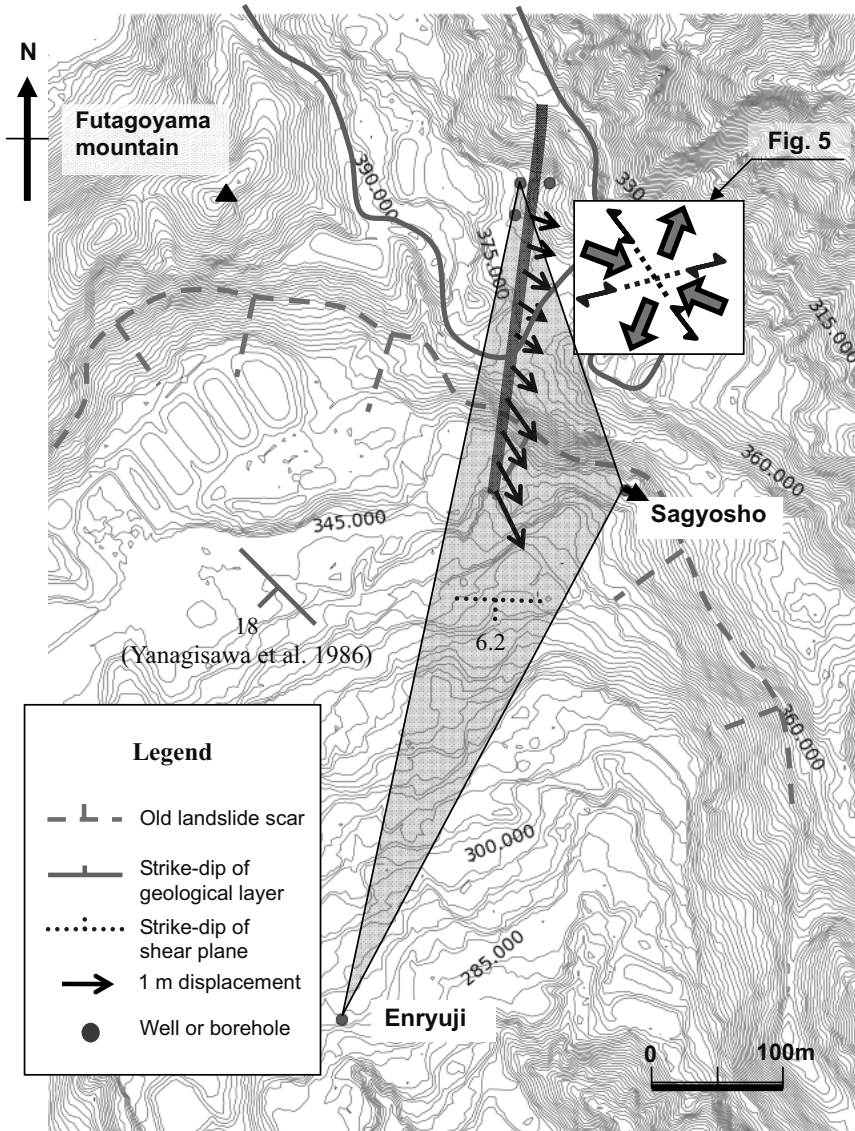
It is to be noted that bends observed in the well shafts, clear shear planes observed in borehole cores and diagonal cracks that appeared on both west and east concrete lining walls of Kizawa Tunnel make up a large flat plane in the interior of the sedimentary rock beneath Kizawa hamlet. The plane has a strike in almost east-west direction and dips 6.2° southward as shown in Fig. 9. This plane is thus almost parallel with the wide spread terrain of Kizawa hamlet. Considering stratified and gently folded structure of mud and silt rocks (Yanagisawa et al., 1986), this fact is suggestive of the presence of a hidden shear plane beneath the exposed slip surface of an old landslide. This plane, when it is plotted in Fig. 1, is located exactly in the middle of the gap that appeared in the wide brush of landslides densely distributed along Kajigane syncline. The soil/rock mass on this hidden plane may have shifted east to southeast sideways. For now it is not known yet if the soil/rock mass is completely stable. Moreover there may be more slip surfaces hidden in the interior of the middle raised mountain terrains of geological folding. Further detailed studies will be necessary for coping with long lasting problems for rational rehabilitations.

Figure 9. Shear plane related information compiled on Kizawa helmet
