INTERPRETATION OF BREACHING FAILURE OF HATTIAN BALA LANDSLIDE DAM FORMED BY 2005 KASHMIR EARTHQUAKE WITH EXPERIMENTAL APPROACH

ABSTRACT: On February 9, 2010, a natural landslide dam at Hattian Bala of Pakistan, which was formed in the Oct 8, 2005 Kashmir earthquake, failed due to incessant rains. The landslide dam was formed of mainly crushed mudstones and sandstones which can be easily deteriorated through their slaking process. Under this threat, we had made four surveys to monitor the landform changes at about half-year's regular interval since June 2008. The back erosion at the toe part of the dam was first observed in the third field survey of June 2009. GPS-measured displacements conducted in both June and November 2009 showed a settlement of the crest part and slight uplift near the toe where the overflowed water fell in the eroded gully. We performed slaking and direct shear tests on prepared samples of crushed mudstones and sandstones with some materials taken in-situ to understand slaking effects on their stress-deformation characteristics. A significant creep deformation and a reduction in the peak strength were observed as the slaking developed in the mudstone specimen

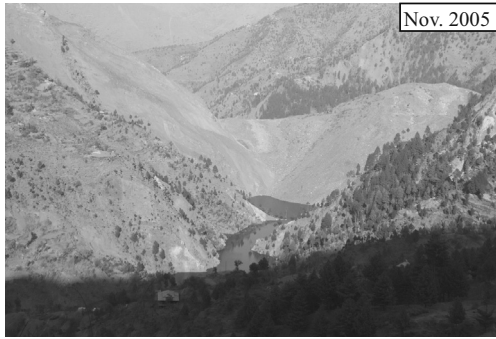
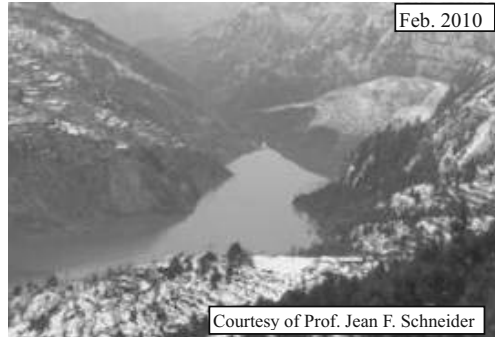
On 9th February 2010, the landslide dam failed after 5 days of rainfall as shown in Photo 2. The discharged water reportedly destroyed dozens of houses and killed one child, and the flood inundated several downstream areas (The News, 2010). Sattar et al. (2010) conducted dam break analysis before

Photo 2 Hattian Bala landslide dam before and after failure (photography from upstream)

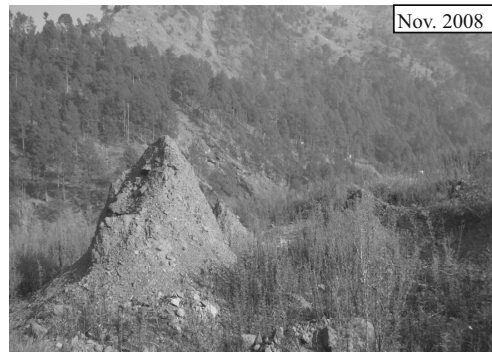
The landslide dam formed by the 2005 Kashmir earthquake consists of both sandstones and mudstones from Murree formation. Deposited debris mass was composed of rocks that were expected to be weathered easily because of their weak and slakable features as shown in Photo 3.

Photo 3 Mudstone of Murree formation weathered by slaking around the middle portion of landslide dam (point C, c.f. Fig.2)

Many cones of weathered fragments of mud rocks (Photo 3) and reddish water marks of finer substances remaining on rocks along the spillway (Photo 8) indicate that the mudstones there are highly susceptible to deterioration due to both weathering and slaking. The weathering/slaking process of the mudstones and sandstones may have accelerated removal of finer substances from the interior of the dam by seeping waters, and thus the breaching of the dam. To discuss this possibility, simple slaking tests were conducted on the rock samples taken from the landslide mass.

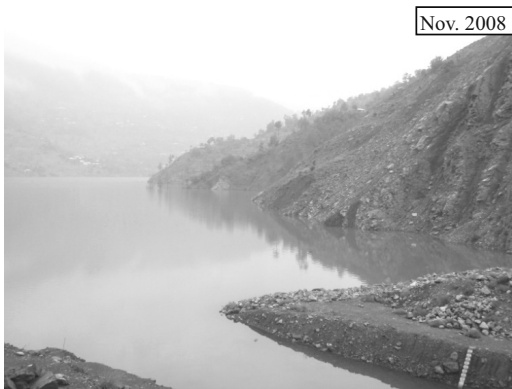
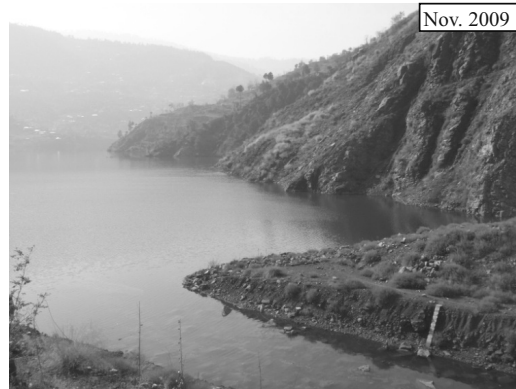
Photo 4 Dam water flow into the spillway at the crest part (point A, latitude 34.137885°, longitude 73.732342°, c.f. Fig. 2). The spillway seems to be unchanged after 2 years.

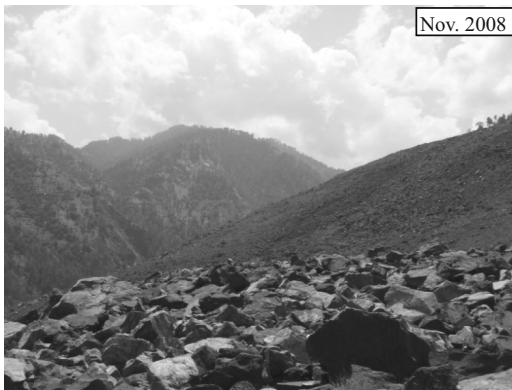
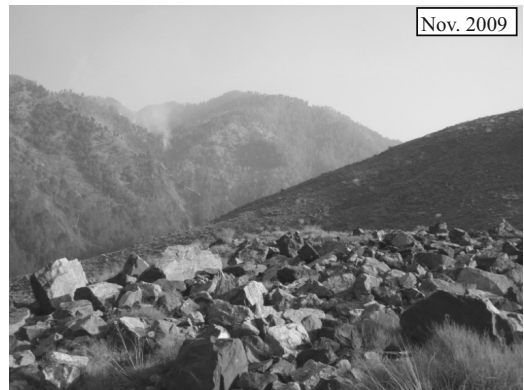
Photo 6 Middle portion of the dam (photography the westward from point B, latitude 34.138185°, longitude 73.730911°, c.f. Fig. 2). There was little change on the dam surface for 2 years)

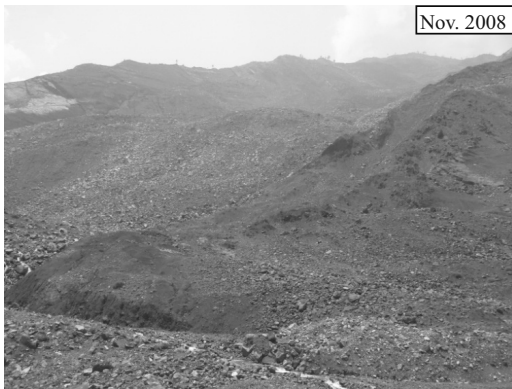
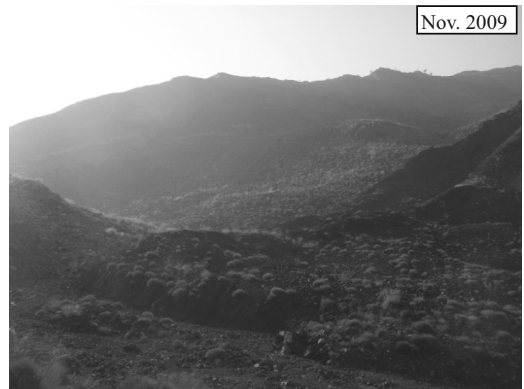
Photo 7 Source area of landslide mass (photography from point C, latitude 34.138562°, longitude 73.728825°, c.f. Fig. 2). The spillway can be seen near side of the source area. There was little change on the slope for 2 years.

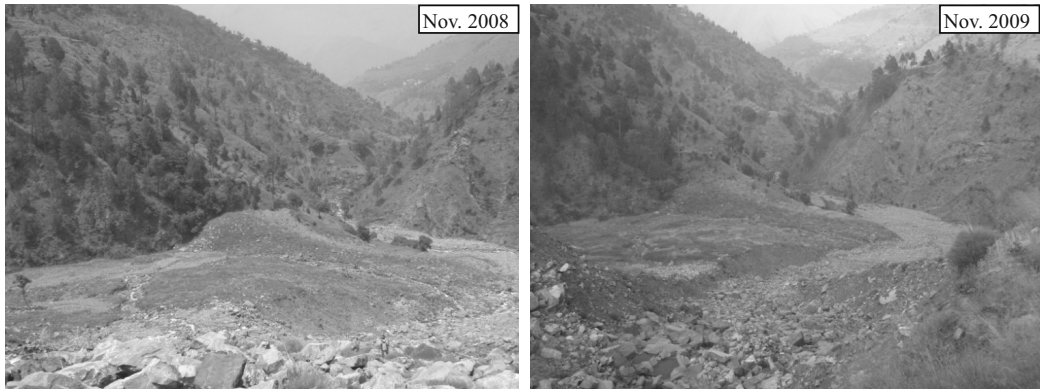
Photo 8 Toe part of the dam (photography the downstream from point D, Latitude 34.138564°, Longitude 73.725544°, c.f. Fig. 2). Significant erosion could be observed along spillway in the survey in June 2009 after that in November 2008.

Meanwhile, the perimeter of the erosion gully shown in Photo 8 was also measured with the GPS receiver in June 2009 and November 2009. The two perimeters traversed at different times of the year were about identical with each other (Fig. 2), and showed little sign of progressive erosion during the half-year period.

As we mentioned previously, there was significant erosion at the toe part of landslide dam during dry season (between November 2008 and June 2009) while no clear and visible sign of landform change was observed during rainy seasons (between June 2008, 2009 and November 2008, 2009). In fact, it was exactly dry season when the landslide dam failed. It may be considered that the significant slaking has caused rapid reduction in the strength of the dam that was mainly formed by mudstones and therefore buildup of deformations simultaneously, and then the dam body failed due to the increase in the water level of the Karli lake, which can have caused an increase in a hydraulic grade in the dam body as well as the spillway discharge, accelerating the progressive breaching.

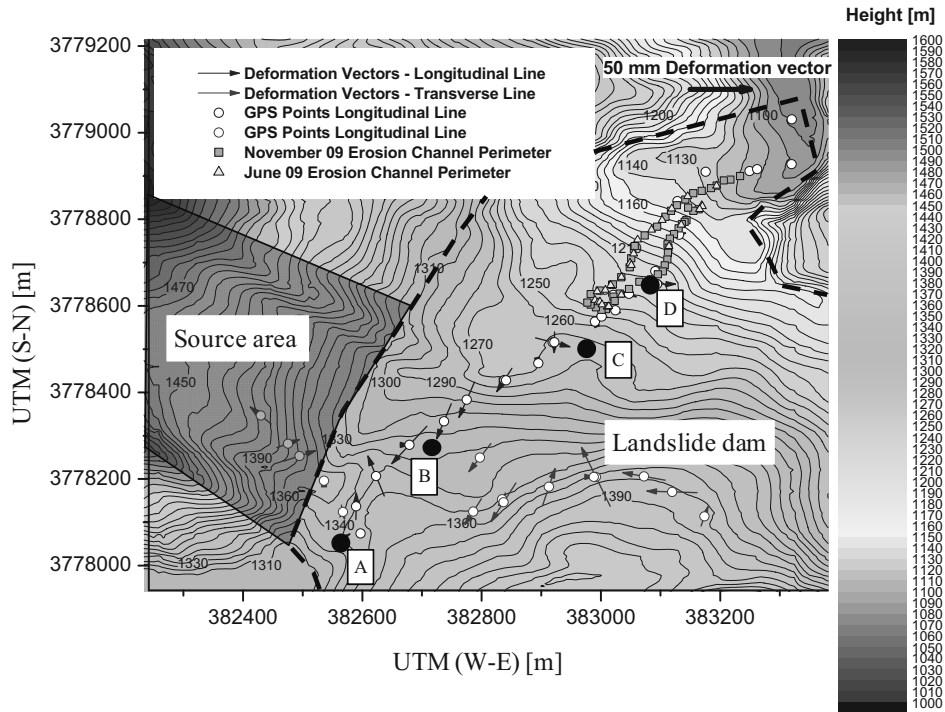
Figs. 2 shows that in-plane deformations are up to or comparable to 5 cm, No trend for the in plane movement vectors was observed indicating that the local deformations were dominant at the marked GPS points instead of integral body movement. On the other hand, the maximum settlement of about 10 cm was reached near the crest with the greatest thickness of dynamically placed loose debris mass presumed, while a slight uplift was observed where the spillway water falls in the gully eroded near the toe of the debris mass.

Figure 2 Deformation vectors superimposed on contour map generated using 5 m resolution DEM (after Sattar et al., 2010)

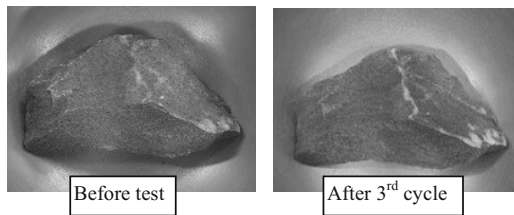
Fig. 5 and Photo 10 show that the mudstone specimen is sensitive to the duty cycle for accelerating slaking, while Fig. 4 and Photo 9 show little sign of slaking of the sandstone specimen (estimated slaking class = 0). Small cracks and small bubbles showed up on the surface of the mud specimen 30 minutes after the first pouring. The mudstone specimen however did not show any further changes in the subsequent wetting/drying cycles, and their shapes were kept intact (estimated slaking class = 1).

Photo 9 Sandstone samples before and after accelerated slaking test

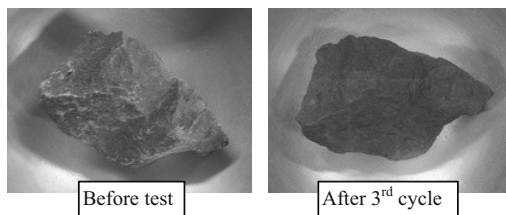
Photo 10 Mudstone samples before and after accelerated slaking test
