DAMAGE TO NON-STRUCTURAL COMPONENTS IN LARGE ROOF BUILDINGS FAILED DURING AN EARTHQUAKE IN SURUGA-BAY ON 11 AUGUST 2009

Yoshiro OGI¹, Yasushi OBA² and Ken'ichi KAWAGUCHI³

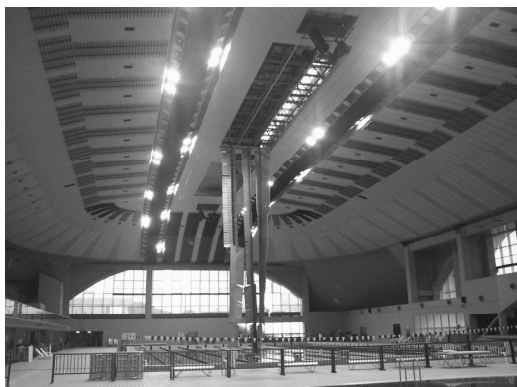
**Figure 3.** Public Pool-1 – hung louvers in the arena**PUBLIC POOL-1**

As outstanding damage to non-structural components in this report, three big louvers each of which weighs 300 kg had hung down from the top of the ceiling at a public pool (**Figure 3**). The building was completed in 1990. Its skeleton is mainly reinforced-concrete (RC) and partially steel. There are three ground stories and one underground story. A 50-m swimming pool, a diving pool, and gallery seats are in an arena (width: 43.8 x 99.1 m, height to ceiling: 13.0-18.5 m). Damage to non-structural components had occurred in the arena and in a foyer, while the building skeleton, a pool tank, lighting equipment in every room, and a machine room seemed not to be damaged. According to an interview, the seismic intensity on the site was approximately 5.

Three movable louvers which had been laid horizontally in the skylight (5 x 56 m) at the top of the ceiling, hung down to the pool tank. The skylight was separated into three blocks (13-m-long, 19-m-long, and 13-m-long), and three louvers had been laid in each block. The hung louvers, each of which weighed approximately 300 kg, had been laid in the center 19-m-long block.

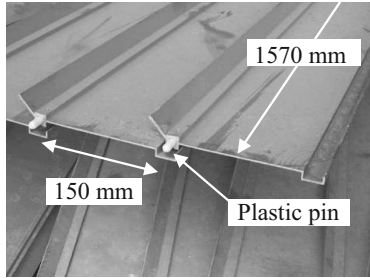
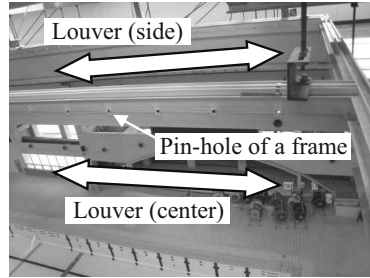
Figure 4. Public Pool-1 – details of louver system in the arena

(a) Louvers

(b) Frame where louvers had been laid

As shown in **Figure 4**, a piece of damaged louvers consisted of approximately 120 aluminum plates (1570-mm wide, 190-mm long, and 2-mm thick) arranged in a line. The plate is supported by two plastic pins ($\phi 8$ mm, 20-mm-long) at the both ends of width direction, inserted into a metal frame having 150-mm intervals. Therefore, as each plate can rotate around a connecting line between its pins, the louver can open and close, driven by a straight guide-member which connects to every plate and which can move back and forth using a motor. But the louvers were left to open during summer.

The reason of hanging was slip-off of the pins from the frame bending during the earthquake.

Several pins had also been cut off due to shear. In two 13-m-long blocks, louvers had not hang down, but slip-off of several pins had occurred.

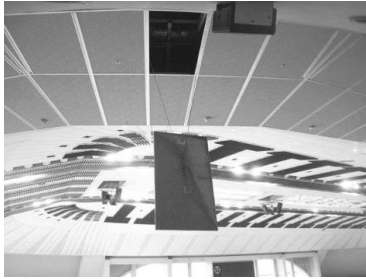
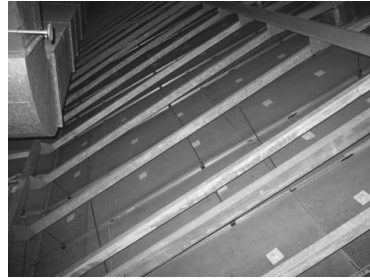
Figure 5. Public Pool-1 – failed ceiling panels in the arena

(a) Panel hung by an electric cable

(b) Furring under the roof

As shown in **Figure 5**, failure of ceiling panels had occurred in the arena. The ceiling was grid-type, and its panel is a glass-wool board (1750 x 850 x 25 mm for example) with a waterproof membrane on the back side. One panel had fallen off and two panels had hung down. Hanger bolts of approximately 0.6-m length were arranged normal to the slope of the arch-shaped ceiling, which causes constant thrust of gravity inside the ceiling face.

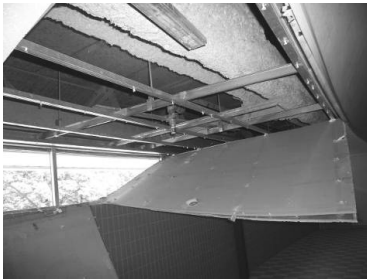
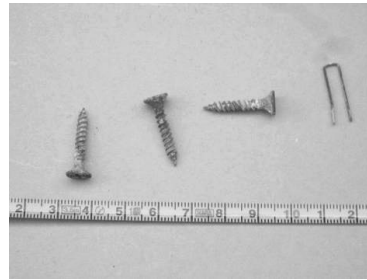
Figure 6. Public Pool-1 – failed ceiling panels in the foyer

(a) Failure of panels

(b) Rusty screws and a staple

As shown in **Figure 6**, two ceiling panels (1600 x 900 mm and 1300 x 900 mm) in a foyer outside of the arena had fallen off. The height to the ceiling was not so high (1.4 m), but its space had often been used by athletes during swimming competitions. Failed ceiling panels were sets of a 9-mm-thick plaster board as a base layer and a 12-mm-thick rock-wool board as a finishing layer.

Several staples and 20-mm-long screws, both of which were in rust, had been scattering around. It may be considered that leak of water from eaves just above the fallen panels, or bedewing on panels caused the metal ones rusty. Mold could be observed on ceiling panels and walls.

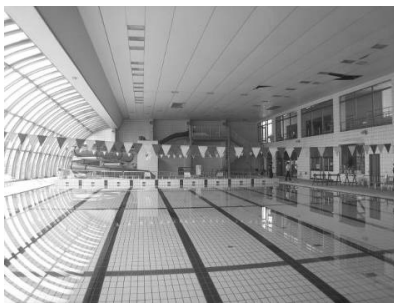
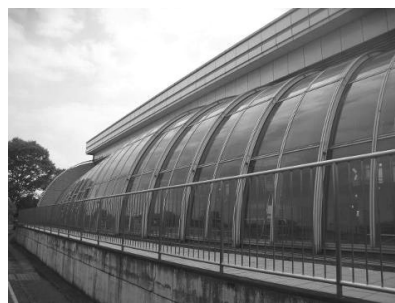
Figure 7. Public Pool-2 – internal and external view

In another public pool as shown in **Figure 7**, damage to the line-type ceiling and sliding walls had occurred. The building was completed in 1989. Its skeleton is RC. There are two ground stories. A room (width: 27.5 x 45.7 m, height to ceiling: 7.5 m) where damage had occurred had a large swimming-pool and a small play-pool. According to an interview, fall of ceiling panels had not occurred until this earthquake while roof space had usually been bedewing.

The eastern side of the room consisted of eighteen 2.6-m-wide sliding walls which could open and close. Each wall consisted of a quarter-cylinder metal frame and pieces of glass, and could move along a longitudinal direction of the room driven by a motor. The walls were closed when the earthquake had occurred. A lot of pieces of glass had got cracks but not fallen off.

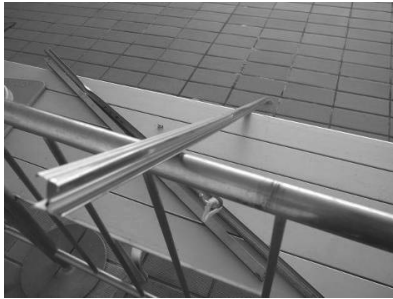
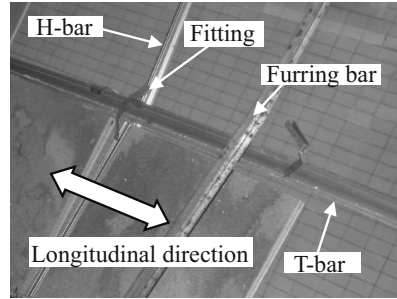
Figure 8. Public Pool-2 – line-type ceiling

(a) Fallen H-bar

As shown in **Figure 8**, the ceiling was line-type composed of 15-mm-thick rock-wool boards and metal H-bars, T-bars, and fittings. Panels, connected each other in a line by H-bars, were laid on two T-bars and kept by fittings. Several ceiling panels had fallen off with H-bars.

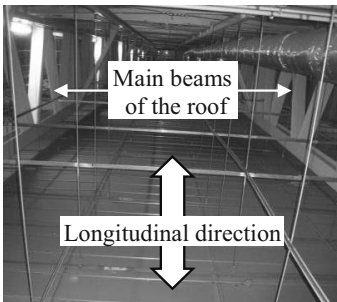
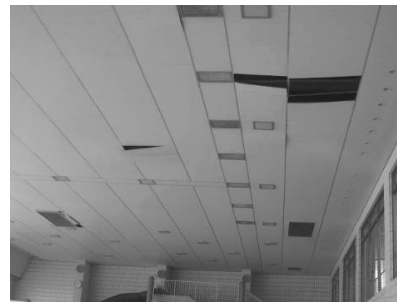
Figure 9. Public Pool-2 – ceiling panels

(a) Furring under the roof

(b) Failure of ceiling panels

The suspending length of the ceiling panels was approximately 2.4 m (**Figure 9**). There were horizontal reinforcement-members on suspending bolts. But they were located 0.9-m above ceiling panels, and were not valid to suppress deformation of T-bars.

Failures were remarkable around the center of the ceiling. The main beams of the roof were laid along the longitudinal direction, to place sliding walls on the eastern side. It can be considered that, during the earthquake, the middle of the main beams had been moving laterally, which caused the damage to the panels under them.

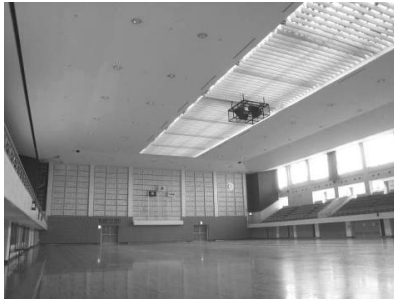
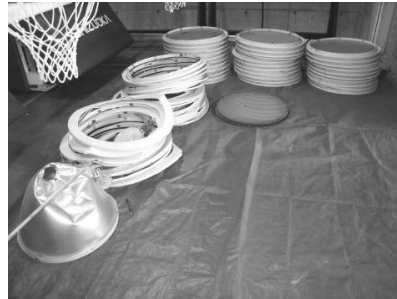
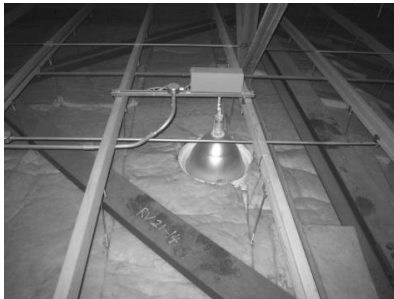
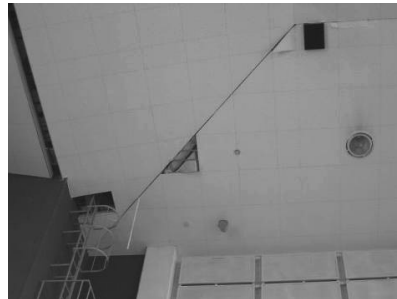
Figure 10. Public Complex – Failure of non-structural components in the gymnasium

(b) Failure of lighting equipment

(d) Failure of ceiling panels

Damage to non-structural components in a gymnasium (width: 39.8 x 59.8 m, height to ceiling: 14.3 m) in the first building had occurred as shown in **Figure 10**. Out of 51 pieces of lighting equipment, 1 whole piece and cover-glass and frames of 42 pieces had fallen off. A frame is attached to a piece of lighting equipment by three coil springs. The reason of the fall is elastic deformation of the spring during the earthquake.

The ceiling consisted of horizontal and inclined faces. Failures of ceiling panels had occurred on their boundary edges. The length of suspending bolts was approximately 60-150 mm.

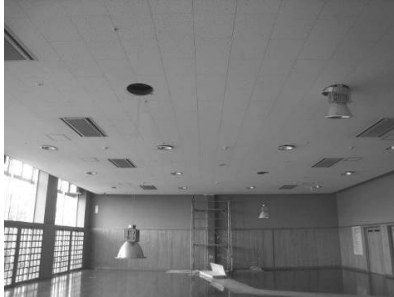
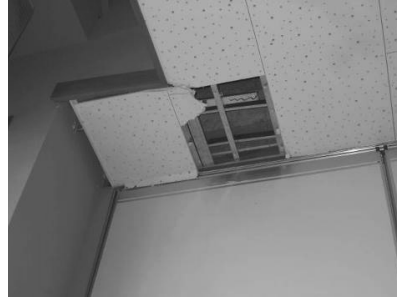
Figure 11. Public Complex – Failure of non-structural components in the judo-kendo room

(a) Failure of lighting equipment and ceiling panels around a steel column

(b) Failure of sliding walls and a ceiling panel

The judo-kendo room on the 2nd story can be split into two rooms by sliding walls. As shown in **Figure 11**, sliding walls had deformed, lighting equipment which could lift by wire had hung down to height of a human's head, and ceiling panels had broken around a steel column and in several places.

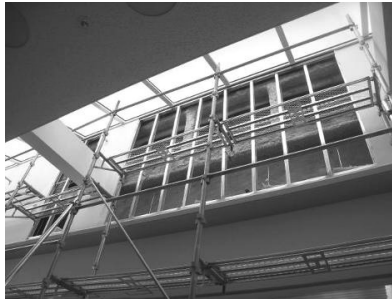
Figure 12. Public Complex – Failure of facing panels in the joint of two buildings on the 2nd story

While two buildings completed in different years as described before, their skeletons are different as well: the first one is steel reinforced concrete and the second one is steel. In their joint on the 2nd story, there was space for skylight, and facing panels there had failed (**Figure 12**).

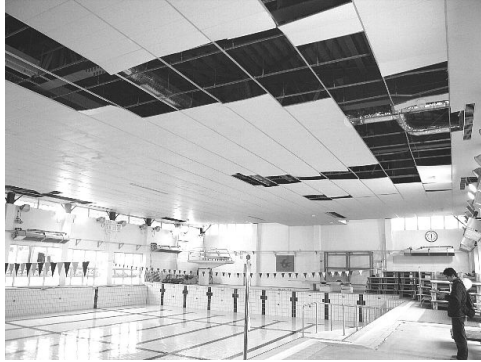
Figure 13. Example of damage to line-type ceiling (The Niigataken Chuetsu-Oki Earthquake in 2007)

Line-type ceilings had frequently been damaged, as shown in the case of Public Pool-2. As another example, **Figure 13** depicts failed line-type ceiling during “The Niigataken Chuetsu-Oki Earthquake in 2007”. The problem is that panels are laid on T-bars with very narrow margin parts, which can fall apart easily during earthquakes.
