Survey of September 30, 2009 Sumatra Earthquake

Muneyoshi Numada¹, Shigeru Miwa², Ömer AYDAN³ and Masanori Hamada⁴

Key Words: Sumatra Earthquake, Masonry structure, Liquefaction, Tsunami, Disaster survey

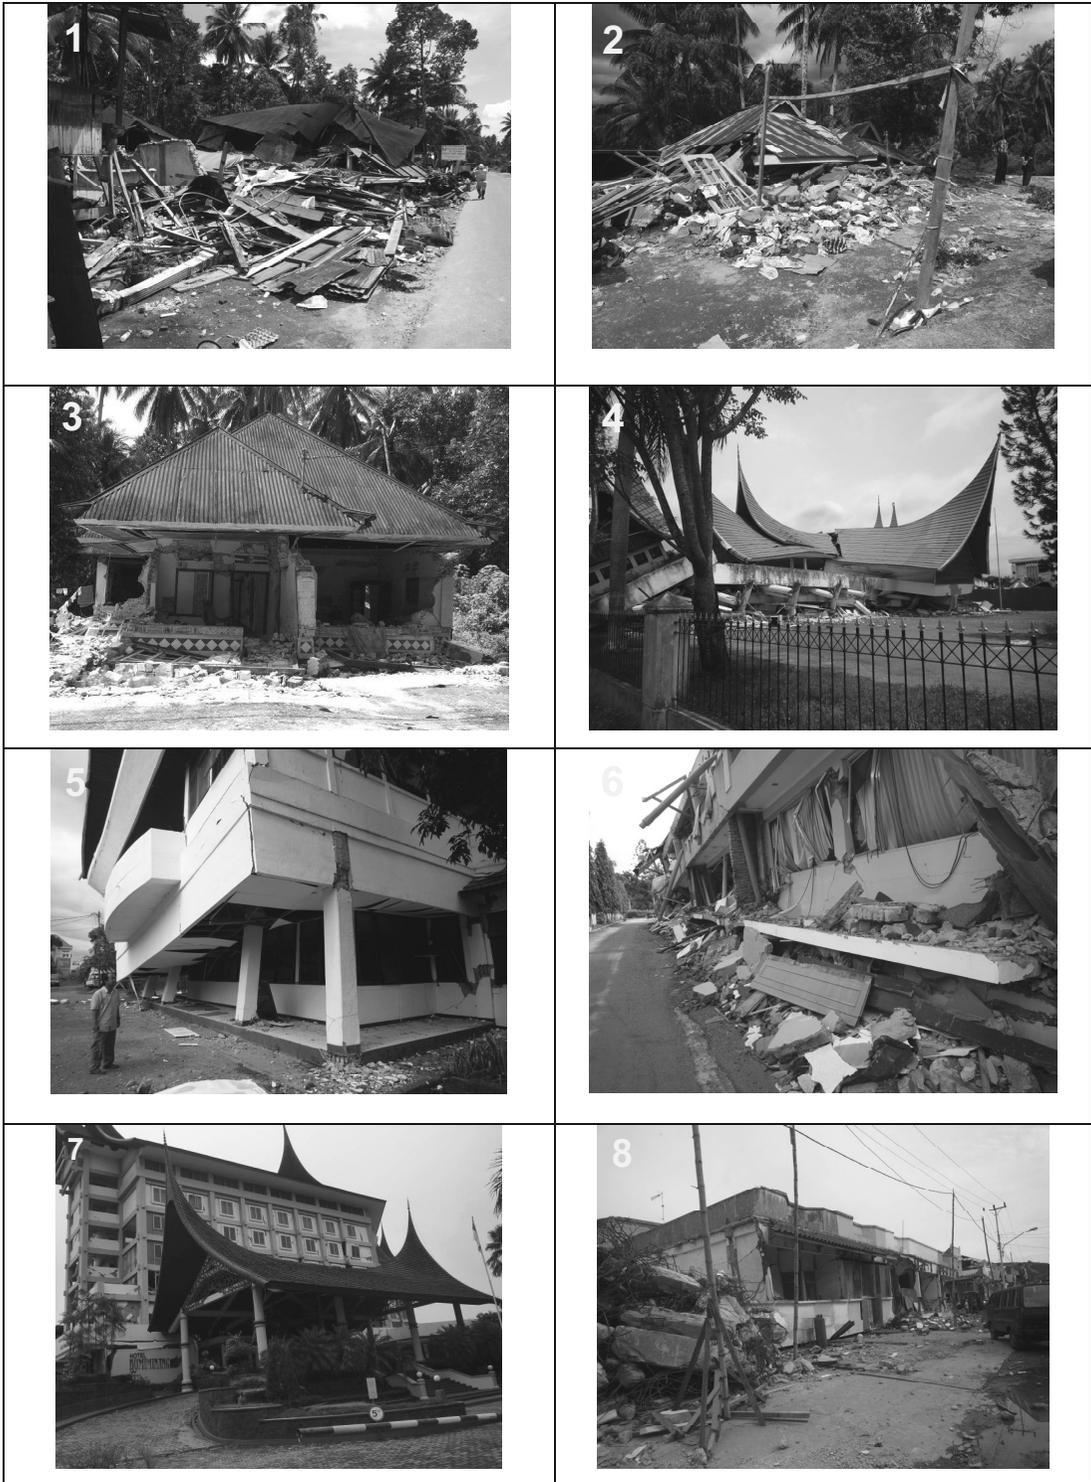
Figure 2. Photos of damaged structures in Padang

In **Figure 2**, Photos 1 and 2 show the typical damage to wooden houses and masonry houses constructed with bricks. There were many wooden houses in the damaged area. These structures performed better than brick masonry houses with or without RC slabs and/or columns; however, there were instances of total collapse due to intense ground shaking. Photo 3 shows an old one story masonry building with no reinforced concrete slabs and columns. Low-rise residential masonry buildings are generally constructed with bricks and are either one or two stories. This type of collapse was observed even in areas with high ground acceleration. Newly-constructed buildings with concrete slabs and columns, there is no doubt that when such structural elements are integrated with masonry walls they perform better and prevent the total collapse of the buildings in spite of some structural damage. Photos 4 and 5 show a government office constructed with an engineered structure. Several cases of total collapse or heavy damage were observed. Some hotel structures also totally collapsed as shown in Photos 6 and 7. Photo 7 shows damage to a hotel which was assigned as a vertical evacuation space in the case of tsunami. People could not use this building as an evacuation structure due to its collapse. This damage illustrated the problem with vertical evacuation spaces. Pancake-type collapse was observed in the buildings of China Town, as shown in Photo 8. The concrete buildings with two or more stories either collapsed or were heavily-damaged. These type of reinforced concrete structures are framed structures with integrated or non-integrated in-fill walls.

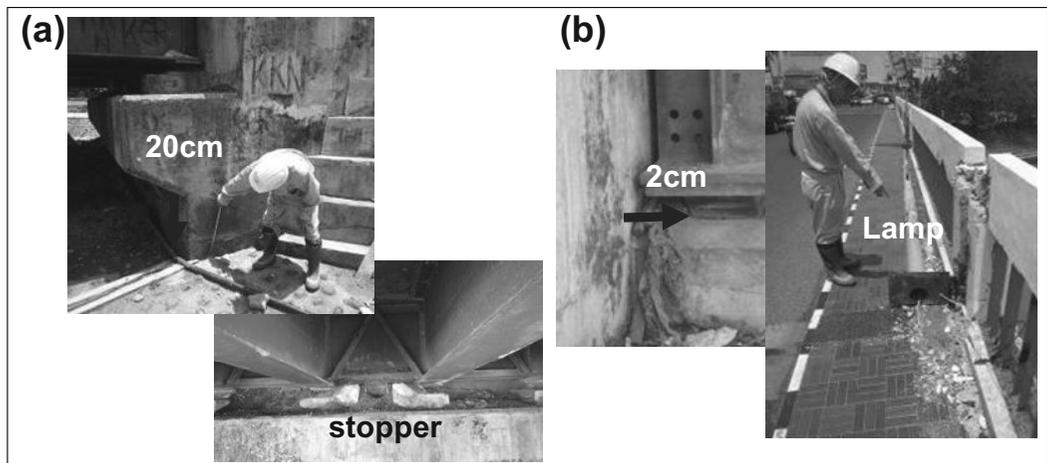
Figure 5. The damage of Mirang bridge (No. 4)

The most heavily-damaged bridge, Sitinurbaya bridge with concrete type (No. 1), underwent settlement of around 100 centimeters in backfill soil, and lateral deformation of ground due to liquefaction at the pier was observed. However, the pier was not affected by the ground movement. Sitinurbaya bridge was constructed to withstand the seismic motion and liquefaction. Mirang bridge shown in **Figure 4** (No. 4) was constructed as a parallel concrete beam structure. Lateral movement was not observed due to the stopper at the bearing. Settlement of about 20 centimeters at abutment was also observed at Mirang bridge (**Figure 5** (a)). Lateral movement was observed, as well as the collapse of electric lamp on the beam and displacement of 2 centimeters at the bridge's rubber bearing in **Figure 5** (b). The function of road could be maintained with such light damage.

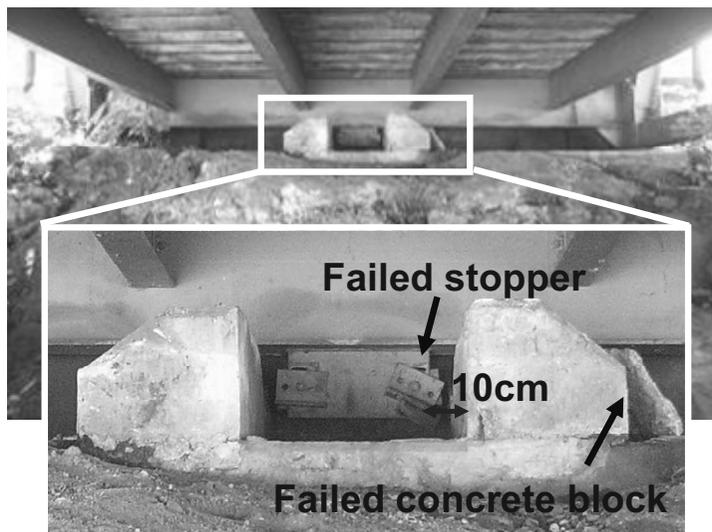
Figure 6. The damage of Bungus bridge (No. 8)

At Bungus bridge (No. 8), damage was observed with over 10 centimeters of lateral movement due to the failure of the stopper, which should reduce lateral movement.

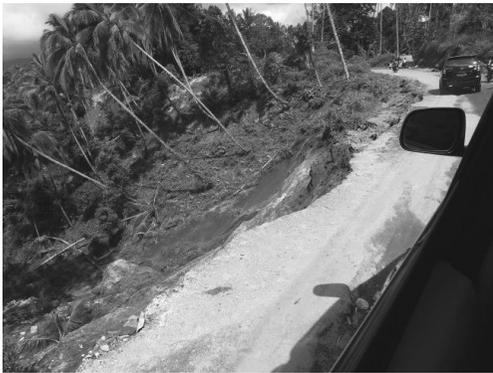
Figure 7. Slope failure in Pariaman

Extensive slope failures were observed along the mountain roads. Some of these roadways were constructed on a thin ridge with soil surface along the river (**Figure 7**), with the failure points on the attacking side of river, where the foot of the slope had lost stability due to erosion by water flow.

Typically, the slope on the attack side may be unstable due to erosion of the foot.

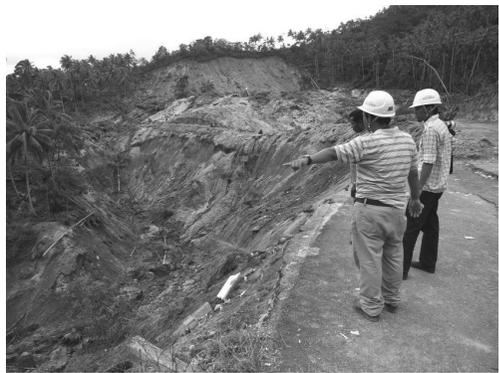
Figure 8. Large Slope failure in Pariaman

Figure 8 shows a large slope failure of volcanic sediment. Since the volcanic sediment is a type of pumice soil, under water supply it can easily fail on the sliding surface of the clay layers. When the earthquake occurred, a wedding ceremony was being held on the sliding soil mass. This failure caused the deaths of 200 people attending the party. Some rock falls along the road side slope of volcanic geology at Southern Padang area were observed.

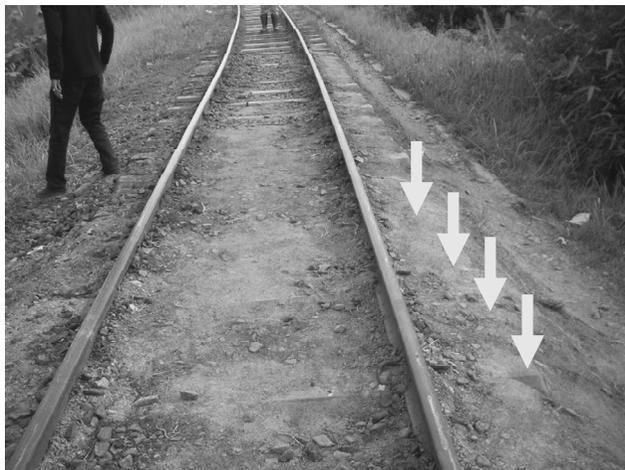
Figure 9. Embankment damage of railway

The railway is normally used for leisure on the weekends. The railway was available on the first weekend after the earthquake. Slight failure of railway embankments was observed: however, they were completely recovered after the first leisure day (**Figure 9**).

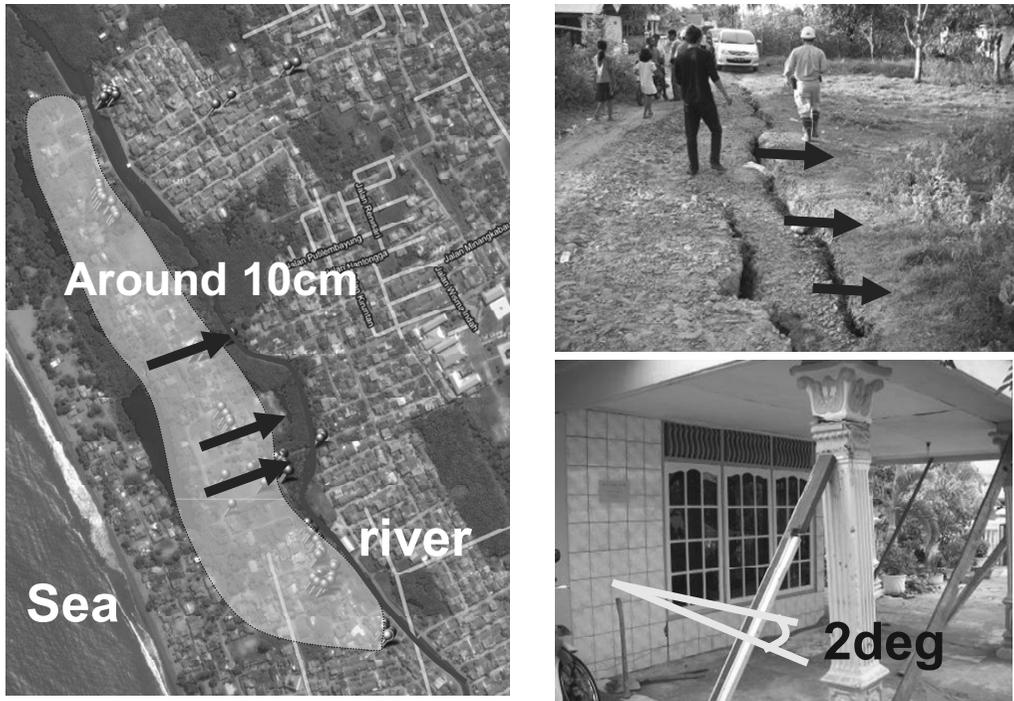
Figure 11. Lateral movement at Point 1 in Figure 10

Lateral flow and/or movement of over 10 centimeters caused damage to several houses on the affected ground at Point 1 (**Figure 11**). The liquefaction sites are located between the coastal line and a small river with ground layers of sand and a shallow ground water level in the marine deposit. Settlement of buildings and foundation damage due to liquefaction-induced ground failure and lateral spreading resulted in the collapse of masonry houses and/or severe cracking walls. The ground liquefaction caused damage due to non-uniform settlement of house foundations. Several houses needed to be supported by bar to prevent collapse due to the inclination of ground foundation (**Figure 11**). Permanent ground deformation caused extensive damage to the wide region.

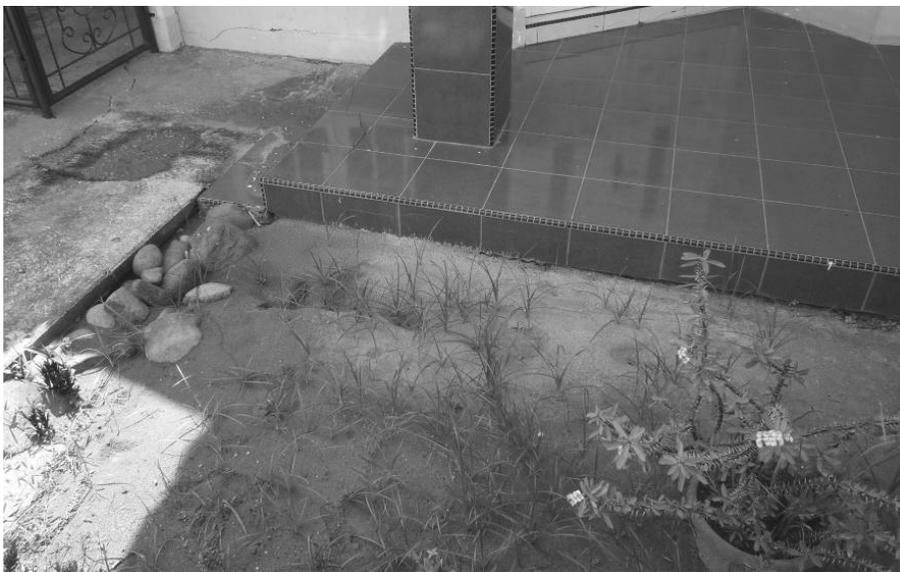
Figure 12. Liquefaction at Point 2 in Figure 10

Liquefaction was also observed at Points 2 and 3 along the river on the sandy ground (**Figure 12**). Sand boils was observed at Points 4 and 5. Since the ground in this region consisted of a sandy layer, liquefaction easily occurred due to intense shaking. Fortunately, no damage occurred at the sea port at Point 4.

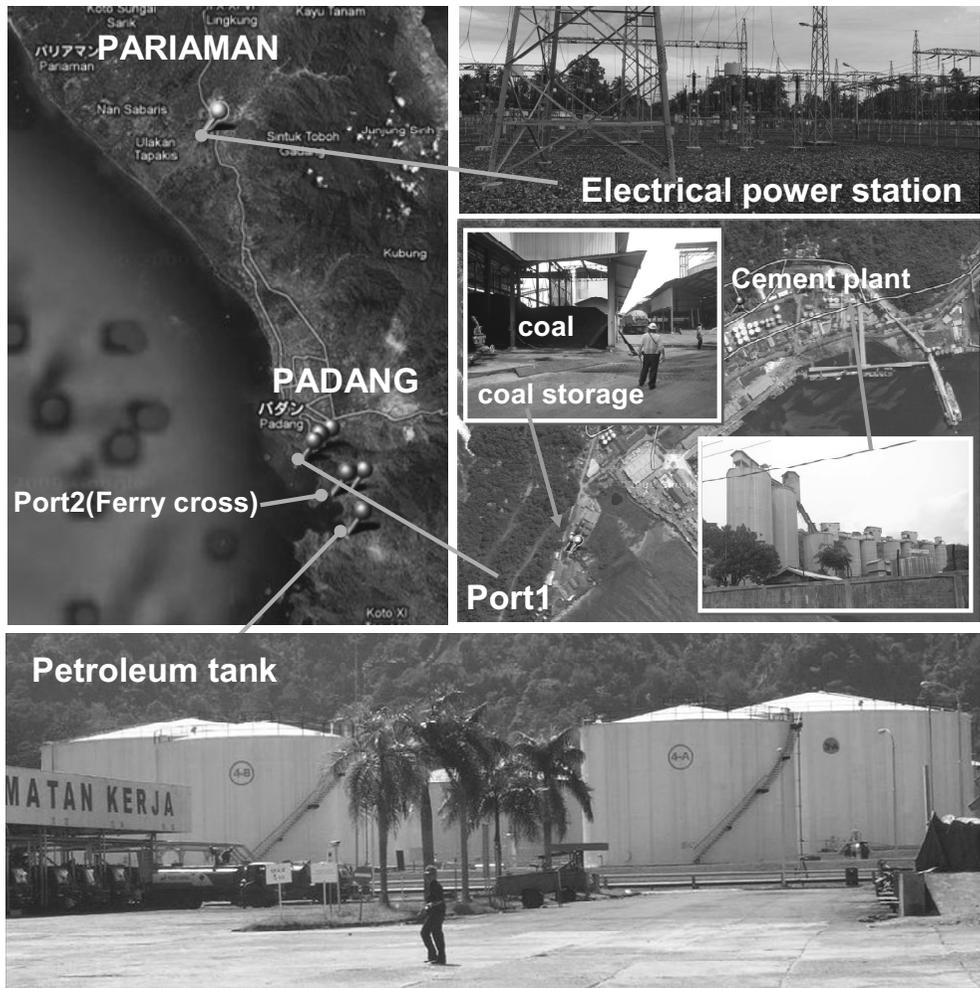
Figure 13. Industrial place and main industrial facilities

Most industrial facilities are located in Southern Padang City. The earthquake did not cause any major damage to industrial facilities except some small scale damage from the inspection of some industrial plants (Figure 13).

Two ceramic isolators in electric power station were damaged but repaired two days later, whereas seven to ten days were needed to restore electric power in Padang city.

Two port facilities in Padang were observed. The cement plant and coal storage did not suffer from considerable damage and the economic loss due to the subsidence or lateral movement of coastal line was small. Liquefaction and slight damage at the ferry crossing were observed. No damage was found in the petroleum tank yard.
