LIQUEFACTION-INDUCED DAMAGE CAUSED BY THE 2010 DARFIELD EARTHQUAKE, NEW ZEALAND

Takashi KIYOTA¹, Mitsu OKAMURA², Hirofumi TOYOTA³ and Misko CUBRINOVSKI⁴

Key Words: Darfield earthquake, Liquefaction, Field reconnaissance, Swedish weight sounding test

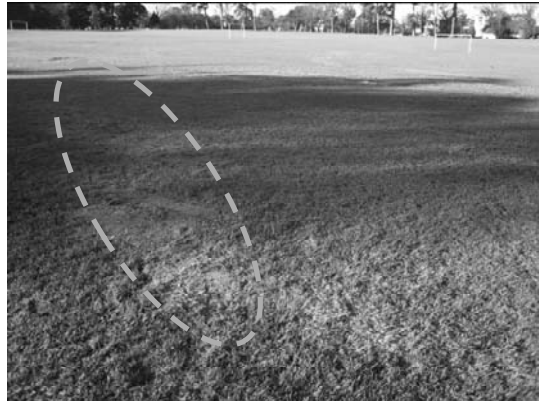
Figure 4 shows the map of the business area. At site 1 in the park, sand boiling occurred as shown in Photo 1. This suggests that soil deposits in the park have been liquefied. However, in this park, the occurrence of liquefaction was very limited. Although some old buildings suffered damage from ground shaking, no sand boiling could be observed at the center of business area (e.g., sites 25, 50 in Fig. 4).

Photo 1 Trace of sand boiling in the park of business area (Site 1 in Fig. 4)

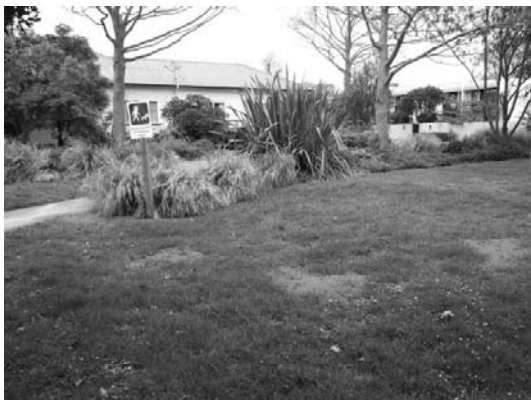
At sites 56 (Photo 2), where the Avon river shows meandering shape, sand boiling was found in residential which clearly indicates occurrence of liquefaction. At sites 63 and 62, as shown in Photo 3 and 4 respectively, roads and levees along Avon-river suffered from ground deformation, which may be caused by liquefaction of subsoil deposits. On the other hand, at site 55 about 300 m from the Avon river channel, the traces of liquefaction were not observed.

Photo 2 Sand boiling occurred at residential district in Business area (Site 56 in Fig. 4)

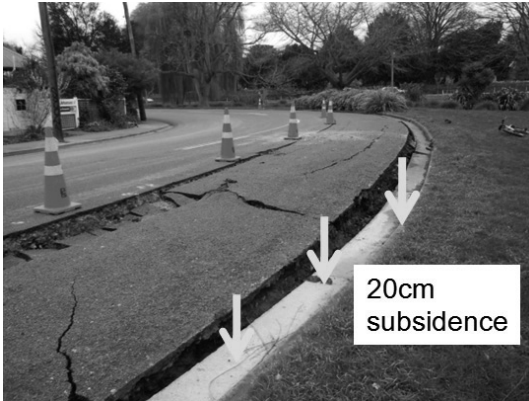
Photo 3 Road on river dike suffered from settlement and cracking (Site 63 in Fig. 4)

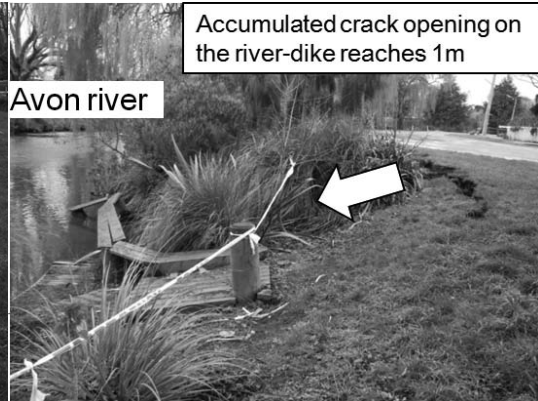
Photo 4 River dike along Avon-river suffered from large crack and lateral deformation (Site 62 in Fig. 4)

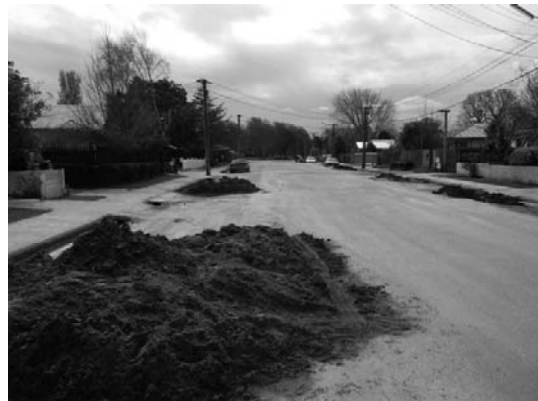
However, at the time of survey that was conducted in a week after the earthquake, no water could be observed on the street, and the boiled sand was placed at the side of the street (Photo 5).

Photo 5 Boiled sand was placed at side of the street. (Site 6 in Fig. 6)

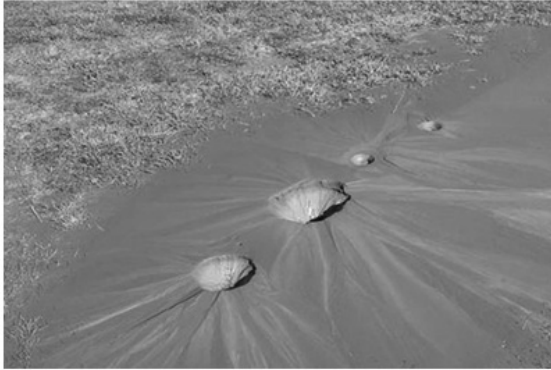
At site 7, significant liquefaction occurred in the residential district. A large amount of boiled sand could be observed at their backyards (Photo 6). The boiled sand covered ground surface with a thickness of 30 cm as shown in Photo 7. A number of housing floors suffered from cracking that was caused by uneven settlement of the ground after liquefaction.

Photo 6 Boiled sand (Site 7 in Fig. 6)

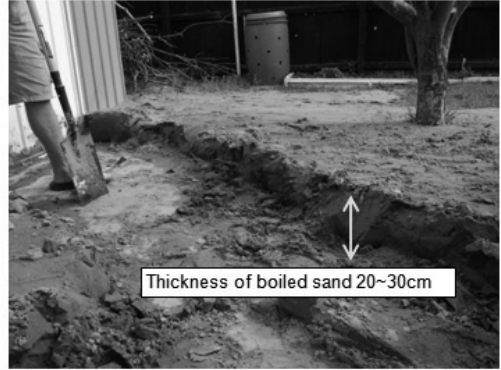
Photo 7 Boiled sand (Site 7 in Fig. 6)

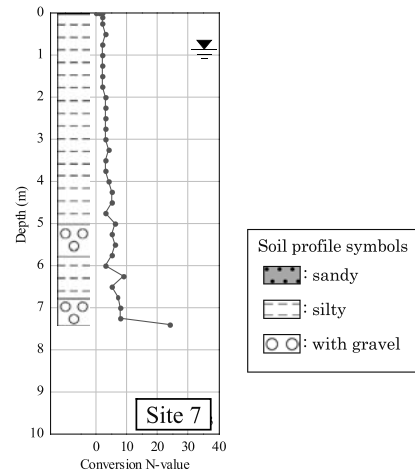
As shown in Fig. 7, the ground water table was shallower than 1m from the ground surface, below which soft soil deposits with N_{SPT} values less than 5 could be found for a thickness of about 5 m. It clearly indicates occurrence of liquefaction with this soft layer. The boiled sand that was retrieved at the same location as SWS test was fine sand with D_{50} of 0.12 mm and fines content of 18%.

Figure 7 SWS test results (Site 7 in Fig. 6)

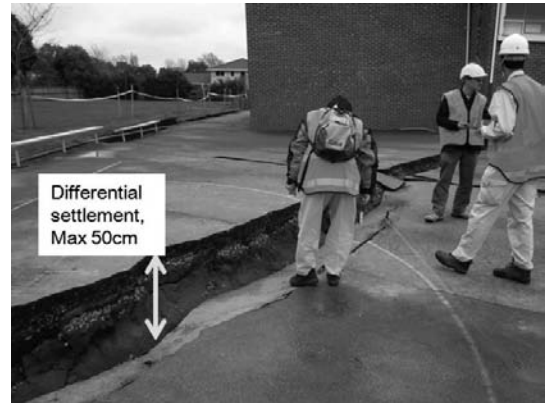
At site 26, St. Paul's Church that is located near the Avon-river suffered from uneven settlement. As shown in Figure 8, the settlements over 30 cm were measured at each side of cracking at the center part of the church, and the maximum settlement of 109 cm was measured at the tall structure. In addition, the pavement of parking lot around the building also suffered from cracking for a maximum differential settlement of about 50 cm as shown in Photo 9. These damages may have been caused by liquefaction because the extensive sand boiling occurred around the church.

Photo 9 Pavement around St Paul's church suffered from large cracking and settlement (Site 26 in Fig. 6)

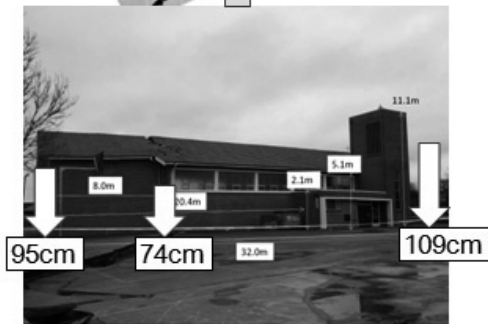
Figure 8 St Paul's church (built in 1956) suffered uneven settlement due to liquefaction (Site 26 in Fig. 6)

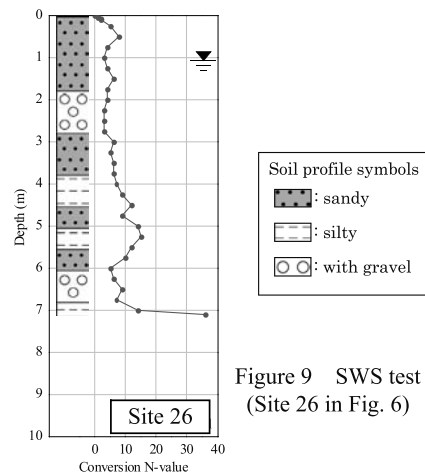
SWS test was conducted at an open space in the same area of the church. As shown in Fig. 9, the ground water level was 1 m from the ground surface, below which soft soil deposits with N_{SPT} values less than 7 could be found for a thickness of about 4 m. The boiled sand that was retrieved around the church was fine sand with D_{50} of 0.11mm and fines content of 28% ($PI= NP$).

Figure 9 SWS test results (Site 26 in Fig. 6)

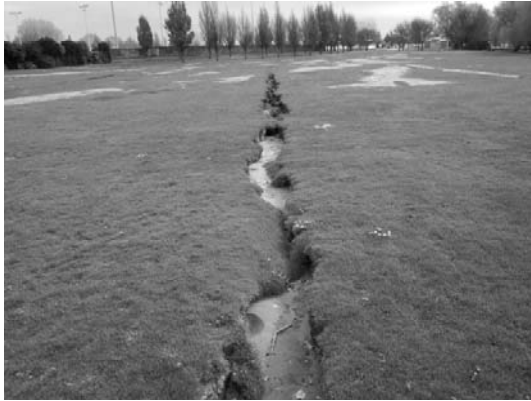
At site 20 at Porritt Park that is located about 1 km east from the St. Paul's Church, sand boiling occurred throughout the park. Numerous cracks having a maximum opening width of 70 cm occurred on ground surface (Photo 10). These cracks were caused by liquefaction because almost all crack openings were filled with boiled sand.

Photo 10 Number of cracking and boiled sand could be observed in Porritt Park (Site 20 in Fig. 6)

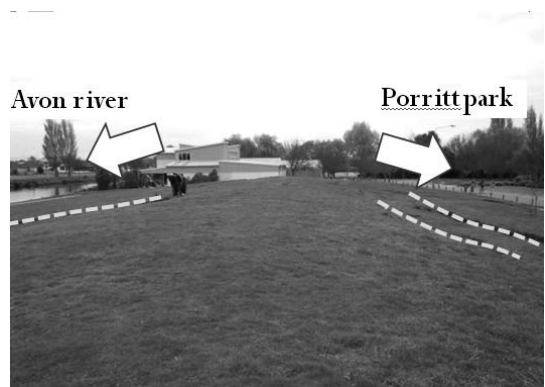
In the adjacent area (site 15), as show in Photo 11, river levee suffered from lateral spreading, and

significant cracking could be observed on the ground surface, possibly caused by liquefaction of subsoil deposits.

Photo 11 River levee was damaged due to settlement and cracking (Site 15 in Fig. 6)

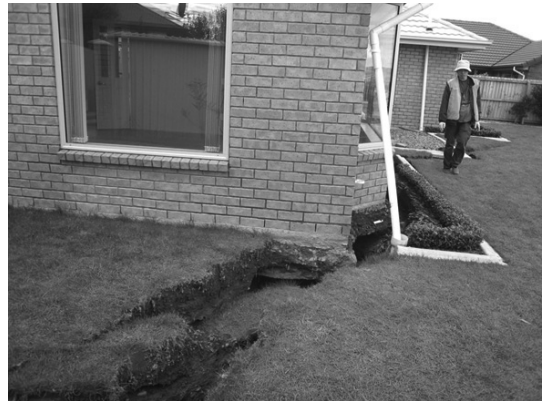
Reportedly, the residential area in Bexley had been elevated by soil filling about 5 years ago. Photo 12 shows a significant cracking which was found in the backyard of house along the margin of the landfill. Since the boiled sand could be found in the cracking, the filled material in this area was expected to be liquefied. In Bexley area, high damage ratio of houses was observed along the margins of landfill, and the slope of the filling was damaged due to excessive settlement and cracking.

Photo 12 Foundation of house suffered from large cracking (Site 93 in Fig. 11)

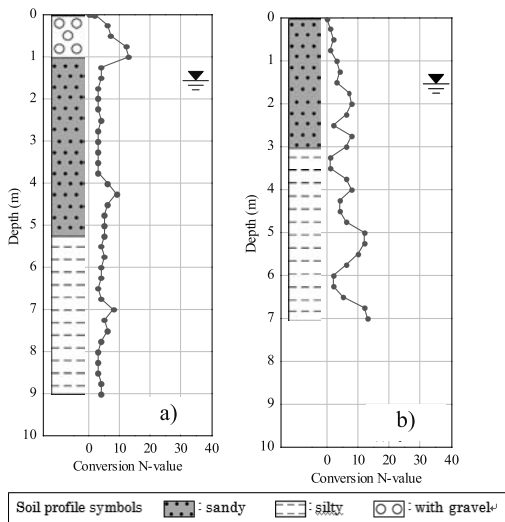
Figure 12a) shows the result of SWS tests at site 93 that were conducted at the side of damaged house (Photo 12). The groundwater level was about 1.5m from the ground surface, below which very soft sandy soil deposits with N_{SPT} values less than 5 could be found for a thickness of about 4 m. This suggests that the compaction work had not been properly-conducted when the landfill was constructed. The boiled sand that was retrieved at the same location of SWS test was fine sand with D_{50} of 0.13mm and fines content of 12% as shown in Fig. 13.

Figure 12b) shows the result of SWS test that was conducted on the landfill at site 100, about 300 m from the margins of the landfill. The ground water level was shallower than 1.5 m from the ground surface, below which soil deposits with N_{SPT} values less than 10 could be found for a thickness of about 5 m. The N_{SPT} values at this point were slightly higher than those measured at the margin of landfill as shown in Fig. 12a). In fact, sand boiling around the site 100 was not significant as compare with the site 93.

Figure 12 SWS test results (a) sites 93 and b) 100 in Fig. 11)

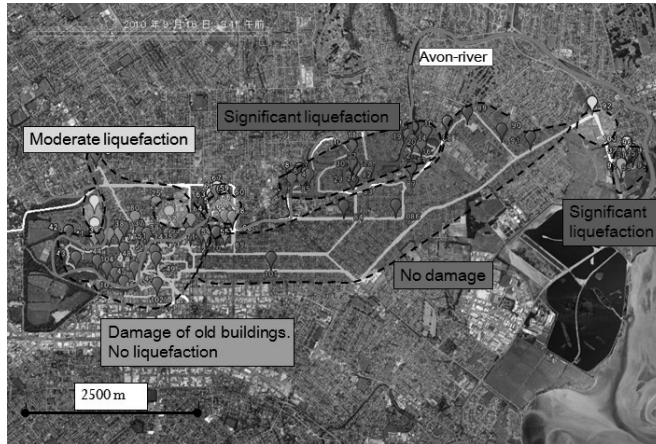
Figure 14 Earthquake-induced damage in Christchurch city on this survey

Based on the survey, the earthquake-induced damages in Christchurch city can be summarized in Fig. 14. The liquefaction-induced damage to the infrastructures including houses could be observed along Avon-river except for business area, while possibility of liquefaction occurrence seems to be limited at the sites that more than 300 m from the river. It should be noted that, the classification of damage in Fig. 14 has not been completed. Further wide-range of investigations is required.

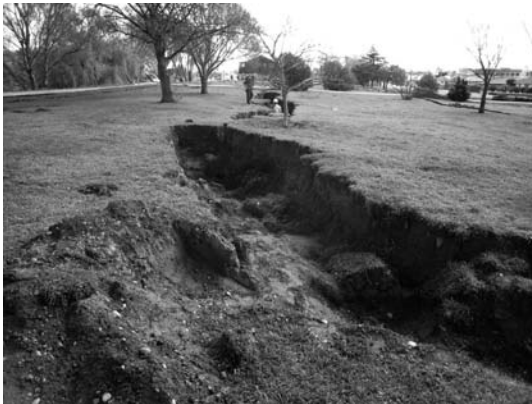
At site 109, a boathouse that is located on the levee suffered from uneven settlement as shown in Photo 13. At site 110, the ground surface of the levee suffered from significant cracking having the maximum opening of 1 m as shown in Photo 14. The groundwater could not be found in the large cracking, and the material of the levee was dense gravelly sandy soils that were not expected to be liquefied. Therefore, it can be considered that the liquefaction occurred in sandy layer beneath the levee and caused above damages. In fact, the sand boiling could be observed at the base of the levee, and the boiled sandy soil was different from the above gravelly soils. The boiled sand that was retrieved at the base of levee was fine sand with D_{50} of 0.15 mm and fines content of 20 % as shown in Fig. 16.

Photo 14 Significant cracking and boiled sand could be observed on the levee (Site 110 in Fig. 15)

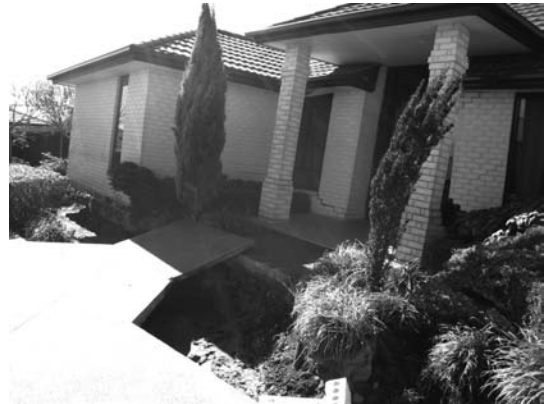
Reportedly, the residential area on the right side of the tributary had been elevated by soil filling about 5 years ago. High damage ratio of houses was observed along the margins of landfill as was seen in Bexley area. Typical damage of house due to liquefaction-induced ground deformation at the margin of filling in this area is shown in Photo 15. The house was caught up in the ground movement, and suffered from significant leaning to the slope side. The boiled sand that was retrieved at this house has fines content of 70 % as shown in Fig. 16. However, it could be liquefied because it has no plasticity.

Photo 15 Damaged house due to liquefaction-induced ground deformation (Site 117 in Fig. 15)
