# GEO-DISASTER REPORT ON THE 2011 TOHOKU-PACIFIC COAST EARTHQUAKE

**ABSTRACT:** On March 11<sup>th</sup>, 2011, the Tohoku-Pacific coast earthquake caused severe damage to the eastern Japan. Authors have made damage surveys on geotechnical problem in south part of Kanto region and Tohoku region. This report briefly summarizes earthquake-induced geo-disasters from the field investigations which were conducted between March 12<sup>th</sup> and April 18<sup>th</sup> in 2011.

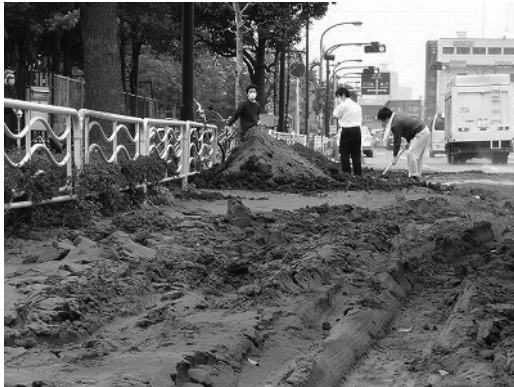
N35 38.687 E139 49.692

Photo 1 shows boiled sand, which is an evidence of subsurface of liquefaction, in Shin-Kiba area in Koto-ku, Tokyo. The boiled sand covered street with a thickness of about 30 cm. Photo 2 shows rehabilitation work of sewage line which can be observed at many locations in the areas where liquefaction occurred. The distribution of boiled sand in Shin-Kiba area is summarized in Fig. 2. Large amount of boiled sand and associated damage to the road, buried lifeline and low-rise building could be observed in north part of the area while few evidences of liquefaction were found in the south area.

Photo 1 Boiled sand on the street in Shin-Kiba area

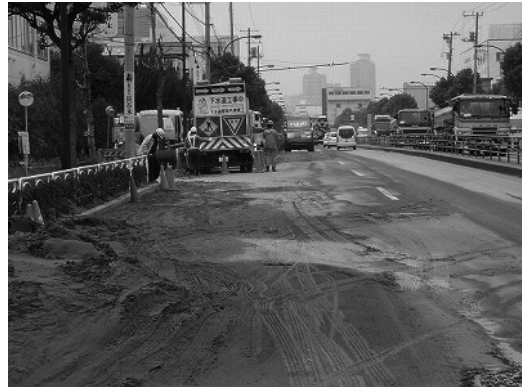
N35 38.713 E139 49.944

Photo 2 Rehabilitation work of sewage line in Shin-Kiba area

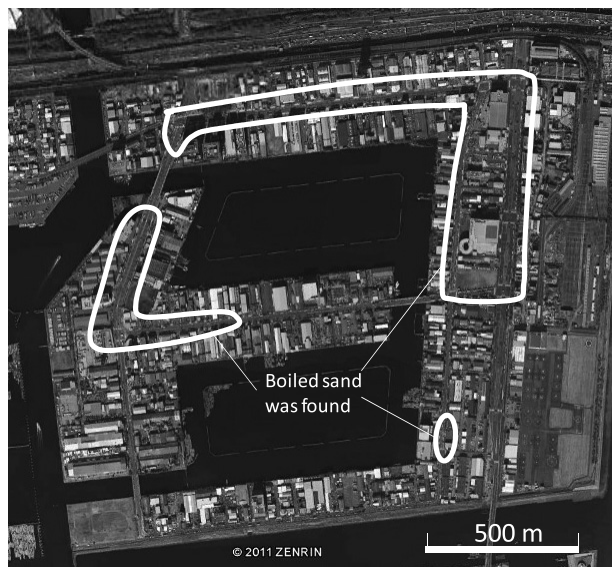
Figure 2 Distribution of boiled sand in Shin-Kiba area. Survey was conducted on 15<sup>th</sup> May.

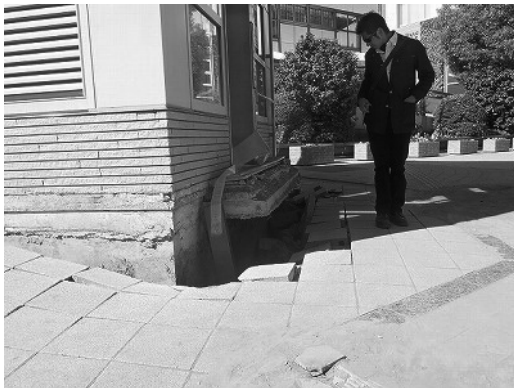
N35 38.977 E139 54.811

Liquefaction-induced damage was found in many reclaimed lands along the coast of Tokyo bay, like Shin-Kiba area, which have been constructed since 1960s. One of the most affected areas by liquefaction was Urayasu city in Chiba Prefecture. Photo 3 shows the differential settlement between the building and ground surface which could cause disconnection of buried lifeline. Liquefaction in reclaimed land caused subsidence of backfill of retaining wall along the river and uneven settlement of many houses as shown in Photos 4 and 5.

Photo 3 Differential settlement due to liquefaction in Urayasu city

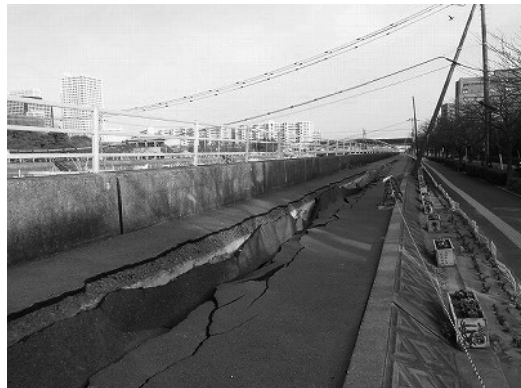
N35 38.902 E139 54.371

Photo 4 Settlement of backfill of retaining wall along Sakai River in Urayasu city

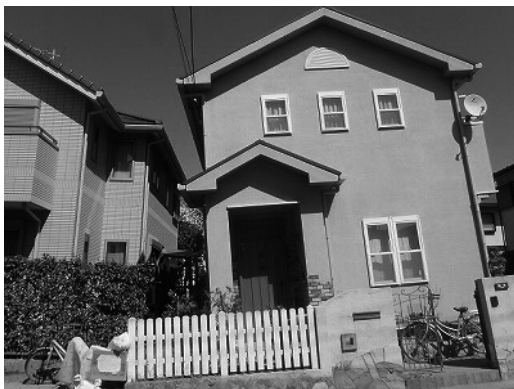
N35 38.509 E139 53.936

Photo 5 Uneven settlement of house due to liquefaction in Urayasu city

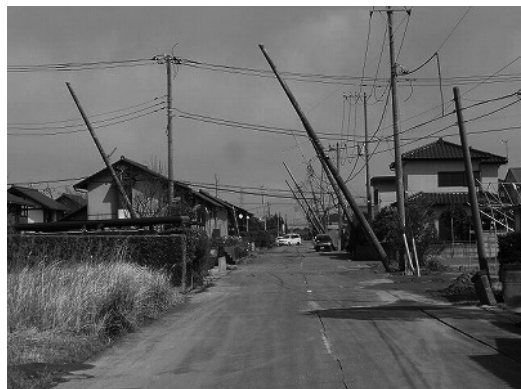
N35 55.712 E140 34.108

Photos 6 and 7 show liquefaction-induced damage to the residential area in Itako city and Kamisu city which are located in downstream basin of Tone River. Photo 8 shows damage of road and buried high-voltage cable. Reportedly, the situation came off badly because liquefaction caused damage to the road followed by tsunami attack. Photo 9 shows water treatment plant in Kamisu city which suffered serious damage due to liquefaction. Before the earthquake, the ground surface in this area was flat. However, floating of buried box culvert and ground subsidence allowed large relative displacement of water pipes, resulting in long-lasting cut of water supply in whole Kamisu city.

Photo 6 Damage of electric poles in Itako city

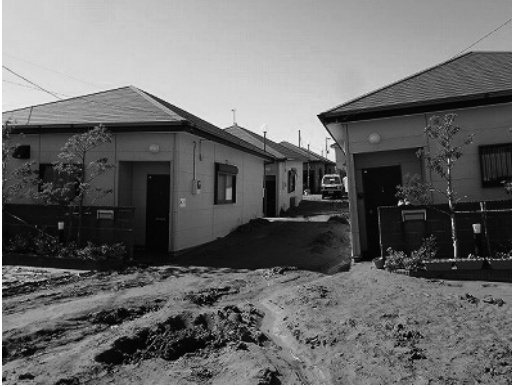
N35 55.112 E140 38.630

Photo 7 Uneven settlement of houses in Kamisu city

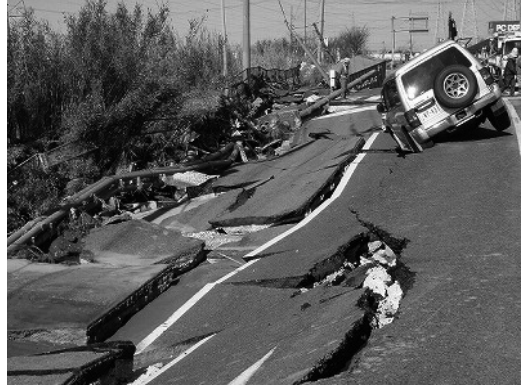
N35 55.488 E140 38.800

Photo 8 Damage of road by Liquefaction and tsunami in Kamisu city

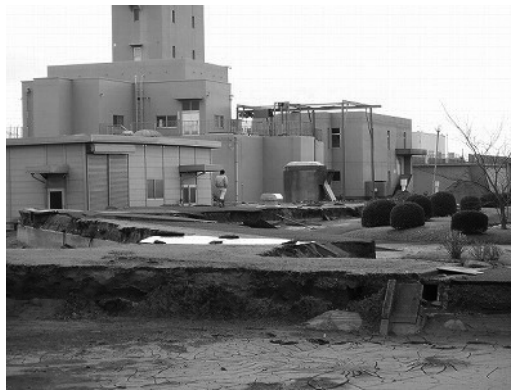
N35 55.906 E140 37.736

Photo 9 Liquefaction-induced damage of Wanigawa water treatment plant in Kamisu city

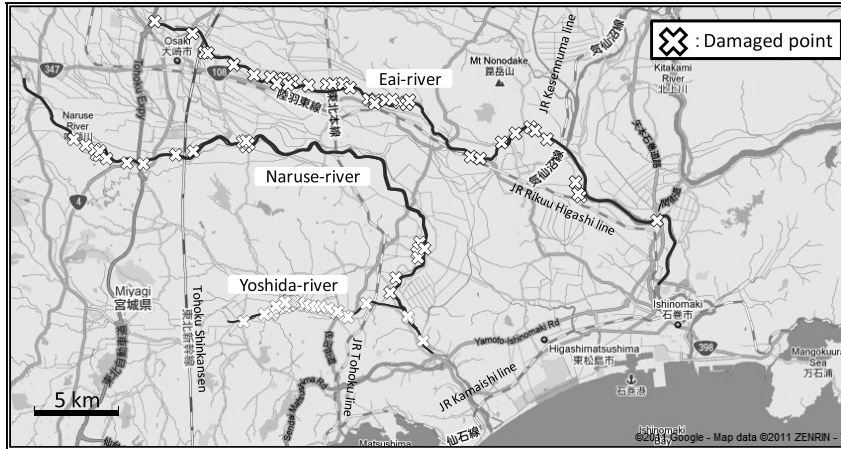
River levee was damaged by the earthquake at many locations in Miyagi Prefecture. Figure 3 shows damaged points of levees of Eai River, Naruse River and Yoshida River. Although we could not check whole levees of these rivers, we found more than 80 damages to the levee during the survey for three days.

Figure 3 Distribution of damage of levees of Eai River, Naruse River and Yoshida River in Miyagi Prefecture

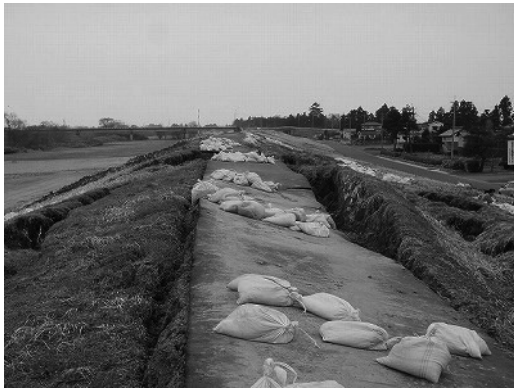
Photo 10 shows damaged levee of Eai River. The levee suffered from large and deep cracking on the crown and slope. Photos 11 and 12 show significantly destroyed levees of Naruse River. They exhibited slope failure and lateral spreading, respectively. Liquefaction of levee body and/or foundation ground would be one of the causes for damages. As shown in Photo 13, boiled sand from the levee body was observed which may link to the slope failure behind it.

N38 33.903 E141 01.933  
Photo 10 Damage of levee (Eai River)

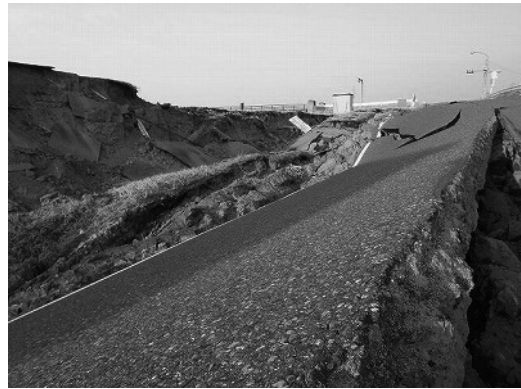
N38 31.810 E141 00.311  
Photo 11 Damage to levee (Naruse River)

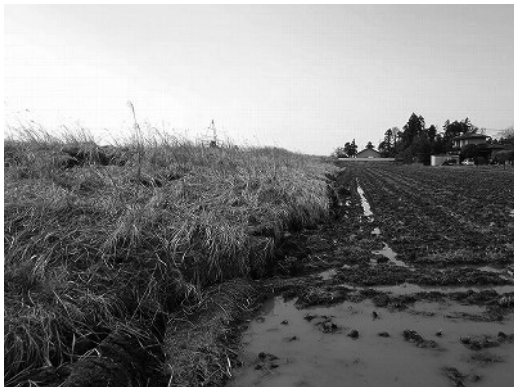
N38 32.223 E140 53.233  
Photo 12 Levee suffered from lateral spreading (Naruse River)

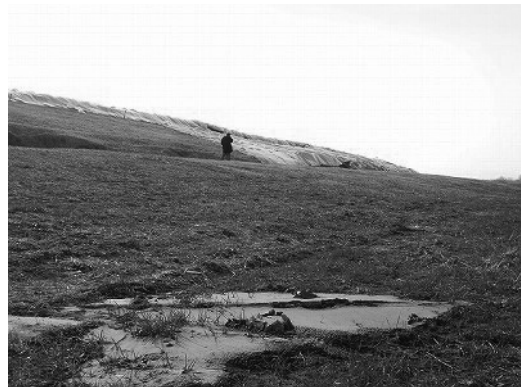
N38 31.705 E140 54.128  
Photo 13 Liquefaction-induced damage of levee (Naruse River)

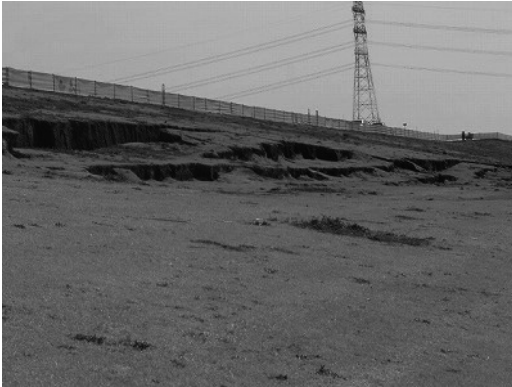
N36 05.313 E139 46.829

Damage of river levee was observed in other areas. Photos 14 and 15 show distortion of Edogawa River levee that are located in Saitama Prefecture. These damages were associated with occurrence of liquefaction because boiled sand was found on the failed slopes.

Photo 14 Liquefaction-induced damage of levee (Edogawa River)

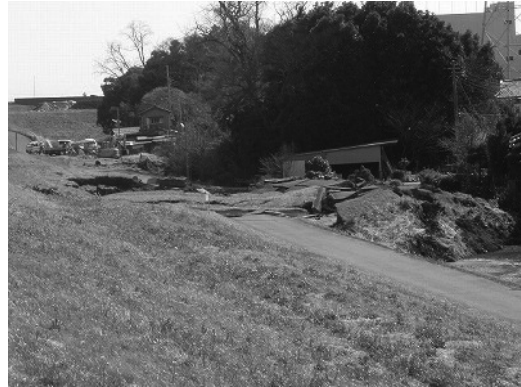
N36 05.116 E139 46.607

Photo 15 Liquefaction-induced damage of levee (Edogawa River)

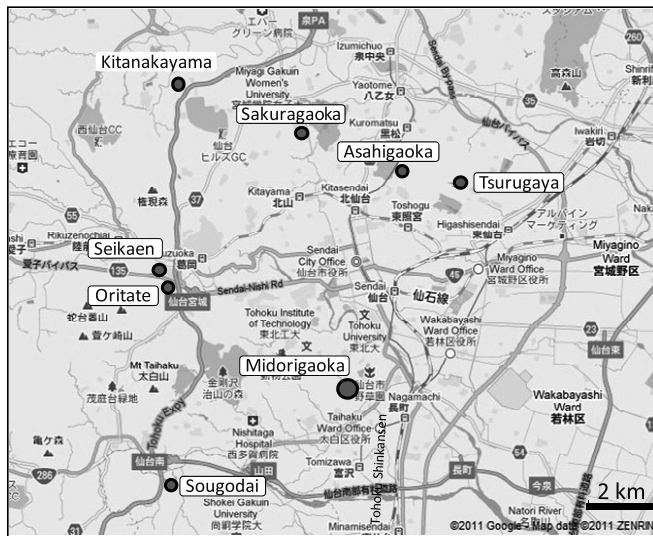
Natural slope failure and distortion of earth fills occurred at many locations in Tohoku region. In the area of Sendai city that is largest cities in Tohoku region, there are many artificial earth fills for housing estate that suffered from serious damage. Figure 4 is map of Sendai city showing locations of developed residential land in hill areas where damages were detected during our survey.

Figure 4 Locations of damaged earth fill for housing estate in Sendai city

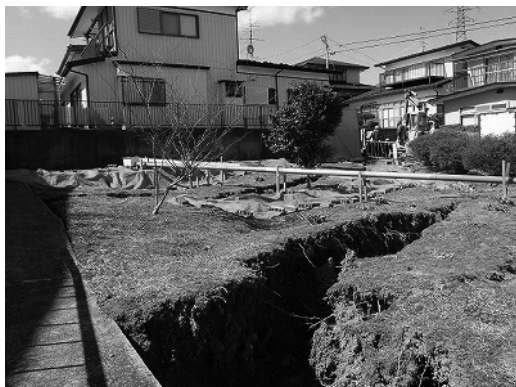
N38 13.984 E140 52.021

Photo 16 shows damage of artificial earth fill in Midorigaoka, Sendai city. This earth fill failed during the 1978 Miyagiken-Oki earthquake at the same location. After the earthquake in 1978, steel pipe piles were installed at toe part of the slope as a countermeasure construction against further distortion of the earth fill (Photo 17), and the land had been used for public garden. Fortunately, therefore, damage to residences in this area was not severe despite large deformation of ground.

Photo 16 Damage of artificial earth fill in Midorigaoka, Sendai city

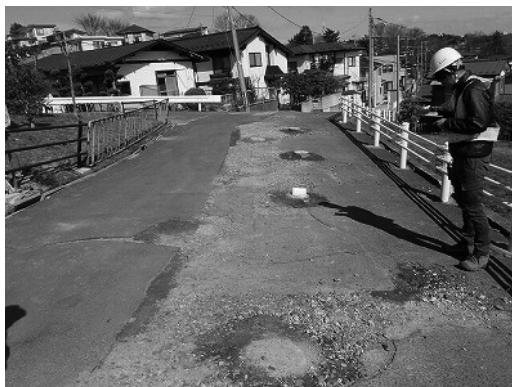
N38 13.986 E140 52.026

Photo 17 Countermeasure work was carried out in Midorigaoka after 1978 Miyagiken-Oki earthquake

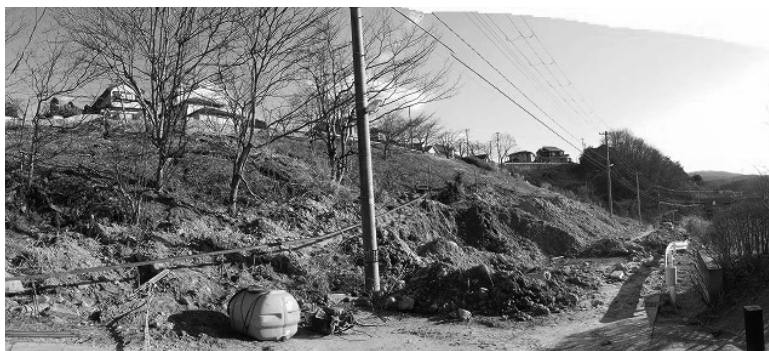
N38 19.003 E140 48.640

Slope failure of earth fill occurred in Kita-Nakayama, Sendai city. Sliding slope towards the toe is remarkable as shown in Photo 18. This failure killed one person who was on the road at the foot of slope.

Photo 18 Slope of earth fill failed in Kita-Nakayama, Sendai city

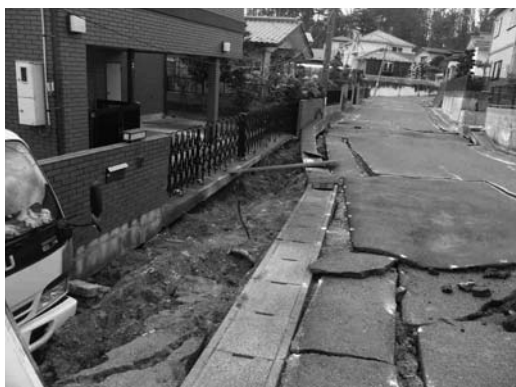
N38 15.593 E140 48.430

Photo 19 shows damage of road and house on the earth fill in Oritate, Sendai city. Although this area survived the 1978 Miyagiken-Oki earthquake, significant distortion of subsurface ground occurred during the earthquake this year. During the construction of this area in 1970s, cut-and-fill work was carried out, and significant earthquake-induced damage could be found only in a fill part. In addition, further ground deformation occurred during aftershocks. Photo 20 was taken at the same location as Photo 19 three weeks after, and it seems that the crack opening between road and house developed.

Photo 19 Ground deformation could be found on the earth fill in Oritate, Sendai city (March 31<sup>st</sup> 2011)

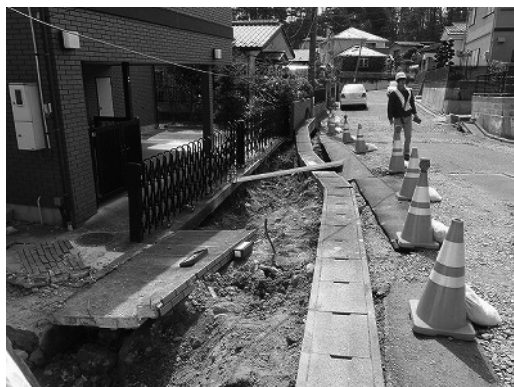
N38 15.593 E140 48.430

Photo 20 Further ground deformation due to aftershocks could be found in Oritate, Sendai city (April 18<sup>th</sup> 2011)

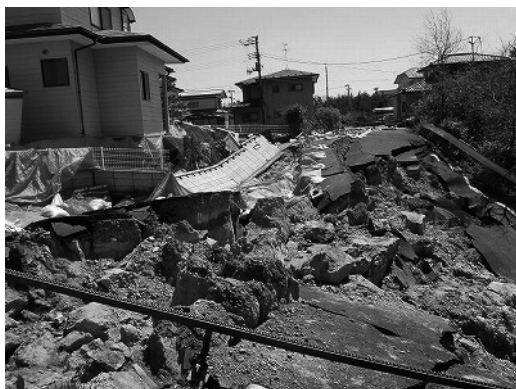
N37 57.291 E140 52.939

Damage of artificial earth fill was observed in other areas of Tohoku region. Photos 21 and 22 show failures of earth fill that are located in Yamamoto-cho, Miyagi Prefecture. Significant damage could be found only in a fill part, similar to the one in Oritate, Sendai city, as mentioned above. It should be noted that geosynthetics reinforced soil retaining wall that can be seen right side in Photo 22 was maintained intact while next unreinforced slope failed completely.

Photo 21 Slope failure in developed land in Yamamoto-cho

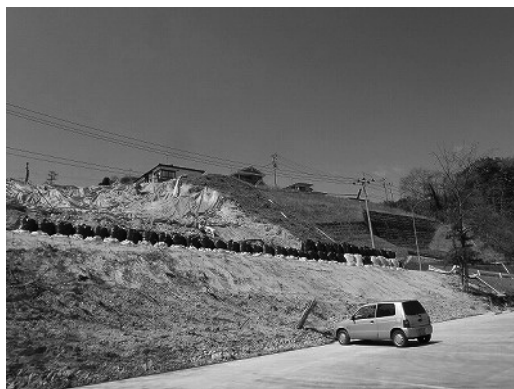
N37 57.367 E140 53.171

Photo 22 Reinforced soil retaining wall survived the earthquake while normal slope failed

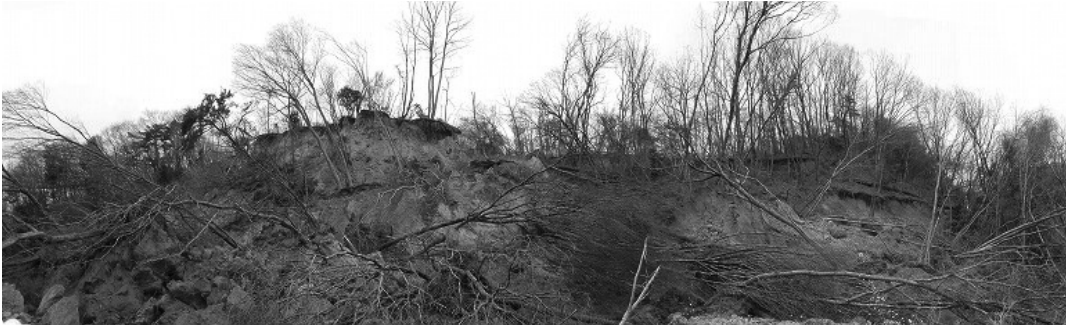
N37 00.015 E140 47.508

Photo 23 shows a huge slope failure in Iwaki city, Fukushima Prefecture, which occurred during aftershock on April 11<sup>th</sup>. As shown in Photo 24, the failure caused the foot of slope to uplift of about three meters.

Photo 23 Slope failure occurred due to aftershock in Iwaki city

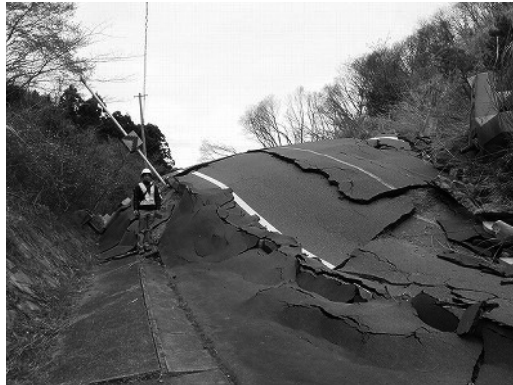
N36 59.985 E140 47.553

Photo 24 The failure of Photo 22 caused the foot of slope to uplift significantly.

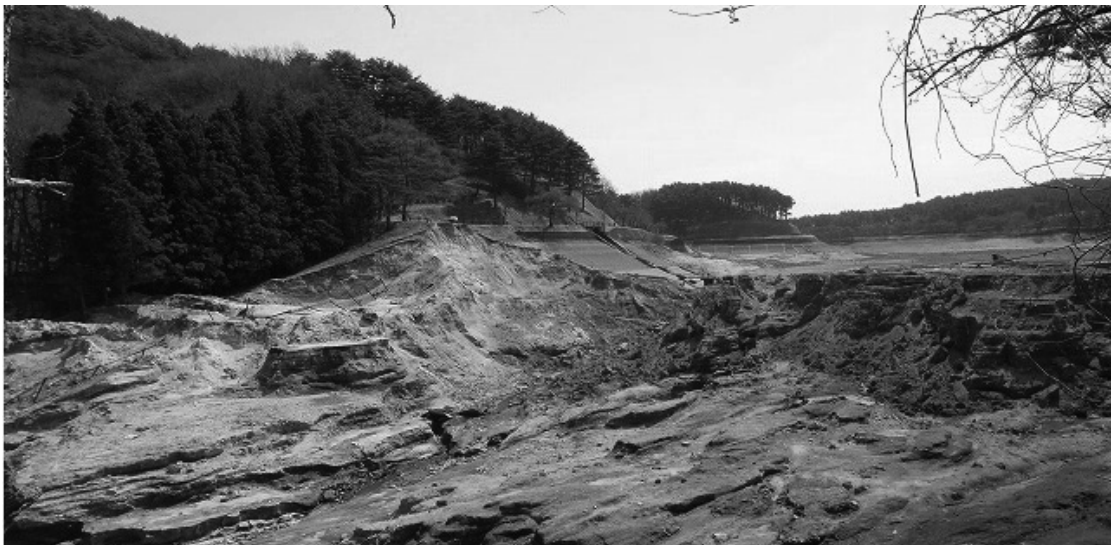
N37 18.149 E140 11.678

Photo 25 shows breaching failure of Fujinuma earth dam in Sukagawa city, Fukushima Prefecture. The discharged water reportedly rushed into downstream village, destroying many houses and killing eight people. It could be found that the toe part of dam failed towards the reservoir which may be responsible for subsidence of the dam body and thus water-overtopping.

Photo 25 Breaching failure of Fujinuma earth dam in Sukagawa city

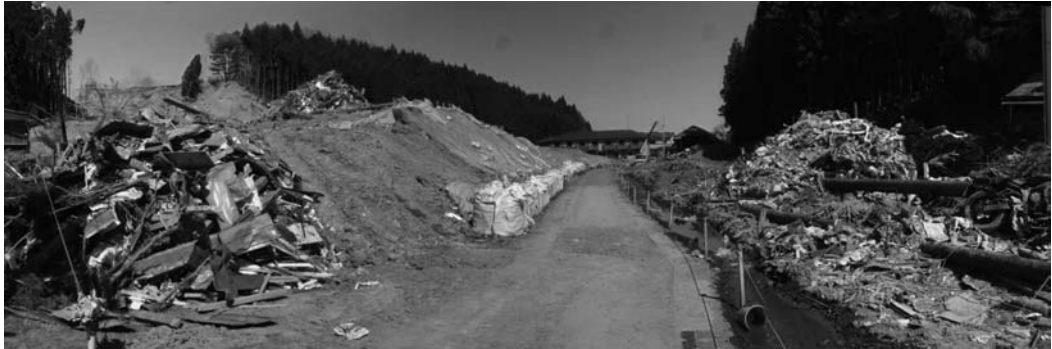
N37.137829, E140.217354

Photos 26, 27 and 28 show natural slope failures caused by the main shock on March 11th, in north of Shirakawa City, Fukushima Prefecture. Back in Aug. 27, 1998, this area, an upstream reach of Abukuma River, was ravaged by a torrential rain. The rain was reportedly responsible for more than 1000 slope failures in this 10km-by-10km area of row-raised mountain terrain. They are mostly found in Early Pleistocene non-alkaline pyroclastic flow volcanic rocks. The fact indicates a potential risk of that slopes that have suffered hidden cracks in the earthquake would slide during either an upcoming rainy season in June or summer/autumn typhoon seasons.

Photo 26 and 27 show the toe part and overall of landslide respectively. 13 people were killed in the debris. Photo 28 shows landslide which occurred near Tohoku Shinkansen railway tunnel. Soil mass reaches around the south mouth of tunnel.

Photo 26 Landslide in Hanokidaira, Shirakawa area, Fukushima prefecture.

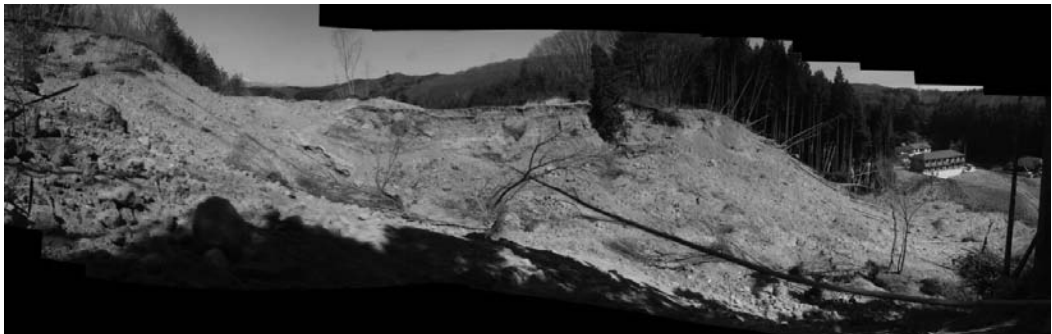
N37.137779, E140.219116

Photo 27 Overall landslide: width 110m, length 205m and height 31m

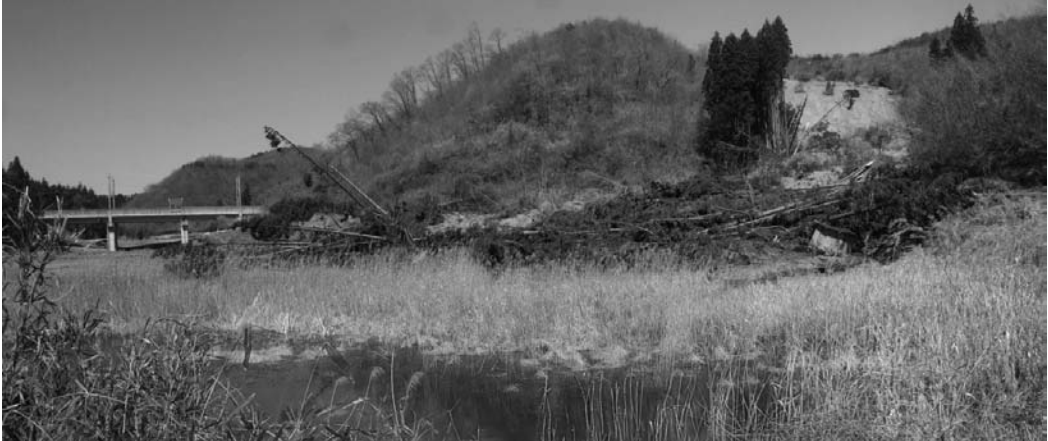
N37.173364, E140.239052

Photo 28 Landslide in Kitanoiri, Shirakawa area, Fukushima prefecture  
: width 50m, length 300m and height 60m.
