MAP OF SOIL SUBSIDENCE IN URAYASU, CHIBA, CAUSED BY THE MARCH 11TH 2011 EAST JAPAN EARTHQUAKE

Kazuo KONAGAI¹, Kenichi SHIBUYA², Chikako ETO² and Takashi KIYOTA³

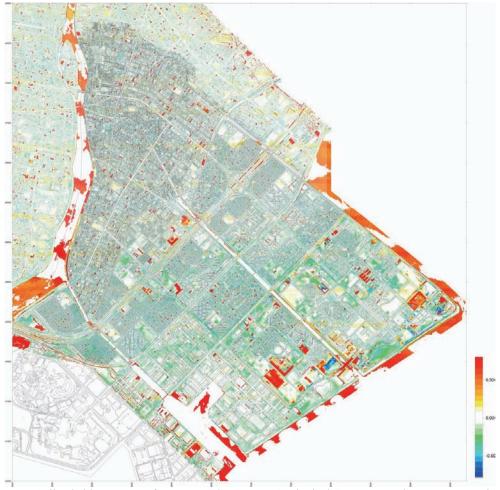
Figure 1 is the soil-subsidence map obtained from the above-mentioned procedure. Subsidence can be seen as a green brush roughly extending in EW direction across the reclaimed lands, which brush is found to be similar in pattern to the distribution of temporary water supply valves (Figure 2) and toilets (Figure 3). On the other hand, on the long-existing natural land of Urayasu before the time of land-fills (Northwest part of Figure 1), no clear change of elevation is seen excluding yellow lateral stripes. These stripes that appear at about 500m regular interval are due to errors in the air-borne LIDAR survey in 2006 to 2007, the error is more pronounced where the laser-beam takes a turn in scanning. The obtained DSMs and the subsidence map are expected to provide necessary information for mapping practical tactics for better rehabilitations.

Figure 1 Soil subsidence map of Urayasu: TheJapaneseGeological Survey uses the Japanese National Grid System. It divides Japan into a set of 19 zones assigned with Greek numerals from I to XIX. The surveyed area is included in Zone IX with its origin located at 139.833333'E, 36.000000N.
