PILES FOR RC/STEEL-FRAME BUILDINGS PULLED UP BY TSUNAMI AT ONAGAWA TOWN, IN THE MARCH 11th 2011 EAST JAPAN EARTHQUAKE

Kazuo KONAGAI¹, Takashi KIYOTA² and Hiroyuki KYOKAWA³

ABSTRACT: The entire stretch of indented Tohoku-Pacific coast was seriously engulfed by tsunami caused by the East Japan earthquake on March 11th, 2011. One of the most noteworthy events seen in Onagawa was that piles supporting RC and/or steel-frame buildings were uprooted, and the buildings were carried over several ten meters distances. This report describes details of the tsunami-driven four buildings.

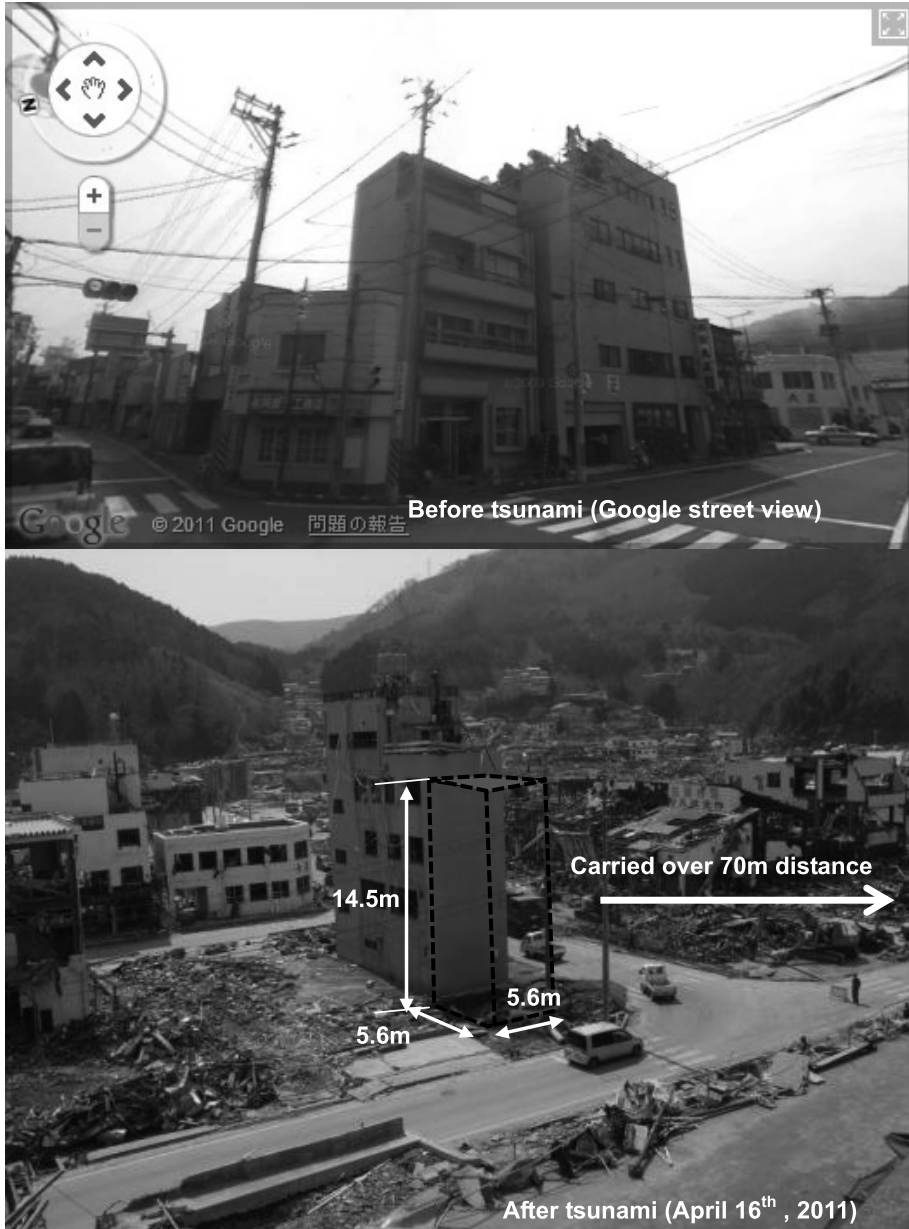
Figure 3 Original location of Building #1 (38.442482, 141.445728): This 4-story building was carried over 70m distance to the west.

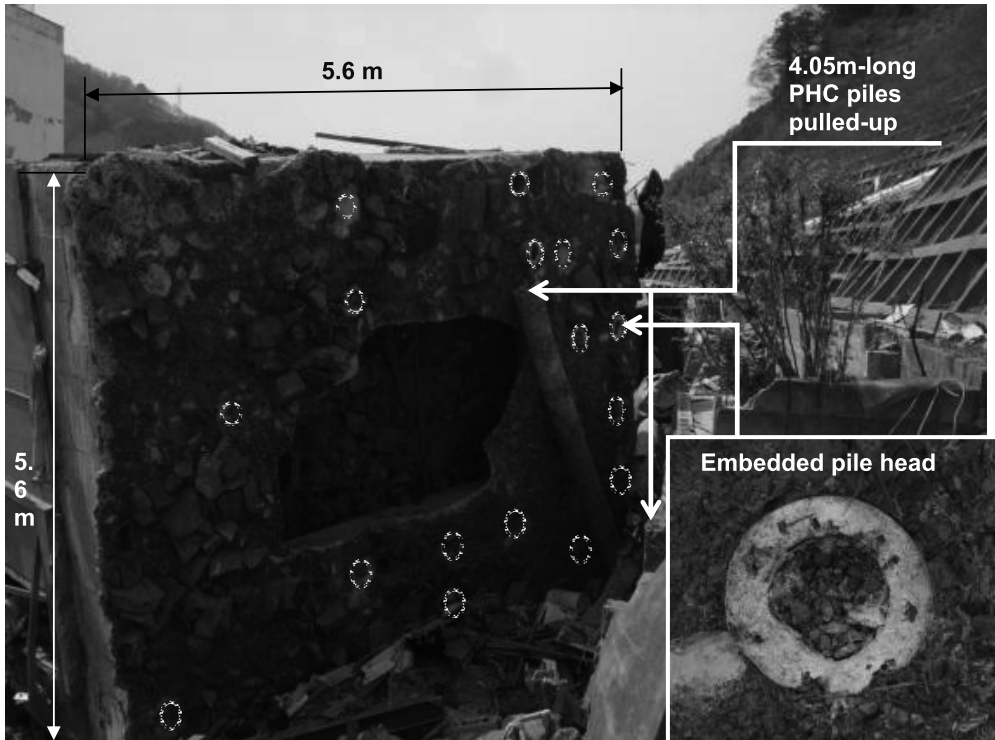
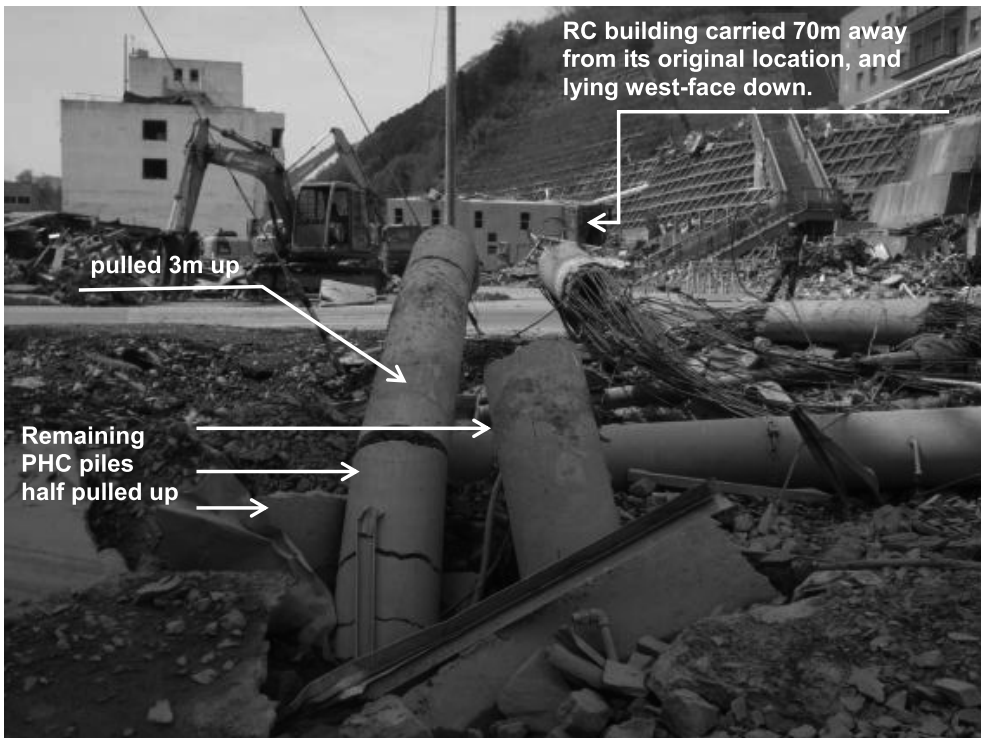
Building #1 was a thin and tall 4-story RC building (5.6m wide, 5.6m deep and 14.5m high) at N38.442482, E141.445728, which was carried over a 70m distance and lying west-face down with its bottom pushed against the cut-hillside of Onagawa Hospital (see Figure 4).

Figure 4 Bottom of foundation for Building #1 and piles left half-embedded in soil

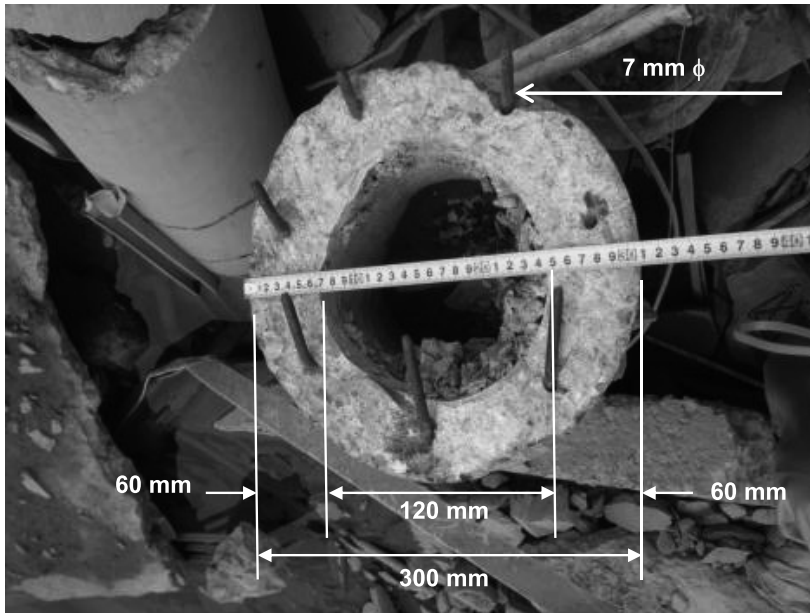
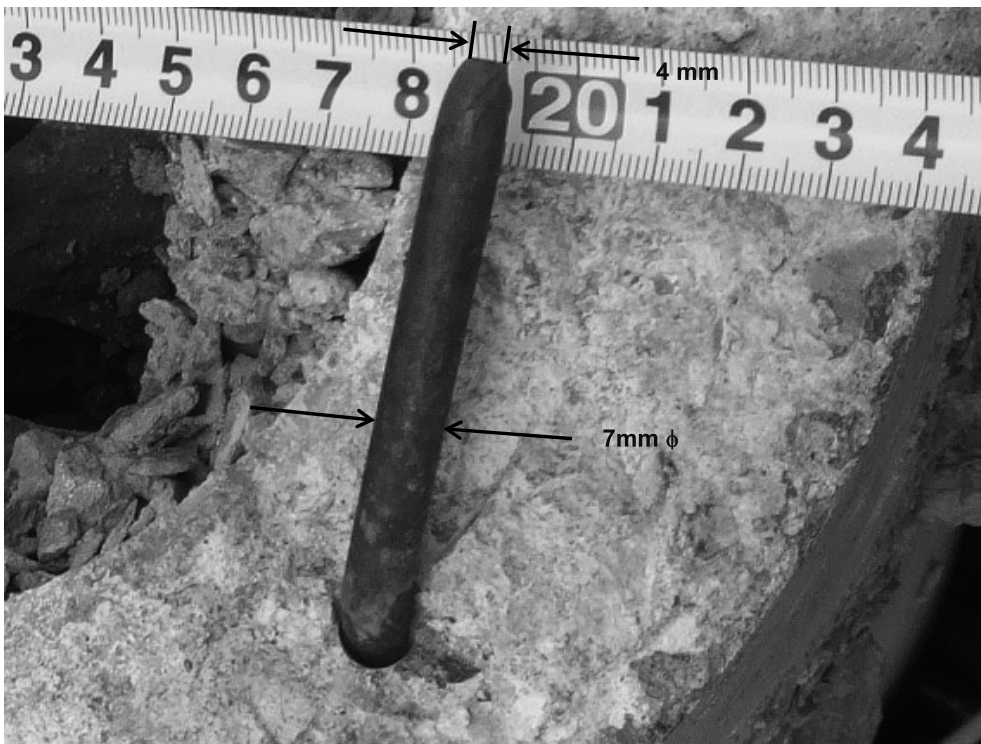
Figure 5 Fracture surface of PHC pile for Building #1: A fracture cross-section of PHC (Pretension type centrifugal High strength pre-stressed Concrete) pile used for Building #1, 300mm and 120mm in outer and inner diameters respectively, has 7 PC wires exposed with cut ends thinning to about 4mm diameter.

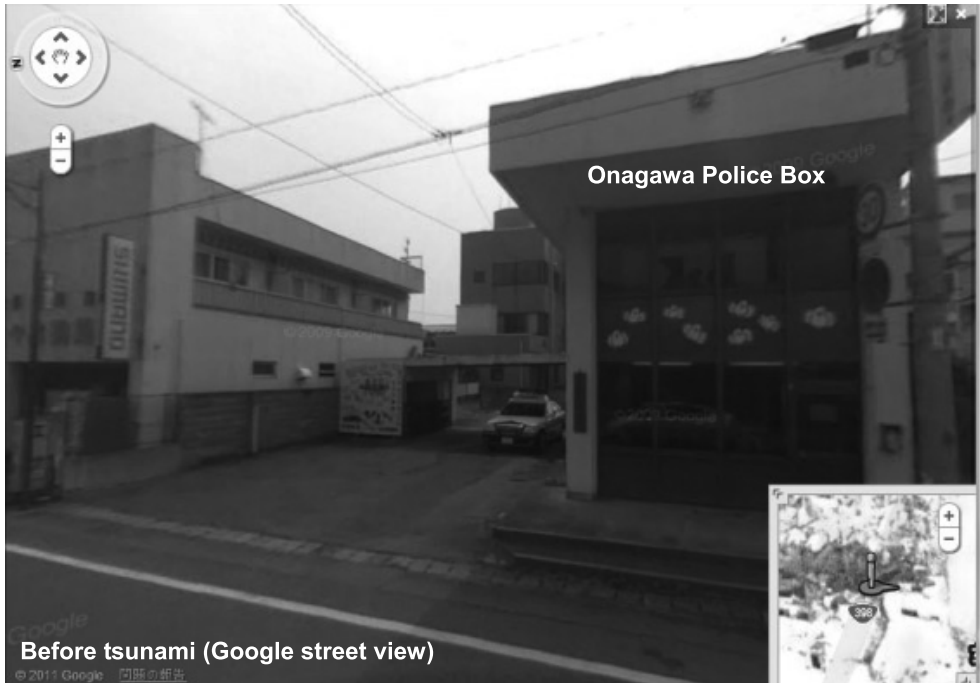
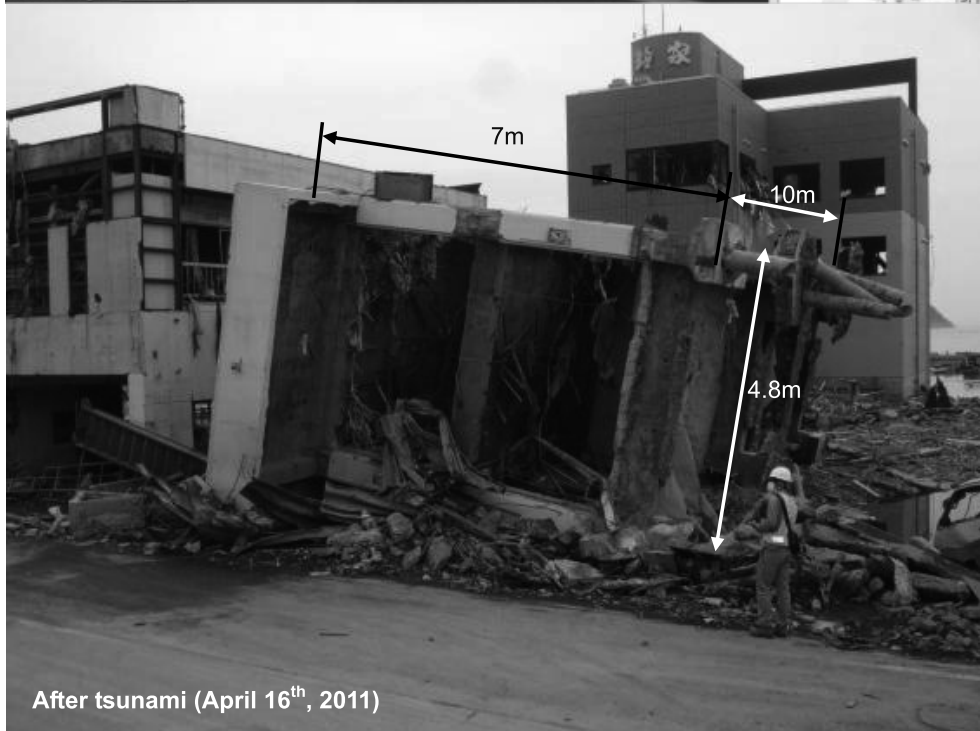
Figure 6 Toppled Building #2 (Onagawa Police Box, Original location at 38.445086,141.446760): Onagawa police box was overturned north. Piles were broken and upper halves of them were uprooted. There is a dent on the roof indicating that something massive was pushed against it.

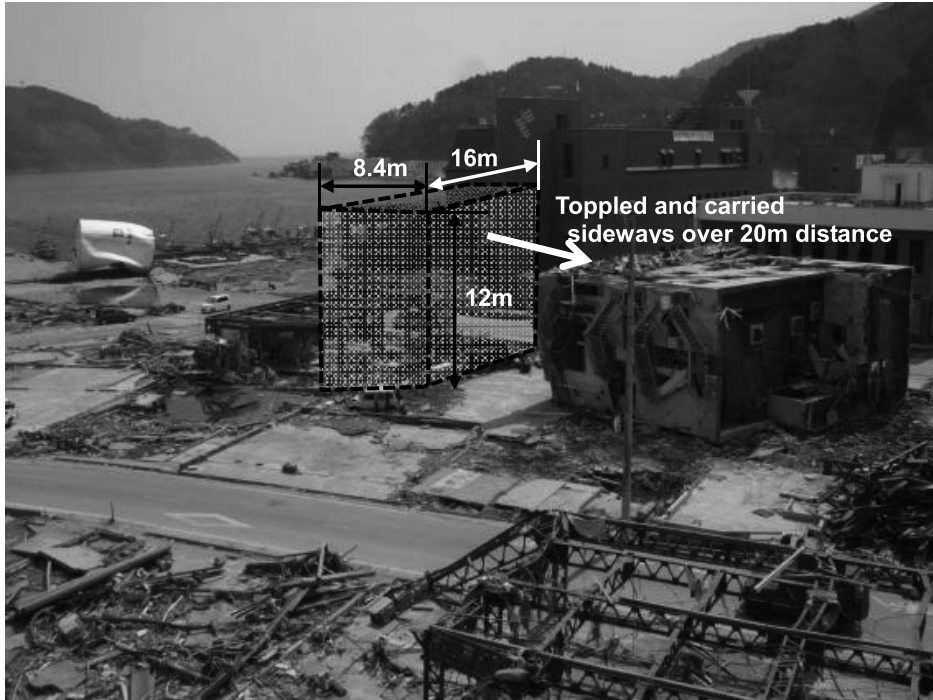
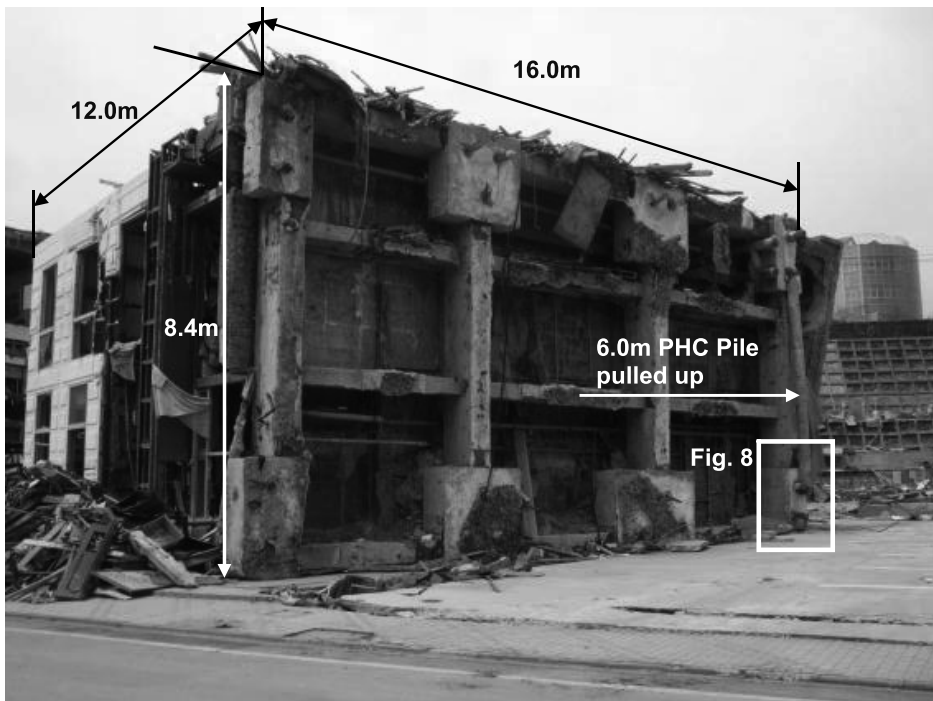
Fig. 7 Building #3 (Original location at Original Location: 38.442657,141.446590), A steel frame 4-story building was toppled and carried sideways over about 20m distance. A PHC pile of about 6m long is found hanging down from the upper right corner.

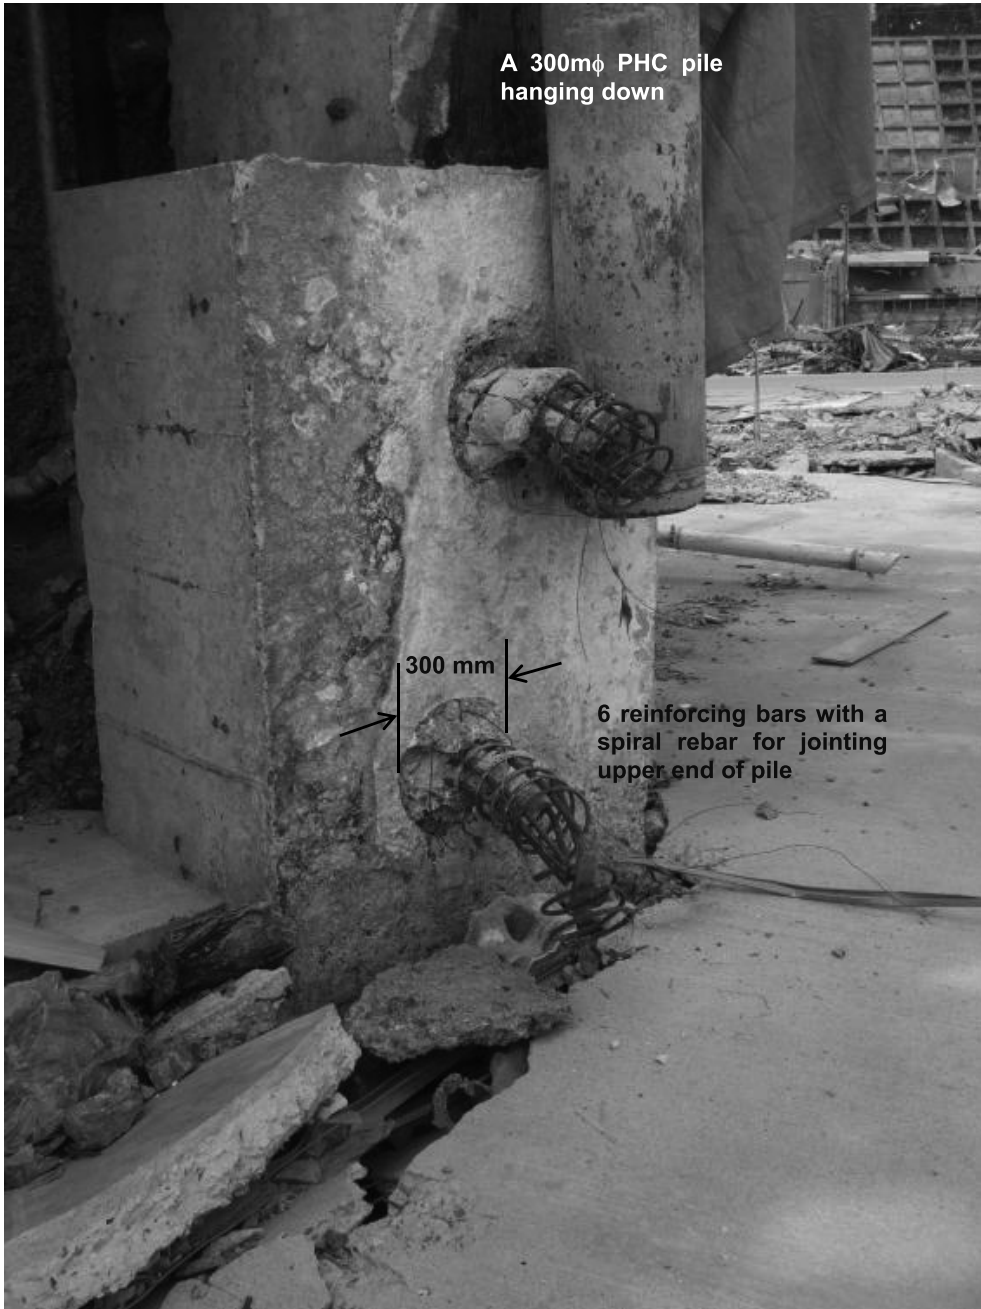
Figure 8 Detail for Jointing pile heads for Building #3: Detail of rebars for jointing a pile head was exposed. There are 6 rebars coiled in a spiral bar for each pile head.

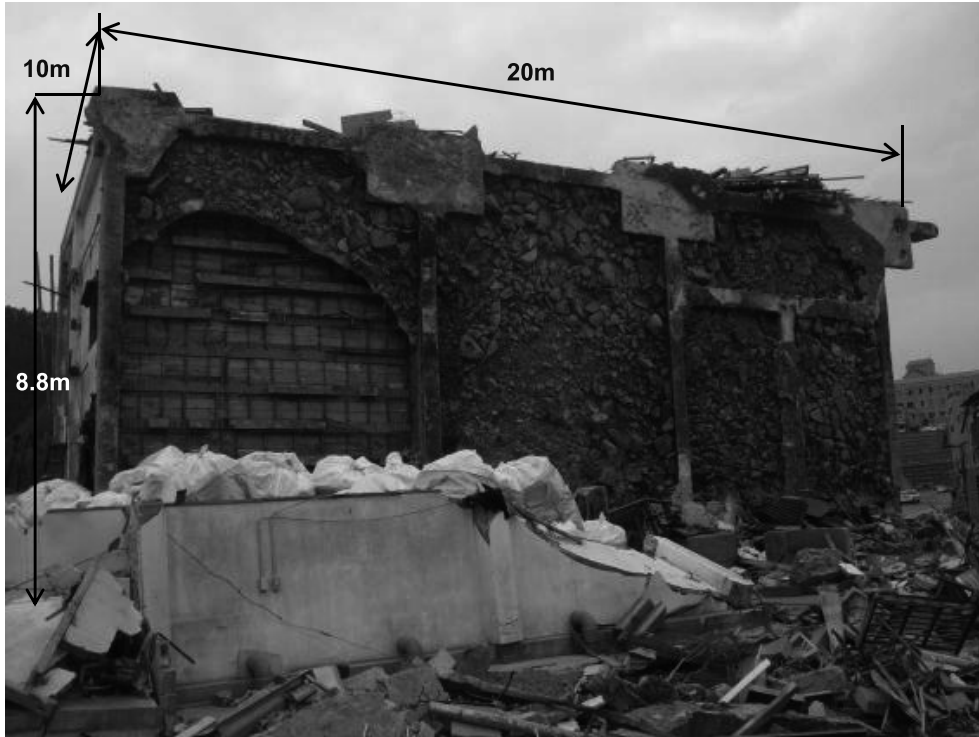
Fig. 9 Building #4: toppled west from its original Location at N38.440608, E141.446511. This was a steel-frame cold storage warehouse for fishes and seafood products. Dim marks of pile head are seen indicating the building was just resting on piles. This warehouse had a small door/window aperture.
