EFFECTS OF LIQUEFACTION IN KANTO REGION CAUSED BY THE 2011 OFF THE PACIFIC COAST OF TOHOKU EARTHQUAKE

Junichi KOSEKI¹, Yukika MIYASHITA², Jianliang DENG³ and Hiroyuki ARAKI⁴

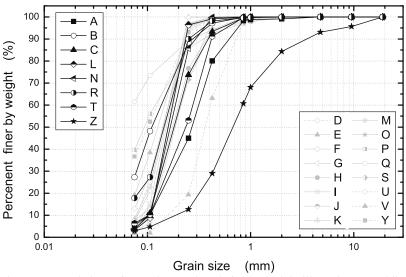
When the residential and industrial areas suffered from sand boiling, as shown in **Photo 2**, the boiled sand covered the ground surface and occasionally caused clogging of drainage facilities. It should be noted that, as shown in **Figure 2**, the samples retrieved by the authors from the sand boiling sites consisted mainly of fine sand to silt particles.

Figure 2. Gradation of samples retrieved from sand boiling sites at Chiba, Ibaraki and Tochigi prefectures

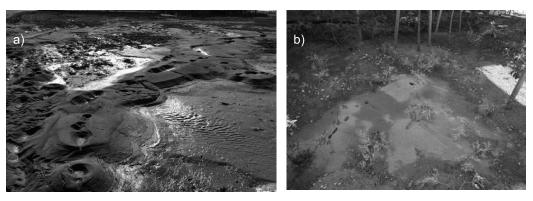
In Kanto region, Japan, as typically shown in **Photo 1**, extensive sand boiling was observed in reclaimed lands along the Tokyo bay areas and basins of several rivers such as Tone, Kokai and Kuji rivers. Refer to **Figure 1** for their locations.

Photo 1. Extensive sand boiling a) at rice paddy in Toride city, Ibaraki prefecture (site C) and b) at back yard of supermarket in Urayasu city, Chiba prefecture (site R)

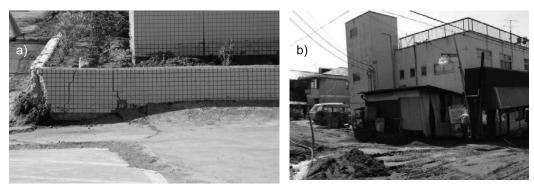
Photo 2. Boiled sand a) at reclaimed old swamp in Katori city, Chiba prefecture (site L) and b) at reclaimed old pond in Abiko city, Chiba prefecture (sites A and B)

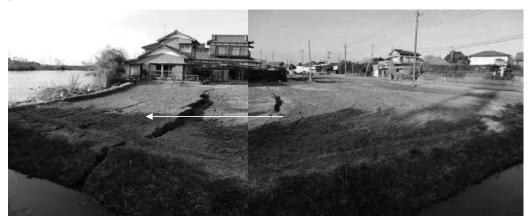
Liquefaction-induced lateral flow was observed in river basins at gently-sloped ground (**Photo 8**) and level ground (**Photo 9**) facing a pond or a river. However, as far as the authors know, it did not occur extensively in the areas along Tokyo bay where liquefaction of reclaimed lands was significant.

Photo 9. Lateral flow of level ground facing a pond in Katori city, Chiba prefecture (site L2)
