THE BREACHED EARTH-FILL DAM FOLLOWING THE 2011 OFF THE PACIFIC COAST OF TOHOKU EARTHQUAKE

Hiroyuki KYOKAWA¹, Kazuo KONAGAI², Takashi KIYOTA³, Toshihiko KATAGIRI⁴ and
Zaheer Abbas KAZMI⁵

ABSTRACT: Fujinuma dam, an earth-fill dam for irrigation located in Sukagawa City, Fukushima prefecture, was breached in the 2011 Off the Pacific Coast of East Japan earthquake. The water from the breached dam scoured its downstream valley floor and walls, and developed into a debris flow. The debris mass flushed a village downstream leaving 8 dead and 1 missing. The authors made a survey along the stream channel of the debris flow. During their survey, the breached dam body was LiDAR surveyed for its entire 3D image. With the findings from the survey, this paper discusses a possible mechanism of the dam breaching.

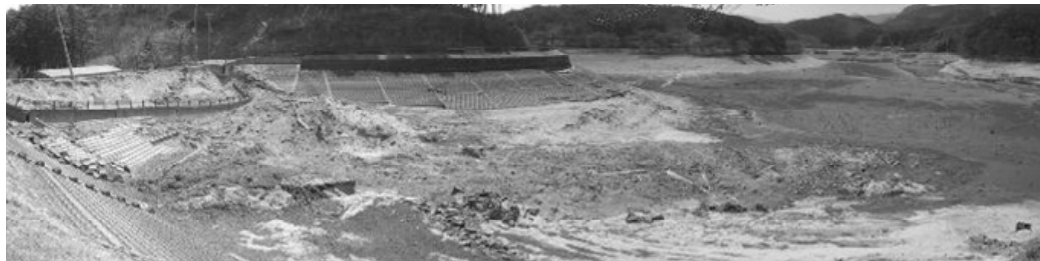
Photo 1 Upstream slope failure of the small dam (April 15th at 37.299778, 140.195348)

Photo 1 shows the failure of the upstream slope of the small dam (13m high, 55m wide and 108m long). Almost the entire upstream slope slid down into the reservoir leaving its thin and fragile crest soil behind the dam body, which narrowly escaped from breaching probably because the larger dam breached first emptying the water of the reservoir. During the emptying process, the soil mass of the upstream slope of the small dam may have been carried further down toward the bottom of the reservoir.

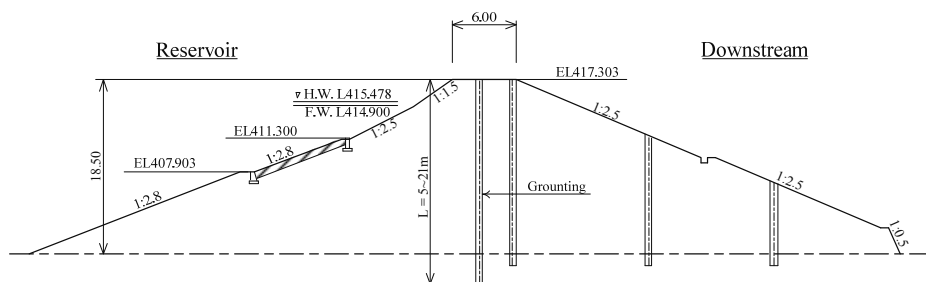
Fig. 3 Cross section of original large dam body

Fig. 3 shows the original cross section of the large dam. The large dam is 6 meters wide at its crest, 133 meters long with upstream surface concrete-block-faced to make it impervious to prevent leakage. Photo 2 and 3 show the breached large dam body (Height 18.5m, Length 133m, Volume 99,000m³) as seen from its right and left abutments, respectively. The middle to right part of the dam body was scoured deep by the overtopped water. A clear laminar structure was seen on the exposed interior of the dam body. Dark-colored mudstone was exposed on the scoured abutment. 20 to 30 cm-thick Ignimbrite sand layers were also found bedding horizontally in the exposed dam body (See Photo 2) indicating that the dam body was constructed by compacting ignimbrite sand. It is known that the dam body was constructed through 3 stages compaction process from 1938. According to a local resident, he witnessed that the crest of the entire dam body had subsided by about 1-2m approximately 20 minutes after the earthquake hit the area (Kokusho, 2011). From these evidences, it can be deduced that the upstream slopes of both the large and small dams slid first toward the reservoir, and it was then followed by the subsidence of the large dam body leading to the water-overtopping.

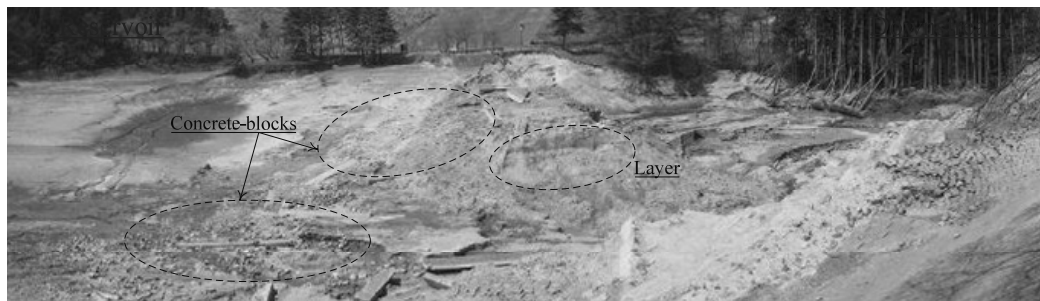
Photo 2 Breached large dam as seen from its right abutment
(April 15th at 37.301265, 140.195401)

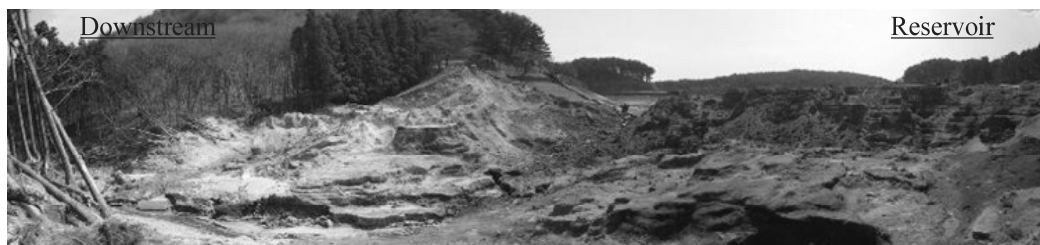
Photo 3 Breached large dam as seen from its left abutment
(April 15th at 37.302465, 140.195223)

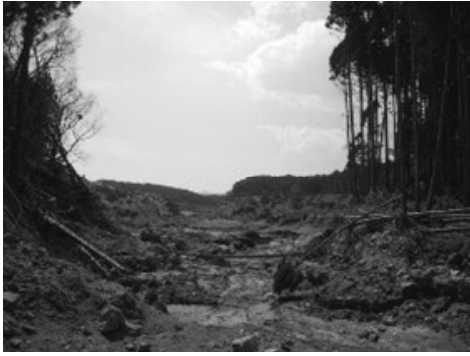
Photo 4 Breached dam body as seen from downstream
(April 15th at 37.302661, 140.196055)

The debris flow from the breached dam scoured its downstream valley floor and walls, and uprooted trees as shown in Photo 4. From mud marks remaining on valley walls, super-elevations were measured at several locations where the stream channel takes sharp turns, and the debris flow velocity was estimated to be around 10m/sec. The debris flow, when it reached the village, took a sharp 90 degrees clockwise turn along the existing river channel and flushed downstream village (See Photo 8).

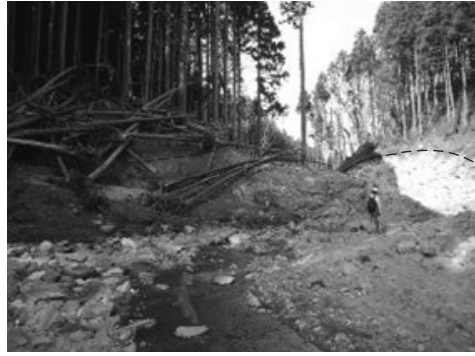
Photo 5 Mud marks on valley walls
(April 15th at 37.306236, 140.199503)

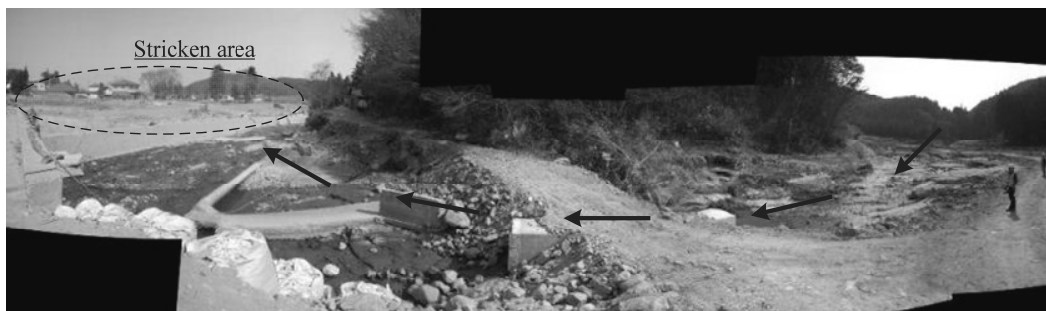
Photo 6 Debris flow channel and the village caught in the flash flood (April 15th at 37.308131, 140.202481)

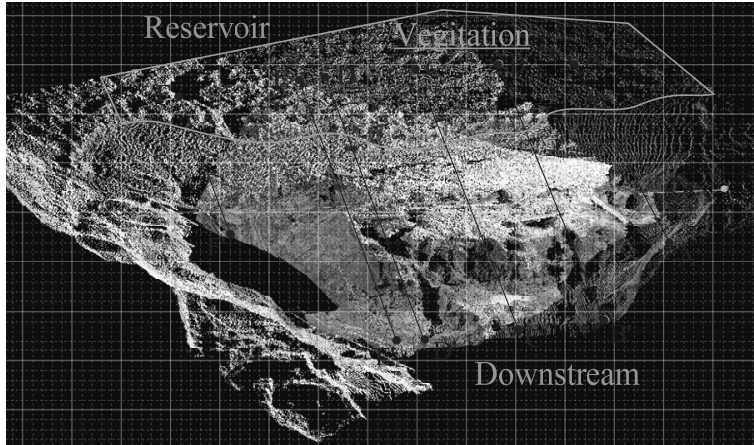
Fig. 5 shows a bird-eye view of the breached dam body. There yet remained some areas hidden from laser light, which appeared black in this figure. 5 months after the earthquake, the bottom of the emptied reservoir was covered thick with vegetation. Fig. 6 shows the contour map with the coordinate origin set at 1.5m above the original dam body crest. The right side of dam body was completely scoured.

Fig. 5 Bird-eye view of the breached dam

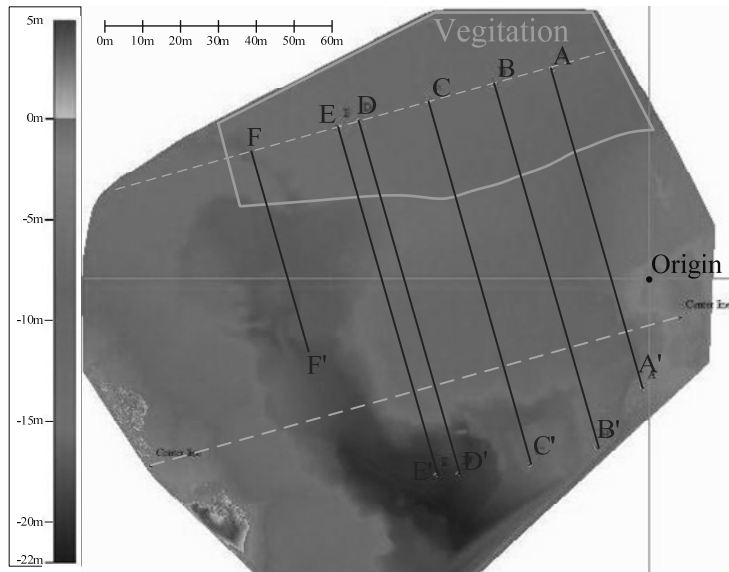
Fig. 6 Contour map of Z-value

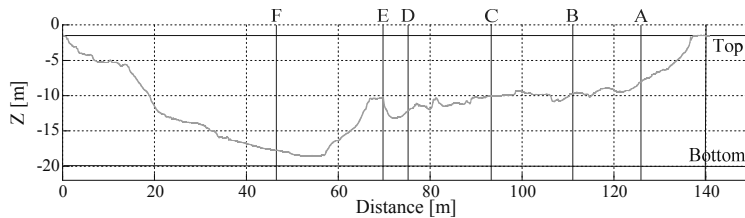
Fig. 7 Longitudinal section of breached dam

Fig. 7 shows the longitudinal cross-section of the damaged dam body, where two lines indicate the top and bottom levels of the original dam body. The top surface of the remaining left dam body is about 50m long, and about 8.5m below the original dam crest. Fig. 8 compares several cross-sections of the

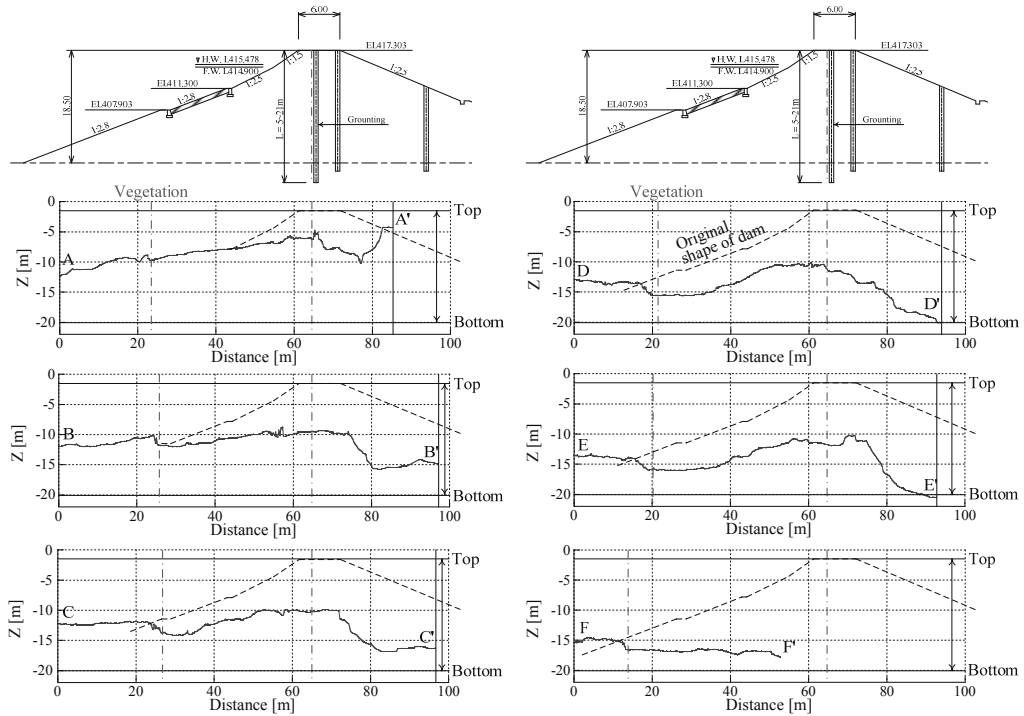
Fig. 8 Comparison of the obtained 3D image of the damaged dam with its original shape

damaged dam body with their original ones. These cross sections in Fig. 8 respectively correspond to lines A-A', B-B', C-C', D-D', E-E' and F-F' in Fig. 5, 6 and 7. With the presence of vegetation, every cross section after the earthquake shows an increase of the reservoir bottom by about 0 to 0.25m. It is clear from these cross-sections that scouring of the soil mass was seen over the entire stretch of the downstream slope. Particularly scouring was the most serious near the middle to right part of the dam body. Therefore, it can be deduced that the right dam body, which is the highest part of the entire dam body, slid first, causing either subsidence of the dam crest or razor-sharp earth wall to remain such that the water forced its way through this point. And then the overflowing water eroded both the upstream and downstream dam body.
