# DAMAGE TO NON-STRUCTURAL COMPONENTS IN LARGE PUBLIC SPACES BY THE GREAT EAST JAPAN EARTHQUAKE

Ken'ichi KAWAGUCHI<sup>1</sup>, Yoshiya TANIGUCHI<sup>2</sup>, Yuki OZAWA<sup>3</sup>,  
Yosuke NAKASO<sup>4</sup> and Sho WATANABE<sup>5</sup>

**ABSTRACT:** This is an investigation report on damage to non-structural components in large public spaces by the “Great East Japan Earthquake.” This paper mainly reports the field survey on damages to non-structural components in five large public spaces. Distribution of buildings which suffered ceiling damage during the “2011 off the Pacific Coast of Tohoku Earthquake” and its aftershocks is also shown by using data on web sites. The distribution clarifies that failure of ceilings occurred in the area of over 5-Lower intensity. Therefore, the distribution is likely to reach widely.

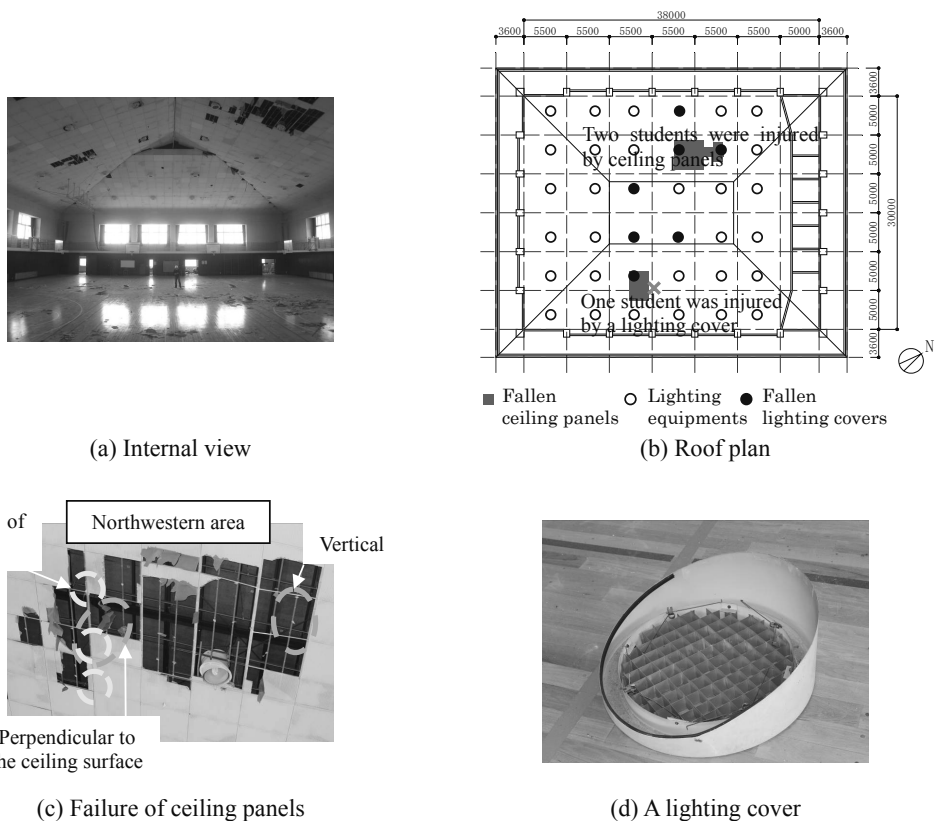
**Figure 2.** School gymnasium

The ceiling of the arena on the second floor of the gymnasium is a half-hipped type in accordance with the roof structure. Several ceiling panels, porous plaster boards of 9.0-mm thickness and  $63.7 \text{ N/m}^2$  weight fell off because of slip out of screws. Lighting covers also fell off (**Figure 2(a), (b)**). Fourteen panels in the northwestern area and six panels in the southeastern area fell from the ceiling of 7~11 m height. Falling of ceiling panels along the hip was also observed. According to observation of the northwestern area (**Figure 2(c)**), the hanger bolts near the main ridge were perpendicularly installed to the ceiling, and the hanger bolts near the edge of eaves were installed vertically. Float going up of a runner from the hanger attached to edge of the hanger bolt installed perpendicularly was also observed.

Lighting is fixed type, and its cover is detachable with four spring fittings for bulb's replacement. The cover fell off during the earthquake (**Figure 2(d)**).

Porous plaster board fell off at the eaves of the northeastern side and the northwestern side.

According to interview with an office staff, falling of ceiling panels had occurred two or more times before the "2011 off the Pacific Coast of Tohoku Earthquake," and leak in the roof had also occurred in the gymnasium. It is estimated that the cause of falling is external force by the earthquake. The force caused the deformation of porous plaster boards which was already brittle due to the leak. The slip off of screws occurred in consequence.

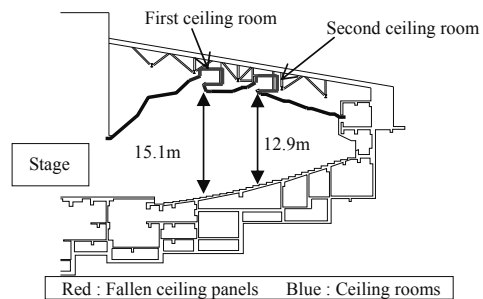
(b) Section

The ceiling which is in tiers for acoustic composed of panels which are a sets of a plaster board and a rock-wool board at 12.9~15.5 m height fell off during the main shock (**Figure 6(a), (b)**).

Ceiling panels had fallen off from two ceiling rooms. Ceiling rooms were suspended by steel frame. It is estimated that the frame’s movement during the earthquake is relatively small. However, the ceiling in front of the ceiling room was suspended from the roof with hanger bolt, and it is considered that the deformations of the ceiling room and the ceiling were different. Although there were braces between ceiling room and the ceiling, the buckling was observed (**Figure 6(d)**). While the ceiling under the ceiling room was suspended from the ceiling room, the other ceiling was suspended from the roof (**Figure 6(e)**). Therefore, it is considered that their hanging lengths are different causing the different earthquake responses.
