FAILURE OF CEILINGS IN AN AIRPORT BUILDING DURING THE 2011 OFF THE PACIFIC COAST OF TOHOKU EARTHQUAKE AND ESTIMATION OF ITS IMPACT

Yasushi OBA¹, Yosuke NAKASO² and Ken'ichi KAWAGUCHI³

ABSTRACT: This is an investigation report on the failure of ceilings at the entrance hall of an airport building with well space during the “2011 off the Pacific Coast of Tohoku Earthquake”. Although nobody was injured by the accident, the height of the ceilings was so high that the estimation of the extent of possible damage to human body is worth to understand the risk of such failure. The impact estimation was carried out by using a broadcasting video record taken accidentally during the earthquake and the results of ceiling dropping test to a dummy head.

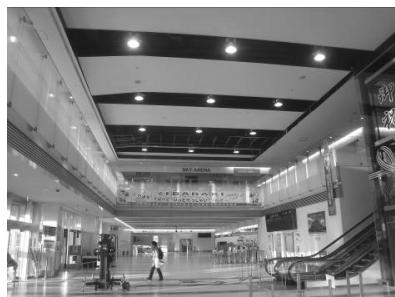
Figure 3. Internal view of lobby

Details of the building and its damage, the building’s site plan, and acceleration observed 12 km away from the airport are shown respectively in **Tables 1** and **2** and **Figures 1** and **2**. The seismic intensity of 6-Lower on the JMA scale was observed near the location. This report focuses on failure of ceilings in large well space (area: 25.8 × 11.2 m, ceiling height: 8.3 m) served as an entrance hall and a lobby. At the well space, ceilings were separated into five rows among which lightings are located. The northernmost row (11.2 m × 3.0 m) fell in whole during the main shock. (**Figures 3 to 6**)

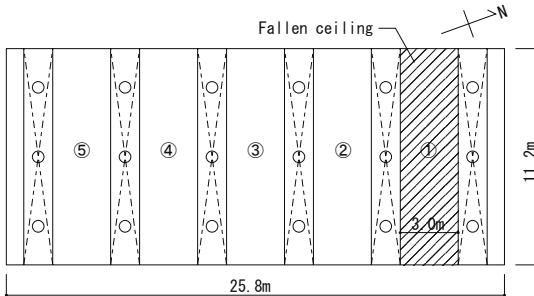
Figure 5. Reflected ceiling plan of lobby

Space	Details of damage
Lobby at the 1st fl.	Failure of ceilings (Figure 5, row①) Failure of ceilings at stepped part (Figure 5, row①~⑤) Deformation of ceilings like hanging (Figure 5, row③))
Gallery at the 2nd fl.	Failure of indirect lightings and ceilings over 11 m long
Shop at the 2nd fl.	Hanging of duct vents

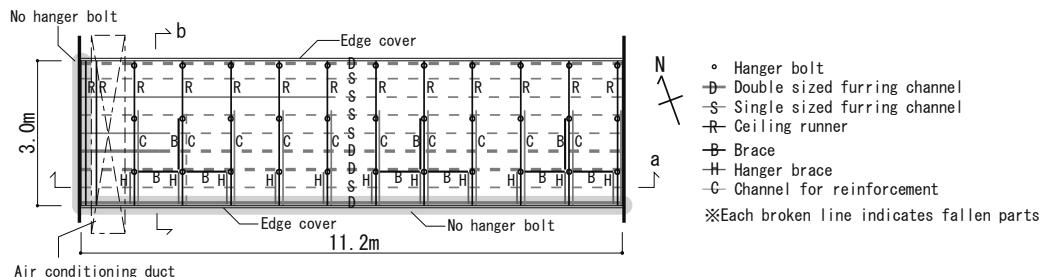
Figure 7. Reflected plan of fallen ceiling

As illustrated in **Figures 7 and 9**, a gap was observed between arrangement of ceiling and one of inserts on roof side and the ceiling was put to one side against arrangement of hanger bolts along the direction of ceiling width (there was no hanger bolt around the bottom of ceiling plan in **Figure 7**). Therefore, there was no hanger bolt to hang panels and furrings on the southern part of the ceiling and they cantilevered. Channels and hanger braces seemed to be reinforcement for that was set only at the southern part of the ceiling (right side in **Figure 9**). These hanger braces was set at each ceiling runners but they had little effect to reduce horizontal motion of the ceiling because of absence of hangar bolt at the end. Braces, which composed triangles with hanger braces, was set only at three points. The arrangement of hanger bolts along the longitudinal direction was uniform, except in west end with air conditioning ducts, but three pairs of braces was set to southern side (braces seen in **Figure 8** was set only at most southern row of hanger bolts in **Figure 7**). Upper ends of braces was fastened to hanger bolts around their roots with metal fittings, on the other hand, lower ends was fastened to furrings and hanger bolts mainly by spot welding (it seemed). Longitudinal end of the ceiling butted against stepped parts of surrounding ceiling without clearance. Finishing panels at the parts also fell off by collision.

Almost all furring channel (**Figure 7**) and many deformed clips fell (**Figure 10**), therefore, it is suggested that direct cause of the failure was coming off of clips. First, there was strong possibility

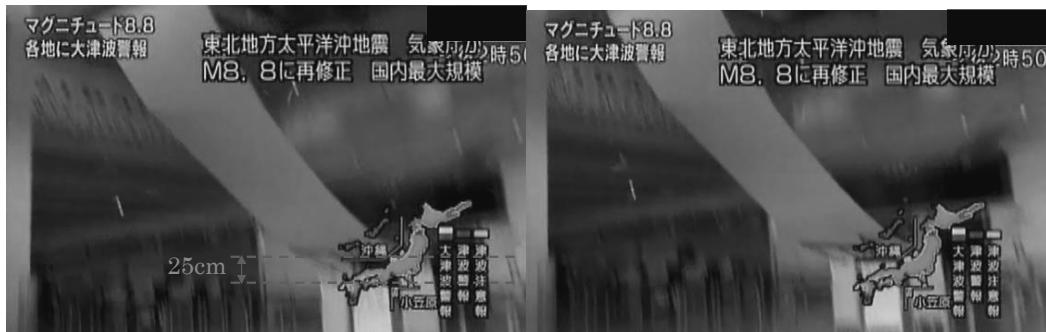
Figure 14. Video of falling ceiling (NHK)

It is assumed that a man of 170 cm tall stands just under the ceiling in the accident. Estimated from the TV video, falling velocity of the ceiling at the height of 170 cm above the floor is approximately 8.5 m/s. Since the ceiling height is 8.3 m, the velocity may be equal to one in condition that falling height is 6.6 m. Here the estimated velocity is verified with relation between falling height and velocity tested in Ref. 3 (Figure 17). The falling velocity of underlayered ceiling with furring channels to falling height of 6.6 m is 8.7 m/s. It agrees approximately with 8.5 m/s estimated above. Therefore, in this case it is assumed that the velocity just before impact of the ceiling falling in a body and one of ceiling the size of 910 mm×910 mm in the test are approximately equivalent for same falling height.

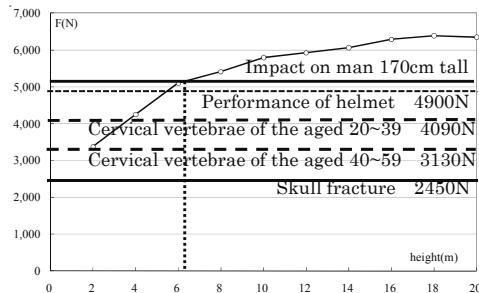
Figure 18. Impact of the underlayered ceiling

According to this, the impact on human head is estimated at 5100 N. In the figure thick solid line indicates the limit of skull (temporoparietal bones) fracture by Nahum. Thick broken lines indicate the limits of cervical fracture for men aged 20~39 and 40~59. Thin broken line indicates the limit used in performance regulation of helmets. It is confirmed that the impact estimated from the test data exceeds the limit of skull fracture. As mentioned above, if a man had stood just under the falling ceiling there might have been possibility that the impact led to critical injury such as brain contusion and injury of cervical vertebrae.
