DAMAGE TO NON-STRUCTURAL COMPONENTS IN A LARGE ROOF BUILDING DURING THE 2011 OFF THE PACIFIC COAST OF TOHOKU EARTHQUAKE AND ITS AFTERSHOCKS AND RECOVERY OF CEILING USING MEMBRANE MATERIALS

Ken'ichi KAWAGUCHI¹, Yoshiro OGI², Yosuke NAKASO³
Kazutaka UEMURA⁴ and Yasushi OBA⁴

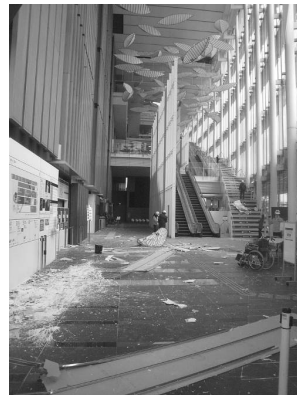
As shown in **Figure 6**, panels of the eastern ceiling failed and fell off with furring bars in a long and thin area next to the smoke barrier. Glass panels of the smoke barrier also broke. And about 30 vertical panels (approximately 0.8 m by 0.9 m) in the vicinity of the facade failed with furring bars in several regions along 25-m length (**Figure 7**). Several small parts of the ceiling next to walls also failed. Two hardened glass panels of the facade broken. One of the hanging art objects also fell off.

Figure 7. Internal view of the entrance hall after the disaster

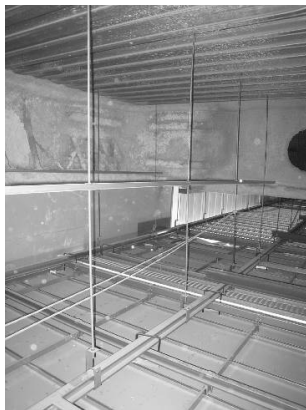
(a) Ceiling system

The ceiling system is hanging from the floor of the 7th story through heavy frame structure as shown in **Figure 8(a)**. The frame is composed of hanger bolts of 1630-mm length and 1500-mm pitch whose one edge is inserted into the deck-slab of the floor, upper runners (C-75×45), and orthogonally intersecting lower runners (C-60×30). The frame is used to support catwalk and hanging art objects. The ceiling panels are hanging of 5-cm hanging length from the frame.

Although horizontal anti-vibration bars and braces (C-60×30) had been placed among hanger bolts, they failed or dislocated due to buckling deformation of the members or fracture of their clasps. As shown in **Figure 8(b)**, a print on fire resistive covering of a steel beam scraped by the handrail was observed, which indicated that, during the earthquake, relative displacement in vibration amplitude between the building skeleton and the ceiling is over 20 cm in east-west direction. Because the duration of the main shock was so long, the circumstances can be estimated that many braces failed during the early part of the earthquake, inducing subsequent large horizontal motion of the ceiling.

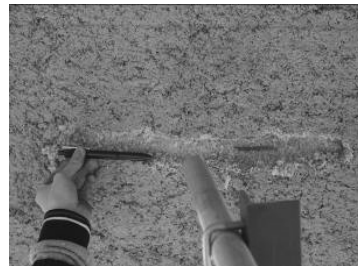
(b) Print on fire resistive covering

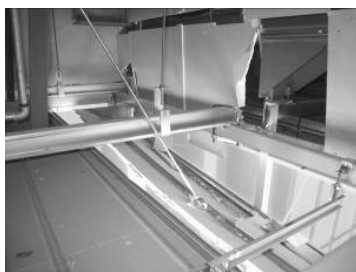
The reason for the failure of the panels next to the smoke barrier (**Figure 8(c)**) can be considered that collision between the barrier and panels due to motions in east-west direction. And the reason for the failure of the vertical panels in the vicinity of the facade (**Figure 8(d)**) can be considered that furring bars deformed and clips were dislocated during motions of lower panels pushing lower edges of the vertical panels.

(c) Failure of the panels next to the smoke barrier

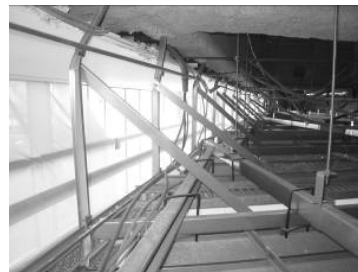
(d) Failure of the vertical panels in the vicinity of the facade

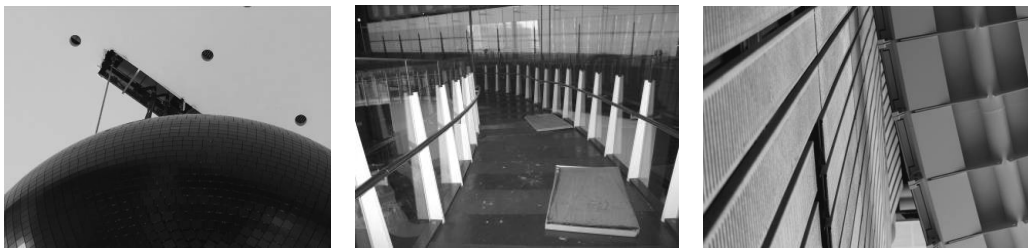
Figure 10. Damage to non-structural components at Symbol Zone

As shown in **Figure 10(a)**, panels of the oval ceiling around the hanging cable of Geo-cosmos had failed. Because hanging lengths of the ceiling and Geo-cosmos are different, the reason is estimated that two of them were oscillating at different phases during the earthquake.

Above the oval ceiling and just below the catwalk, punching metal panels ($1.3 \text{ m} \times 0.8 \text{ m}$, 40-N weight) were used to blind the catwalk, and 29 panels had fallen off to the oval ceiling and the ramp (**Figure 10(b)**). Furthermore, at around the height of the 6th story, finishing metal plates deformed and about to be dislocated (**Figure 10(c)**).

(a) Failure of ceiling panel (b) Fallen punching metal panels (c) Deformed finishing metal plates

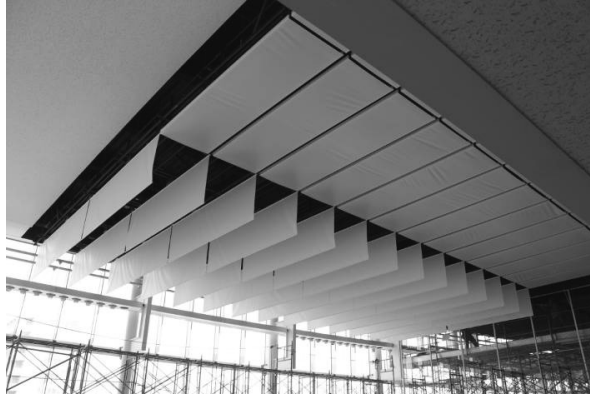
Figure 11. Recovery of the eastern ceiling at the entrance hall by membrane materials

As Miraikan considered becoming a good model to realize safety and reassuring of ceiling system, the recovery was planned with the authors. As a result, at the eastern part of the ceiling at the entrance hall (approximately 500 m²), all the panels with conventional method of construction were removed and recovered by membrane sheets. The duration of the recovery including the design was about 2.5 month. The thickness of the sheet is 0.28 mm, and the material is glass woven fabric coated with vinyl chloride on both sides. As shown in **Figure 11**, the sheets were directly attached to the hanging frame structure in two ways, horizontally and vertically.
