# PRELIMINARY STUDY OF OBSERVED RESPONSE OF SUSPENDED CEILING DURING AFTERSHOCKS IN A LARGE ROOF BUILDING

**ABSTRACT:** This paper reports results of dynamic characteristics of damaged suspended ceiling in the “National Museum of Emerging Science and Innovation (Miraikan),” Tokyo, Japan, by using observed motion data during aftershocks of the “2011 off the Pacific Coast of Tohoku Earthquake.” Analyses of horizontal motion data for the ceiling, the building structure, and the ground next to Miraikan recorded during aftershocks showed that the natural frequency of the ceiling was lower than that of the building structure. However, the structural characteristics of the building strongly affected the ceiling’s response.

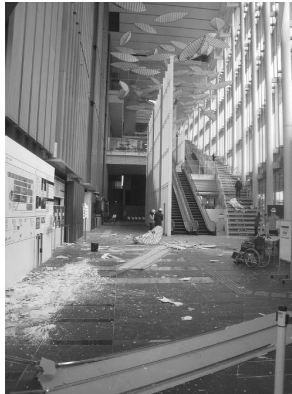
Figure 3. Internal view of the entrance hall after the disaster

The observed ceiling is located at an entrance hall (Figure 3). The hall is an open space of seven stories with a partially cylindrical glass facade, and the maximum height to the ceiling from the ground floor is 25.6 m. The observed ceiling is eastern one which is split by a smoke barrier. Its area is about 500 m<sup>2</sup>. It is hanging from the floor of the 7th story through heavy frame structure as shown in Figure 4. The frame is composed of hanger bolts of 1630-mm length and 1500-mm pitch whose one edge is inserted into the deck-slab of the floor, upper runners (C-75×45), and orthogonally intersecting lower runners (C-60×30). The frame is used to support catwalk and hanging art objects. The ceiling panels are hanging of 5-cm hanging length from the frame. The ceiling panel is a set of a 9.5-mm-thick plaster board as a base layer and a 9.5-mm-thick rock-wool board as a finishing layer.

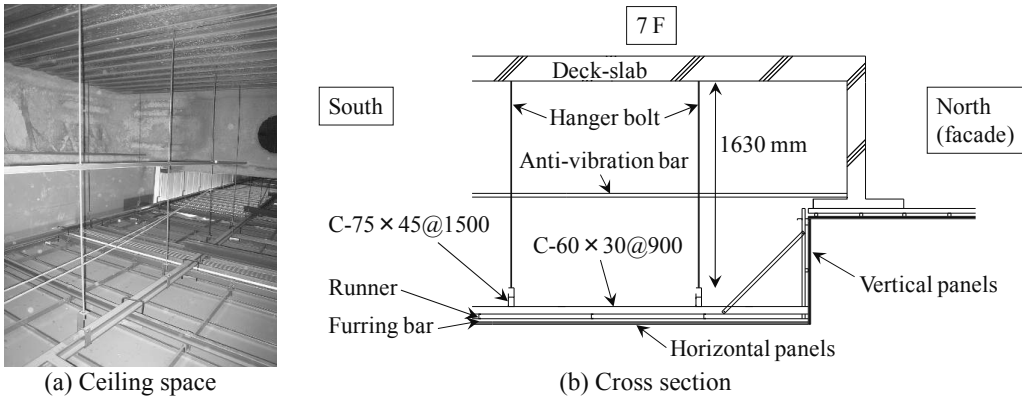
**Figure 4.** Eastern ceiling at the entrance hall

The ceiling suffered damage during the main shock and following aftershocks. Details of the damage and its recovery are described in (Kawaguchi et al. 2012).

The recovery of the ceiling began soon after the disaster. In the recovery, all the hanging art objects and all the panels with furring bars and runners were removed, but the frame structure remained onto which many new braces were placed among hanger bolts. The ceiling was renovated to membrane materials conclusively. However, the ceiling during the observation was a particular condition: no hanging art objects, no preexisting braces, no vertical panels shown in **Figure 4**, and no obstacles to be collided around the ceiling. In this study, the ceiling panels with the frame structure are regarded as a whole suspended ceiling. Therefore, the weight of the suspended ceiling is  $294 \text{ N/m}^2$ , which is two to three times of the conventional ceiling.

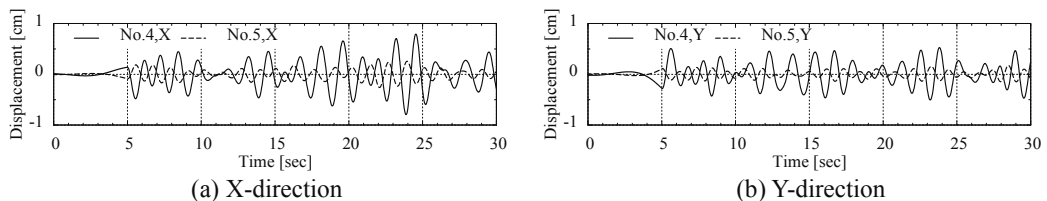
Time history of displacement of the building structure (No. 5) and the ceiling (No. 4) is illustrated in **Figure 6**. The data are numerically processed and integrated from originally recorded ones. Directions X and Y are defined in **Figure 5**. From **Figure 6**, it is observed that the motion of the ceiling is magnified in its vibration amplitude, transmitted through the steel beam from which the ceiling is hanging.

**Figure 6.** Time history of displacement of the building structure (No. 5) and the ceiling (No. 4)

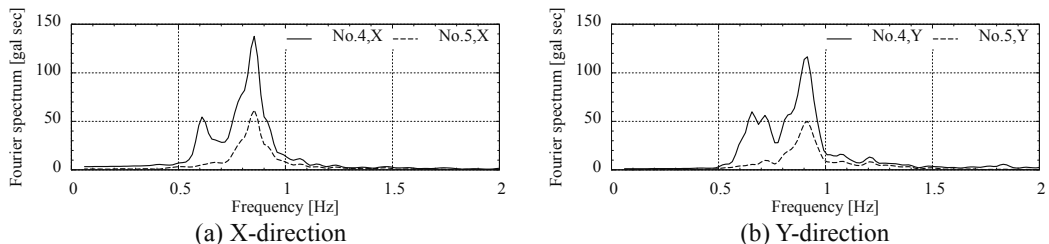
As for acceleration Fourier spectrum (**Figure 7**), the predominant frequencies of the building structure and the ceiling are nearly identical as 0.82 to 0.85 Hz in the X-direction and 0.90 to 0.93 Hz in the Y-direction. However, as for the amplification ratio of the ceiling to the building structure (**Figure 8**), the predominant frequencies are 0.61 to 0.66 Hz, which are lower than those of the acceleration Fourier spectrum. In this study, the lower predominant frequencies should be regarded as the 1st natural frequencies of the suspended ceiling in the X and Y directions. The amplification ratio at around the ceiling's natural frequency is 4.0 to 11.1. Although the ratio decreases with distance from the natural frequency, it is 1.7 to 3.2 at around the predominant frequency of the building structure. The reason can be considered that the ceiling is heavy.

**Figure 7.** Acceleration Fourier spectrum of the building structure (No. 5) and the ceiling (No. 4)

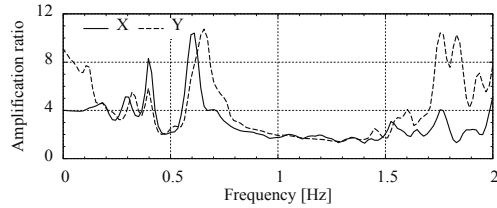
**Figure 8.** Amplification ratio of the ceiling (No. 4) to the building structure (No. 5) in acceleration Fourier spectrum

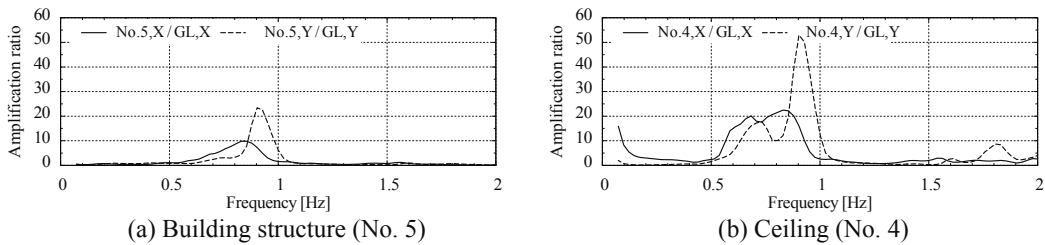
**Figure 10.** Amplification ratio of acceleration Fourier spectrum against the ground

Acceleration Fourier spectrum of the ground motion is illustrated in **Figure 9**. Several peaks can be observed, but the spectrum is distributed in a wide frequency range. The predominant frequencies of the amplification ratio of the building structure to the ground (**Figure 10(a)**) are nearly identical to the ones of acceleration Fourier spectrum of the building structure (**Figure 7**), which indicates the resonance of the building structure at its natural frequency. On the other hand, the amplification ratio of the ceiling to the ground (**Figure 10(b)**) also shows predominant frequencies at the building structure's natural frequency, while small peaks can be observed at the ceiling's natural frequency. Therefore, it can be concluded that the structural characteristics of the building strongly affected the ceiling's response.
