SURVEY REPORT OF 2011 VAN EARTHQUAKE IN TURKEY

ABSTRACT: On October 23, 2011 at 10:41:21 UTC, an intense earthquake ($M_w=7.1$ according to USGS) occurred in eastern Turkey. Another earthquake ($M_w=5.6$ according to USGS) occurred around Van city on November 9, 2011 which also caused the collapse of buildings weakened by the first shock. AIJ and JAEE organized a survey team after the events. The team was dispatched to Van and Ercis cities, Turkey, and conducted initial damage assessment in the damaged area with the survey groups from Yuzuncu Yil University, Bogazici University and mainly Istanbul Technical University. This report outlines the findings obtained from the survey of the damaged area.

Key Words: 2011 Van earthquake, damage reconnaissance, R/C buildings, Masonry buildings, Damage classification

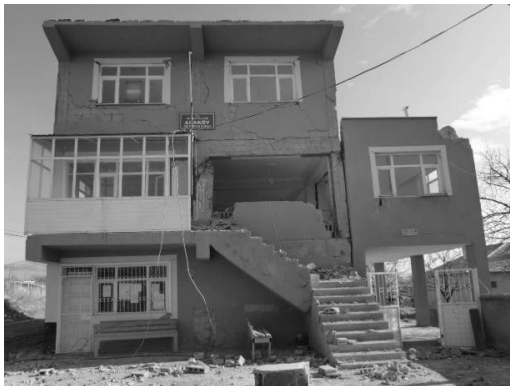
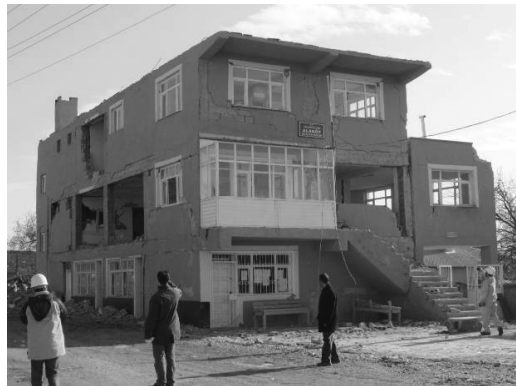
Photo 1 Overview of building

The school building shown in Photo 1 is located in Alakoy and consisted of structurally independent two reinforced concrete buildings stand side by side: three-story and two-story reinforced concrete buildings. The three-story building was severely damaged.

(a) Front view

(b) North-west side of view

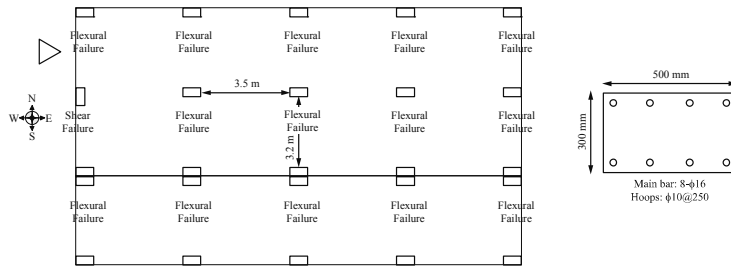
Figure 2 Second floor plan and damage pattern of columns

The second floor plan of the buildings and damage patterns are shown in Figure 2. The details of damage are written beneath the column depicted by rectangular in Figure 2. The three-story building has four spans in the longitudinal direction and three bays in the transverse direction, and those of span lengths are shown in Figure 2. The columns are arranged in the same direction, except the column on the west side, beside the entrance indicated as a triangle symbol. The typical geometry of cross section of the columns shown in Figure 2 has eighteen $\phi 16$ plain bars, a $\phi 10$ plain bar hoop spaced at 250 mm approximately, and 20 mm of concrete cover. A clear height of 2.1 m at the second floor was assumed.

The calculated ultimate strengths of the columns are listed on Table 2. The story shear strength of the floor is calculated as 674.4 kN, and the base shear strength coefficient, C_B is calculated by using the floor weight of two floors (2,688 kN) as 0.25. The west side end column was judged as failing in flexure as shown in Table 2, hence material property or bar arrangement detail are need to be discussed.

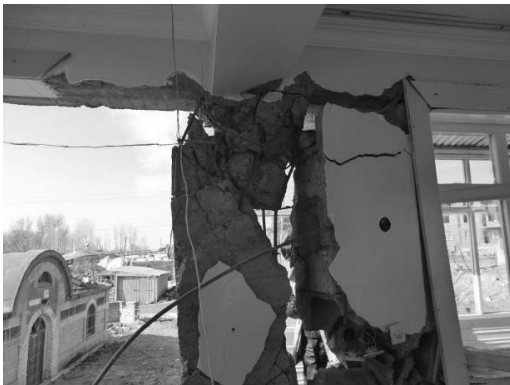
Photo 2(a) shows details of a west side column failed in shear. Concrete of the core was splitted off by the shear crack and the longitudinal reinforcement buckled. All the columns failed in flexure in north-south direction except the west side column as shown in Photo 2(b). Photo 3 shows the expansion joint between two buildings and approximately gap of 60 mm at the top of the second floor observed. The unreinforced concrete masonry wall was damaged and had several shear cracks of non-structural components.

(a) West side column failing in shear

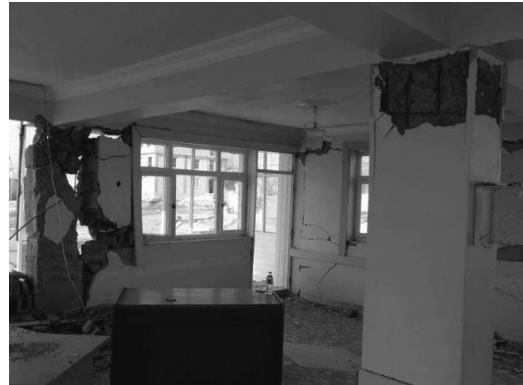
(b) Column flexural yielding at the top

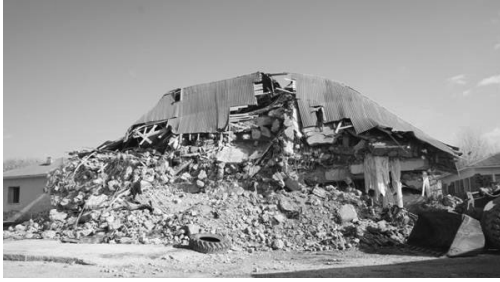
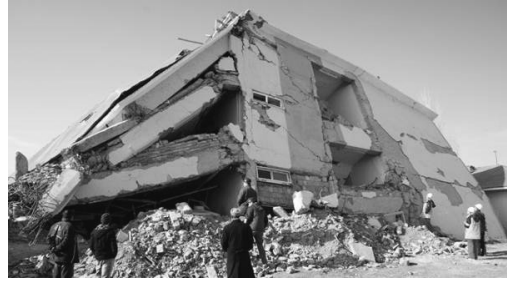
Photo 4 Overview of building

The building is three stories reinforced concrete building which is located at a village apart around 2 kilometers from the epicenter of the main-shock (October 23rd). The building was constructed in sometime from 1980 to 1990. All stories completely collapsed by the earthquake as shown in Photo 4. Fortunately no students and no teachers were killed, because the earthquake occurred on holiday. Since no structural and construction information is available, unquestionable reason of the collapse is unknown. Many beams and columns were observed to be separated at the join as shown in Photo 5(a). The reasons of such premature failures at joints were because of short anchorage length of beam main rebar to column and lack of confinement in the joint, as shown in Photo 5(b). The photograph also shows the ineffective anchorage length in the bottom bars of beam, which demonstrates the structural design and/or detailing was conducted only for vertical load, not for seismic load. Thus, the building must have collapsed by separation of beams and columns at every joint one after another during the earthquake, without providing enough resistance of structural members.

(a) West side of view

(b) East side of view

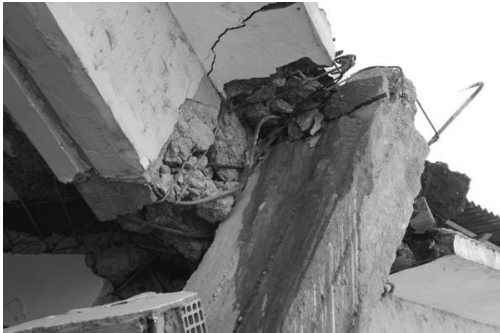
(a) Separation between beam and column

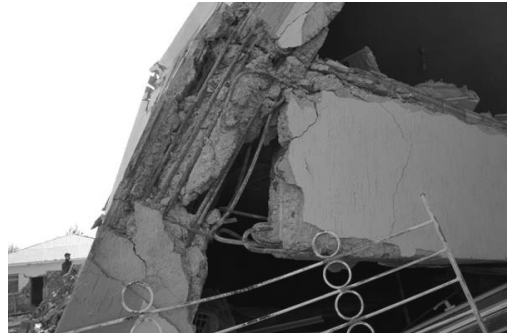
(b) Anchorage failure of beam main rebar

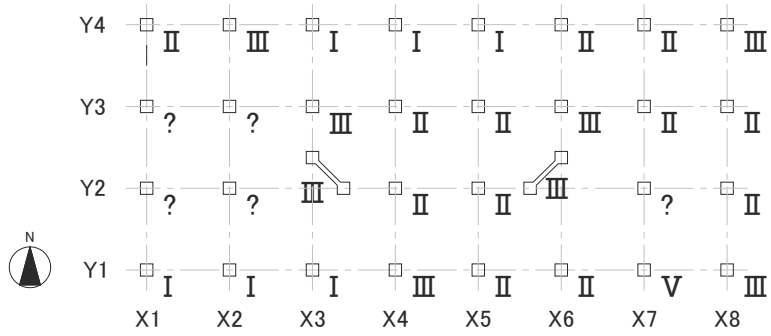
Figure 4 Second floor plan and damage level of structural members (Building A)

Four apartment buildings as shown in Photo 6 were investigated. The buildings are six stories reinforced concrete buildings, and their layout is shown in Figure 3. The first and second floor plan with the damage level in the longitudinal direction of structural members of Building A, B, C and D are shown in Figure 4 to Figure 7, respectively. Photo 7(a) shows details of shear failure at the top of a south side column. The beam-column joint failure was observed in the south-east corner of Building C as shown in Photo 7(b).

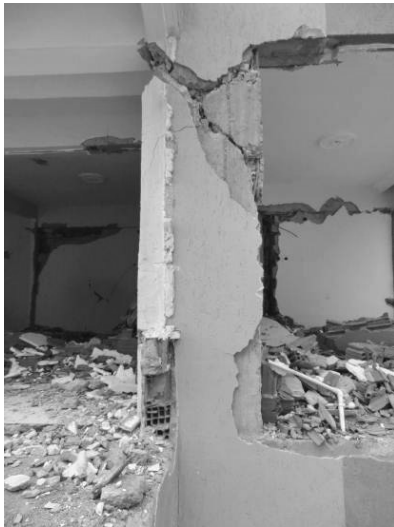
(a) shear failure of south side column of Building A (damage level V)

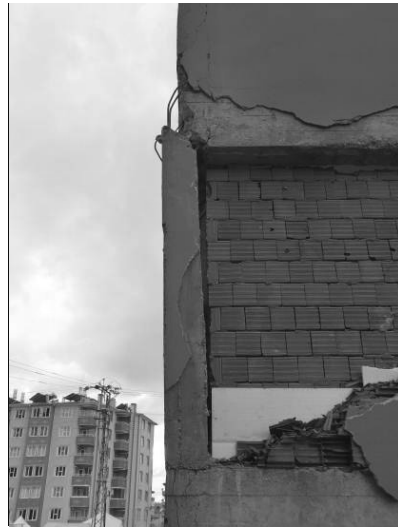
(b) beam-column joint failure (south-east corner of Building C)

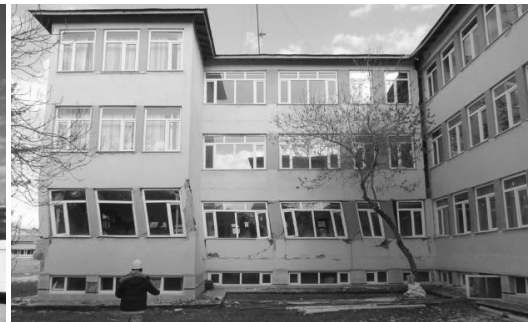
Photo 9 South side of Building C

Building C was severely damaged as shown in Photo 9. All columns yielded at the top and bottom ends of column and residual deformation was measured as about 7 degree. The residual gap between Building B and C at the second floor level is 30cm. Dimensions of all columns are the same, 200mm by 500mm. Bar arrangements in the columns were also investigated through cracks and with radar. There are four bars as main bar, of which diameter is 16mm, and diameter of hoop is 8mm with spacing of 200mm. The plan and column arrangement of building C is shown in Figure 5. Clear heights of columns, story heights, standing wall heights, and total height of the building are also shown in the Figureure.

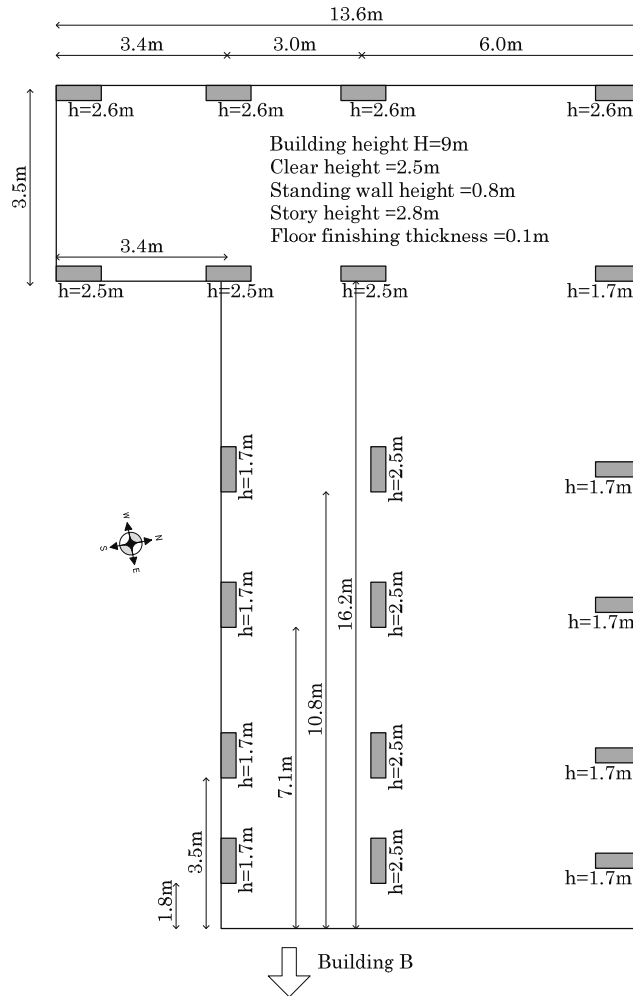
Figure 5 Floor plan and column arrangement of building C

Table 4 shows the calculated strengths. Only the column with D of 500mm and h of 1700mm is evaluated to fail in shear, although it showed flexural failure. Material tests are needed to discuss the failure mode. Story shear strength is calculated as 1006.01kN, $C_B=0.14$.

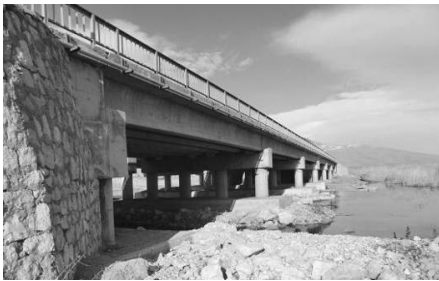
(a) Bridge with no significant damage

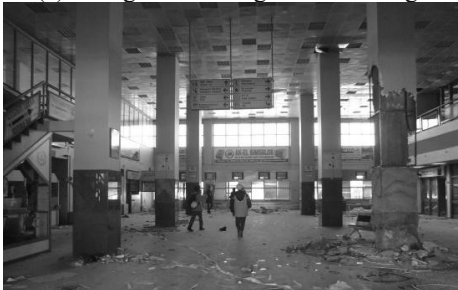
(c) Damage of airport

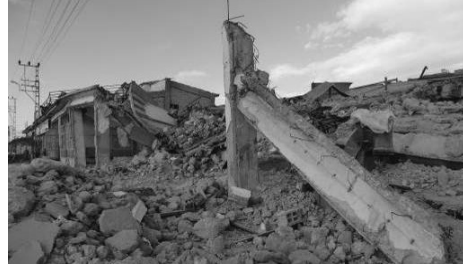
(b) Collapse of an industrial building

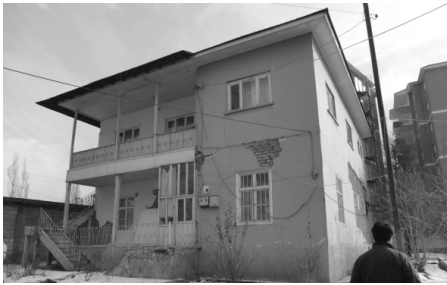
(a) Damage of adobe house
